CLOSURE

**RICE OPERATING COMPANY
JUNCTION BOX FINAL REPORT**

EME A-16 EOL

Unit A, Section 16, T21S, R36E

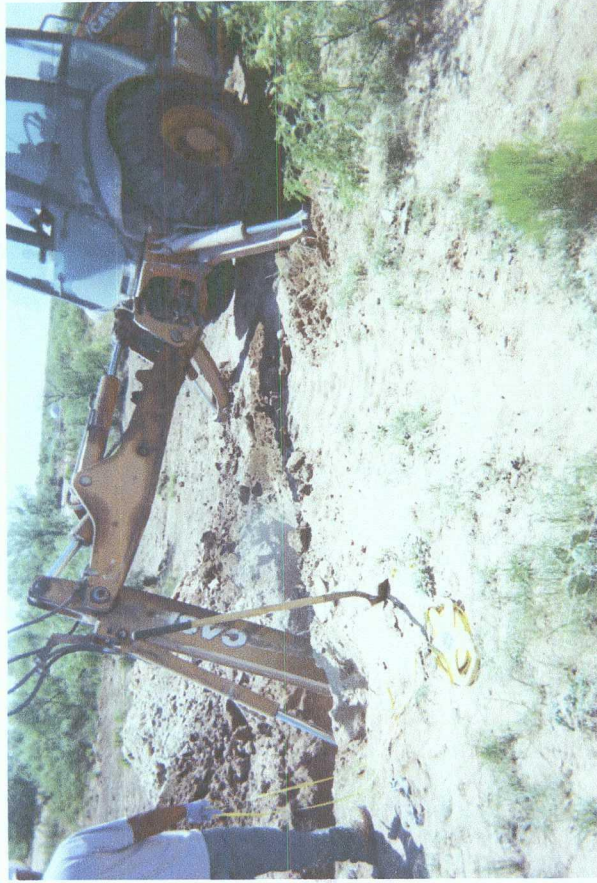
Delineation trench being excavated

6/25/2010

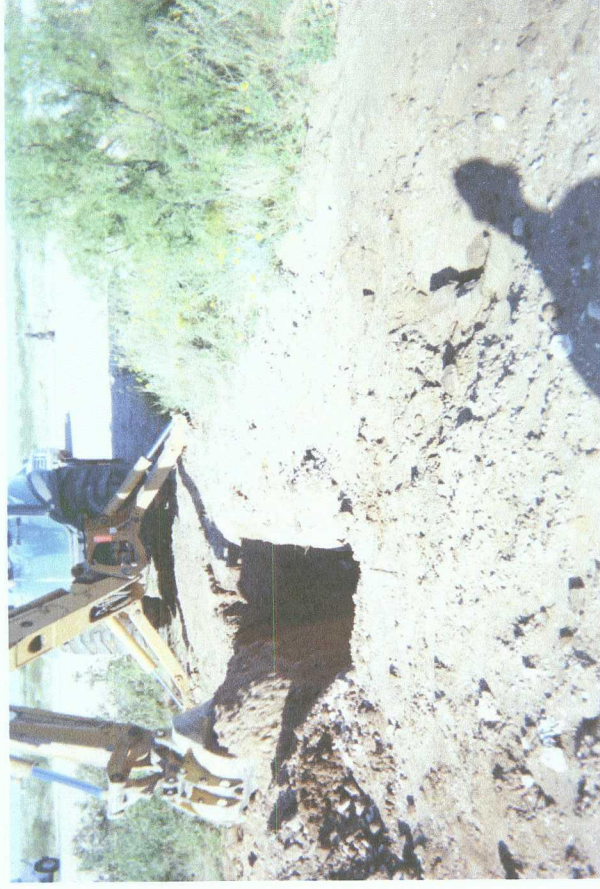
Backfilling trench

9/27/2010

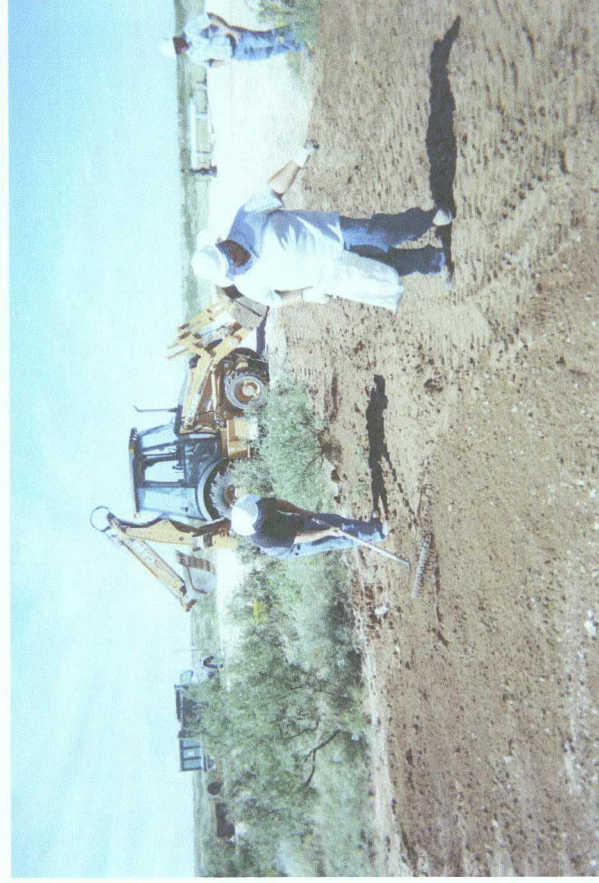
Seeding excavation

9/27/2010

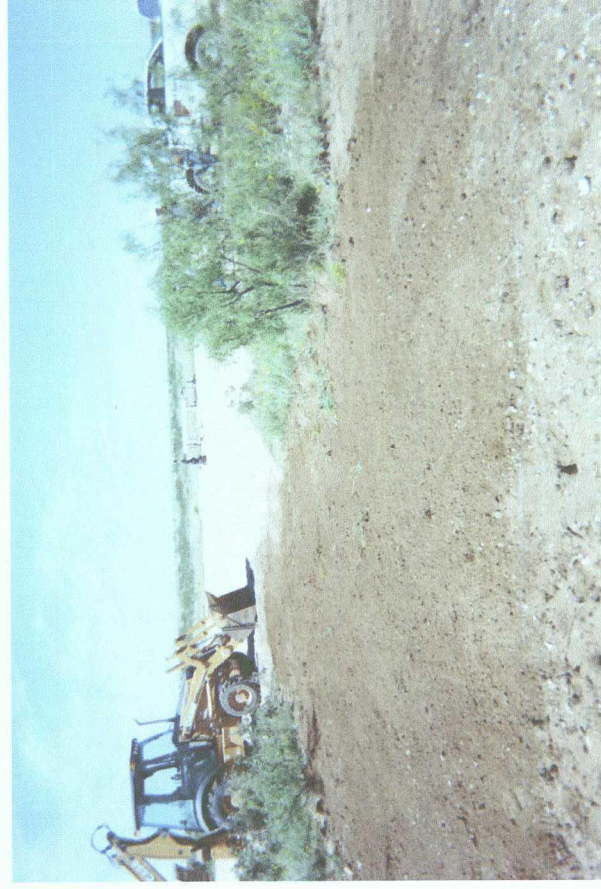
Excavation complete

9/27/2010

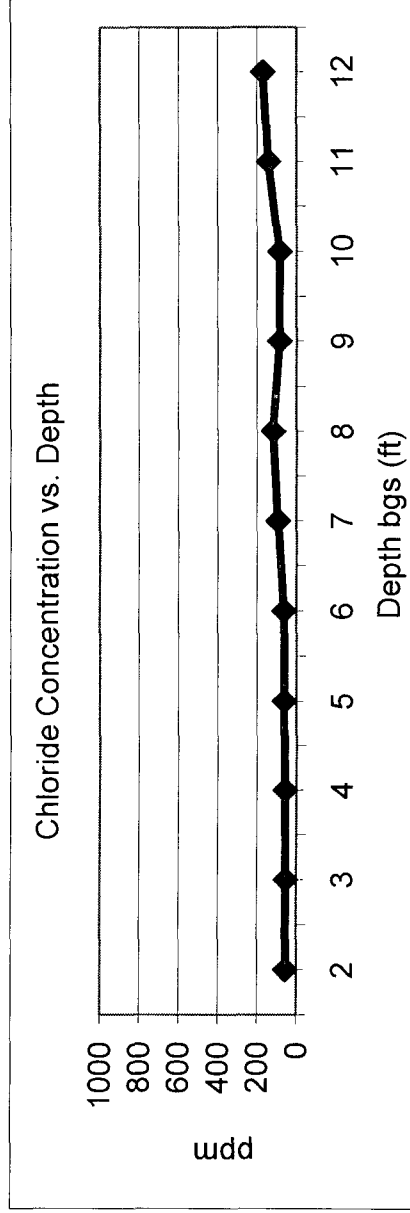
Backhoe samples at the junction (source)

Depth bgs (ft)	[Cl] ppm
2	57
3	54
4	57
5	61
6	62
7	92
8	118
9	86
10	85
11	141
12	170

Groundwater = 195 ft.
