**EME O-13 EOL**

**CLOSURE**

**RICE OPERATING COMPANY  
JUNCTION BOX FINAL REPORT**

Unit O, Section 13, T20S, R36E

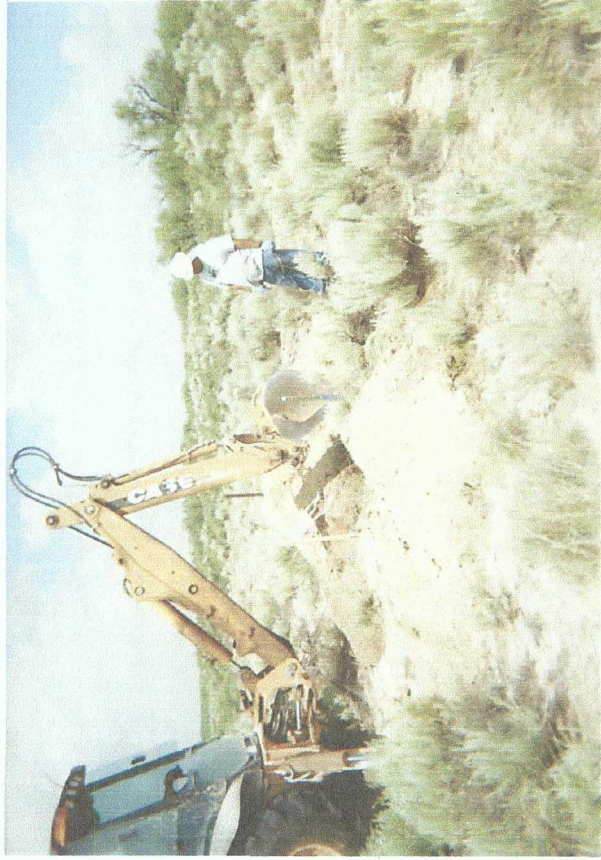
Delineation trench being dug

6/15/2010

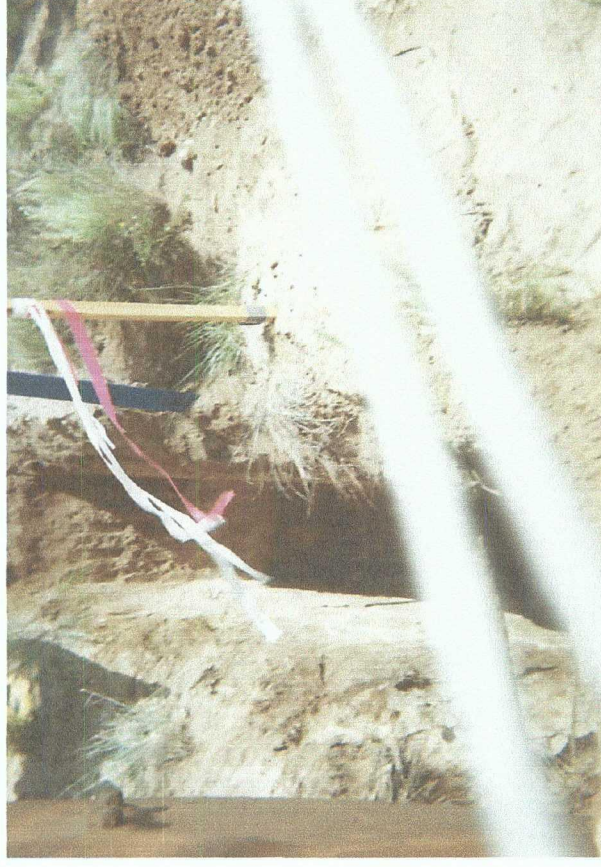
Final excavation

6/15/2010

creating a 5x3x7 ft. deep excavation. Chloride field tests were performed on each sample, which yielded low concentrations of chloride similar to that of the background sample. Organic vapors were measured using a PID, which also yielded low concentrations. The deepest sample, 7 ft. BGS, was sent to a commercial laboratory for analysis, which confirmed low concentrations of chloride and organics. The excavated soil was returned to the excavation to ground surface and contoured to the surrounding area. On 11/12/2010, the site was seeded with a blend of native vegetation and is expected to return to a productive capacity at a normal rate.

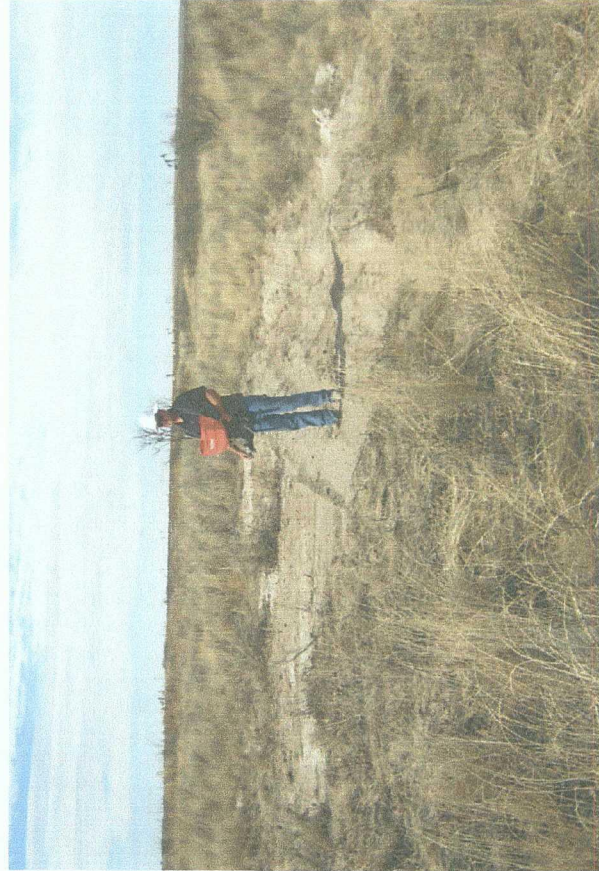
Seeding site

11/12/2010

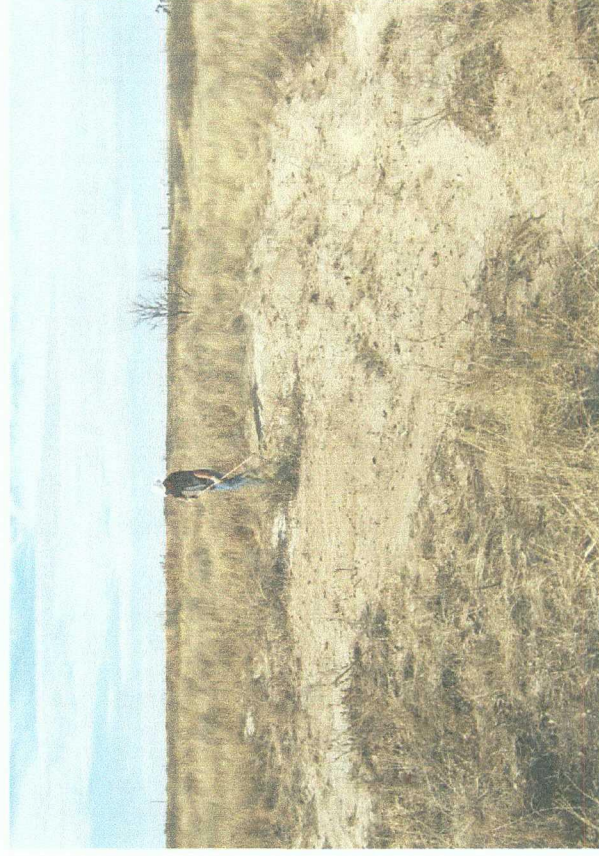
Covering seed

11/12/2010
