**EME Jct. G-13**

**CLOSURE**

**RICE OPERATING COMPANY  
JUNCTION BOX FINAL REPORT**

## EME JCT G-13

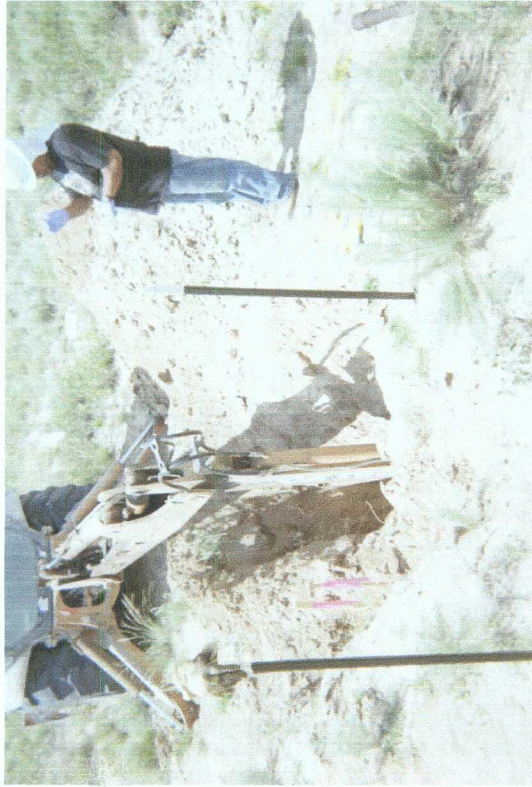
DELINEATION TRENCH BEING EXCAVATED

6/14/10

**General Description of Remedial Action:** This junction and line were eliminated

during the pipeline replacement/upgrade program. After the former junction box was

removed, an investigation was conducted using a backhoe to collect soil samples at

regular intervals producing a 5X3X8-ft. deep excavation. Chloride field tests performed

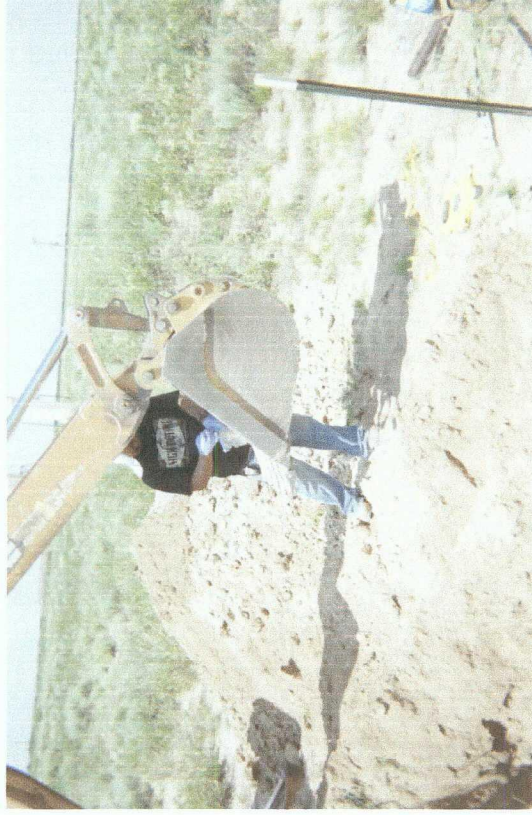
COLLECTING SAMPLE

6/14/10

PID, which yielded low concentrations. The deepest sample, 8 ft. BGS, was sent to a commercial laboratory for analysis of chloride and

TPH, which confirmed low concentrations of each. The excavated soil was returned to the excavation to ground surface and contoured

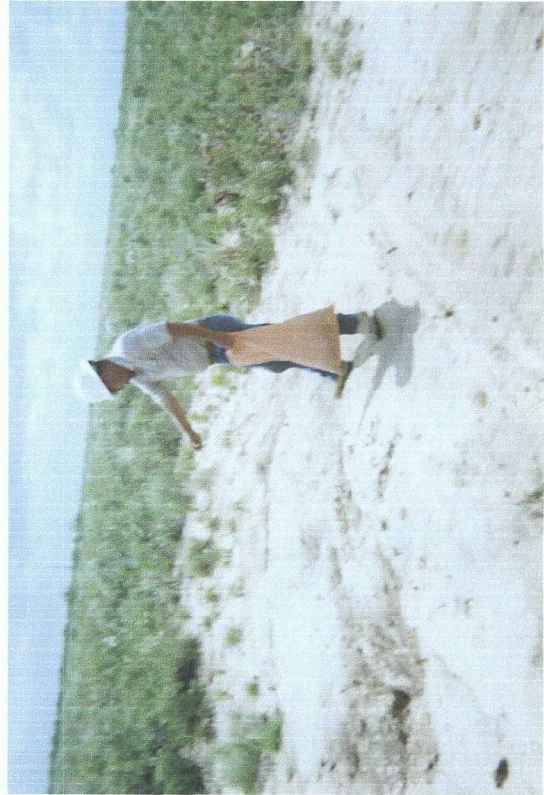
SEEDING SITE

7/8/10

to the surrounding area. On 7/08/2010, the site was seeded with a blend of native vegetation and is expected to return to a normal

capacity at a normal rate.

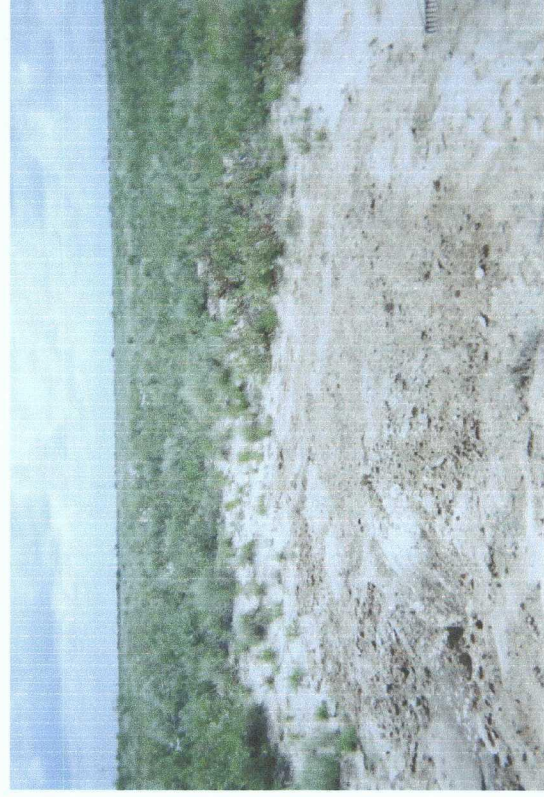
SITE COMPLETE

7/14/10

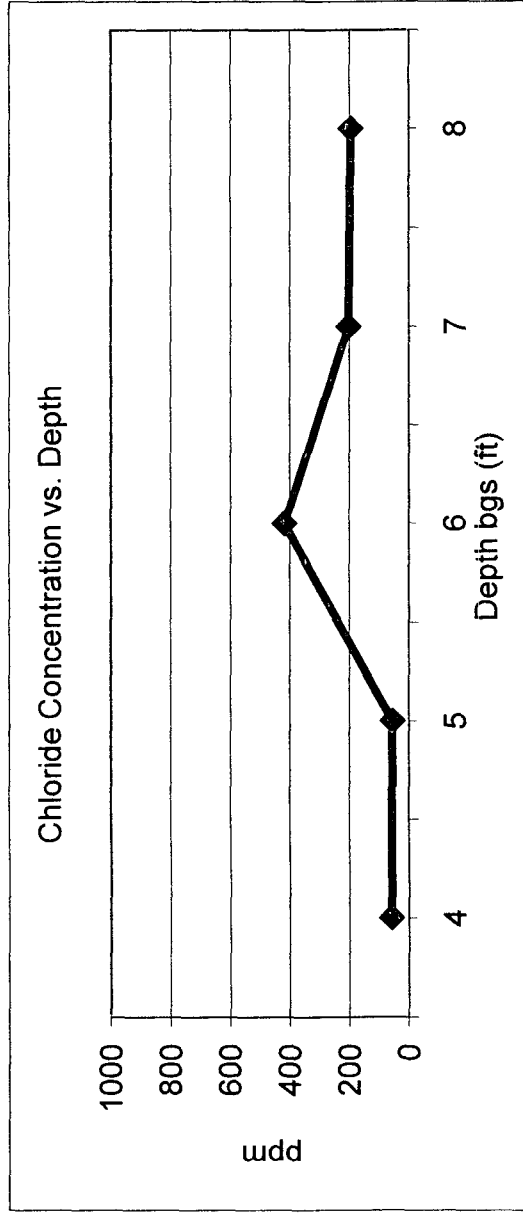
## Delineation of Source

Depth bgs (ft)	[Cl <sup>-</sup> ] ppm
4	59
5	56
6	418
7	204
8	196

Groundwater = 34 ft
