1R427-341

EME Jct. E-11

**RICE OPERATING COMPANY
JUNCTION BOX FINAL REPORT**

Unit E, Section 11, T21S, R36E

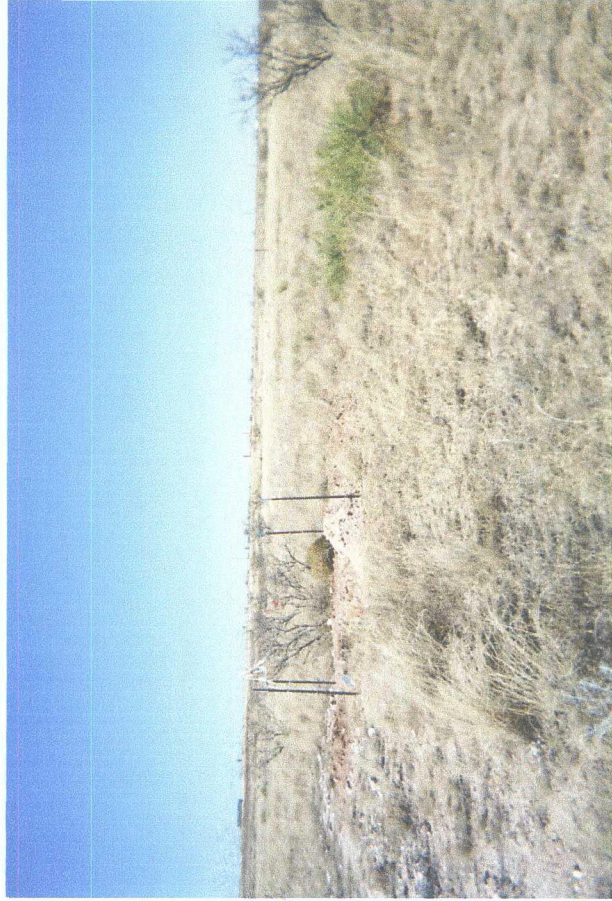
Site prior to excavation

11/29/2010

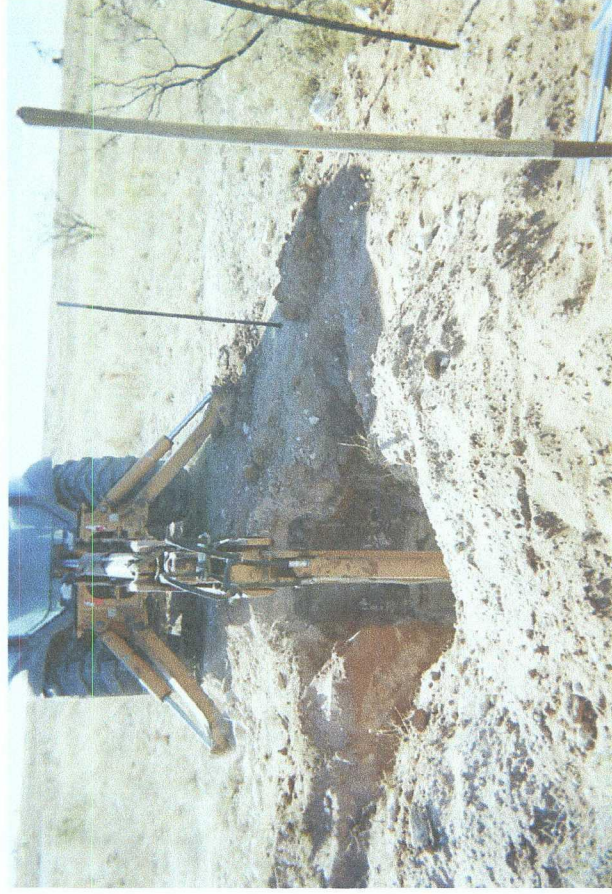
Delineation trench being excavated

11/29/2010

removed, an investigation was conducted using a backhoe to collect soil samples at

regular intervals producing a 5X2X8-ft. deep excavation. Chloride field tests performed

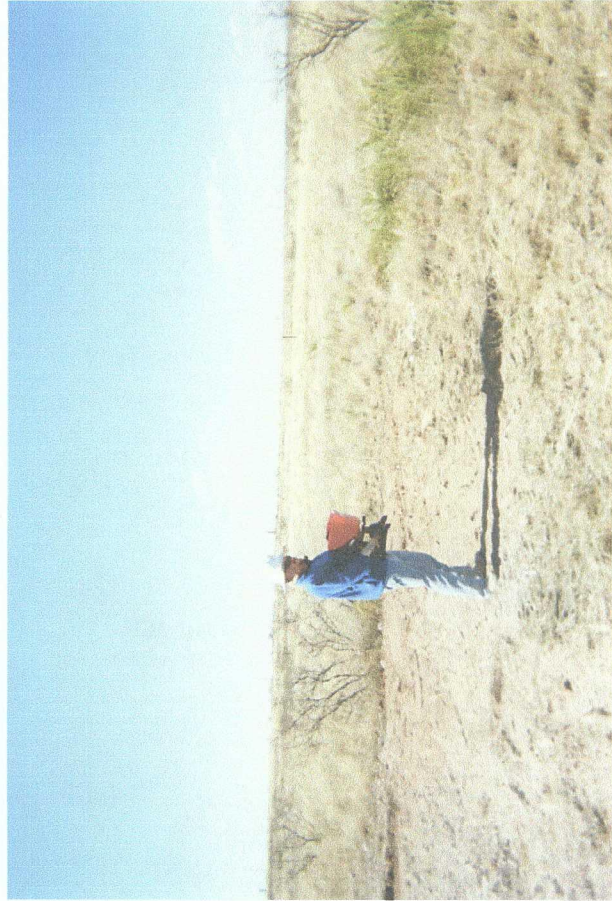
Seeding site

11/29/2010

surrounding area. On 11/29/2010, the site was seeded with a blend of native vegetation and is expected to return to a productive

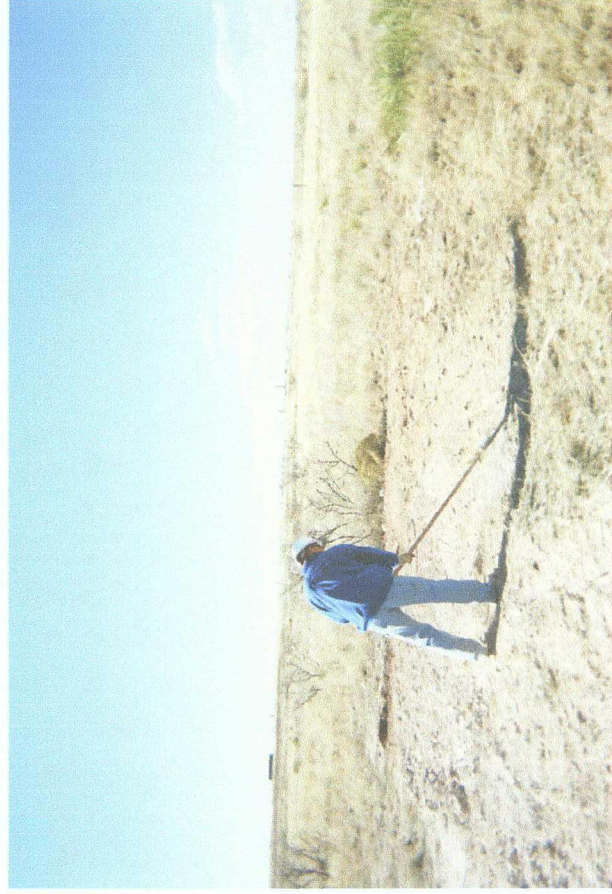
Covering seed

11/29/2010

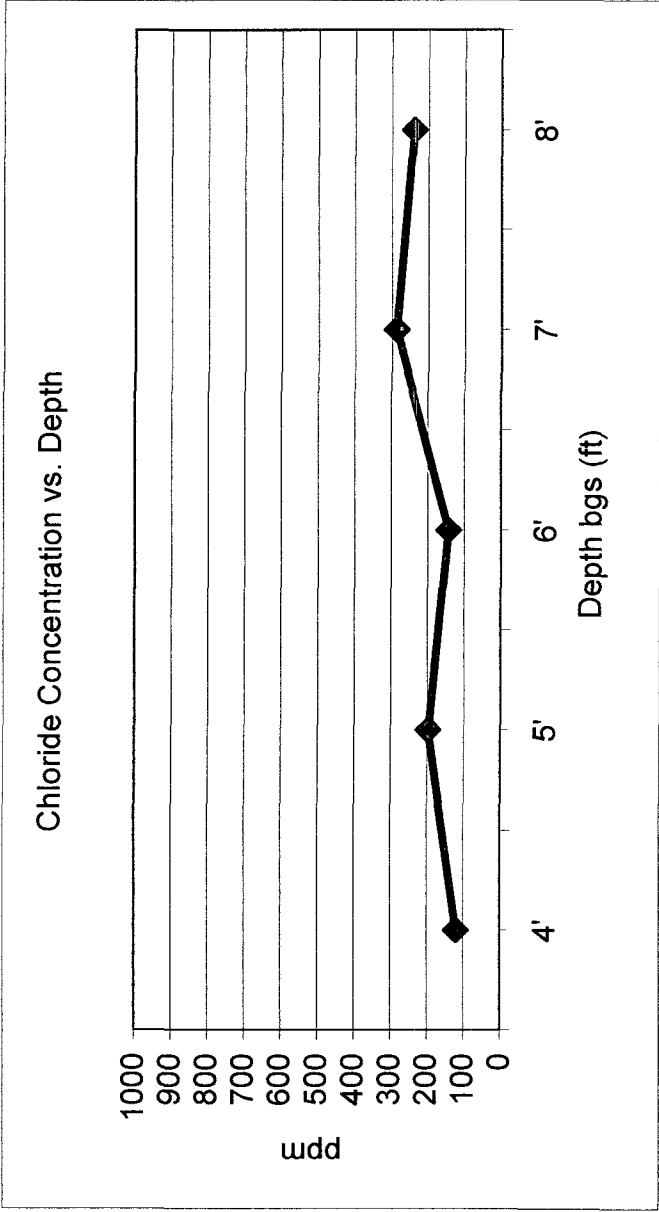
EME Jct. E-11

Backhoe samples at the junction (source)

Depth bgs (ft)	[Cl ⁻] ppm
4'	120
5'	197
6'	143
7'	287
8'	238

Groundwater = 159 ft.
