EME Jct. P-17

CLOSURE

**RICE OPERATING COMPANY
JUNCTION BOX FINAL REPORT**

Unit P, Section 17, T21S, R36E

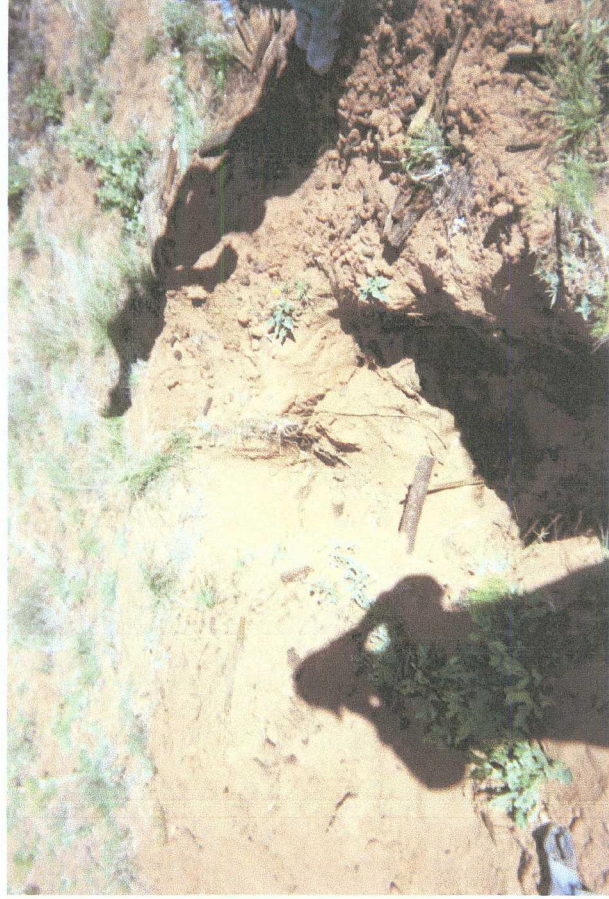
5/11/2010

Site prior to excavation

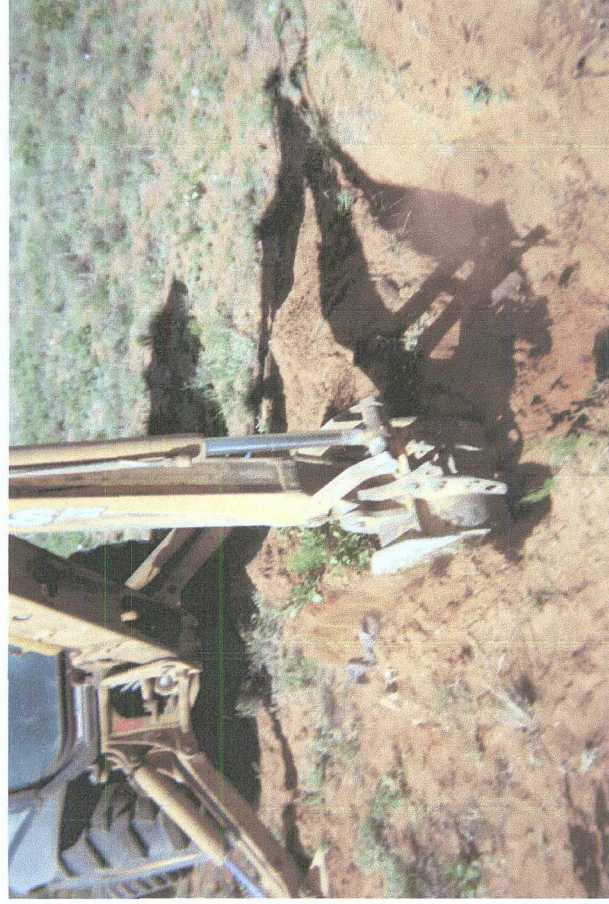
5/11/2010

Delineation trench being excavated

General Description of Remedial Action: This junction box and line were eliminated during the pipeline replacement/upgrade program. After the former junction box was removed, an investigation was conducted using a backhoe to collect soil samples at regular intervals producing a 5x3x6-ft-deep excavation. Chloride field tests performed on each sample yielded low concentrations similar to that of the background. Organic vapors were measured using a PID, which yielded low concentrations. The deepest sample, 6 ft. BGS was sent to a commercial laboratory for analysis of chloride and TPH, which confirmed low concentrations. The excavated soil was returned to the excavation to ground surface and contoured to the surrounding area. On 7/13/2010, the site was seeded with a blend of native vegetation and is expected to return to a productive capacity at a normal rate.

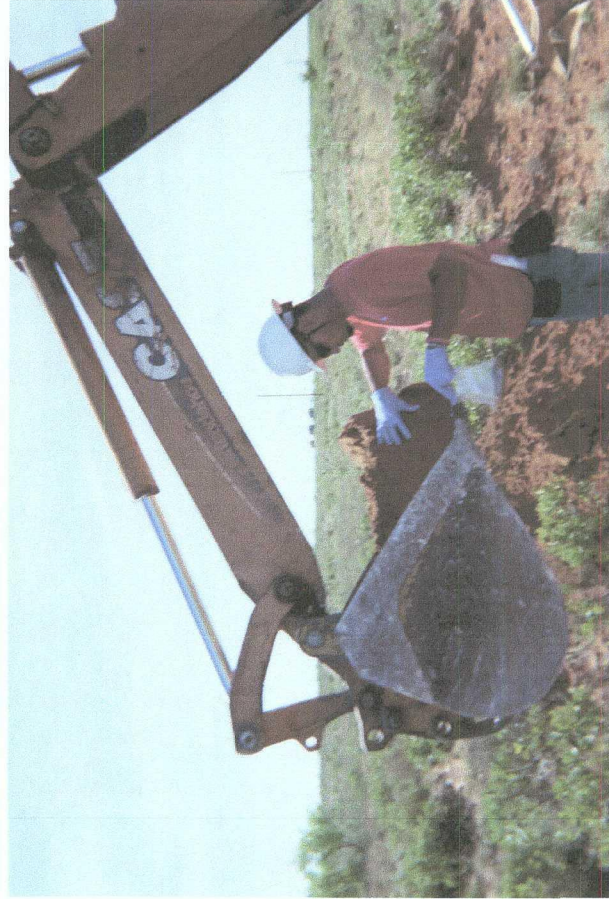
5/11/2010

Sample being collected

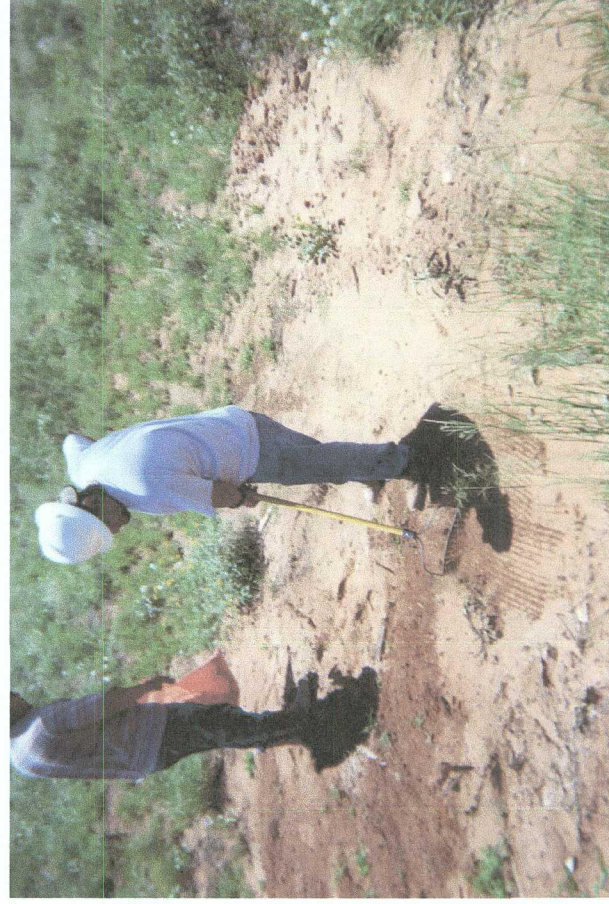
7/13/2010

Seeding excavation

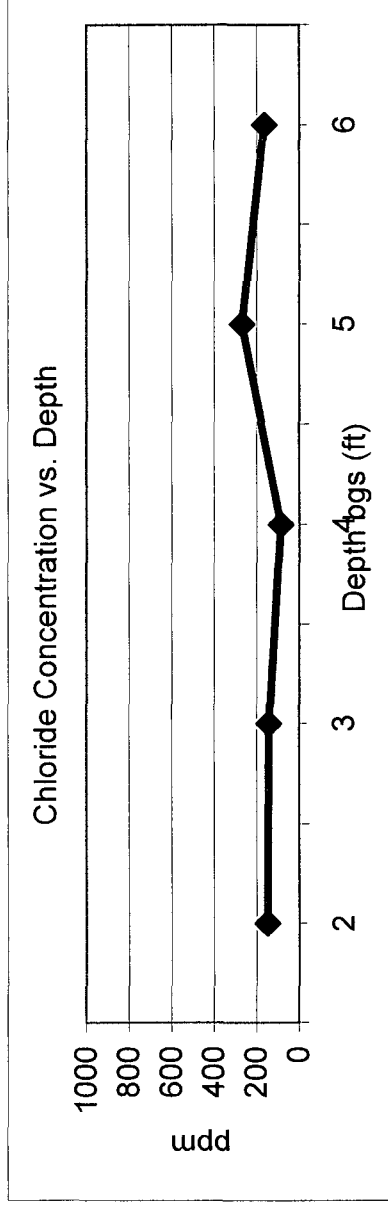
EME Jct. P-17

Backhoe samples at the junction (source)

Depth bgs (ft)	[Cl ⁻] ppm
2	151
3	143
4	87
5	270
6	165

Groundwater = 170 ft.
