EME D-17 EOL

**RICE OPERATING COMPANY
JUNCTION BOX FINAL REPORT**

SWD SYSTEM	JUNCTION	UNIT	SECTION	TOWNSHIP	RANGE	COUNTY	BOX DIMENSIONS - FEET		
Eunice-Monument-Eumont (EME)	D-17 EOL	D	17	21S	36E	Lea	Length	Width	Depth
							Eliminated

Unit D, Section 17, T21S, R36E

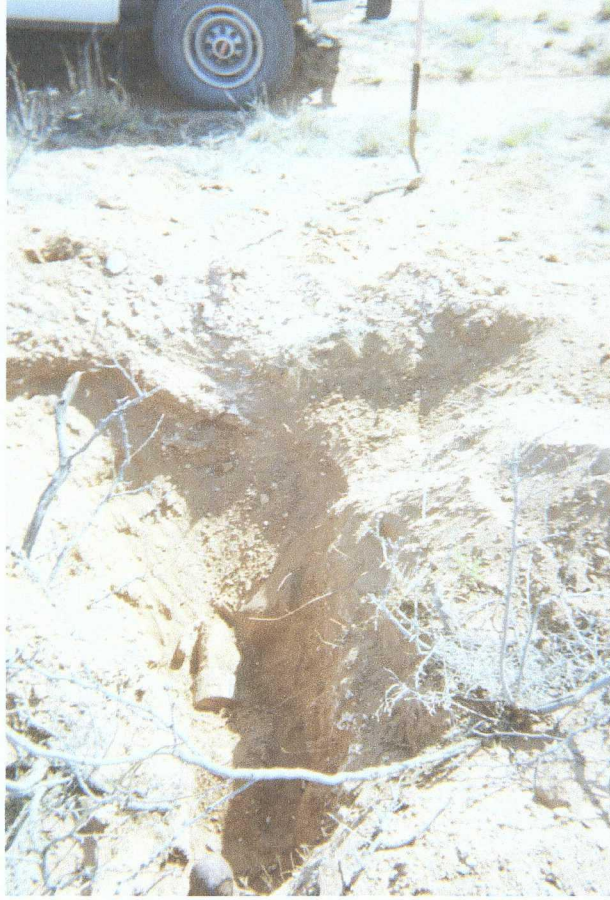
3/29/2010

Site prior to excavation

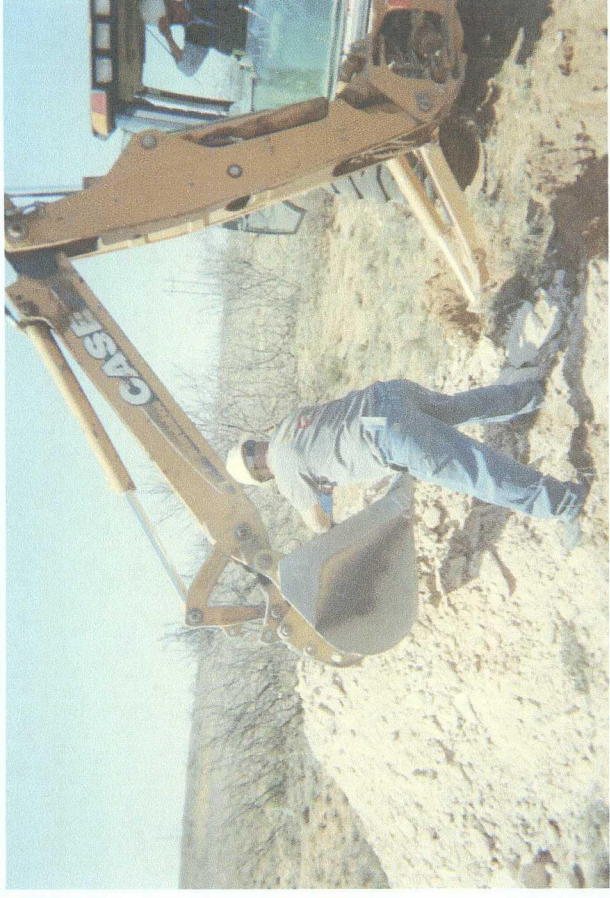
3/29/2010

Collecting a soil sample

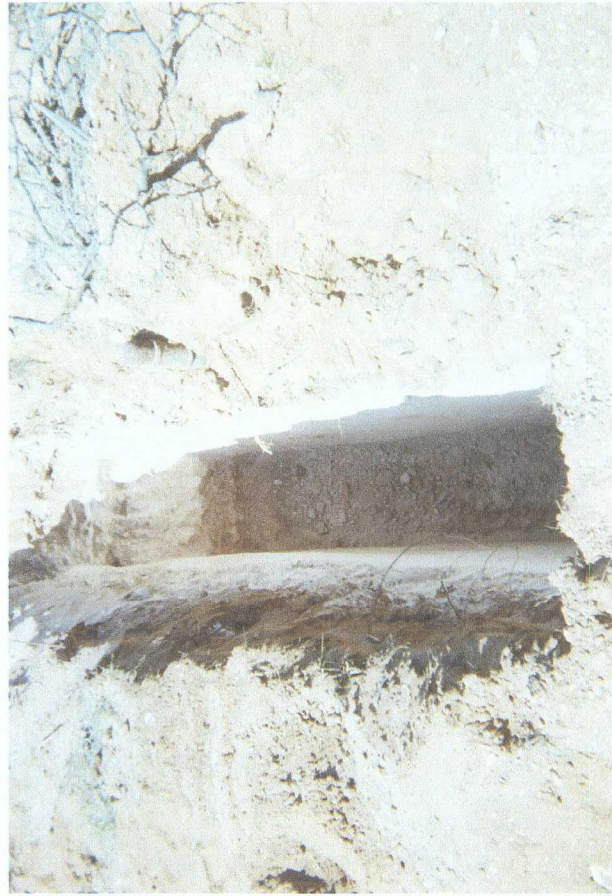
3/29/2010

Final excavation

General Description of Remedial Action: This junction box and line were eliminated during the pipeline replacement/upgrade program. After the former junction box was removed, an investigation was conducted using a backhoe to collect soil samples at regular intervals producing a 5x3x8-ft-deep excavation. Chloride field tests performed on each sample yielded low concentrations similar to that of the background. Organic vapors were measured using a PID and also yielded low concentrations. The deepest sample, 8 ft. BGS was sent to a commercial laboratory for analysis of chloride and TPH, which confirmed low concentrations. The excavated soil was returned to the excavation to ground surface and contoured to the surrounding area. On 4/7/2010, the site was seeded with a blend of native vegetation and is expected to return to a productive capacity at a normal rate.

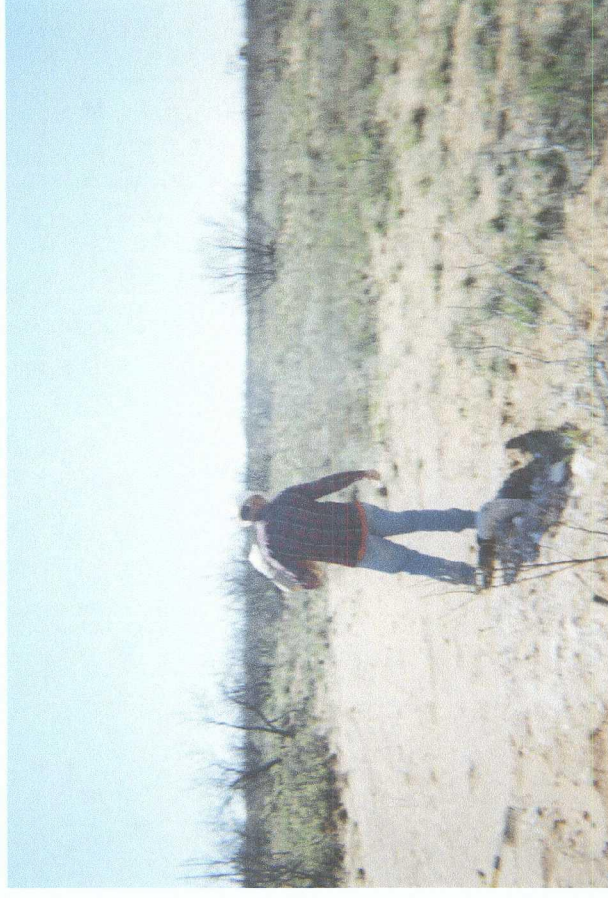
4/7/2010

Seeding excavation

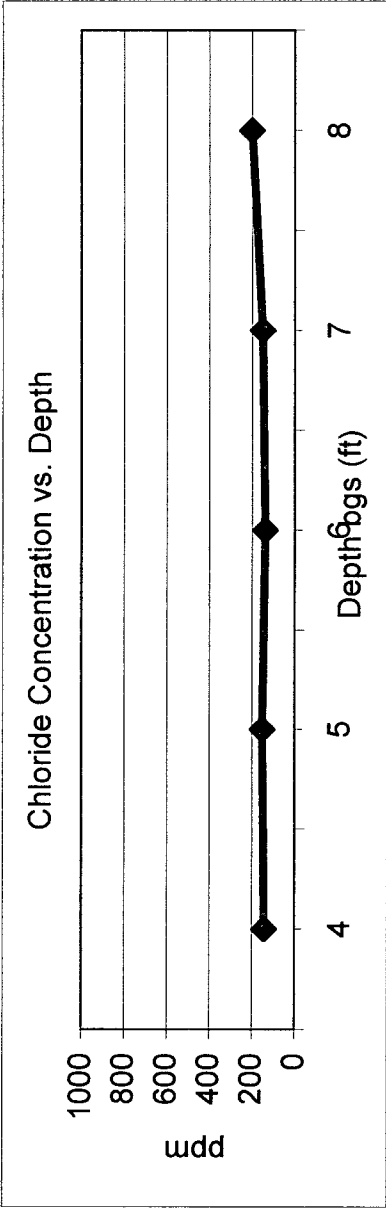
Backhoe samples at the junction (source)

Depth bgs (ft)	[Cl ⁻] ppm
4	143
5	152
6	138
7	150
8	201

Groundwater = 234 ft.
