EME Jct. N-13

CLOSURE

**RICE OPERATING COMPANY  
JUNCTION BOX FINAL REPORT**

Unit N, Section 13, T20S, R36E

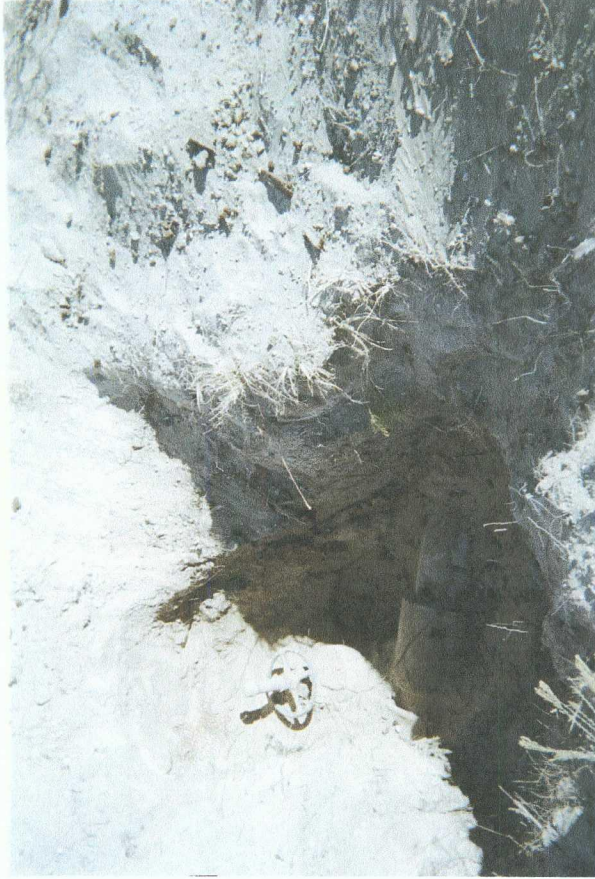
11/23/2010

Site prior to delineation

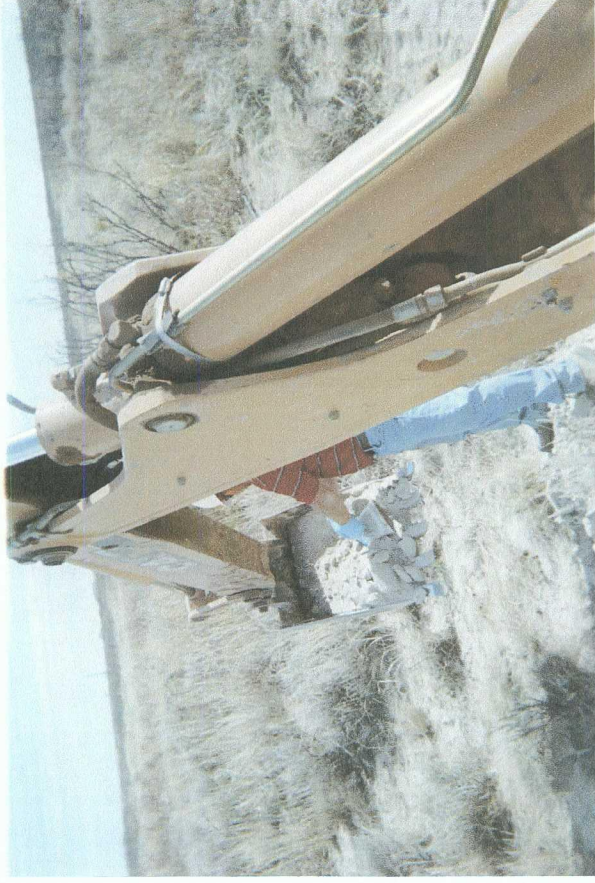
11/24/2010

Collecting sample

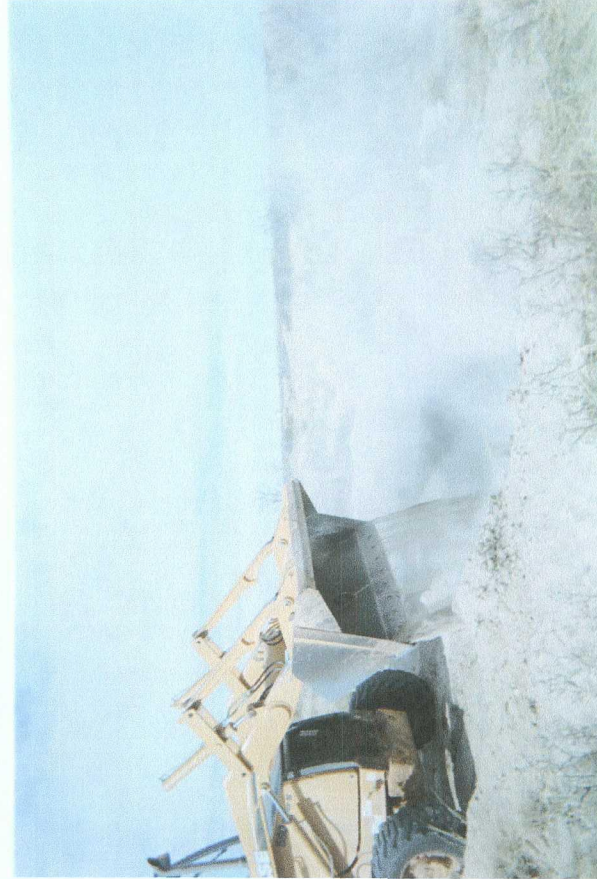
11/24/2010

Backfilling site

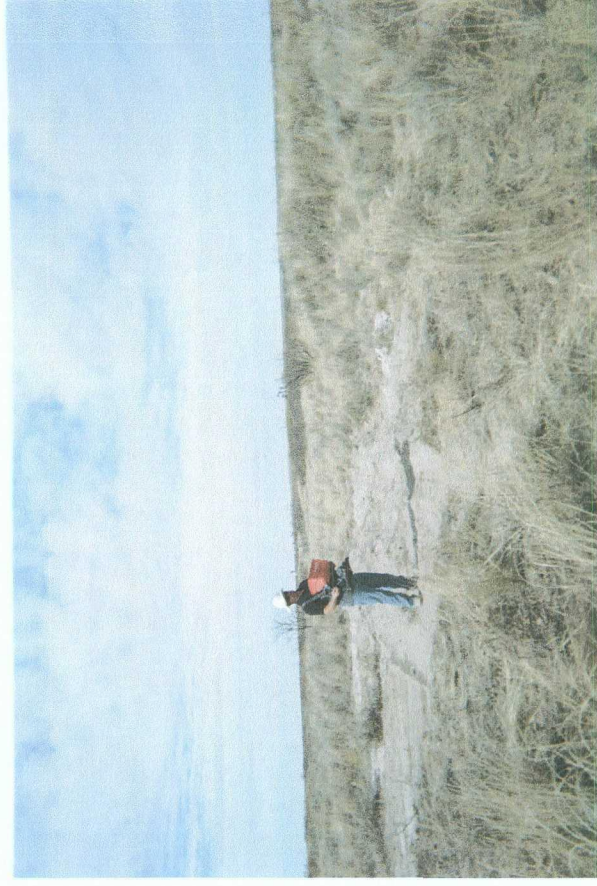
11/24/2010

Seeding site
