RICE OPERATING COMPANY
JUNCTION BOX FINAL REPORT

SWD SYSTEM	JUNCTION	UNIT	SECTION	TOWNSHIP	RANGE	COUNTY	BOX DIMENSIONS - FEET
Blinebry-Drinkard (BD)	K-1 EOL	K	1	22S	37E	Lea	55 Gallon Drum
							Eliminated

BD K-1 EOL

Unit K, Section 1, T22S, R37E

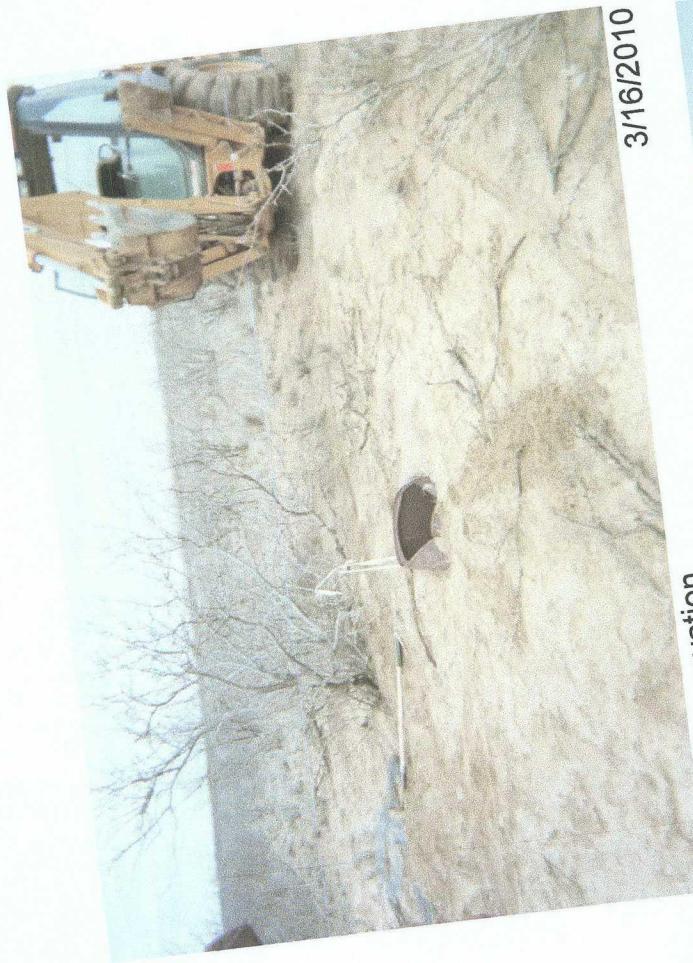
3/16/2010

Site prior to excavation

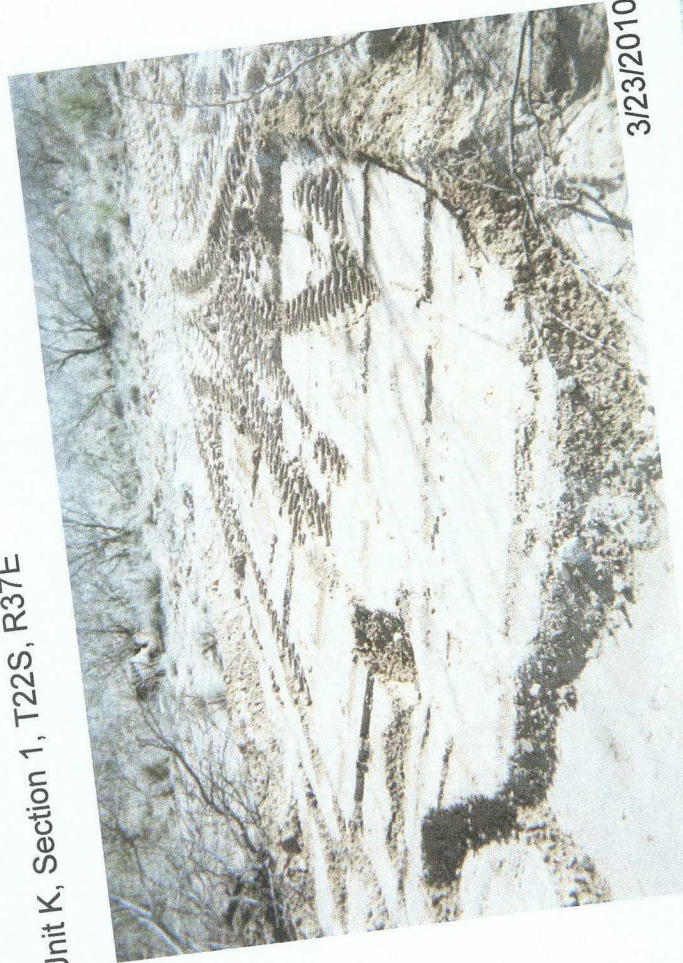
3/23/2010

Site backfilled

low concentrations. The excavated soil was returned to the excavation to ground surface and contoured to the surrounding area. On

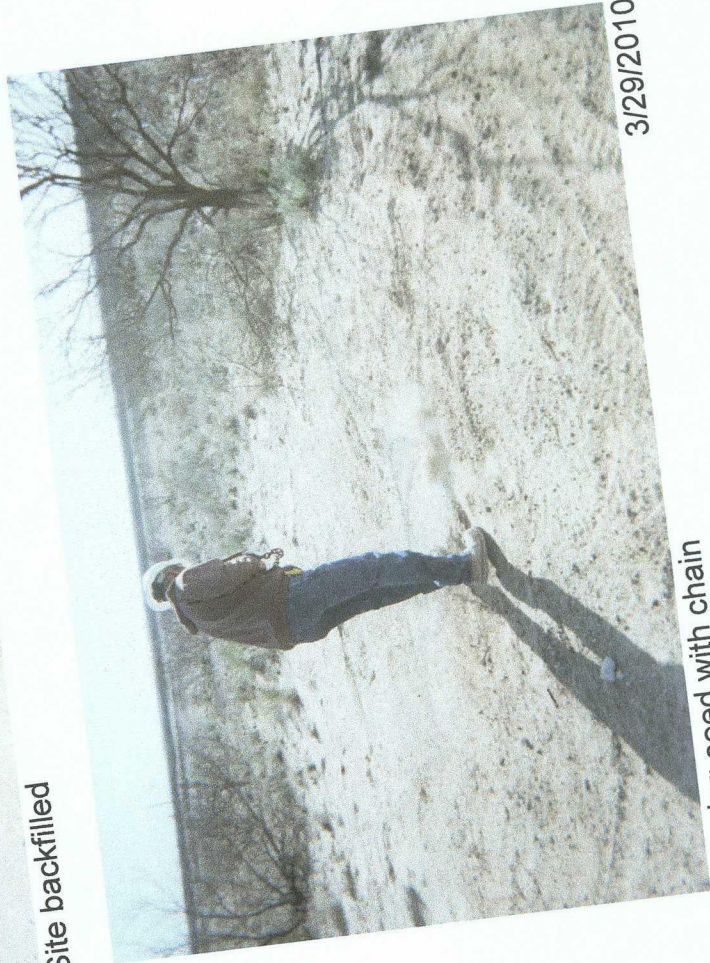
3/29/2010

Covering seed with chain

3/29/2010, the site was seeded with a blend of native vegetation and is expected to return to a productive capacity at a normal rate.

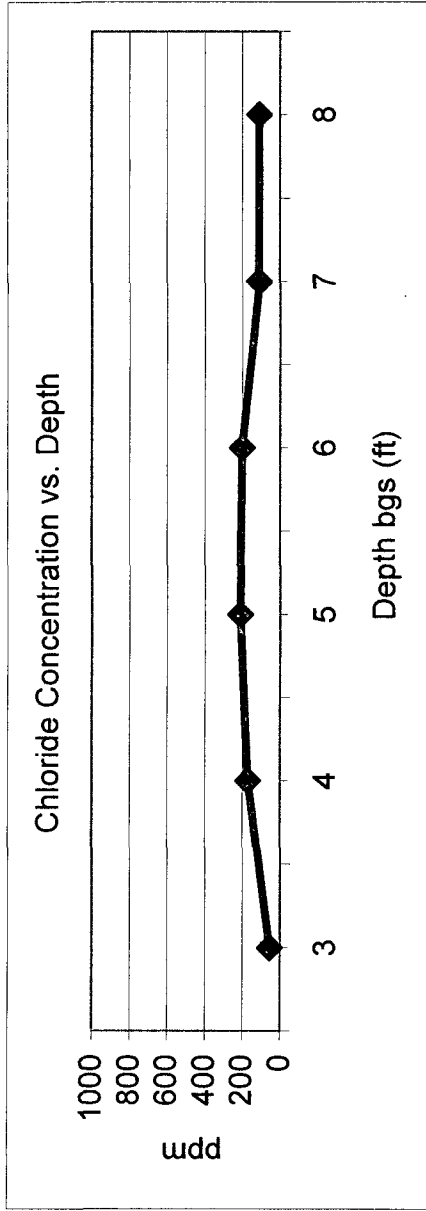
Backhoe samples at the junction (source)

Depth bgs (ft)	[Cl ⁻] ppm
3	56
4	171
5	212
6	203
7	110
8	111

Groundwater = 65 ft
