BD Jct. O-12

**RICE OPERATING COMPANY
JUNCTION BOX FINAL REPORT**

SWD SYSTEM	JUNCTION	UNIT	SECTION	TOWNSHIP	RANGE	COUNTY	BOX DIMENSIONS - FEET		
Blinebry-Drinkard (BD)	Jct. O-12	O	12	22S	37E	Lea	Length 5'	Width 4'	Depth 3'
							Eliminated

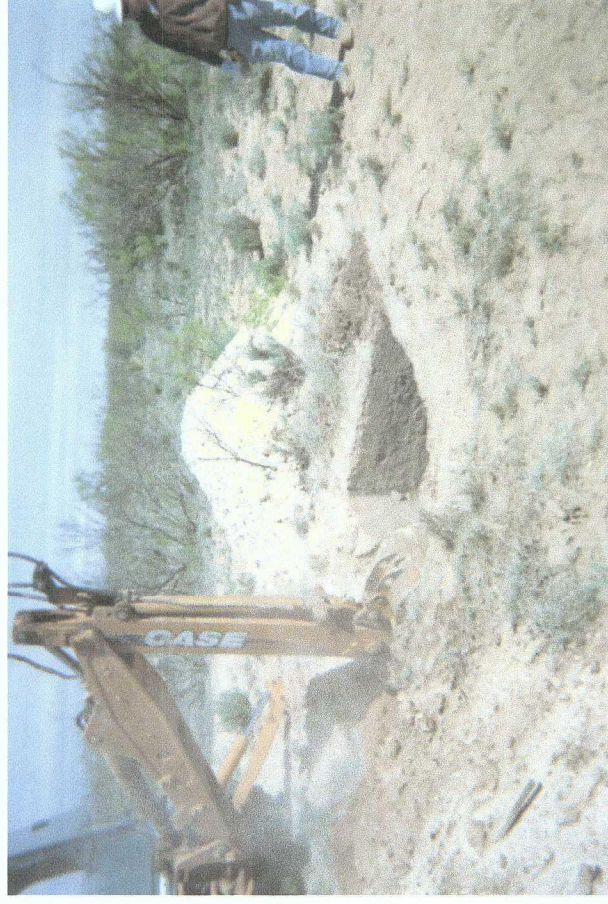
4/30/2010

Delineation trench being excavated

General Description of Remedial Action: This junction and line were eliminated under the pipeline replacement/upgrade program. After the former junction box was removed, an investigation was conducted using a backhoe to collect soil samples at regular intervals producing a 5X3X8-ft. deep excavation. Chloride field test performed on each sample yielded low concentrations similar to that of the background. Organic vapors were measured using a PID, which also yielded low concentrations. The deepest sample, 8 ft. BGS, was sent to a commercial laboratory for analysis of chloride and TPH, which confirmed low concentrations. The excavated soil was returned to the excavation to ground surface and contoured to the surrounding area. On 5/12/2010, the site was seeded with a blend of native vegetation and is expected to return to a productive capacity at a normal rate.

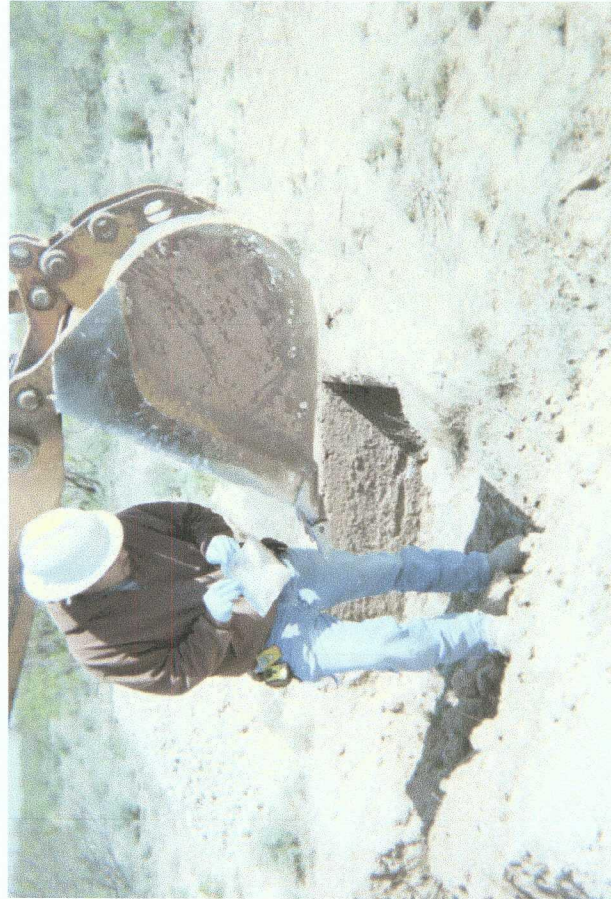
4/30/2010

Sample being taken

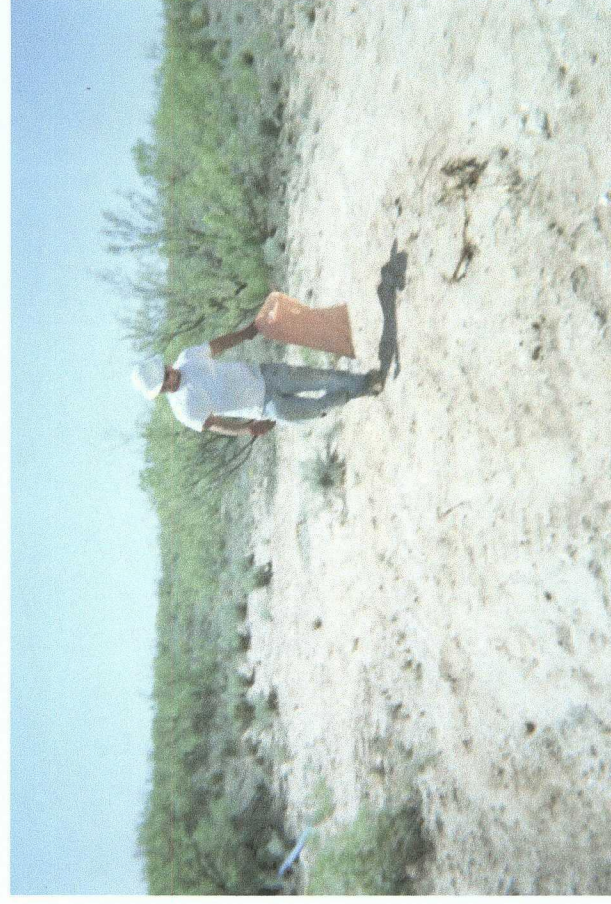
5/12/2010

Seeding excavation

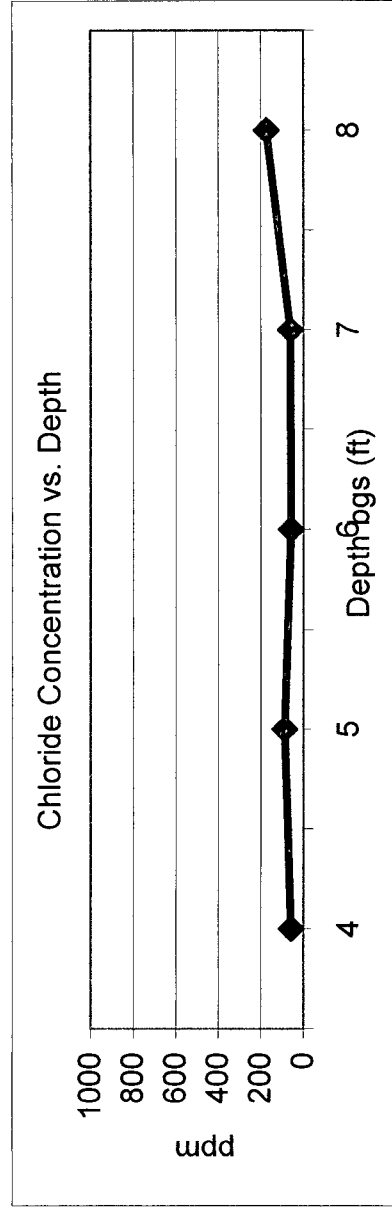
Backhoe samples at the junction (source)

Depth bgs (ft)	[Cl] ppm
4	58
5	89
6	58
7	61
8	175

Groundwater = 61 ft
