BD Jct. D-20

**RICE OPERATING COMPANY
JUNCTION BOX FINAL REPORT**

Unit D, Section 20, T21S, R37E

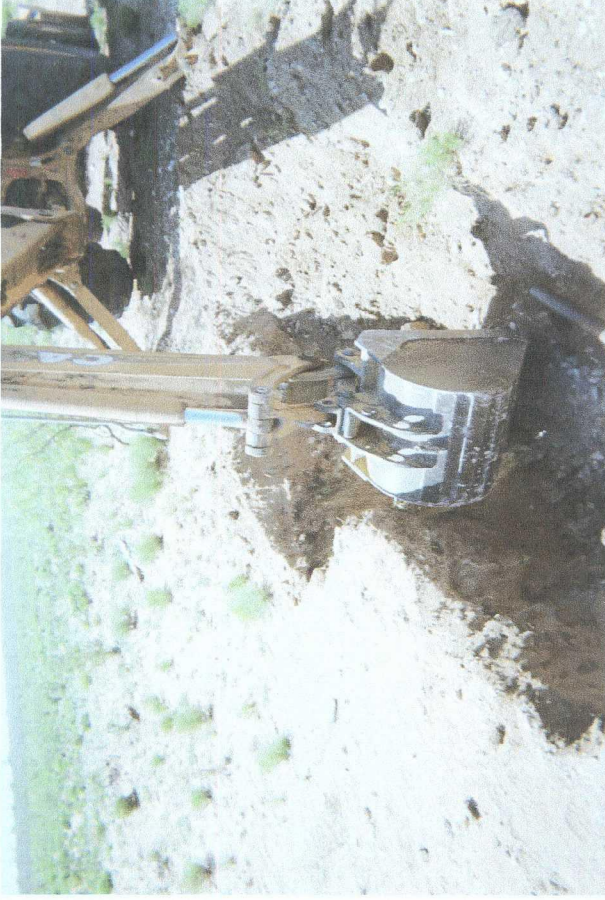
Delineation trench being excavated

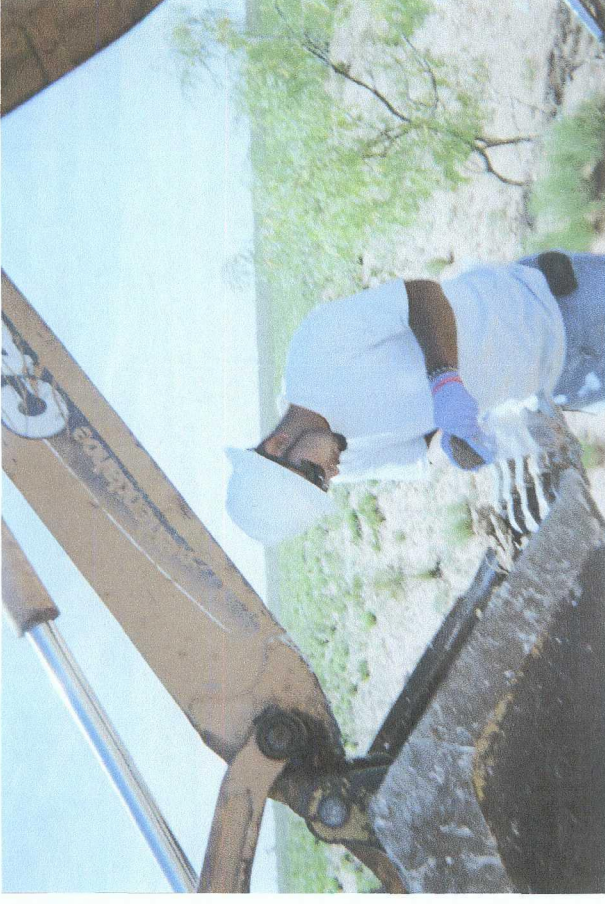
Sample being collected

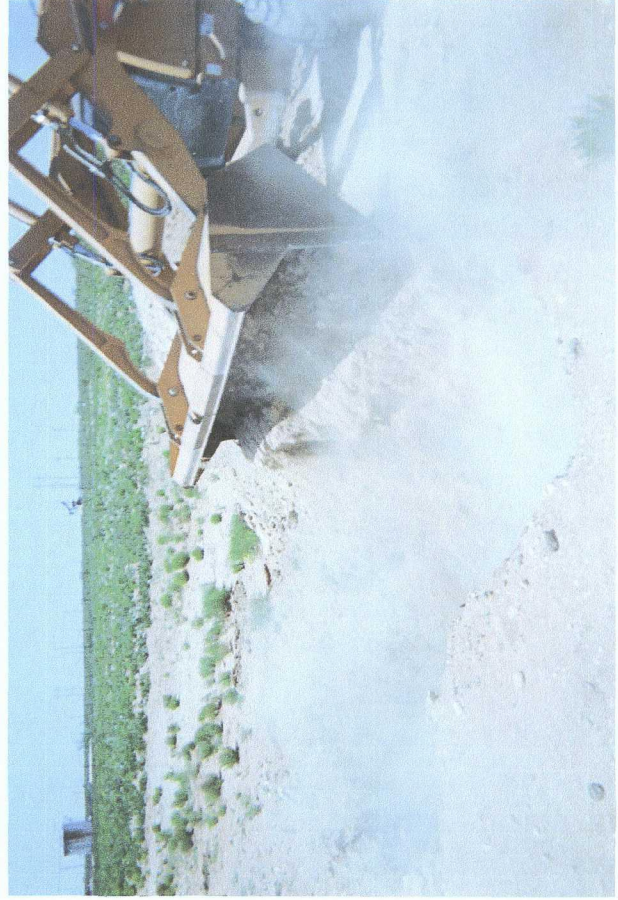
Backfilling excavation

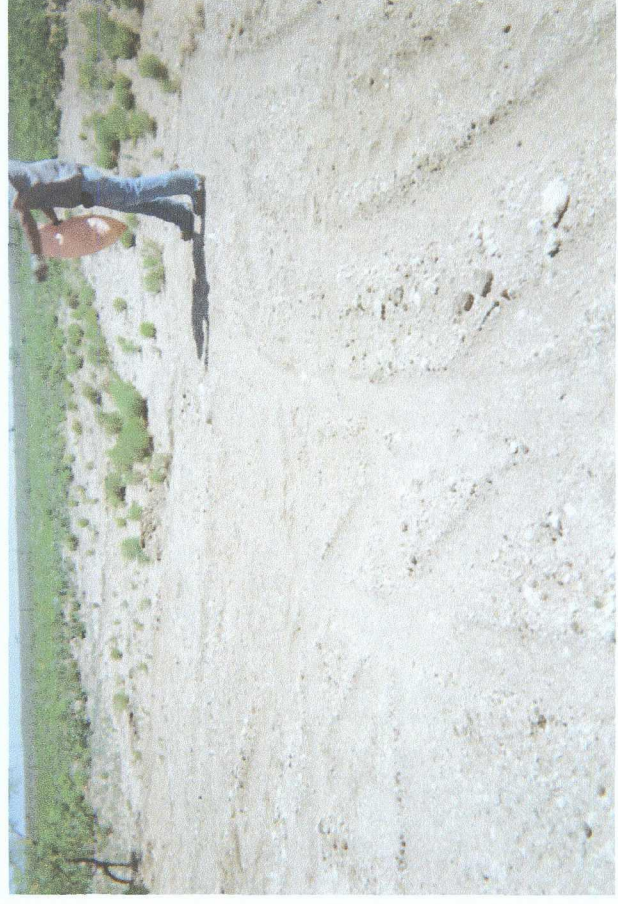
Seeding excavation
