**Vacuum Jct. L-29**

**CLOSURE**

**RICE OPERATING COMPANY  
JUNCTION BOX FINAL REPORT**

Unit L, Section 29, T17S, R35E

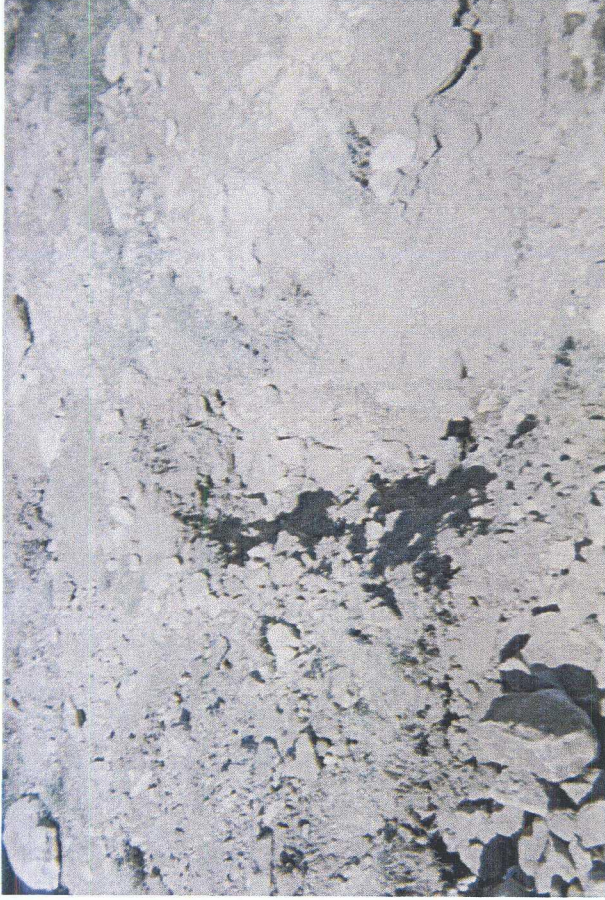
Site prior to delineation

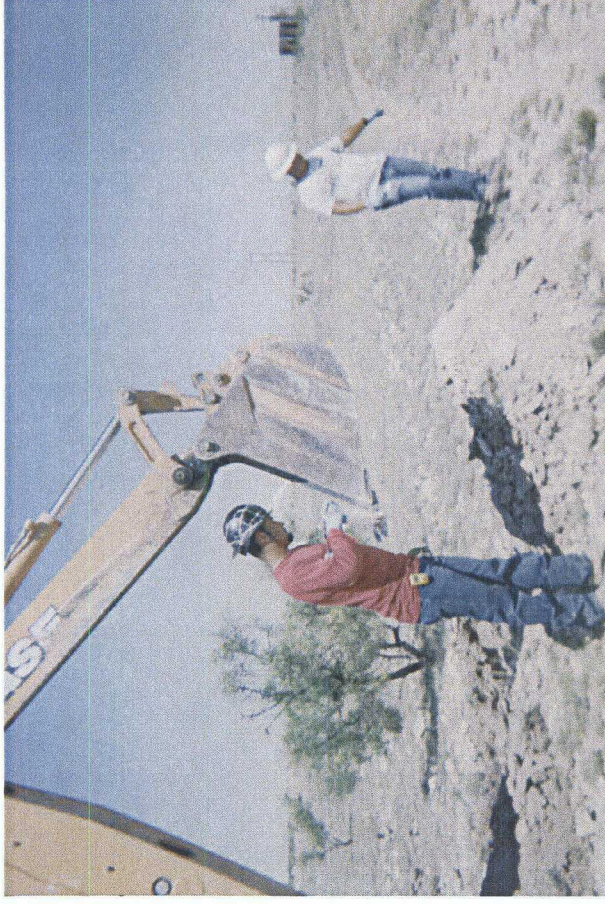
Collecting sample

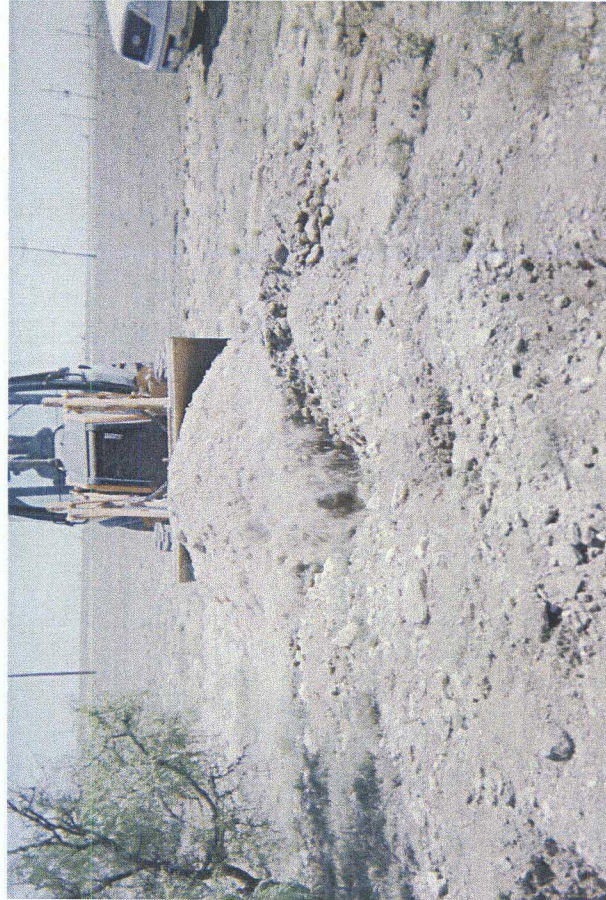
Backfilling excavation

The excavated soil was returned to the excavation to ground surface and contoured to the surrounding area. On 6/22/2010, the site was seeded with a blend of native vegetation and is expected to return to a productive capacity at a normal rate.

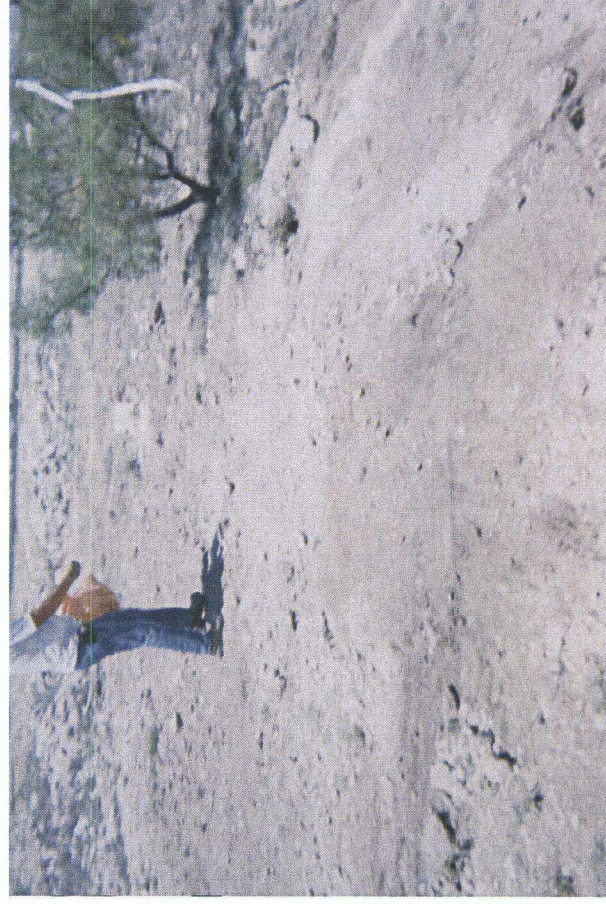
Seeding excavation

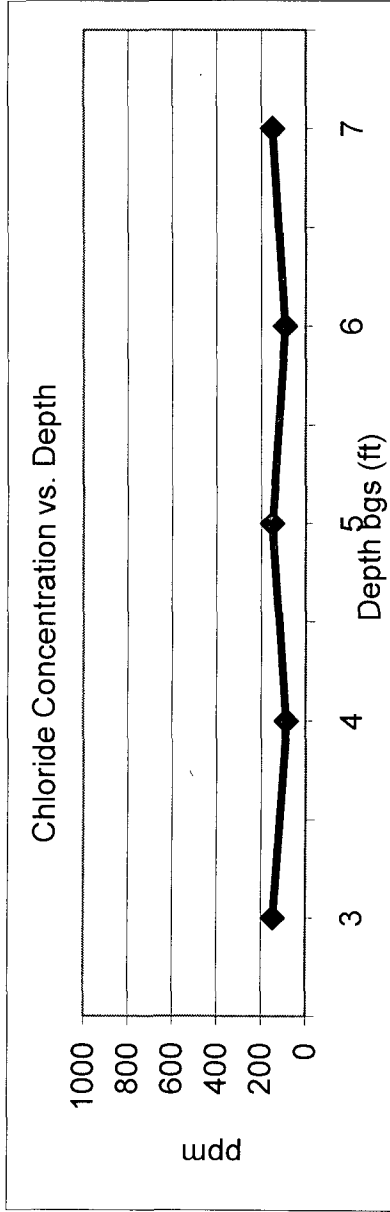
# Vacuum L-29

Backhoe samples at the junction (source)

Depth bgs (ft)	[Cl <sup>-</sup> ] ppm
3	146
4	85
5	150
6	91
7	150

Groundwater = 77 ft
