RE: Termination Request
Hobbs Jct. F-31-1, NMOCD Case #1R428-55
Township 18S, Range 38E, Section 31, Unit F

R.T. Hicks Consultants, Ltd. is submitting this Termination Request on behalf of Rice Operating Company (ROC) for the above-referenced site. The investigation demonstrated that neither chloride nor hydrocarbons are present in the vadose zone in quantities that represent a threat to fresh water or the environment and recommended re-vegetation. Surface restoration activities and re-vegetation efforts have been completed at the site.

Hobbs Jct. F-31-1
T-18-S, R-38-E, Section 31, Unit F
Surface Restoration Summary

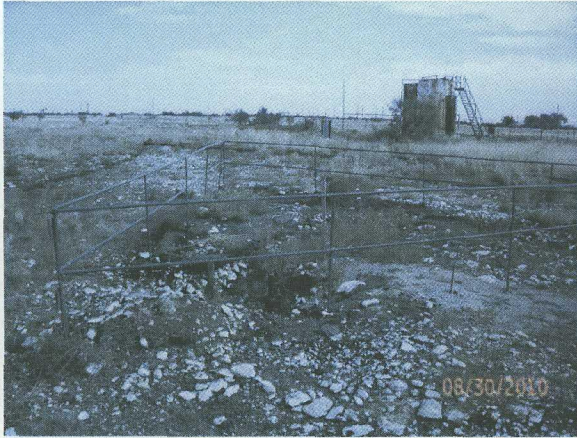
site prior to excavation, facing north

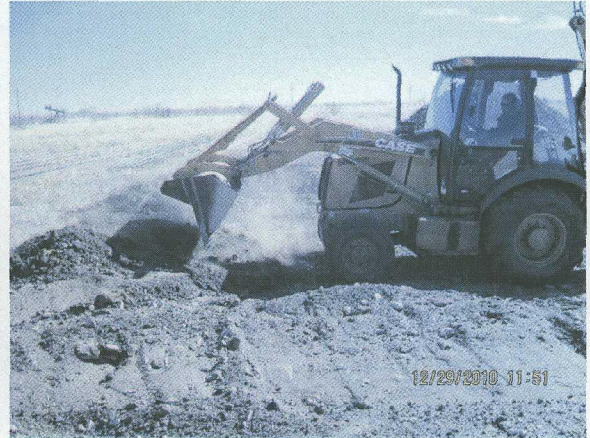
scraping, facing southeast

12-28-10	Began scraping a 34x28x2-ft bgs area.
12-29-10	Finished scraping the site and hauled two (2) loads of soil to Sundance Disposal.
12-30-10	Six (6) loads of soil were hauled to Sundance Disposal.
1-3-11	Imported four (4) loads of soil from Wallach Concrete and began to backfill the excavation.
1-10-11	Imported four (4) loads of hay-sand mixture from the TCT yard and contoured the site to the surrounding area.
1-11-11	Imported one (1) load of hay-sand mixture from the TCT yard and contoured the site to the surrounding area.
1-12-11	Built a silt net fencing around the perimeter of the scraped area.
2-17-11	Added amendments (150 lbs BioNhance and 100 lbs InfiltrationNhance). Seeded the site with 4 lbs black gramma, 5 lbs winter wheat, and 2.54 lbs blue gramma.

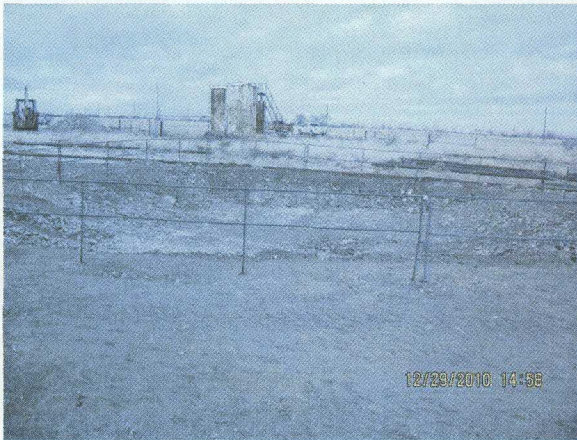
final scraped area, facing north

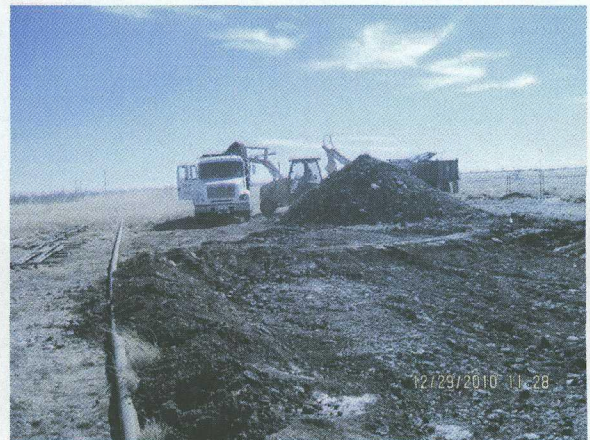
hauling off soil, facing southeast

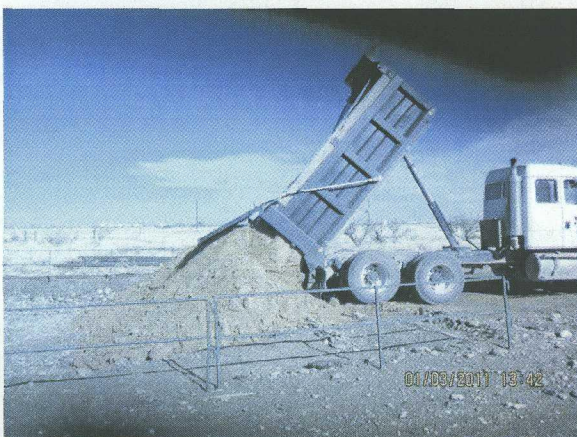
importing clean soil, facing northeast

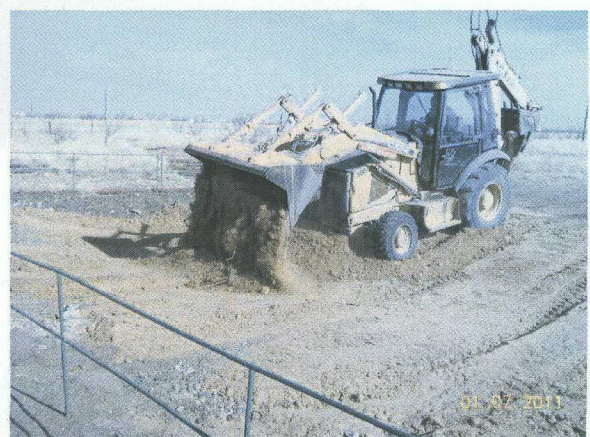
backfilling the scraped area, facing east

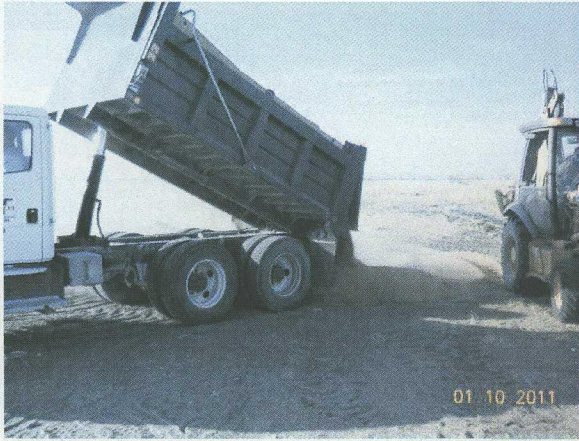
importing clean soil blended with hay, facing west

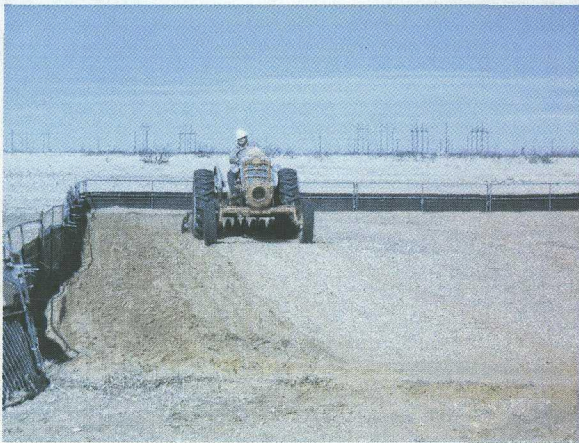
2/17/2011

discing the site

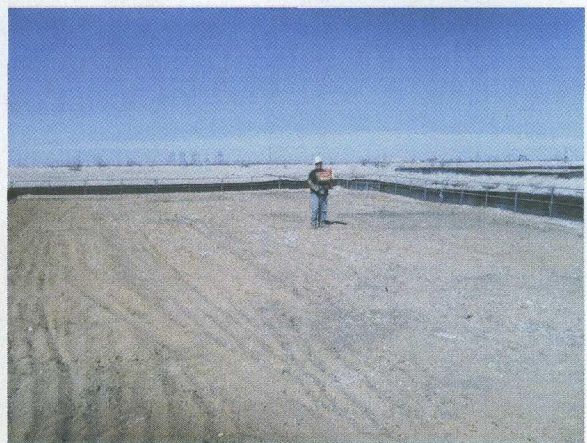
seeding the backfilled site

Custom seed mix <input checked="" type="checkbox"/>	Prescribed mix <input type="checkbox"/>	Seed mix name:	Seeding date: 2/17/2011
Broadcast <input checked="" type="checkbox"/>			
Method: portable seeder			
Soil conditions during seeding: Dry <input checked="" type="checkbox"/> Damp <input type="checkbox"/> Wet <input type="checkbox"/>			
Photos attached <input checked="" type="checkbox"/>		Observations: 5 lbs winter wheat, 2.54 lbs blue gramma, 4 lbs black gramma
