Oil Conservation Division  
Case No. 15235  
Exhibit No. 1

## Forehand Ranch Cherry Canyon Sands

October 2, 2014

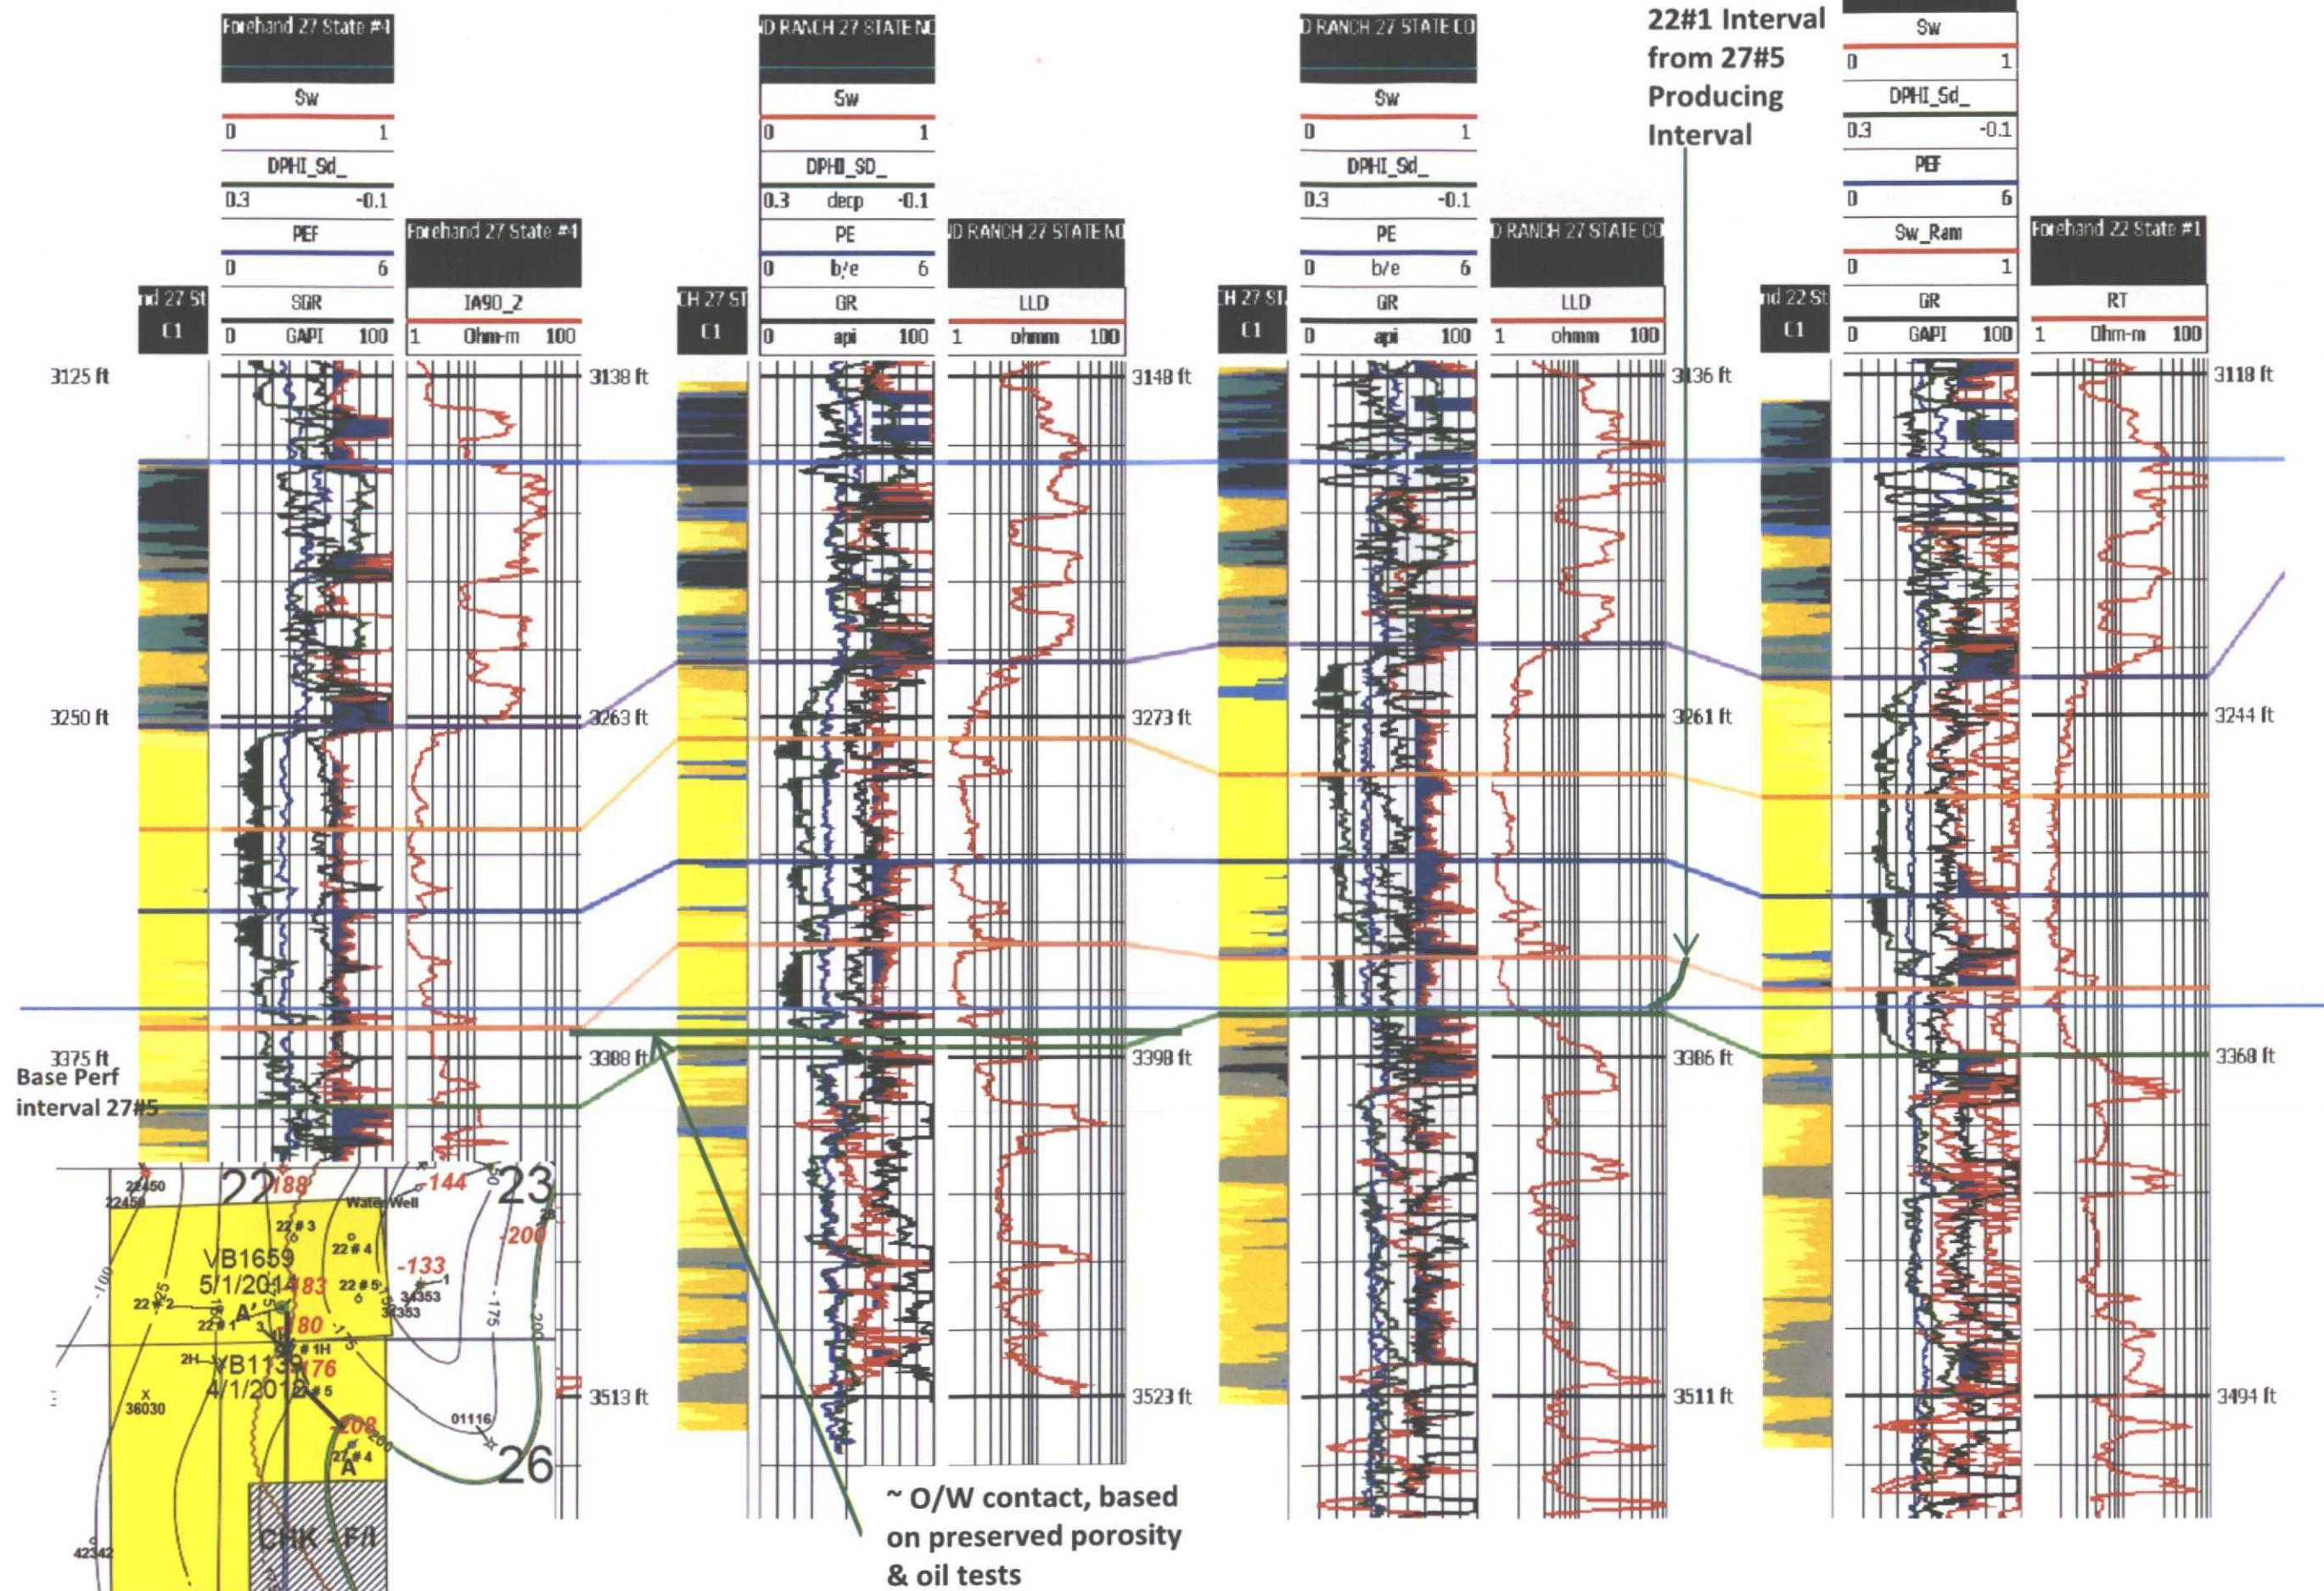
## Structural Cross Section

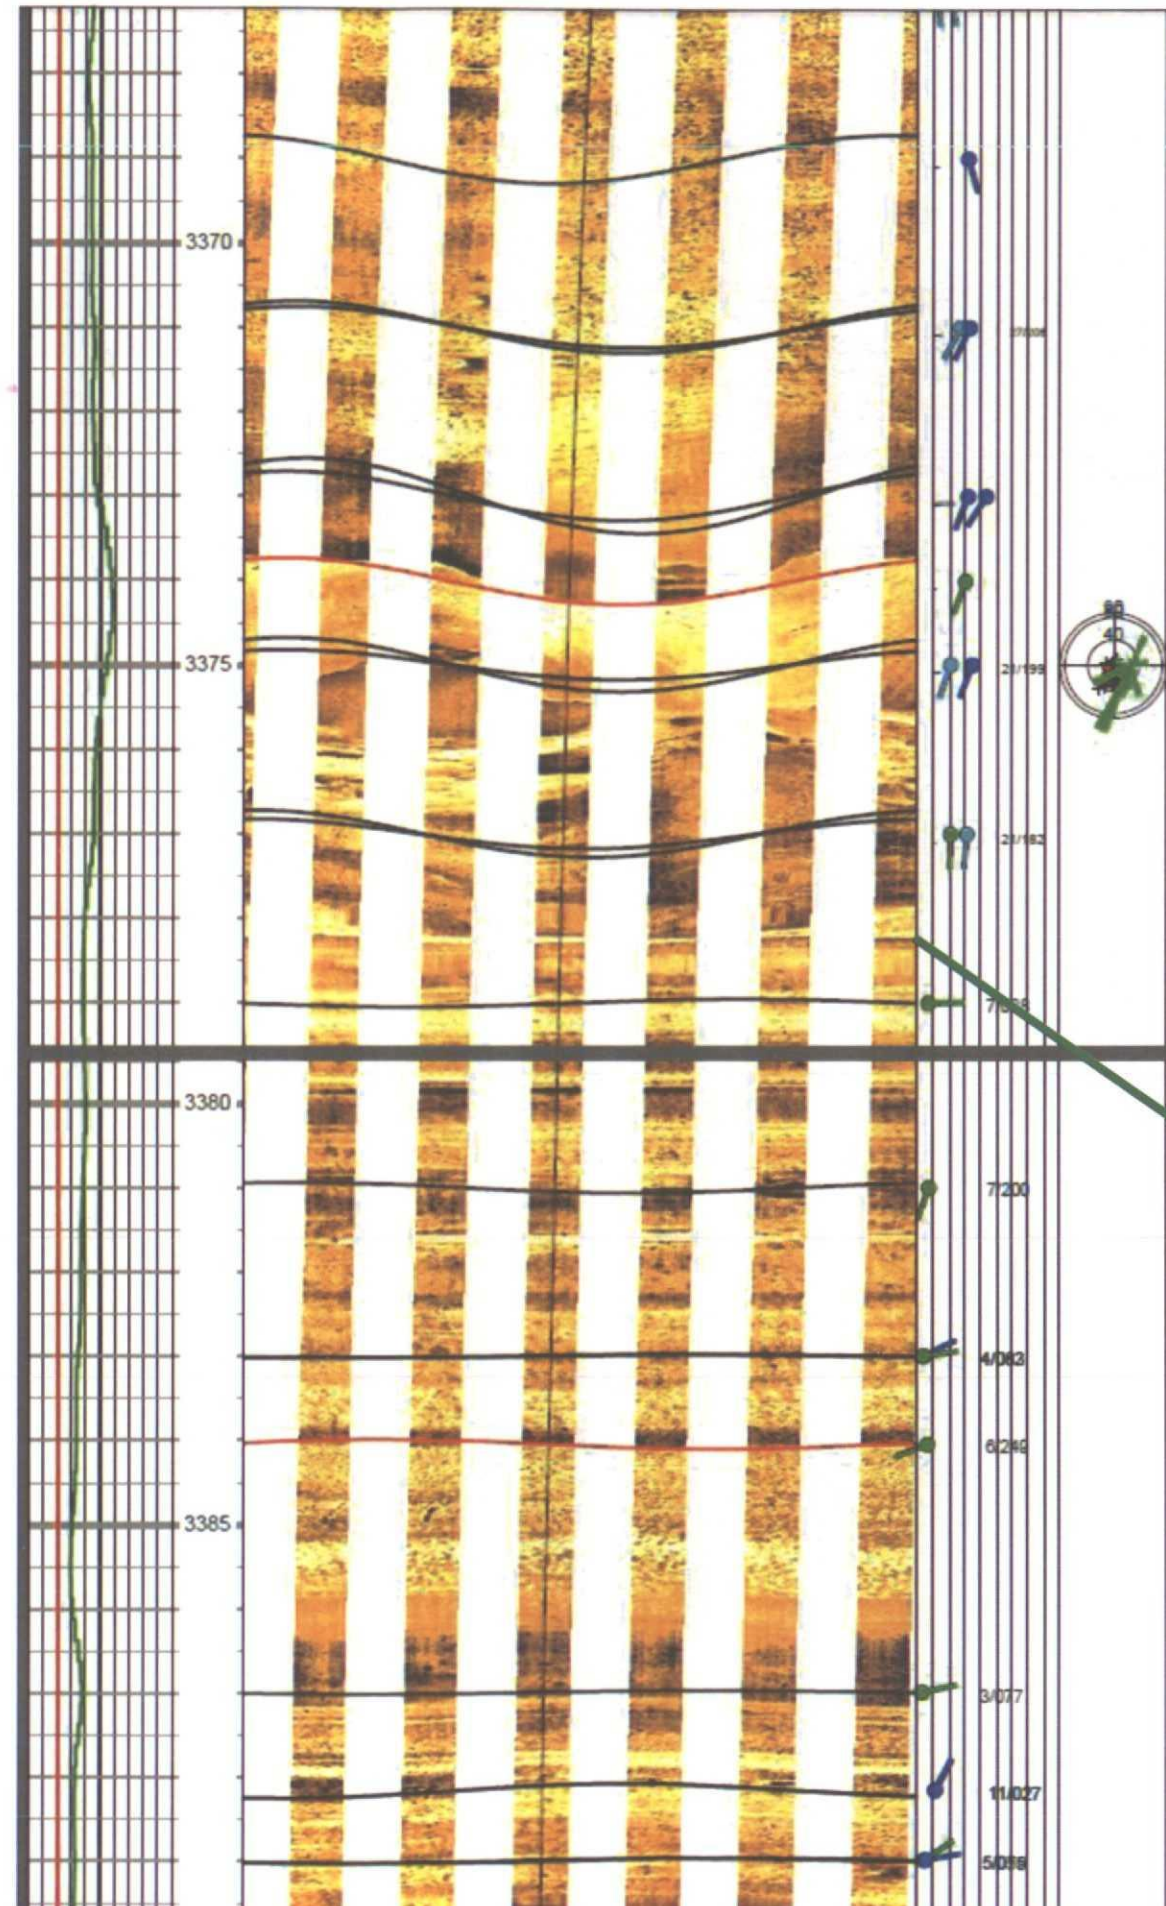
# Imaging Log Shows Base Channel

Channel cut  
from imaging  
log

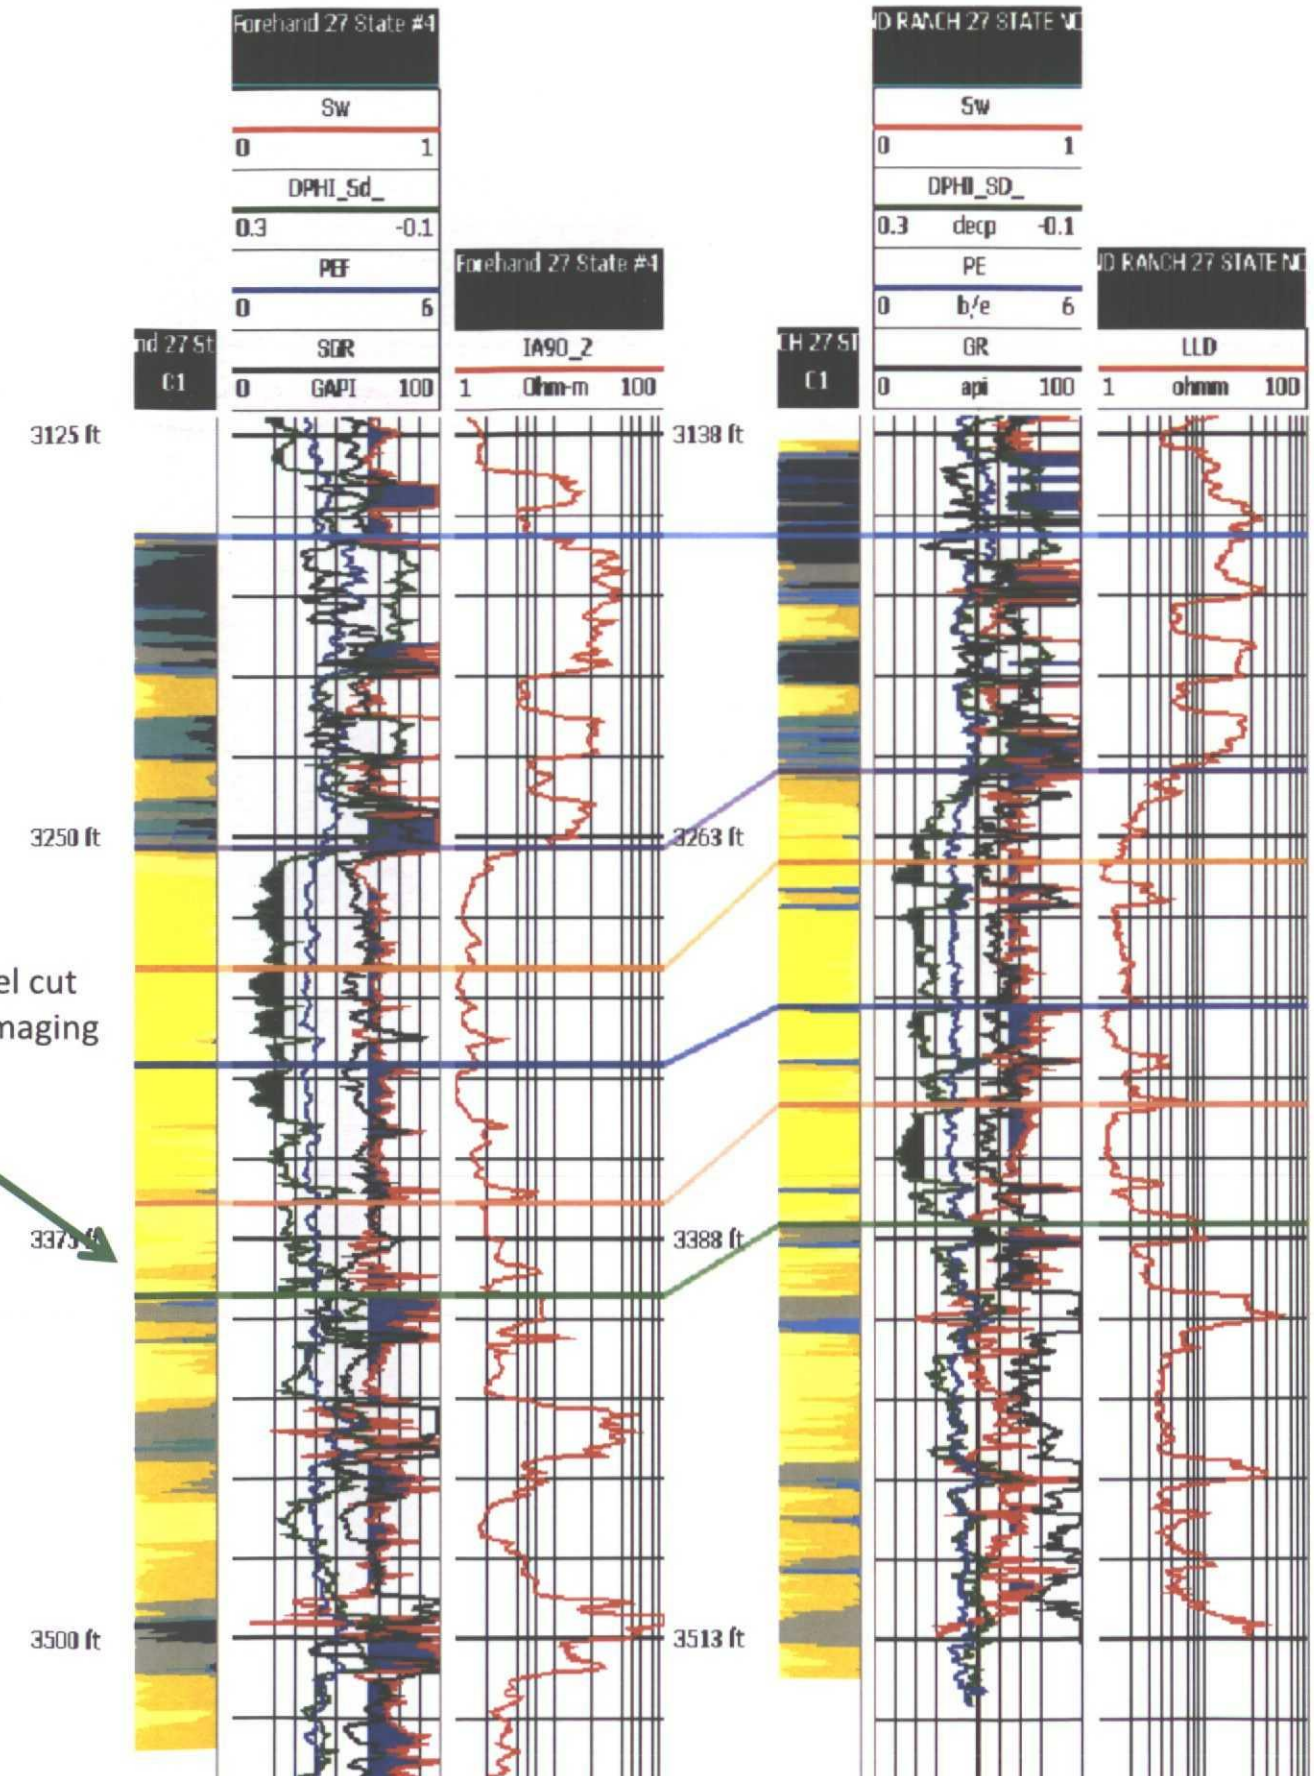
Caza Forehand Ranch 27#5 – Oil Well

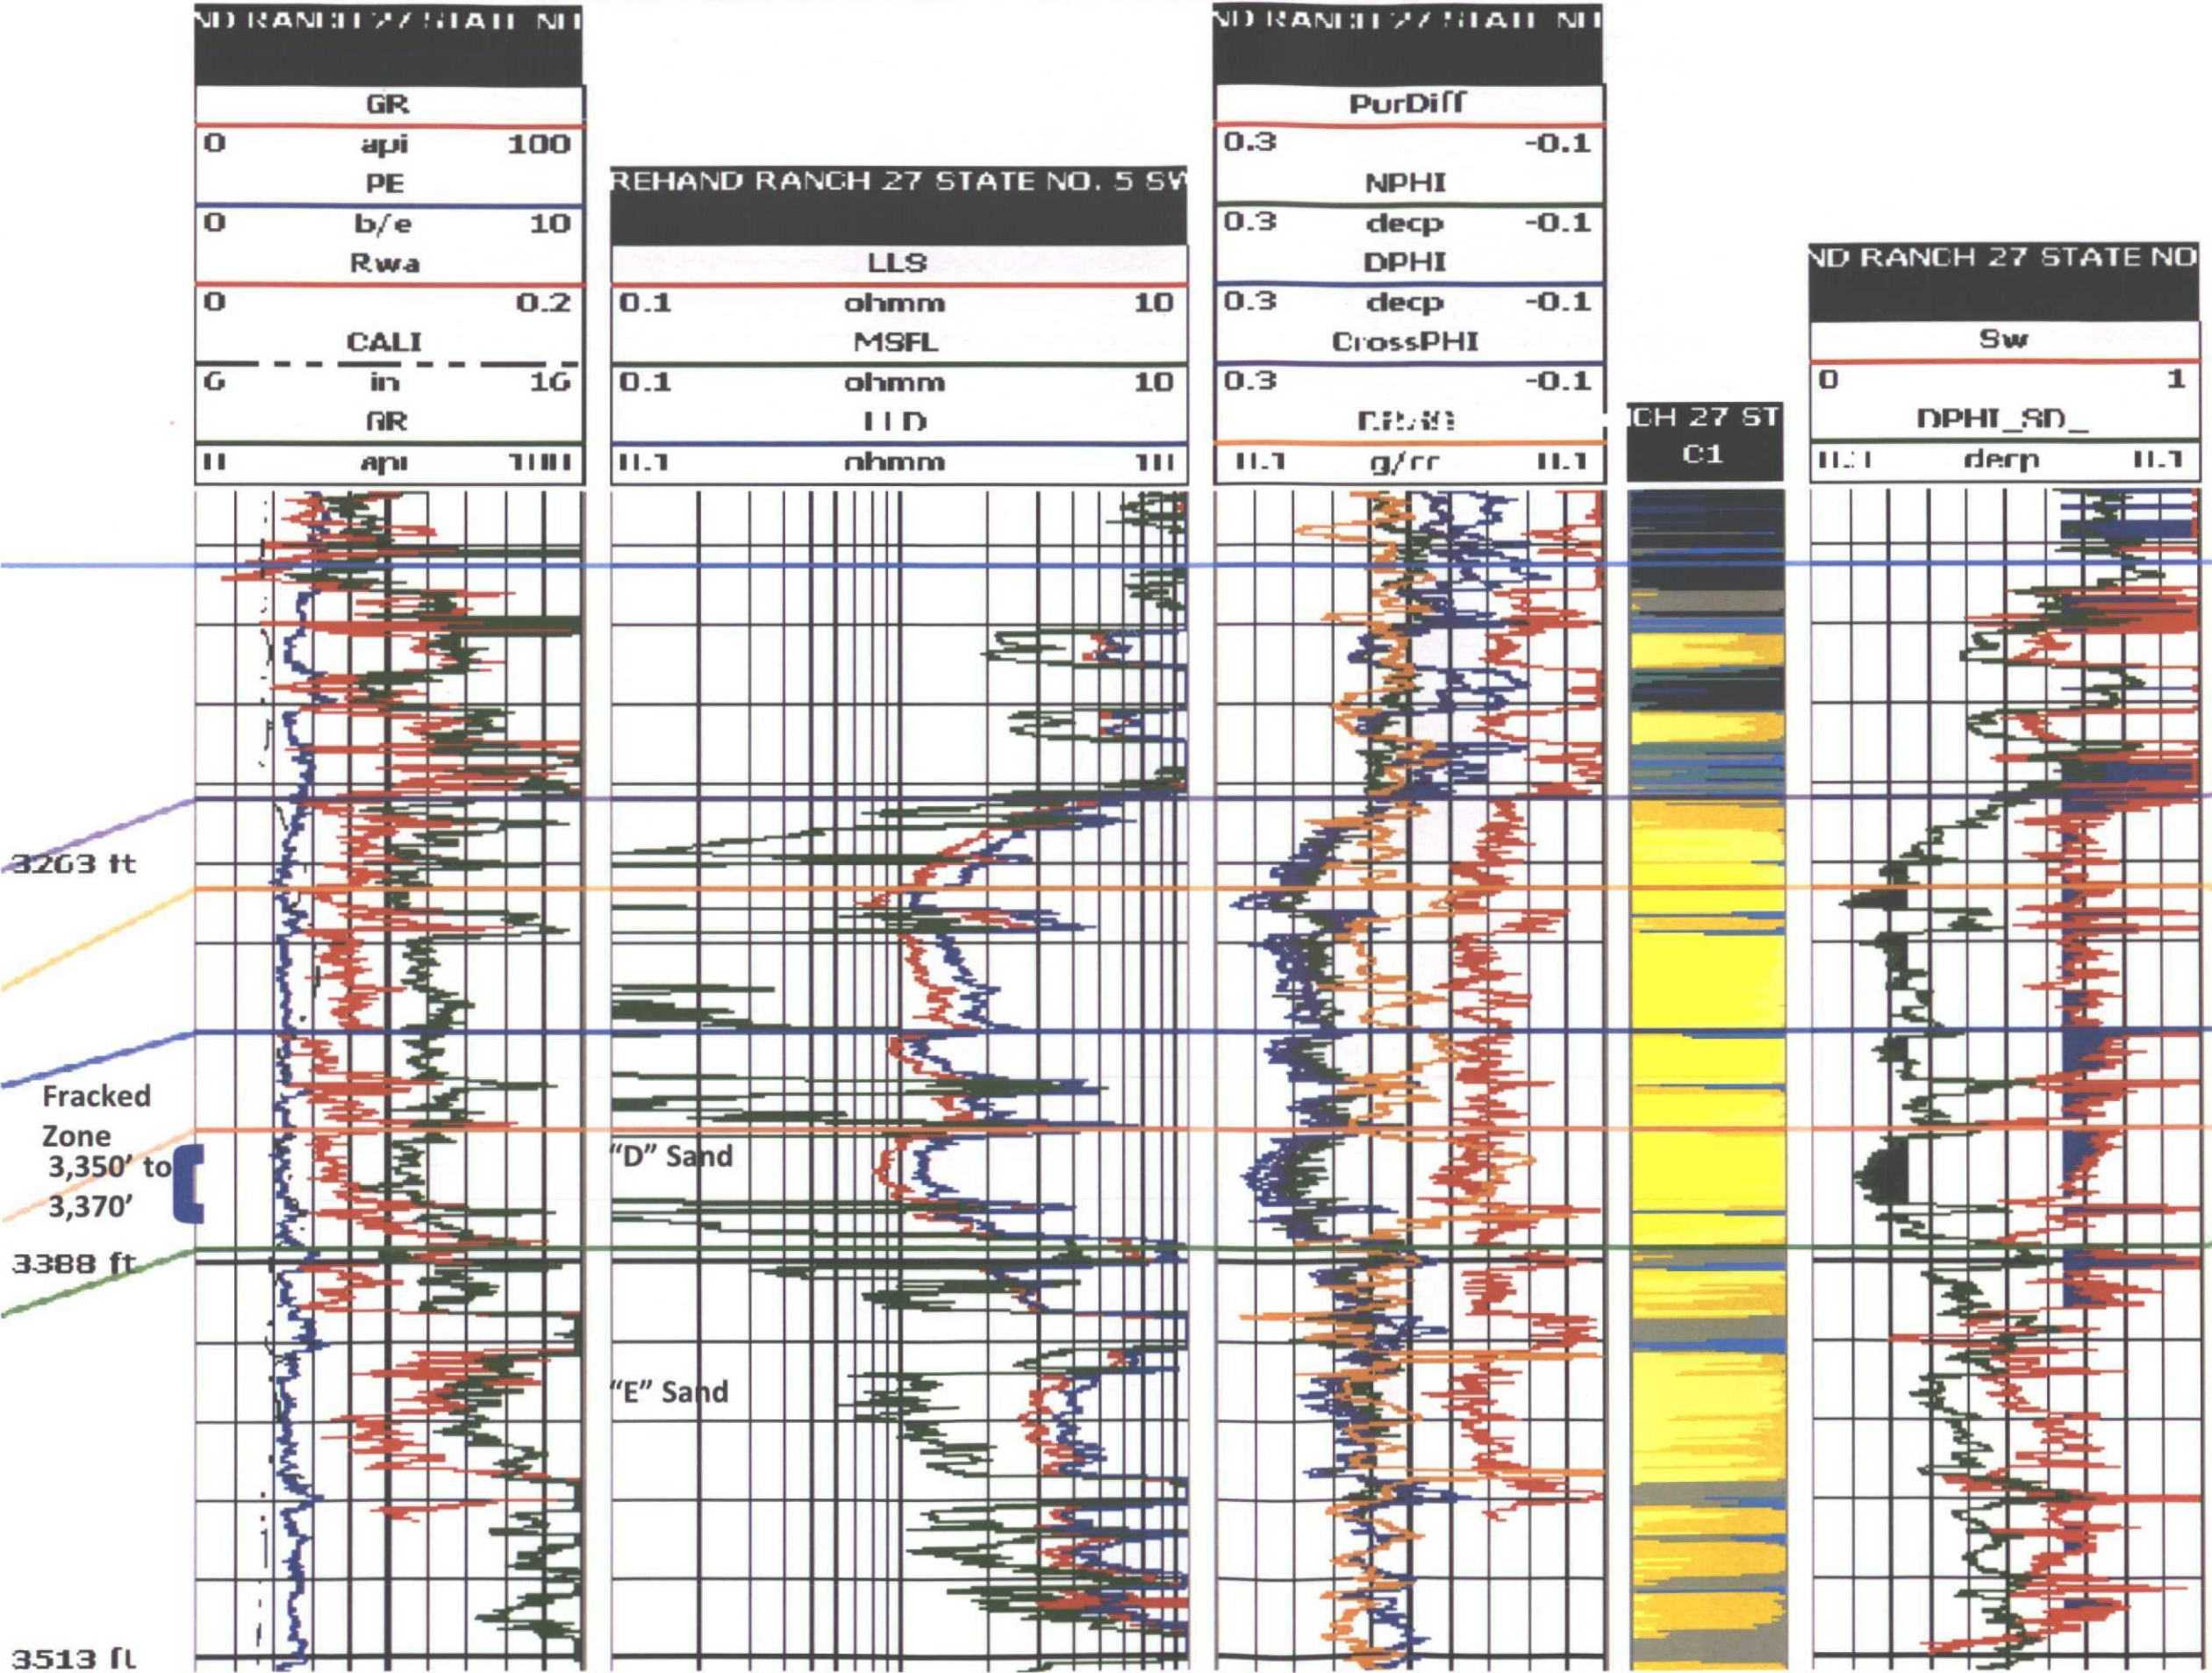
Caza Forehand Ranch 27#4 – Pressure Maintenance/SWD

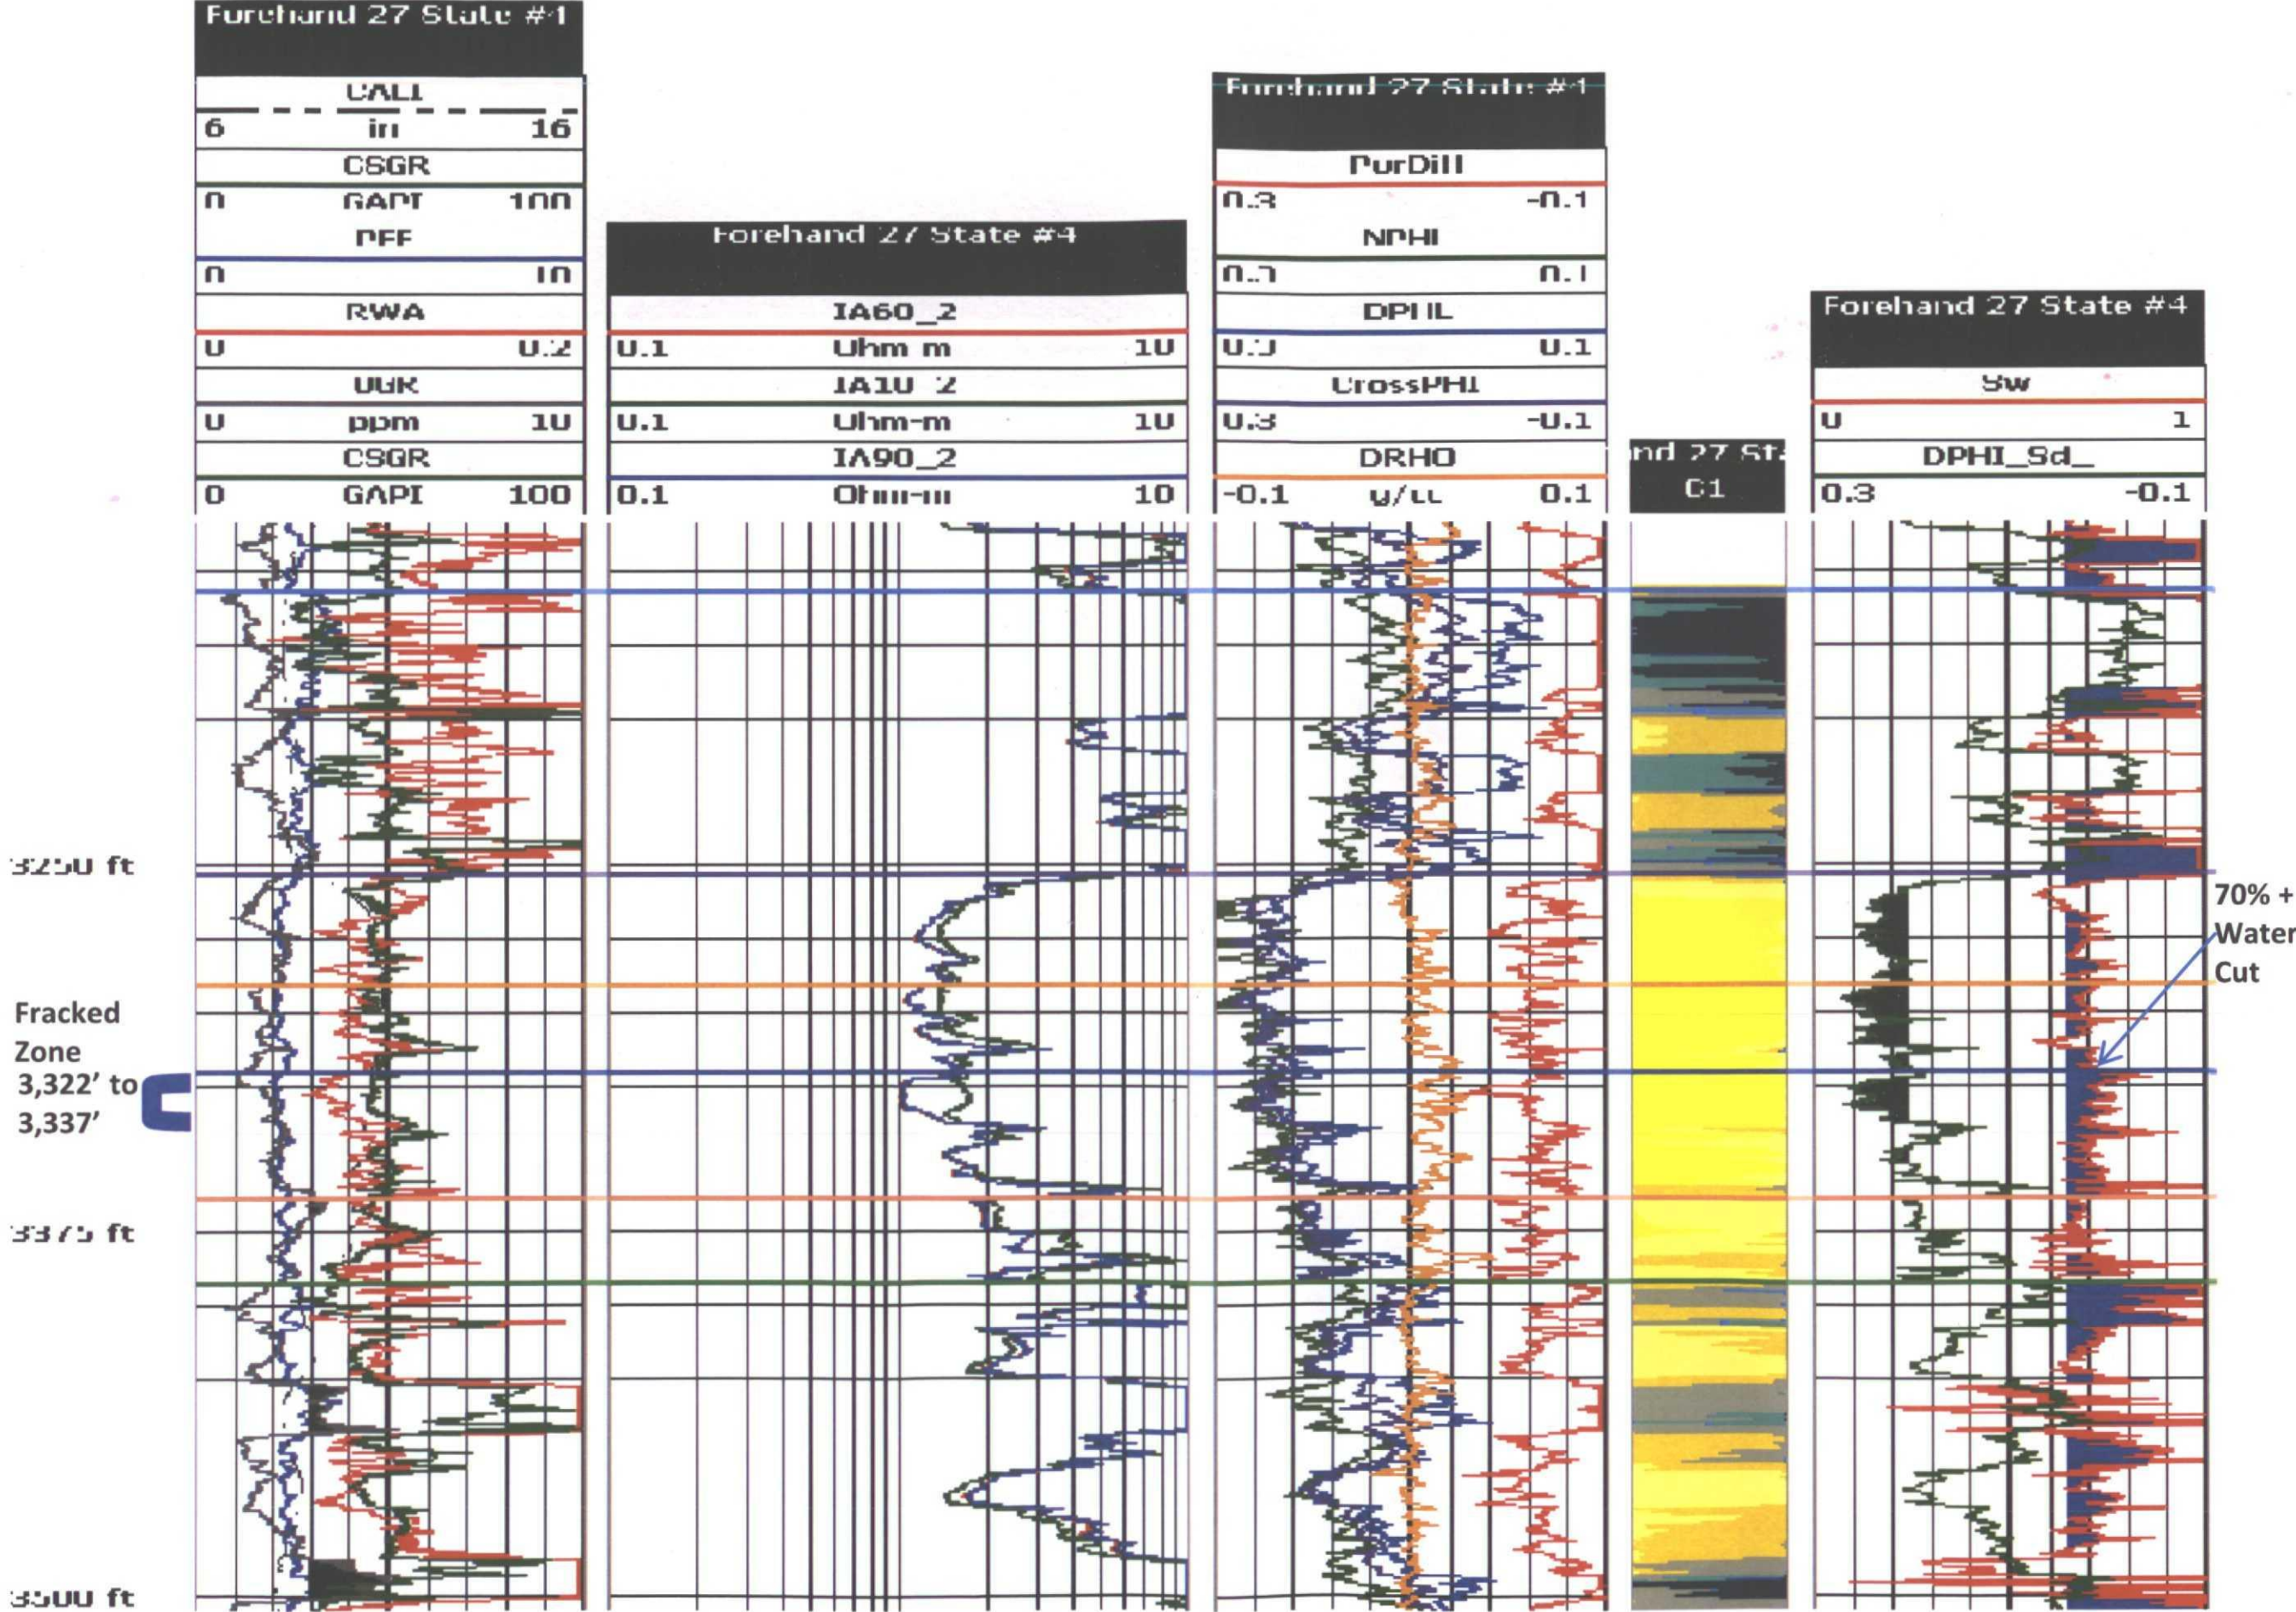
# Endurance Forehand Ranch – Pressure Maintenance/SWD 1 ½ Mile North of the Caza Forehand Ranch 27#4

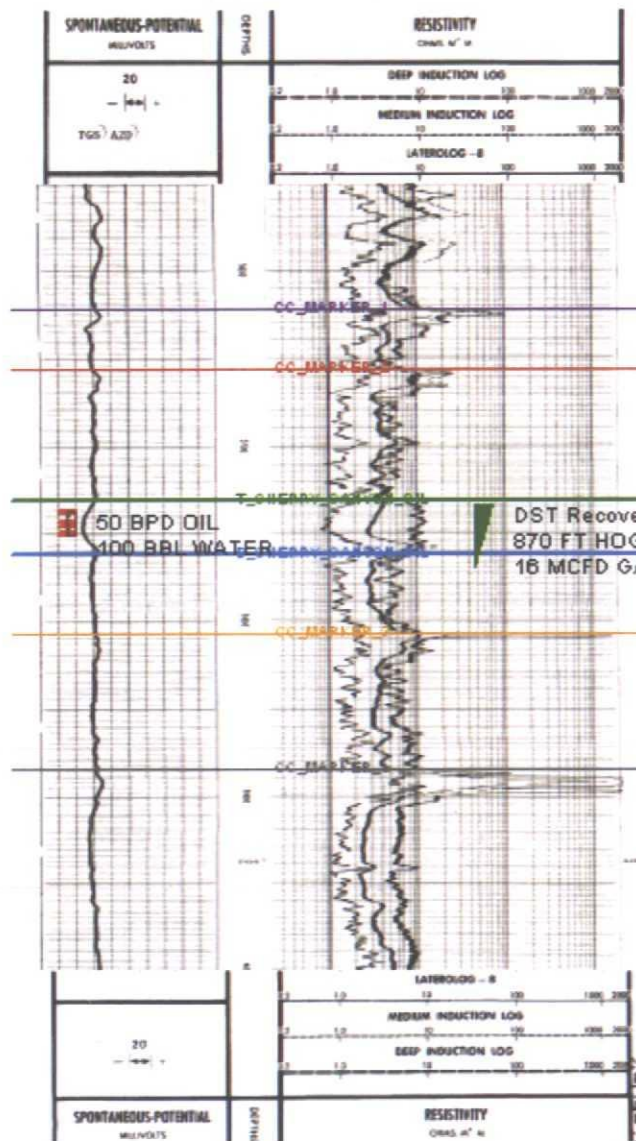
**TD : 5,610**  
**FOREHAND RANCH**  
**CUM OIL : 36,789**  
**CUM GAS : 1,673**  
**CUM WTR : 395,492**

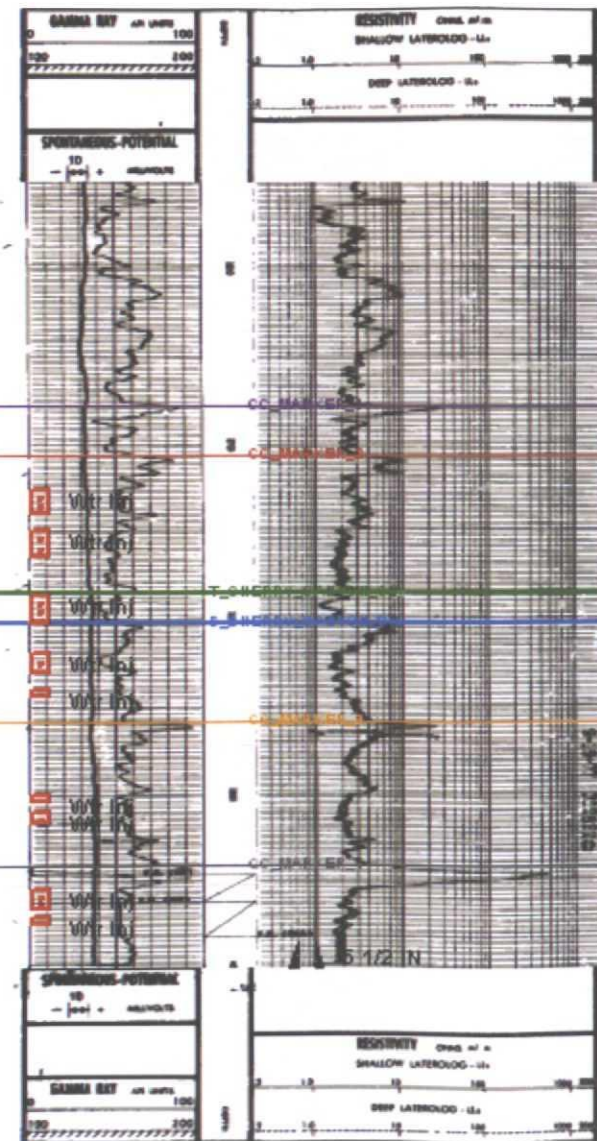
**TD : 4,000**  
**FOREHAND RANCH**  
**CUM OIL : 6,603**  
**CUM GAS : 0**  
**CUM WTR : 33,381**

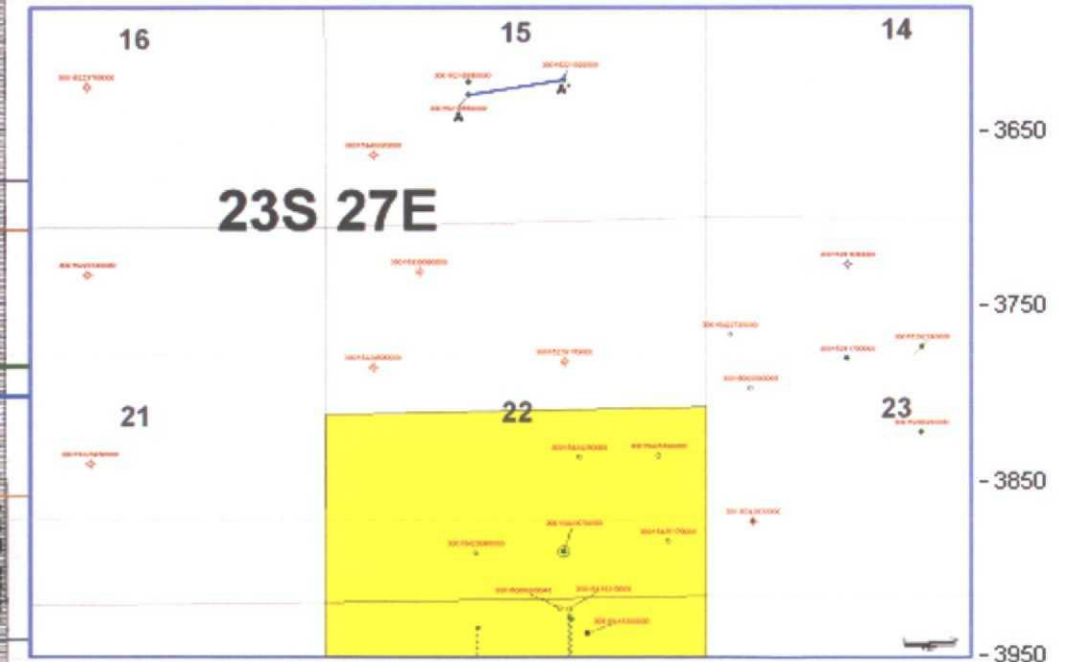
424,746 Bw injected  
since August 2001
