Table 1: Drilled Sidewall Core Analysis Report

Company : SDX Resources, Inc. Field: Artesia  
 File No. : 9646 Formation: Premier & San Andres  
 Well : NW State #7 County : Eddy County, New Mexico  
 Location : 990' FSL & 990' FWL, Sec 32, T17S, R28E

Plate 8: Northwest State #7, 2954-2996 ft. Anhydrite in Fossil Molds in Dolomitized Wackestones

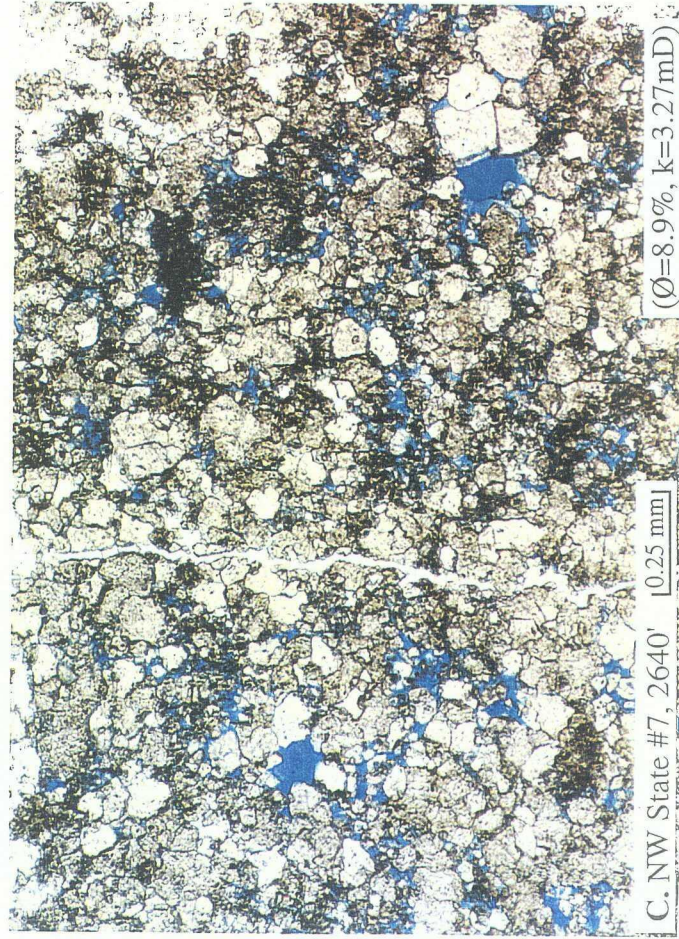
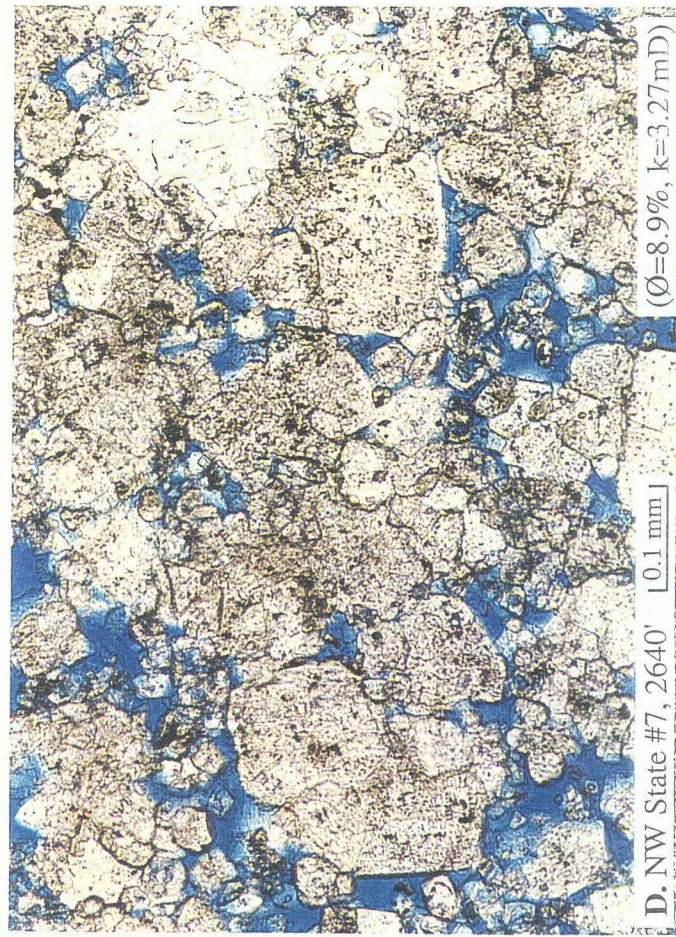
Plate 8: Northwest State #7, 2954-2996 ft. Anhydrite in Fossil Molds in Dolomitized Wackestones

**Photos C and D: 2640 ft.** This is another example of the dolomitized skeletal wackestone to packstone facies that forms many of the porous streaks in the middle of the San Andres Formation. The dolomite is fine- to medium crystalline with scattered larger crystals, at least some of which represent former crinoid fragments. Also present are some hairline vertical fractures, most of which are cemented with anhydrite. Traces of bitumen are present. Patches of white, late-stage anhydrite cement occur as relatively large crystals cementing the dolomite rhombs (e.g., at upper right in both photos). This sidewall core showed about 95% bright yellow fluorescence, had an oil saturation of 24.7%, and yielded 1000 units of gas indicating that it is saturated with hydrocarbons. The measured residual water saturation was 38.4%, which is somewhat higher than normal for these porous dolomites. Photos taken with plane light.

| 6 | 2,640.0 | 3.27 | 8.9 | 2.86 | 38.4 | 24.7 | 1000 | 95 | yel | Dol: tn-gry,wkst,intxtn & ppp |
