From: Hansen, Edward J., EMNRD
Sent: Thursday, February 21, 2013 3:48 PM
To: Hack Conder (hconder@riceswd.com)
Cc: Leking, Geoffrey R, EMNRD; Laura Pena (lpena@riceswd.com); Katie Jones <kjones@riceswd.com> (kjones@riceswd.com); Scott Curtis (scurtis@riceswd.com)
Subject: Remediation Plan (1R427-344) Termination - ROC EME Jct G-20 Site

RE: Termination Request
EME Jct. G-20 (1R427-344): UL/G, Sec. 20, T19S, R37E
RICE Operating Company – Eunice Monument Eumont SWD System

**RICE OPERATING COMPANY
JUNCTION BOX FINAL REPORT**

EME JCT. G-20

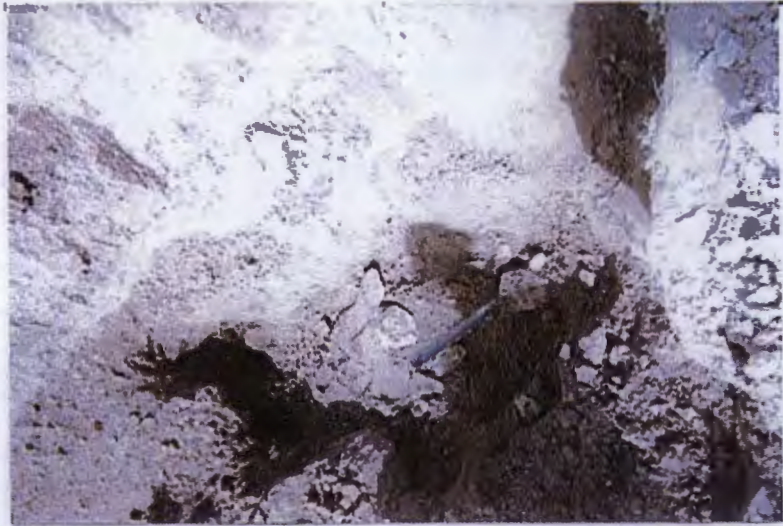
Site prior to delineation

2/25/2010

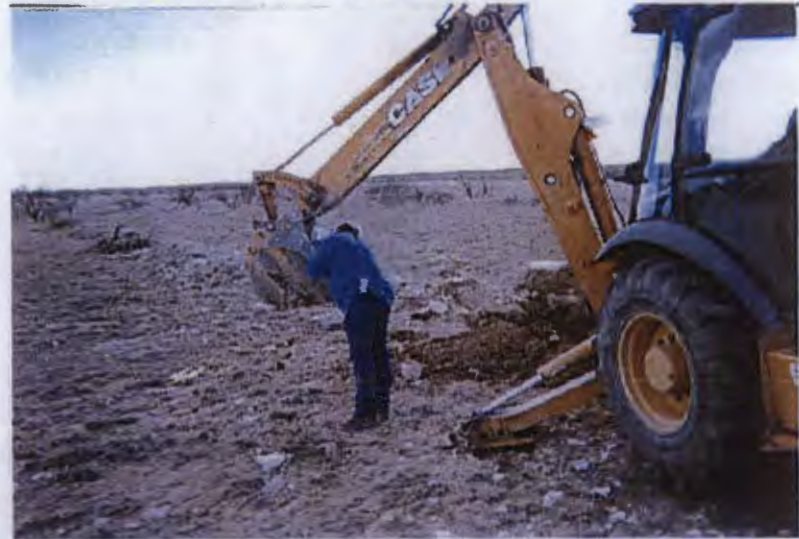
Collecting a sample

2/25/2010

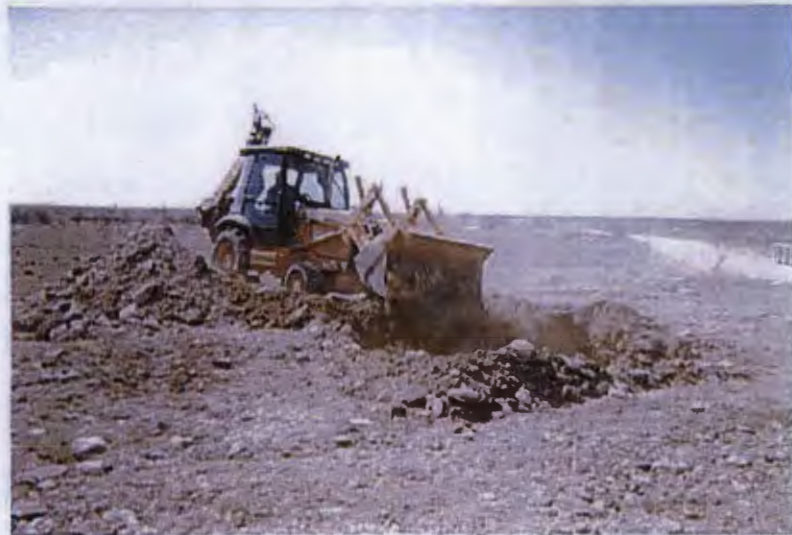
Backfilling excavation

2/25/2010

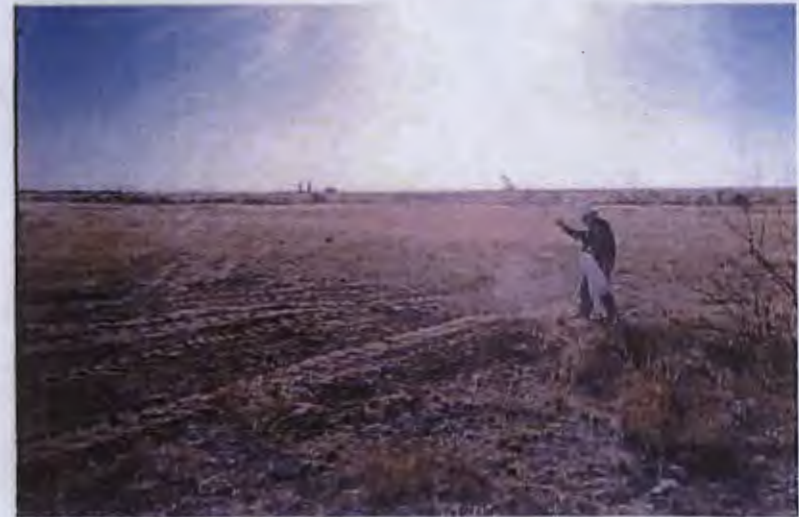
Seeding excavation

11/30/2010

General Description of Remedial Action: This junction box was eliminated during the pipeline replacement/upgrade program. After the former junction box was removed, an investigation was conducted using a backhoe to collect soil samples at regular intervals, creating a 5x3x12-ft deep excavation. Chloride field tests yielded low concentrations similar to that of the background. Organic vapors were measured using a PID, which yielded low concentrations. The deepest sample, 12-ft bgs, was sent to a commercial laboratory for analysis of chloride and TPH, which both yielded low concentrations. The excavated soil was returned to excavation to the ground surface and clean imported soil was imported as a top dressing. This soil was contoured to the surrounding area. On 2/25/2011, the site was seeded with a blend of native vegetation and is expected to return to a productive capacity at a normal rate.

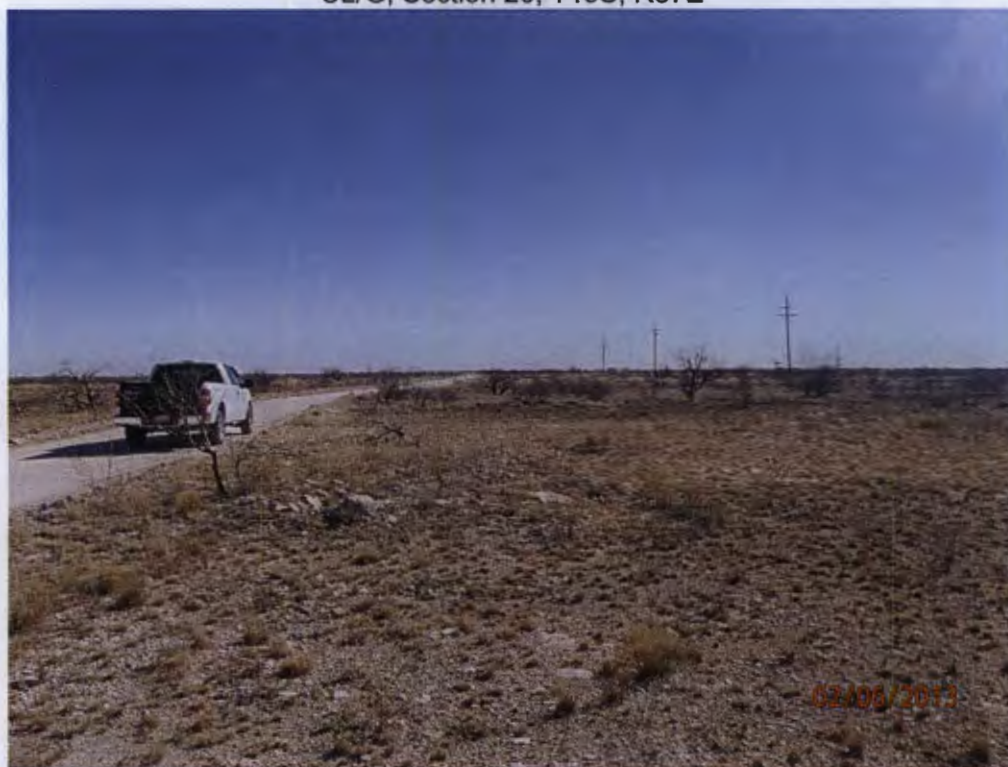
Facing east

2/6/2013

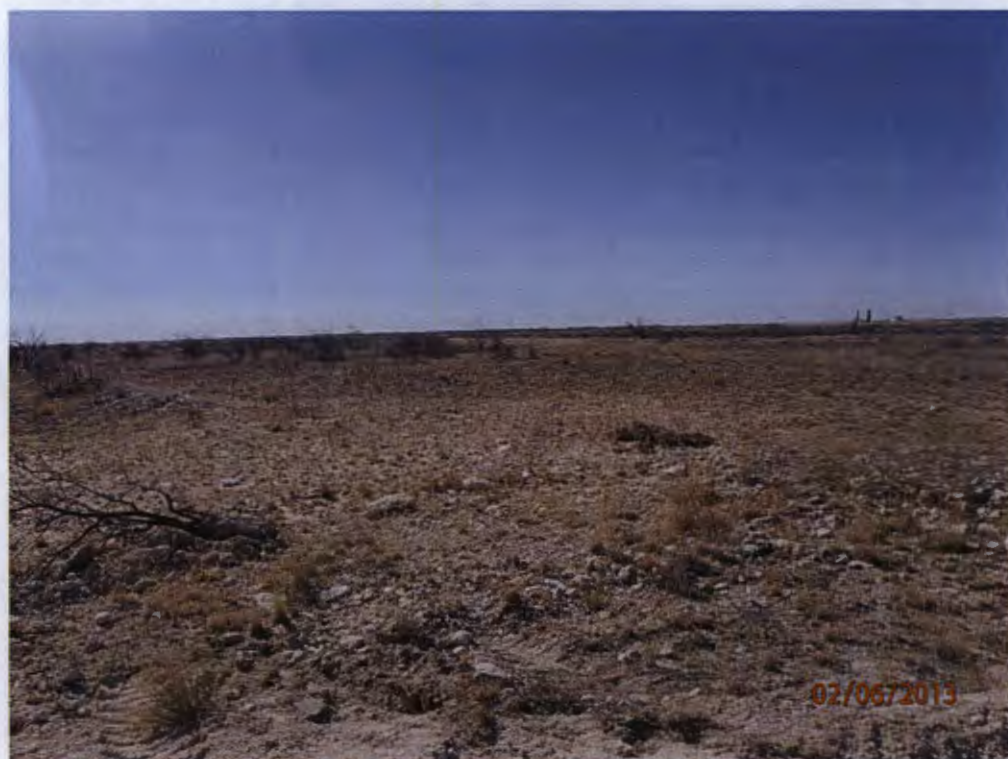
Facing west

2/6/2013
