**RE: Investigation and Characterization Plan (ICP) Report and Corrective Action Plan (CAP) for the Rice Operating Company's  
EME H – 9 EOL  
Unit Letter K, Section 30, T19S, R37E, NMPM, Lea County, New Mexico  
Corrective Action Plan (1R427-406) Approval**

**June 13, 2014**

**RE: ICP Report & Corrective Action Plan (CAP)  
Rice Operating Company – EME SWD System  
EME H-9 EOL (1R427-406): UL/H sec. 9 T21S R36E**

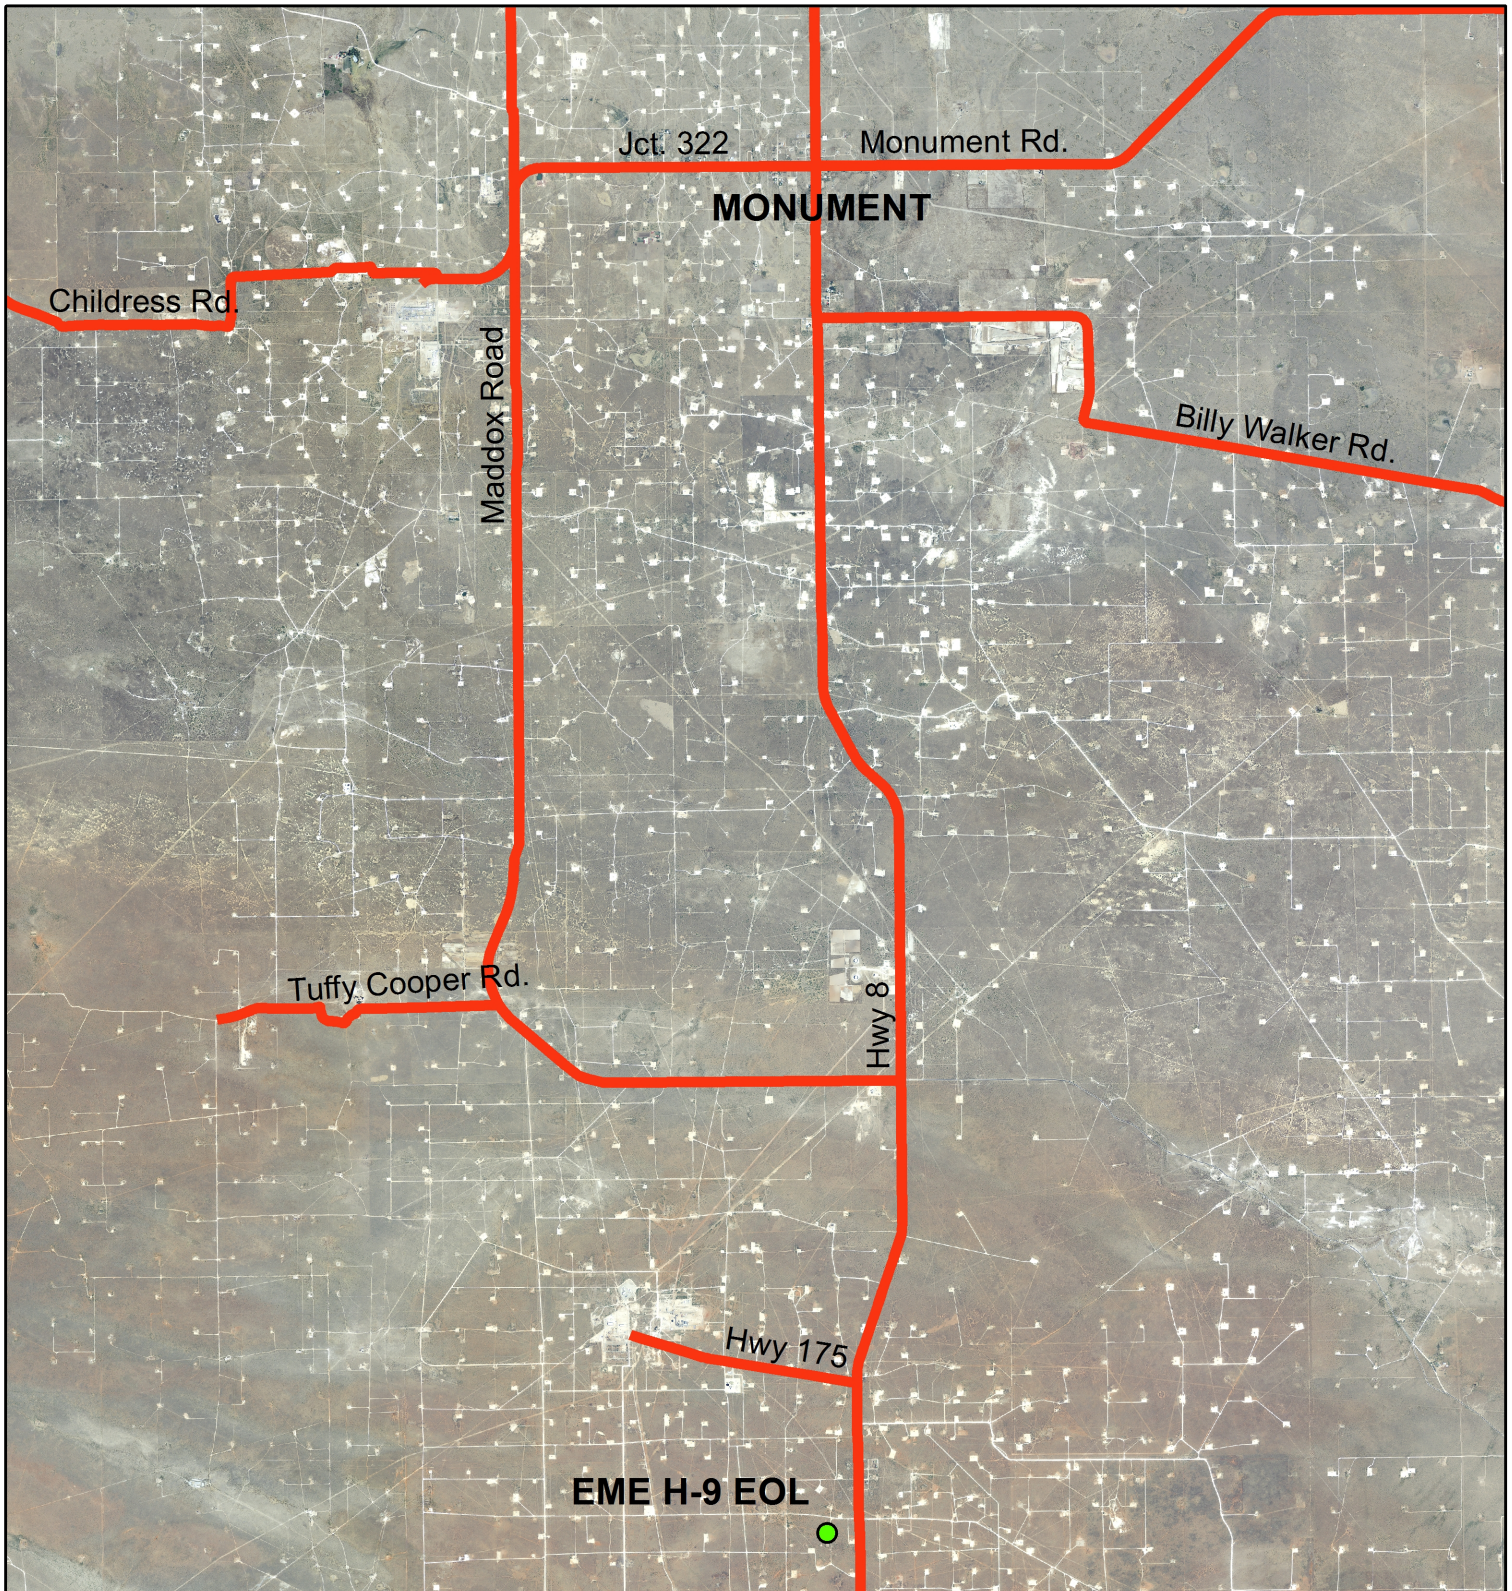
Figure 1

# Site Location Map

***EME H-9  
EOL***  
UL/H SECTION 9  
T-21-S R-36-E  
LEA COUNTY, NM  
NMOCD Case #: 1R427-406

The site is located approximately 9 miles south of Monument, New Mexico in UL/H sec. 9 T21S R36E as shown in the Site Location Map (Figure 1). NM OSE records indicate that groundwater will likely be encountered at a depth of approximately 198 +/- feet.

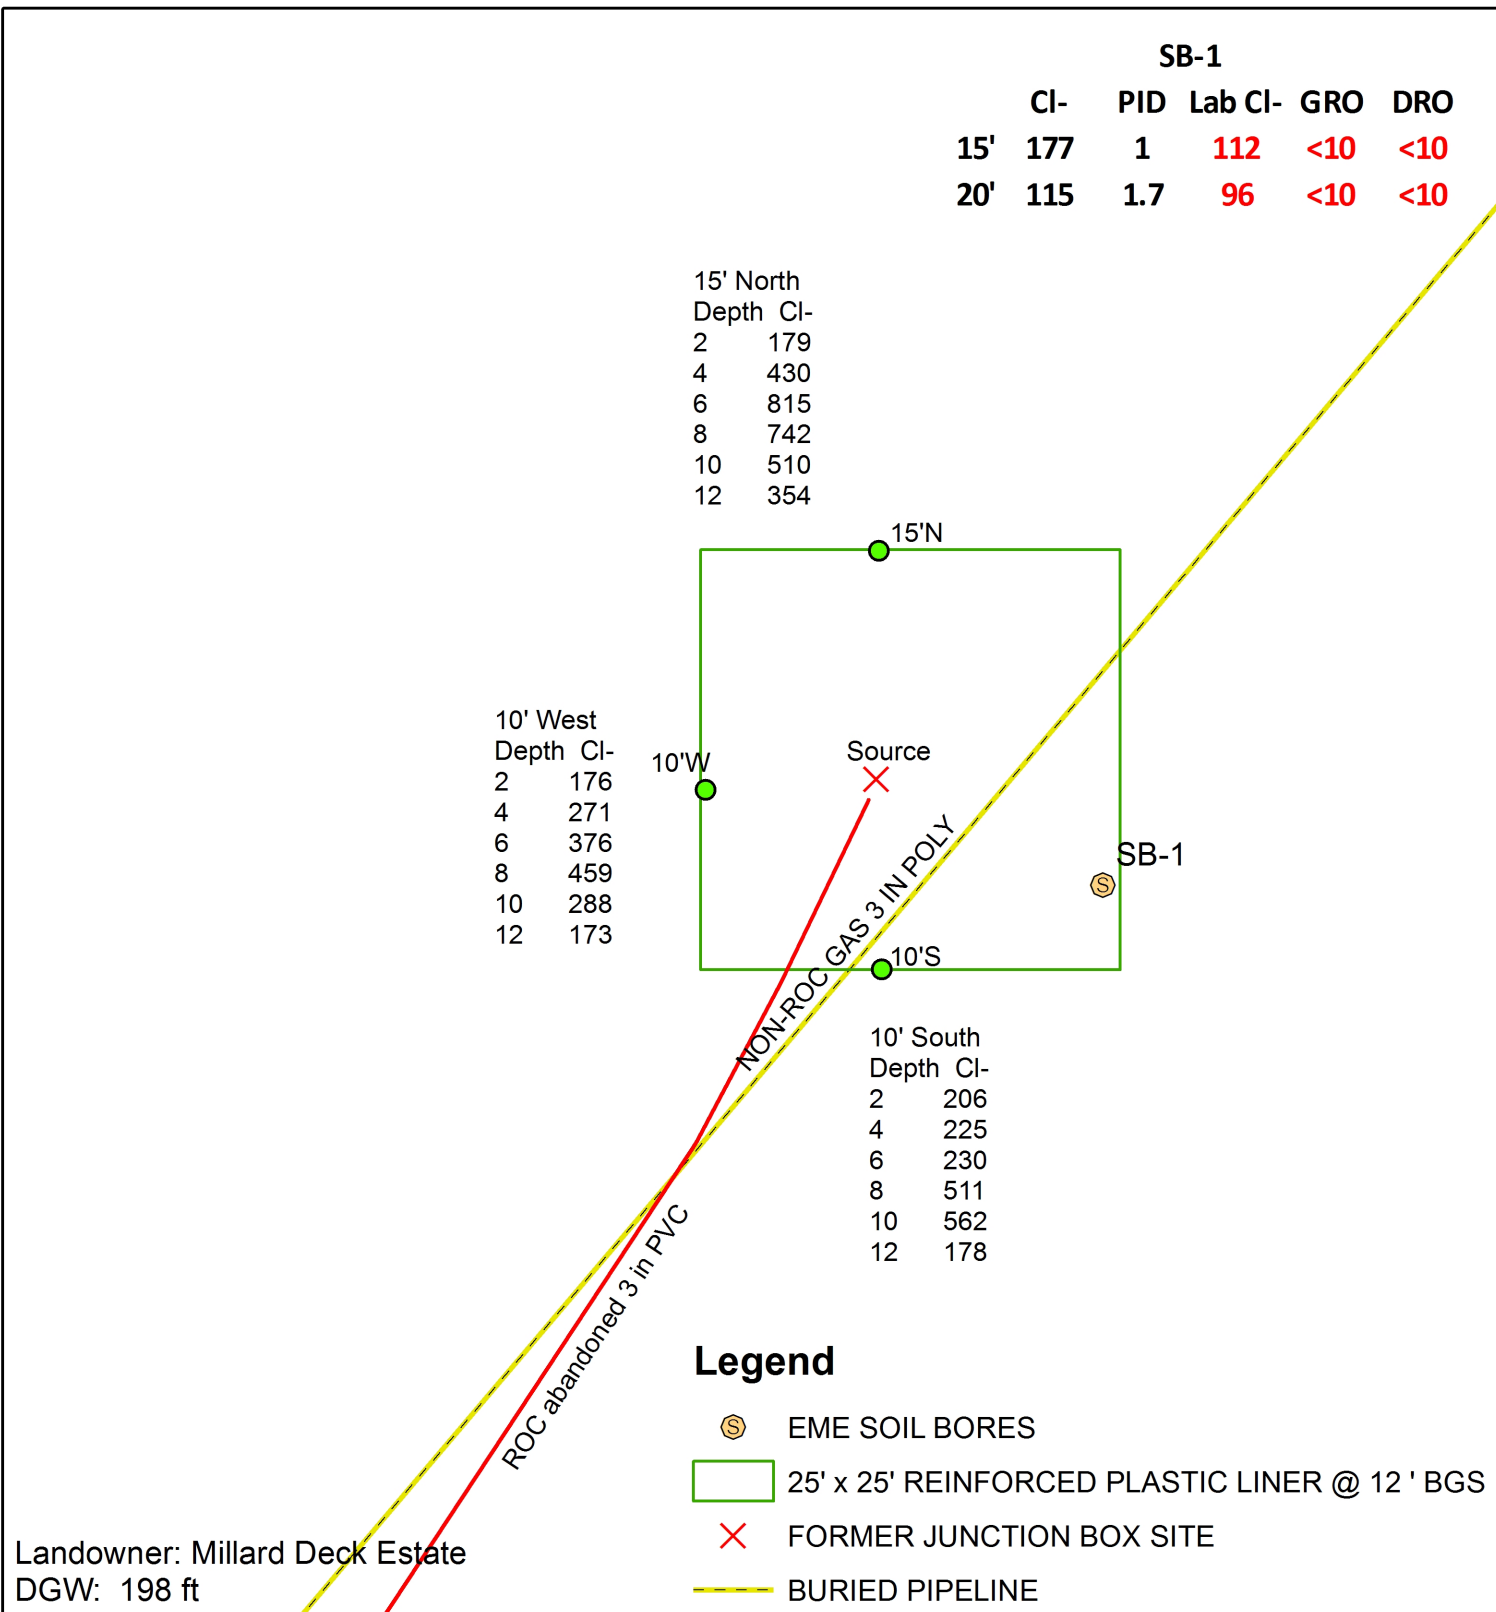
# Soil Bore Installation

Figure 2 – Soil Bore Installation Map

As part of the Investigation and Characterization Plan submitted to NMOCD on October 10<sup>th</sup>, 2013, and approved on October 21<sup>st</sup>, 2013, RECS personnel were on site on February 2<sup>nd</sup>, 2014, to conduct soil bore installations (Figure 2). One soil bore was drilled east of the source to a depth of 20 ft bgs. As the soil bore, SB-1, was advanced, samples were taken at regular intervals and field tested for both chlorides and hydrocarbons. Representative samples were taken to a commercial laboratory for field number confirmation. Laboratory chloride readings for SB-1 returned results of 112 mg/kg at 15 ft bgs and 96 mg/kg at 20 ft bgs. Gasoline Range Organics (GRO) and Diesel Range Organics (DRO) readings throughout all depths were non-detect (Appendix A).

The lateral extent of the site was defined to the west with the 10 ft west vertical, in which chloride concentrations were low and decreased to 173 mg/kg at 12 ft bgs. The southern edge was defined by the 10 ft south vertical, with a chloride concentration of 178 mg/kg at 12 ft bgs. The northern edge was defined by the 15 ft north vertical, with a concentration of 354 mg/kg at 12 ft bgs. SB-1 defined the eastern edge of the site with a low concentration of 96 mg/kg at 20 ft bgs. Based on the low concentrations observed across the site and the existing 25 ft x 25 ft, 20-mil reinforced poly liner, it is evident that the residual chlorides in the vadose zone will not contribute to the degradation of groundwater beneath the site. Vegetation has not returned to this site; therefore, RECS recommends that the site be scraped to an approximate depth of 6 inches. Clean, imported soil will be used as backfill over the site. The backfill material will have a laboratory chloride reading no greater than 500 mg/kg and a field PID reading below 100 ppm. The area will be contoured to the surrounding location and the site will be seeded with a blend of native vegetation. Soil amendments will also be added, as necessary, to promote the growth of vegetation. Vegetation will provide a natural infiltration barrier for the site since plants capture water through their roots thereby reducing the volume of water moving through the vadose zone to groundwater.
