NM1-57

Revised Permit Application

Volume 4, Part 2 of 3: Siting and Hydrogeology

WATERCOURSES, FLOODPLAINS, AND WETLANDS INVESTIGATION
FOR A SURFACE WASTE MANAGEMENT FACILITY ON 562 ACRES IN PORTIONS
OF SECTION 31, TOWNSHIP 17 SOUTH, RANGE 33 EAST, AND SECTION 6,
TOWNSHIP 18 SOUTH, RANGE 33 EAST, LEA COUNTY, NM FOR DNCS
PROPERTIES, LLC

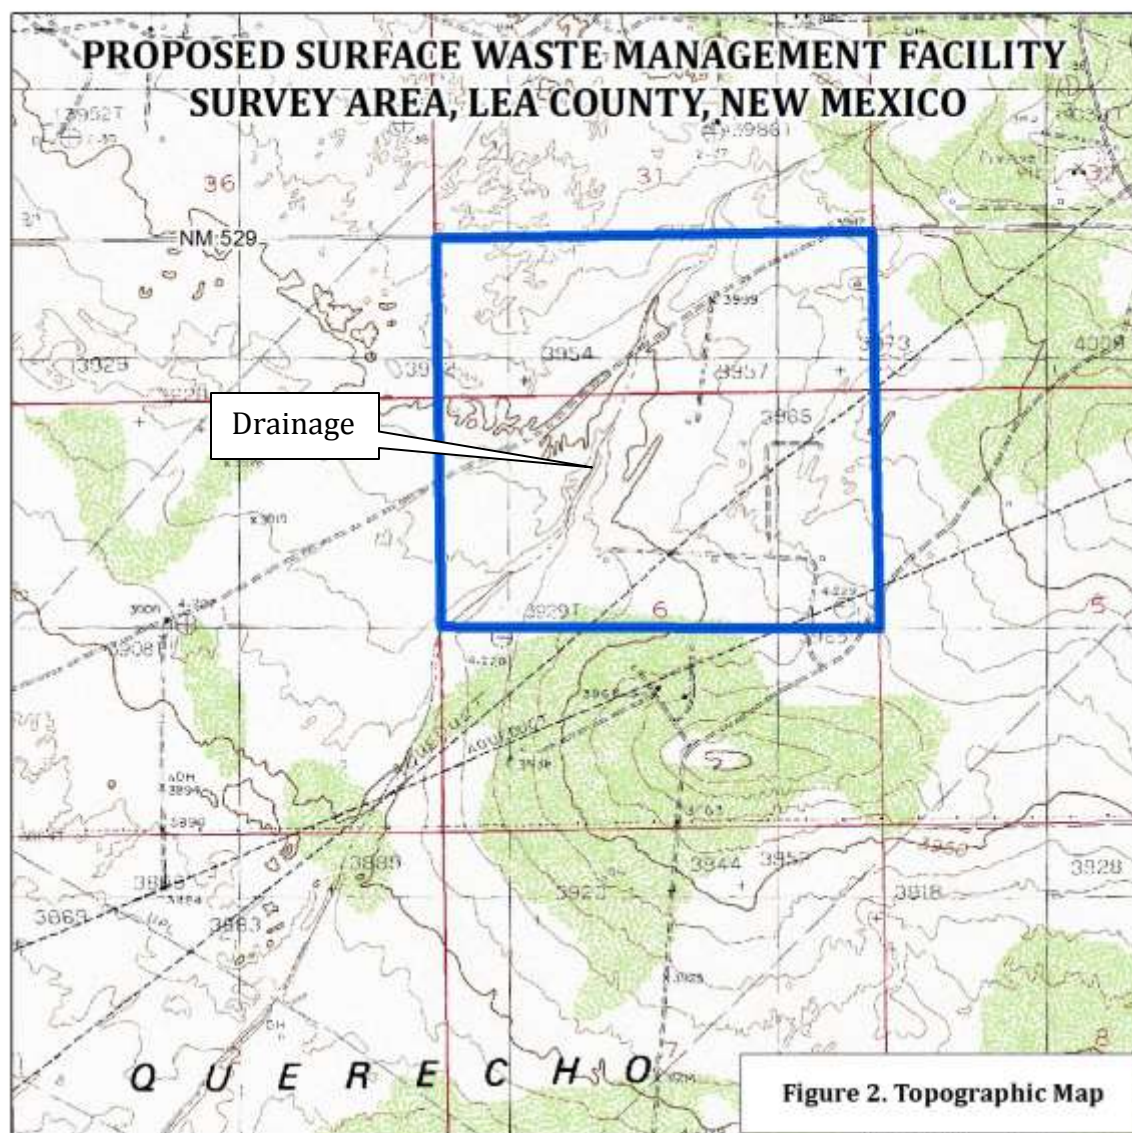
One noteworthy, un-named ephemeral drainage flows from the Northeast, to the Southwest corner of the DNCS Site (Figure 2). No surface water was located within this drainage during the field survey. The Oil & Gas Rules define a "watercourse" as a "*river, creek, arroyo, canyon, draw or wash or other channel having definite banks and bed with visible evidence of the occasional flow of water*" (19.15.27.W(4) NMAC). Based on the field investigation, the un-named ephemeral drainage identified within the site may be defined as a watercourse, as it does have definite banks and a bed with visible evidence of occasional water flow.

A pipeline is located on the surface in the bottom of this drainage. Based on the USGS (1999), the DNCS Site is located entirely within the Williams Sink closed basin. Accordingly, runoff from this site drains to the Southwest, beyond the property boundary, ultimately percolating into the ground within the basin boundary (Figure 4). Further, two aqueducts are located across the southeast portion of the DNCS property, as depicted in Figure 2.

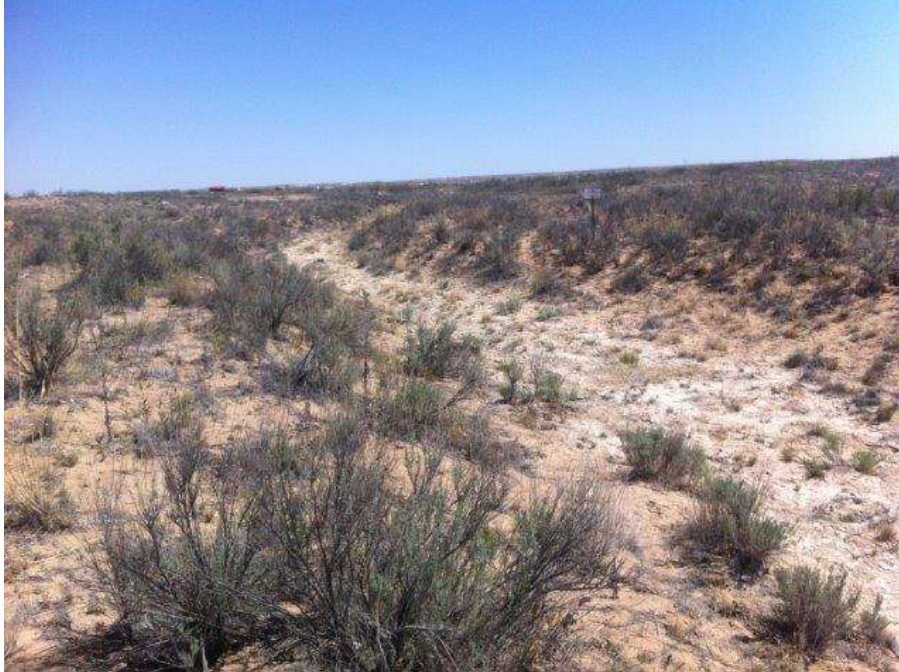
Photo 1. View of drainage, facing to the Southwest from the North-Central portion of the property.

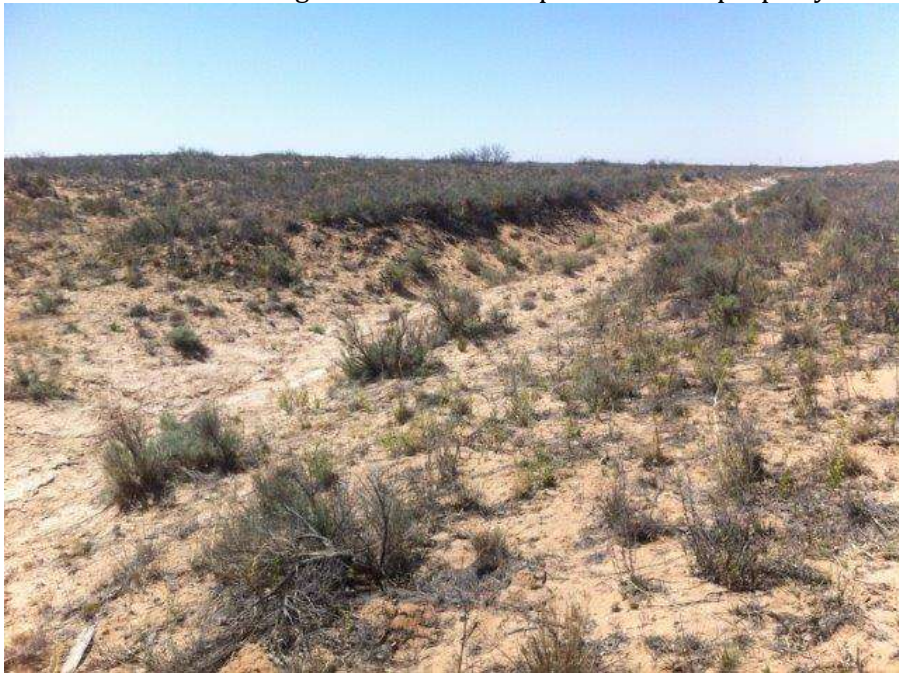
Photo 2. View of drainage from the central portion of the property.

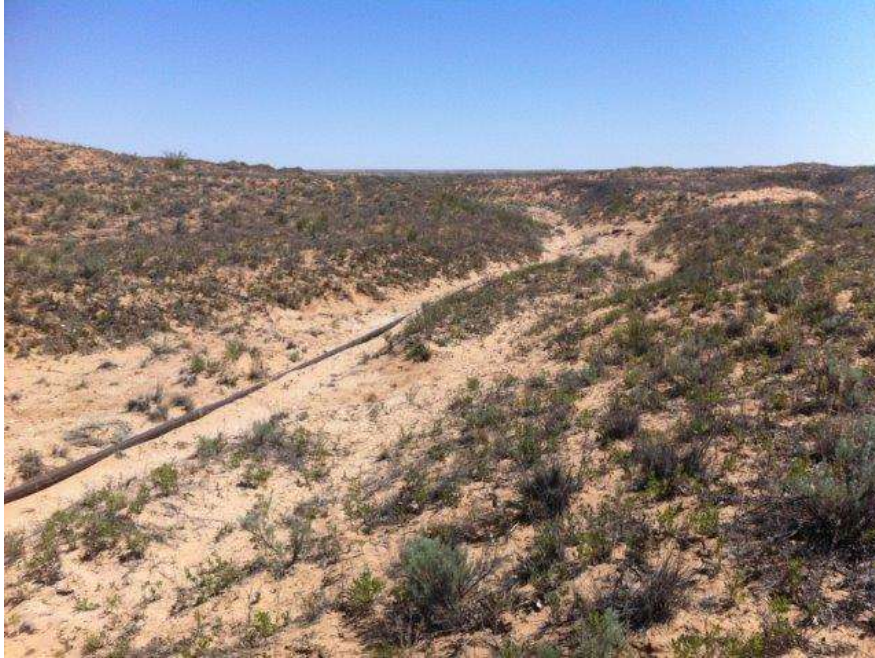
Photo 3. View of pipeline, located in bottom of the subject drainage.

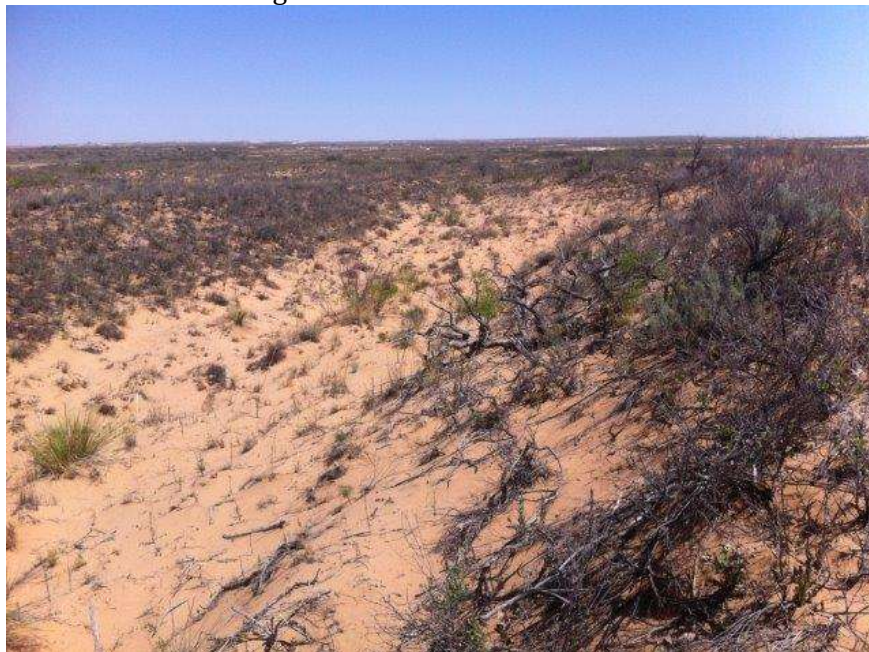
Photo 5. Typical view of a small sand blowout depression in the southeast portion which likely channels water during runoff events.

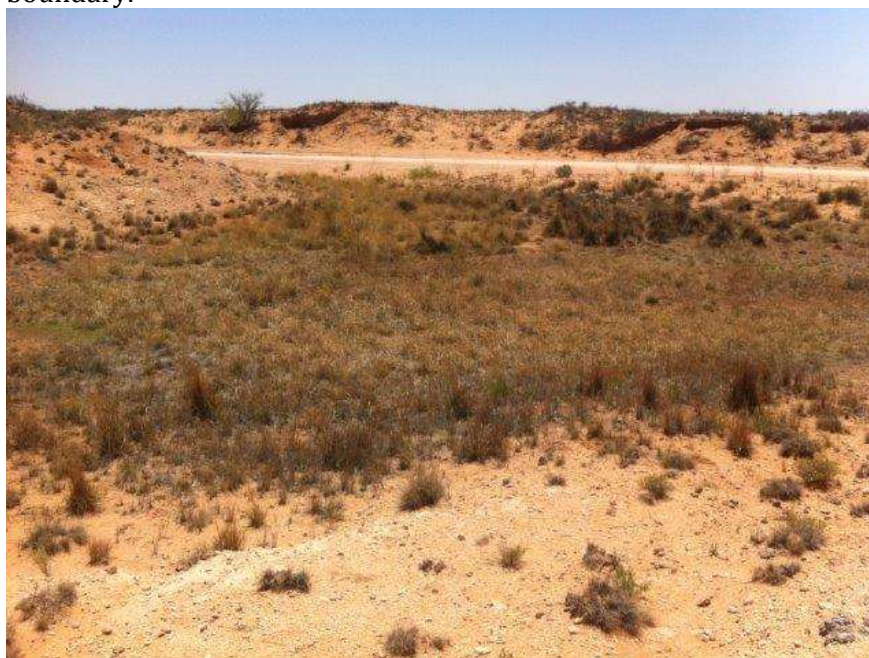
Photo 6. View of minor depression with vine mesquite in the bottom, located near the western boundary.
