**RE: Closure Request  
Chistera 32 State 1H  
Remediation Permit Number 1RP-5338  
Lea County, New Mexico**

LT Environmental, Inc. (LTE), on behalf of XTO Energy, Inc. (XTO), presents the following report detailing excavation of impacted soil and confirmation soil sampling activities at the Chistera 32 State 1H (Site) located in Unit C, Section 32, Township 20 South, Range 33 East, in Lea County, New Mexico (Figure 1). The purpose of the excavation and soil sampling activities was to address impacts to soil after a hydraulic fracturing tank overflowed.

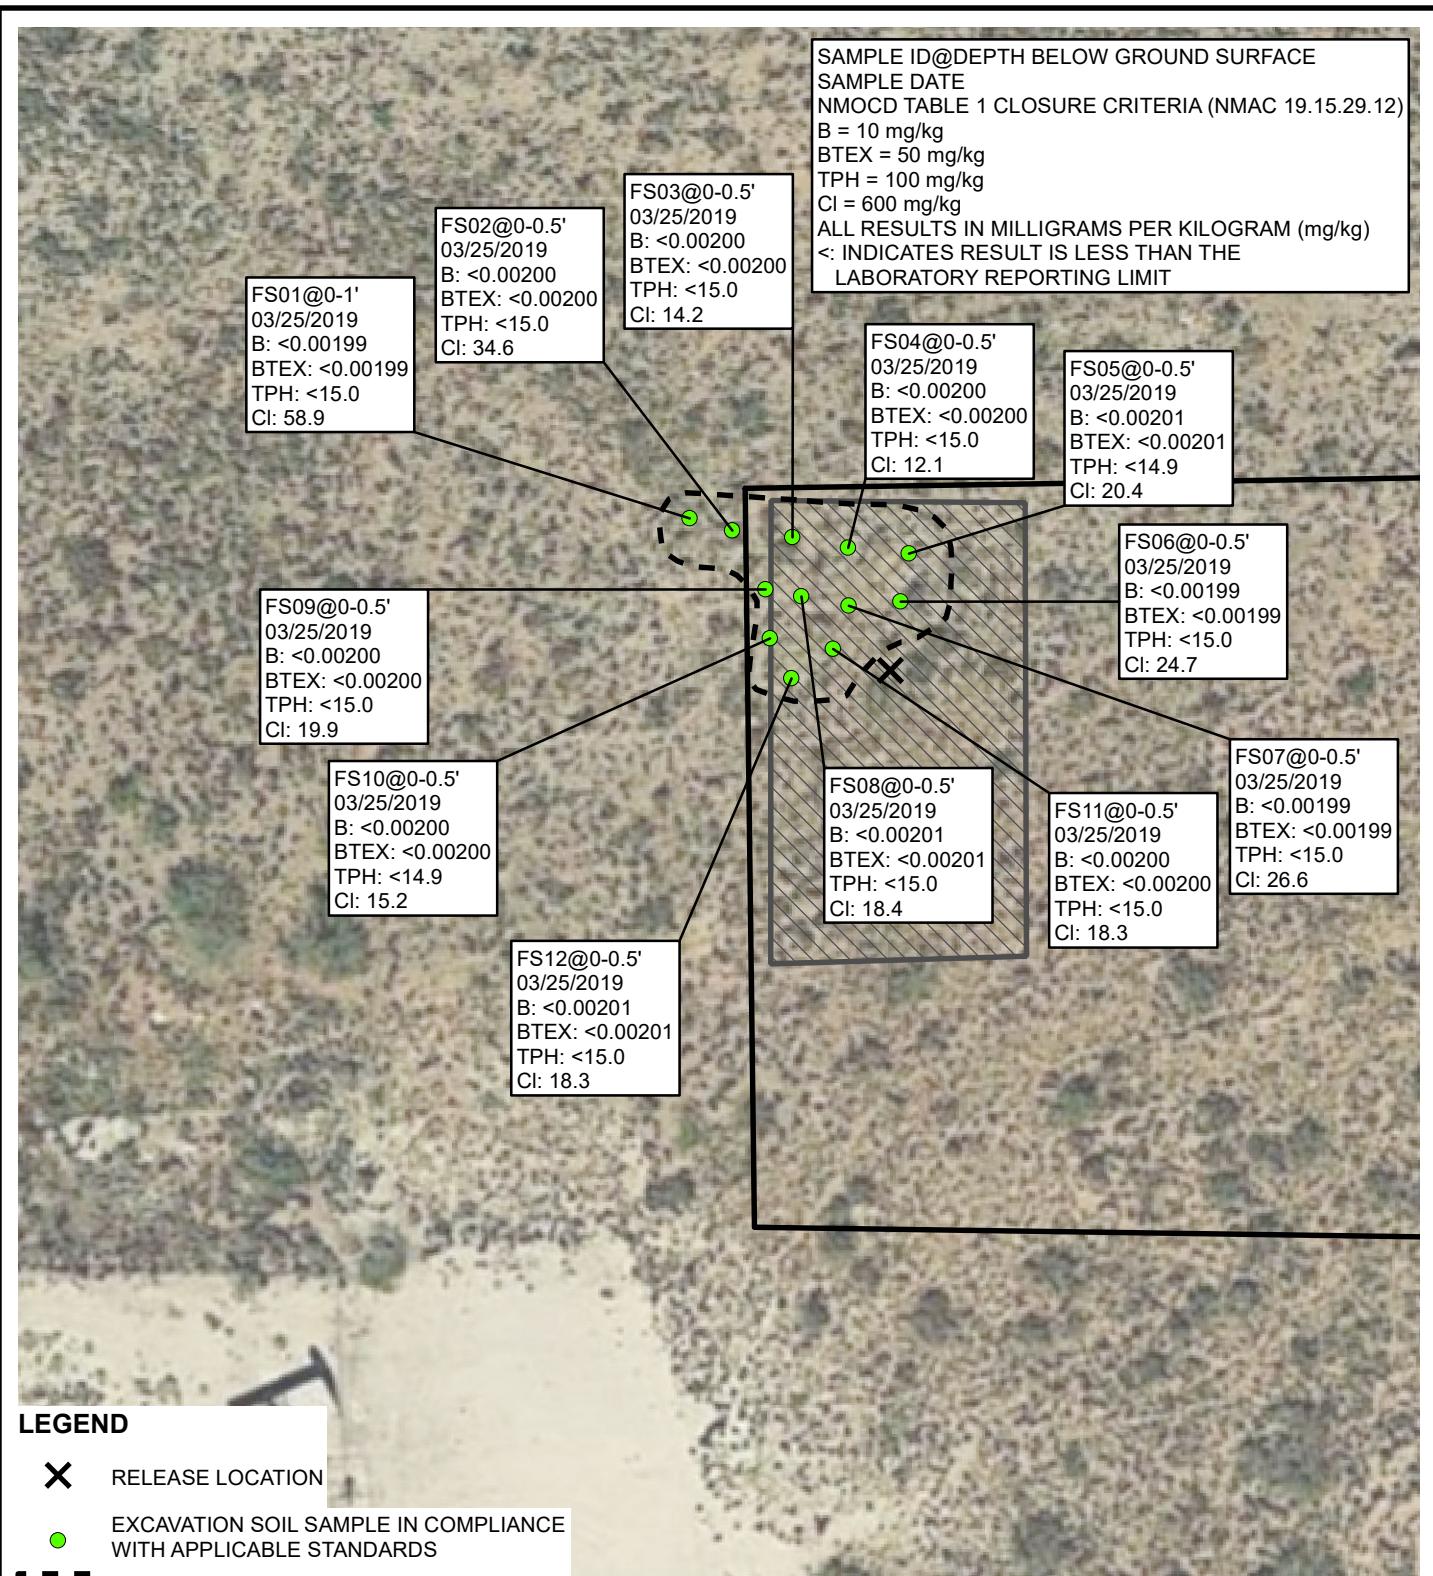
**FIGURE 3**  
**EXCAVATION SOIL SAMPLE LOCATIONS**  
**CHISTERA 32 STATE 1H**  
**UNIT C SEC 32 T20S R33E**  
**LEA COUNTY, NEW MEXICO**  
**XTO ENERGY, INC.**

On March 25, 2019, upon removal of the temporary hydraulic fracturing tank and containment, LTE personnel returned to the Site to oversee excavation of impacted soil in the northern release area. To delineate impacts to soil and direct excavation activities, LTE screened soil using a PID and Hach® chloride QuanTab® test strips. Impacted soil was excavated to a depth of 0.5 feet to 1 foot bgs in the pasture release area west of the former tank containment and to a depth of 0.5 feet bgs in the area beneath the former tank containment where liquids migrated laterally under the liner. Following removal of impacted soil, LTE collected twelve 5-point composite soil samples (FS01 through FS12) every 200 square feet from the sidewalls and floor of the excavation. The 5-point composite samples were collected by depositing 5 aliquots of soil into a 1-gallon, resealable plastic bag and homogenizing the samples by thoroughly mixing. Based on the shallow depth of the excavation, samples FS01 through FS12 were representative of the sidewalls and floor of the excavation. Composite soil sample FS01 was collected from a depth of 0 to 1 foot bgs, and composite soil samples FS02 through FS12 were collected from a depth of 0 to 0.5 feet bgs. The soil sample locations and depths are depicted on Figure 3.

The excavation measured approximately 2,680 square feet in area. The horizontal extent of the excavation is presented on Figure 3. A total of approximately 75 cubic yards of impacted soil were removed from the excavation. The impacted soil was transported and disposed of at the Lea Land landfill facility, in Hobbs, New Mexico.

The impacted soil was excavated from the northern release area and laboratory analytical results for the confirmation soil samples collected from the final excavation extent indicated that BTEX, TPH, and chloride concentrations were compliant with the NMOCD Table 1 closure criteria. No excavation was required in the southern release area. Initial response efforts and excavation of impacted soil have mitigated impacts at this Site. XTO requests no further action for RP Number 1RP-5338. Upon approval of the no further action request, XTO will backfill the excavation with material purchased locally and recontour the Site to match pre-existing conditions. An updated NMOCD Form C-141 is included in Attachment 1. A photographic log of the Site is included as Attachment 4.

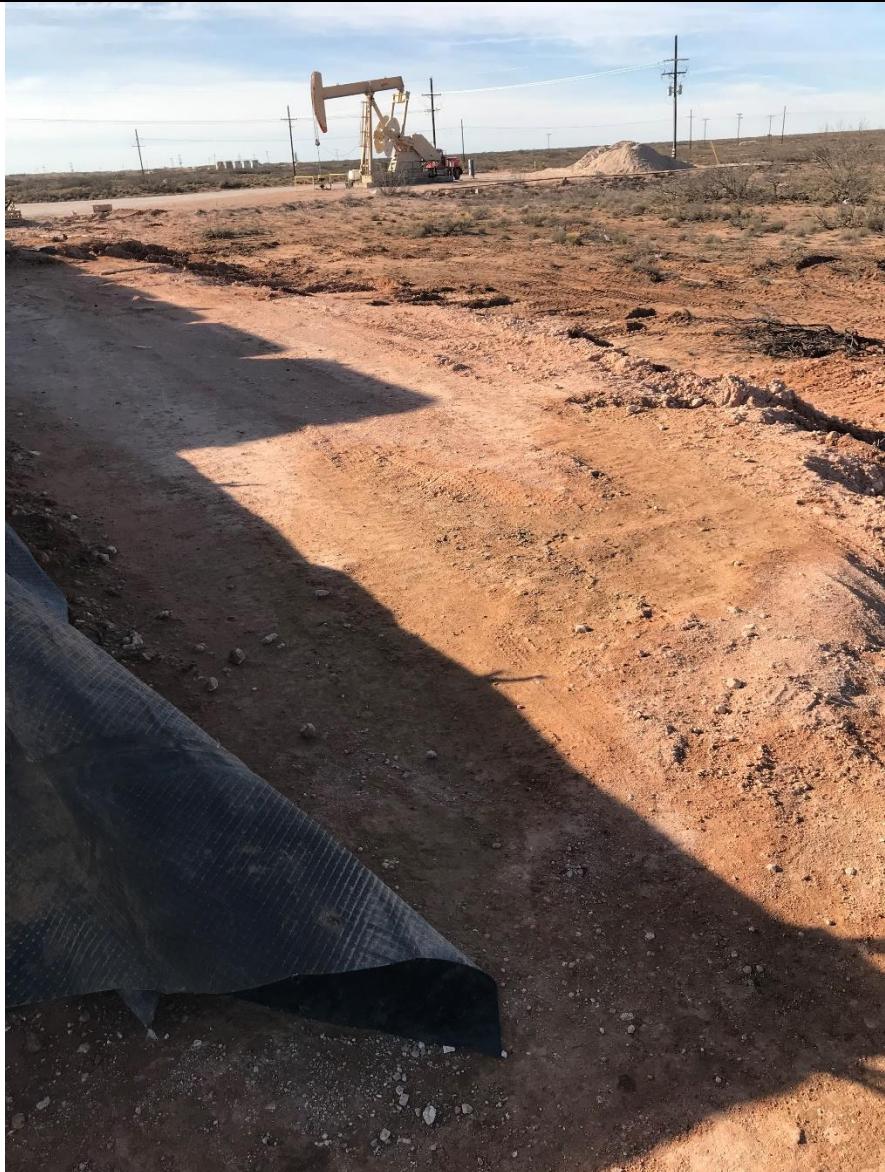
**Southwestern view of the northern release area prior to excavation activities.**

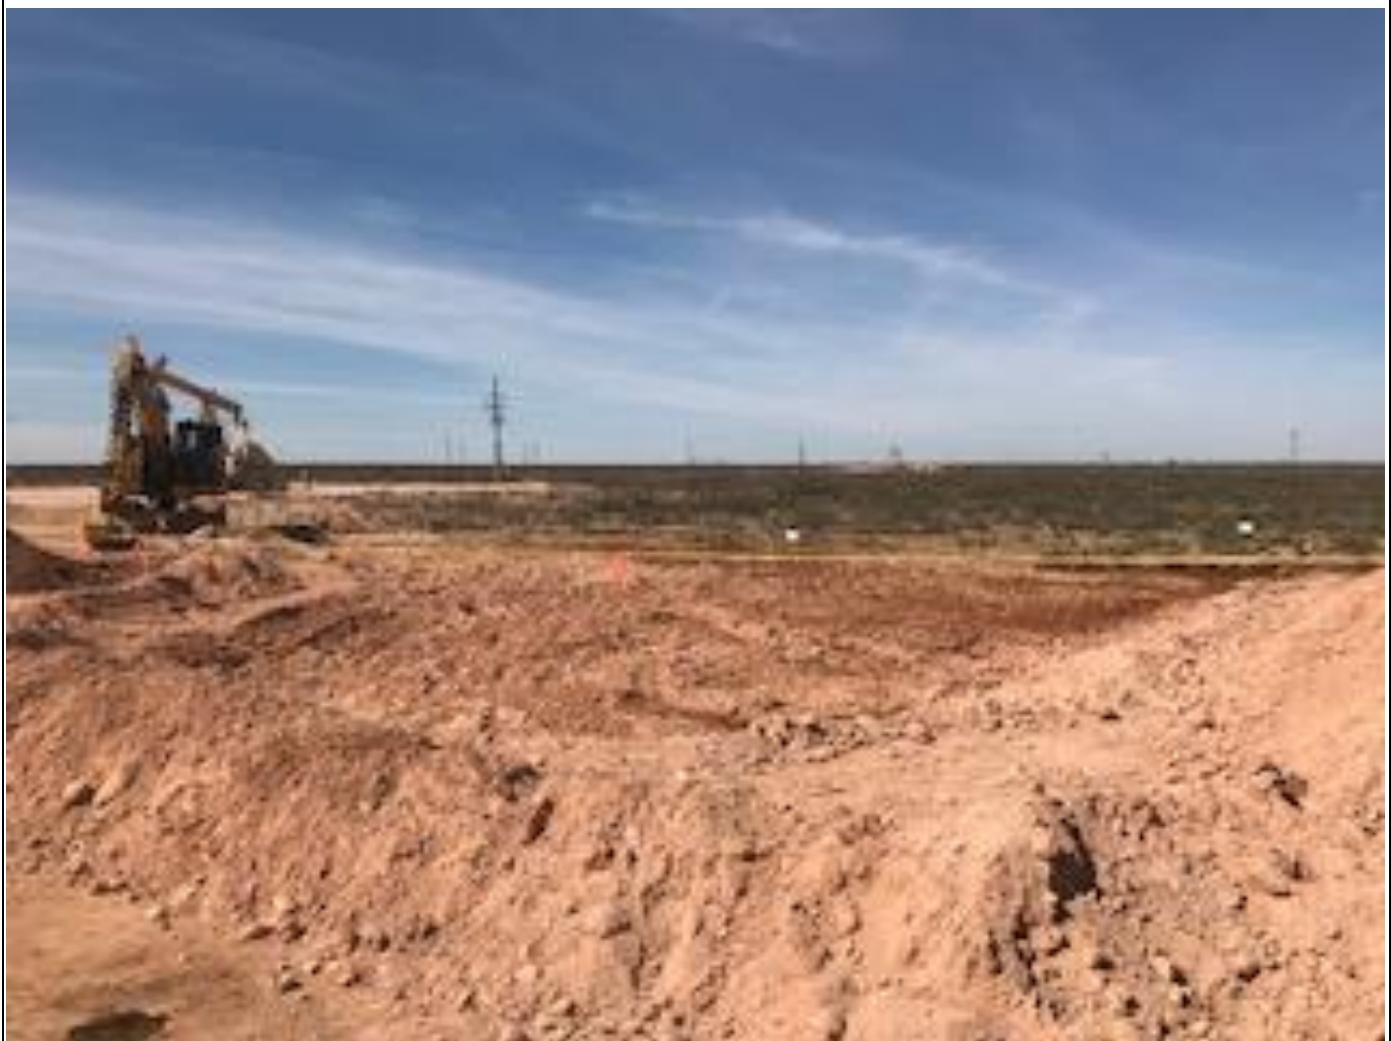
**Southwestern view of the final excavation extent.**
