**Re: Remedial Action Report
Vaca Line Strike
1RP-5243
EOG Resources, Inc.
Site Location: Unit A, Sec. 36, T 24-S, R 33-E
(Lat 32.180794°, Long -103.518761°)
Lea County, New Mexico**

At the request of EOG Resources, Inc. (EOG), New Tech Global Environmental, LLC (NTGE) has prepared this letter to document remedial action activities following a release at the Vaca Line Strike (Site). The Site is an active produced water line at the intersection of Vaca Lane and Resource Lane within Unit A, Section 36, Township 24 South, Range 33 East, approximately 19.6 miles northwest of Jal, New Mexico (Figures 1 and 2).

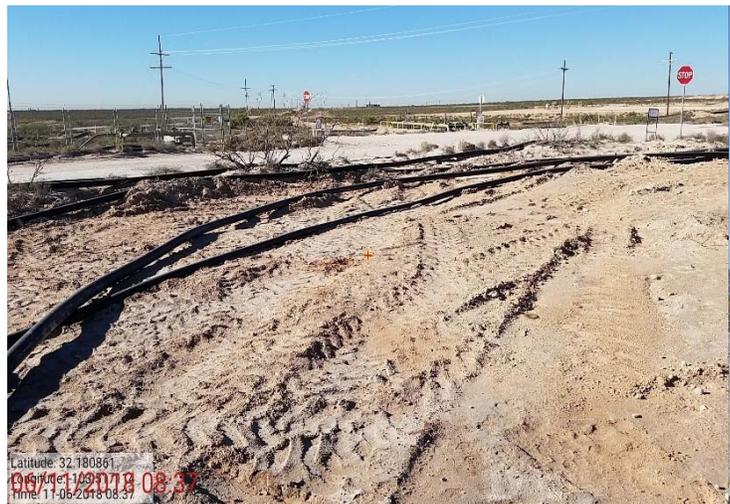
Photograph No. 2

View of point of release and area of TP 1 looking southwest. Note intersection of Vaca Lane (N to S) and Resource Land (E to W).

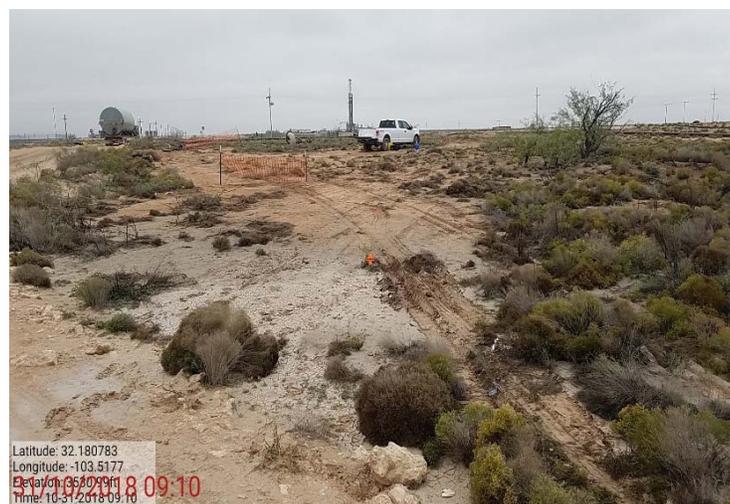
Photograph No. 3

View of spill trajectory looking west from area of TP5.

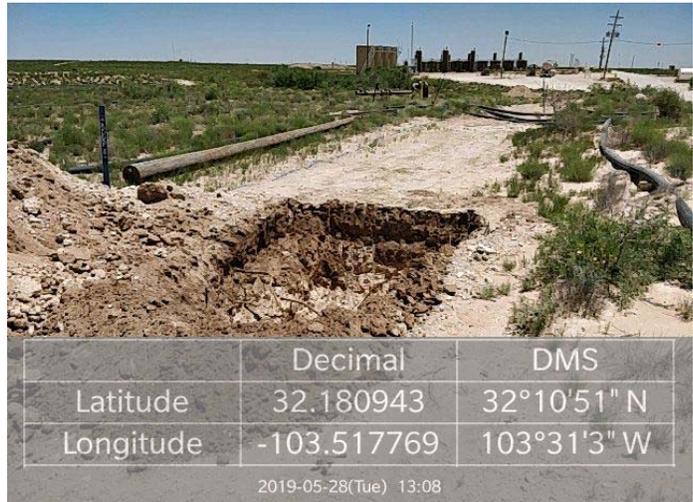
Photograph No. 4

View of AOC1 looking east.

Soils in the areas of AOC1 and AOC 3 were excavated to a depth of 4 ft bgs and soils in AOC2 were excavated to a depth of 5 ft bgs. The bottoms and sidewalls were field screened using Hach Quantab Chloride Strips to ensure all impacts had been removed. Soil confirmation samples were collected from the sidewalls and bottoms of the excavation for lab analysis. Excavation and confirmation sample locations are illustrated on Figure 4, attached. Site Photographs taken at the time of excavation and sample collection are included in the attached photographic log.

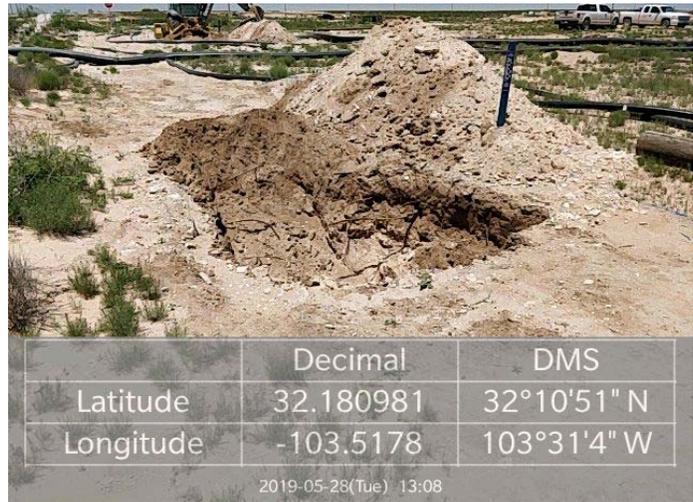
Photograph No. 5

View of AOC2 looking west.

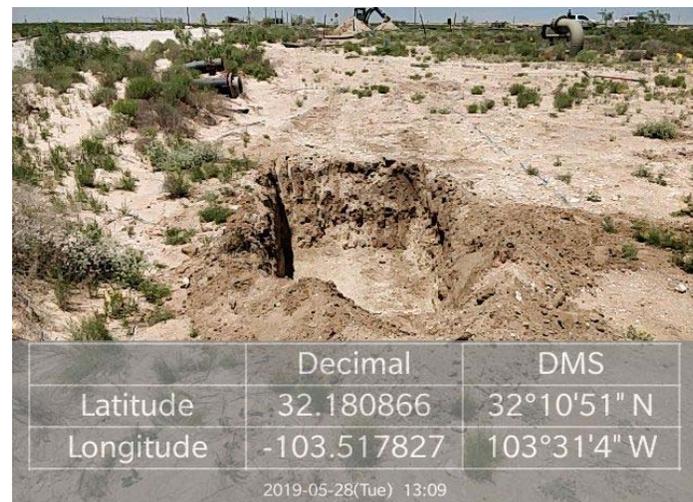
Photograph No. 6

View of AOC3 looking west.

After reviewing the laboratory results, it is determined that chloride levels at sample locations, AOC3 SW1 (603 mg/kg) and AOC3 SW3 (649 mg/kg) were still slightly above regulatory limits. As seen on Figure 4, the two samples (AOC3 SW1 and AOC3 SW3) are adjacent to active saltwater disposal lines and Resource Lane. Since the sample results are slightly above the NMOCD regulatory limits of 600 mg/kg ($\pm 10\%$), and due to the proximity to active saltwater disposal lines and Resource Lane, EOG respectfully requests the NMOCD consider closure of the site and/or delayed remediation adjacent to the pipeline/road due to integrity issues.
