Remediation Plan

*Re: WBDU 23
API# 30-025-21225
Case # 1RP-5181*

Background:

Remediation Plan:

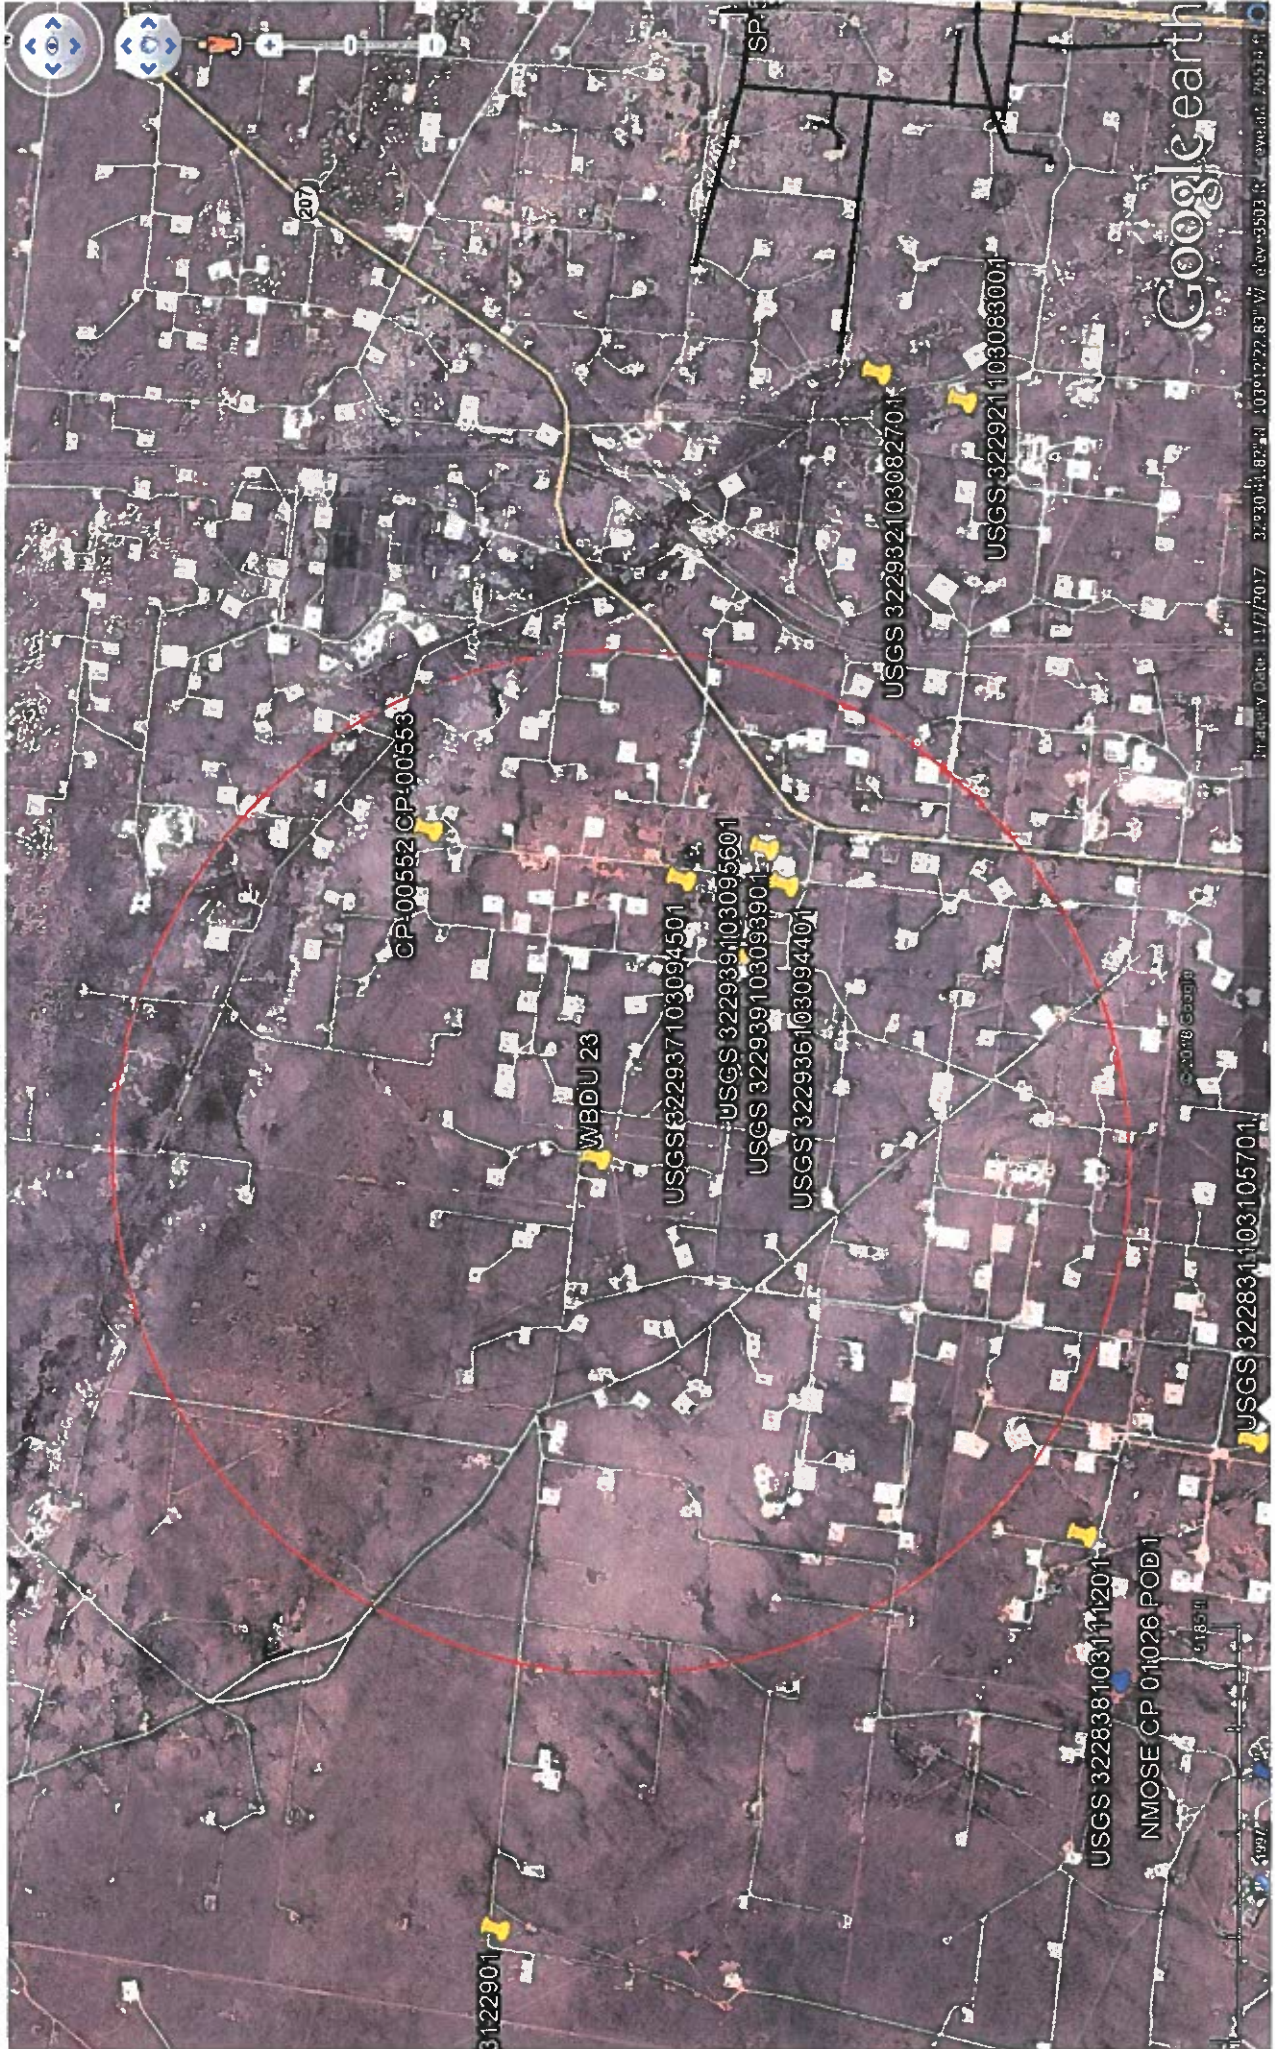
WB DU 23

USGS 322937103094501

USGS 322939103095601

USGS 322939103093901

USGS 322936103094401

USGS 322932103082701

USGS 322921103083001

USGS 322838103111201

NMOSE CP 01026 POD 1

USGS 322831103105701

What is the shallowest depth to groundwater beneath the area affected by the release?	<u>58</u> (ft bgs)
Did this release impact groundwater or surface water?	<input type="checkbox"/> Yes <input checked="" type="checkbox"/> No
Are the lateral extents of the release within 300 feet of a continuously flowing watercourse or any other significant watercourse?	<input type="checkbox"/> Yes <input checked="" type="checkbox"/> No
Are the lateral extents of the release within 200 feet of any lakebed, sinkhole, or playa lake (measured from the ordinary high-water mark)?	<input type="checkbox"/> Yes <input checked="" type="checkbox"/> No
Are the lateral extents of the release within 300 feet of an occupied permanent residence, school, hospital, institution, or church?	<input type="checkbox"/> Yes <input checked="" type="checkbox"/> No
Are the lateral extents of the release within 500 horizontal feet of a spring or a private domestic fresh water well used by less than five households for domestic or stock watering purposes?	<input type="checkbox"/> Yes <input checked="" type="checkbox"/> No

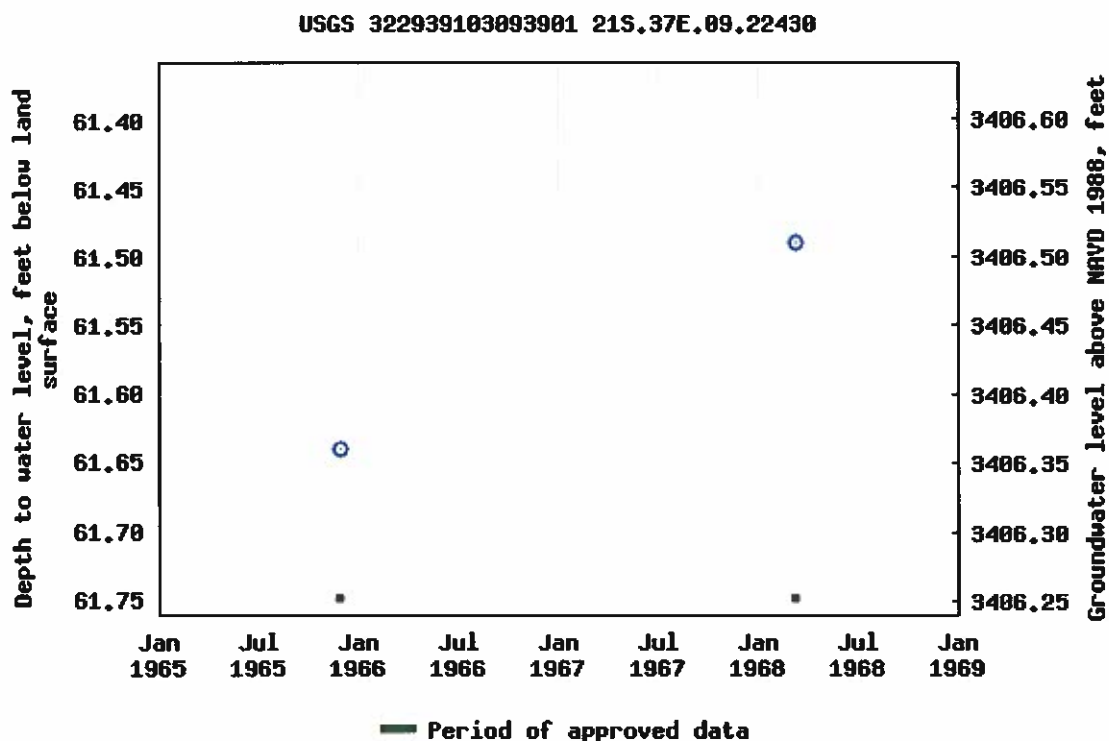
USGS 322939103093901 21S.37E.09.22430

Lea County, New Mexico

The depth of the well is 90 feet below land surface.

This well is completed in the Alluvium, Bolson Deposits and Other Surface Deposits (110AVMB) local aquifer.

Breaks in the plot represent a gap of at least one year between field measurements.

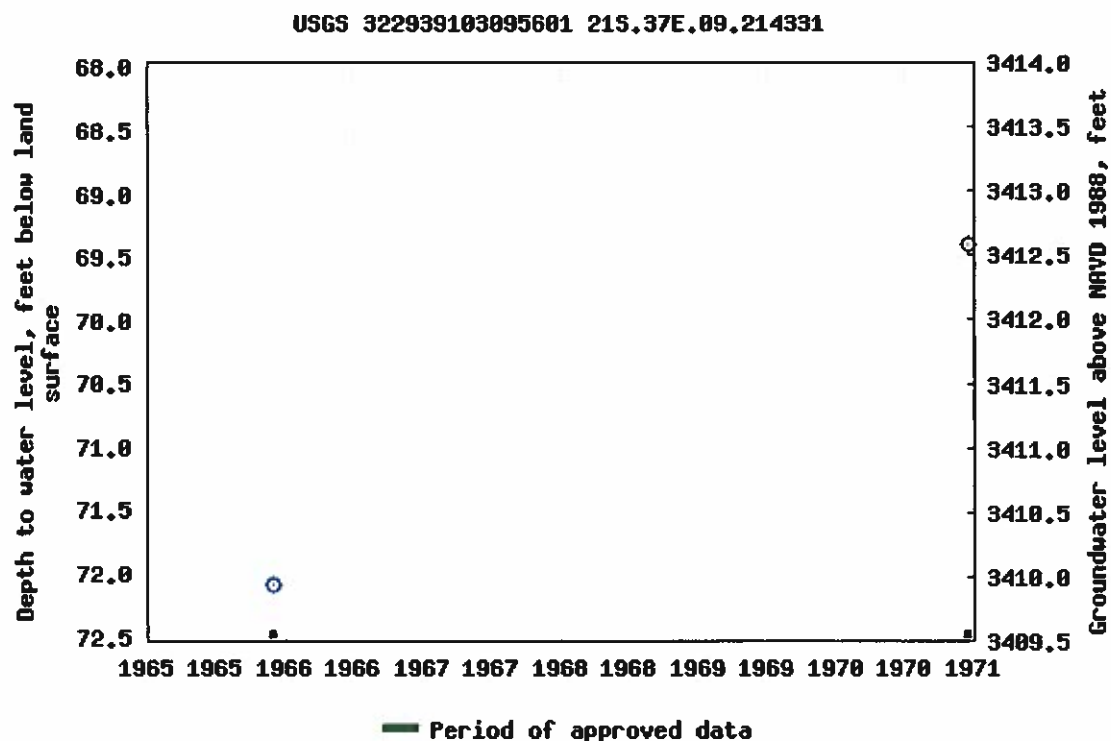
USGS 322939103095601 21S.37E.09.214331

Lea County, New Mexico

The depth of the well is 400 feet below land surface.

This well is completed in the Chinle Formation (231CHNL) local aquifer.

Breaks in the plot represent a gap of at least one year between field measurements.

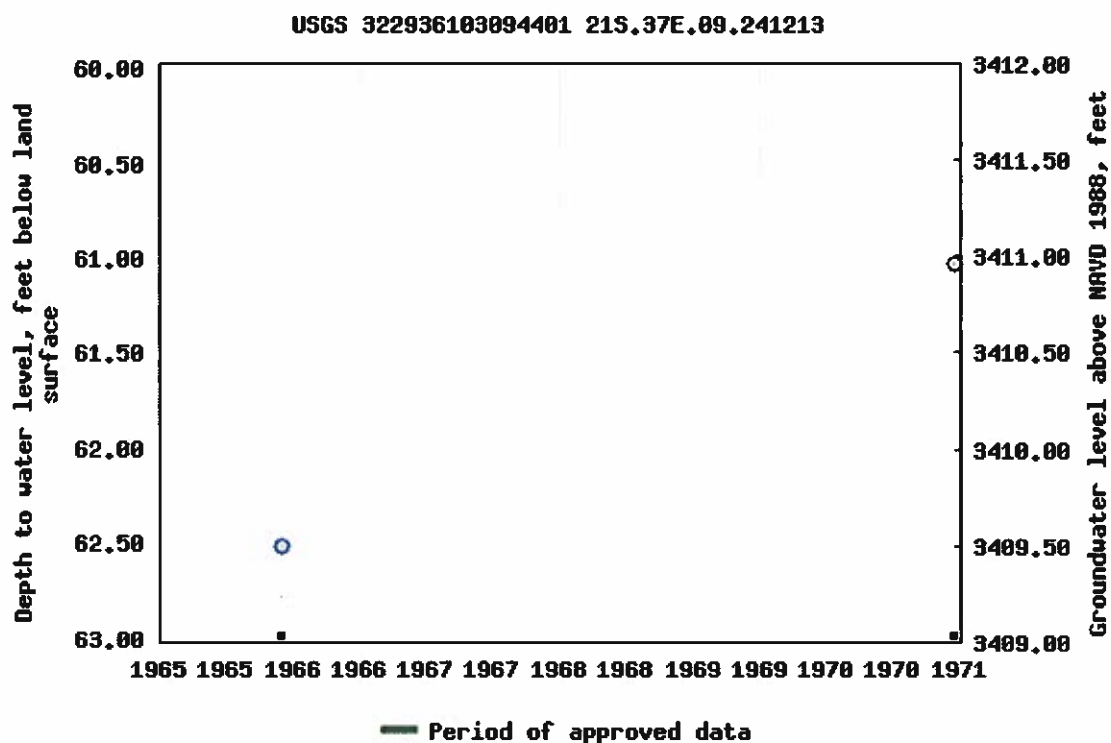
USGS 322936103094401 21S.37E.09.241213

Lea County, New Mexico

The depth of the well is 90 feet below land surface.

This well is completed in the Alluvium, Bolson Deposits and Other Surface Deposits (110AVMB) local aquifer.

Breaks in the plot represent a gap of at least one year between field measurements.

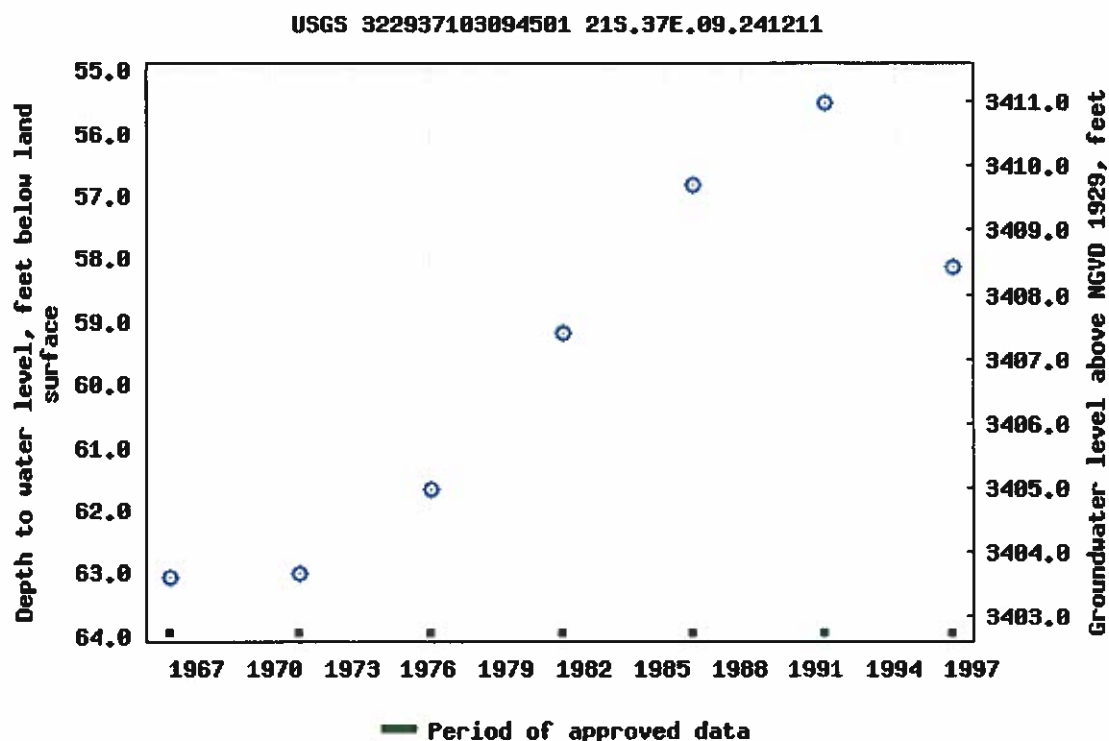
USGS 322937103094501 21S.37E.09.241211

Lea County, New Mexico

The depth of the well is 90 feet below land surface.

This well is completed in the Alluvium, Bolson Deposits and Other Surface Deposits (110AVMB) local aquifer.

Breaks in the plot represent a gap of at least one year between field measurements.
