**AP - 111**

**FACILITY WIDE  
BERM &  
STORMWATER  
REPAIR**

**To:** Mr. John Moore, P.E.  
**From:** Trihydro Corporation  
**Date:** March 21, 2019  
**Re:** Tank Berm Storage Containment Evaluation – Gallup Refinery

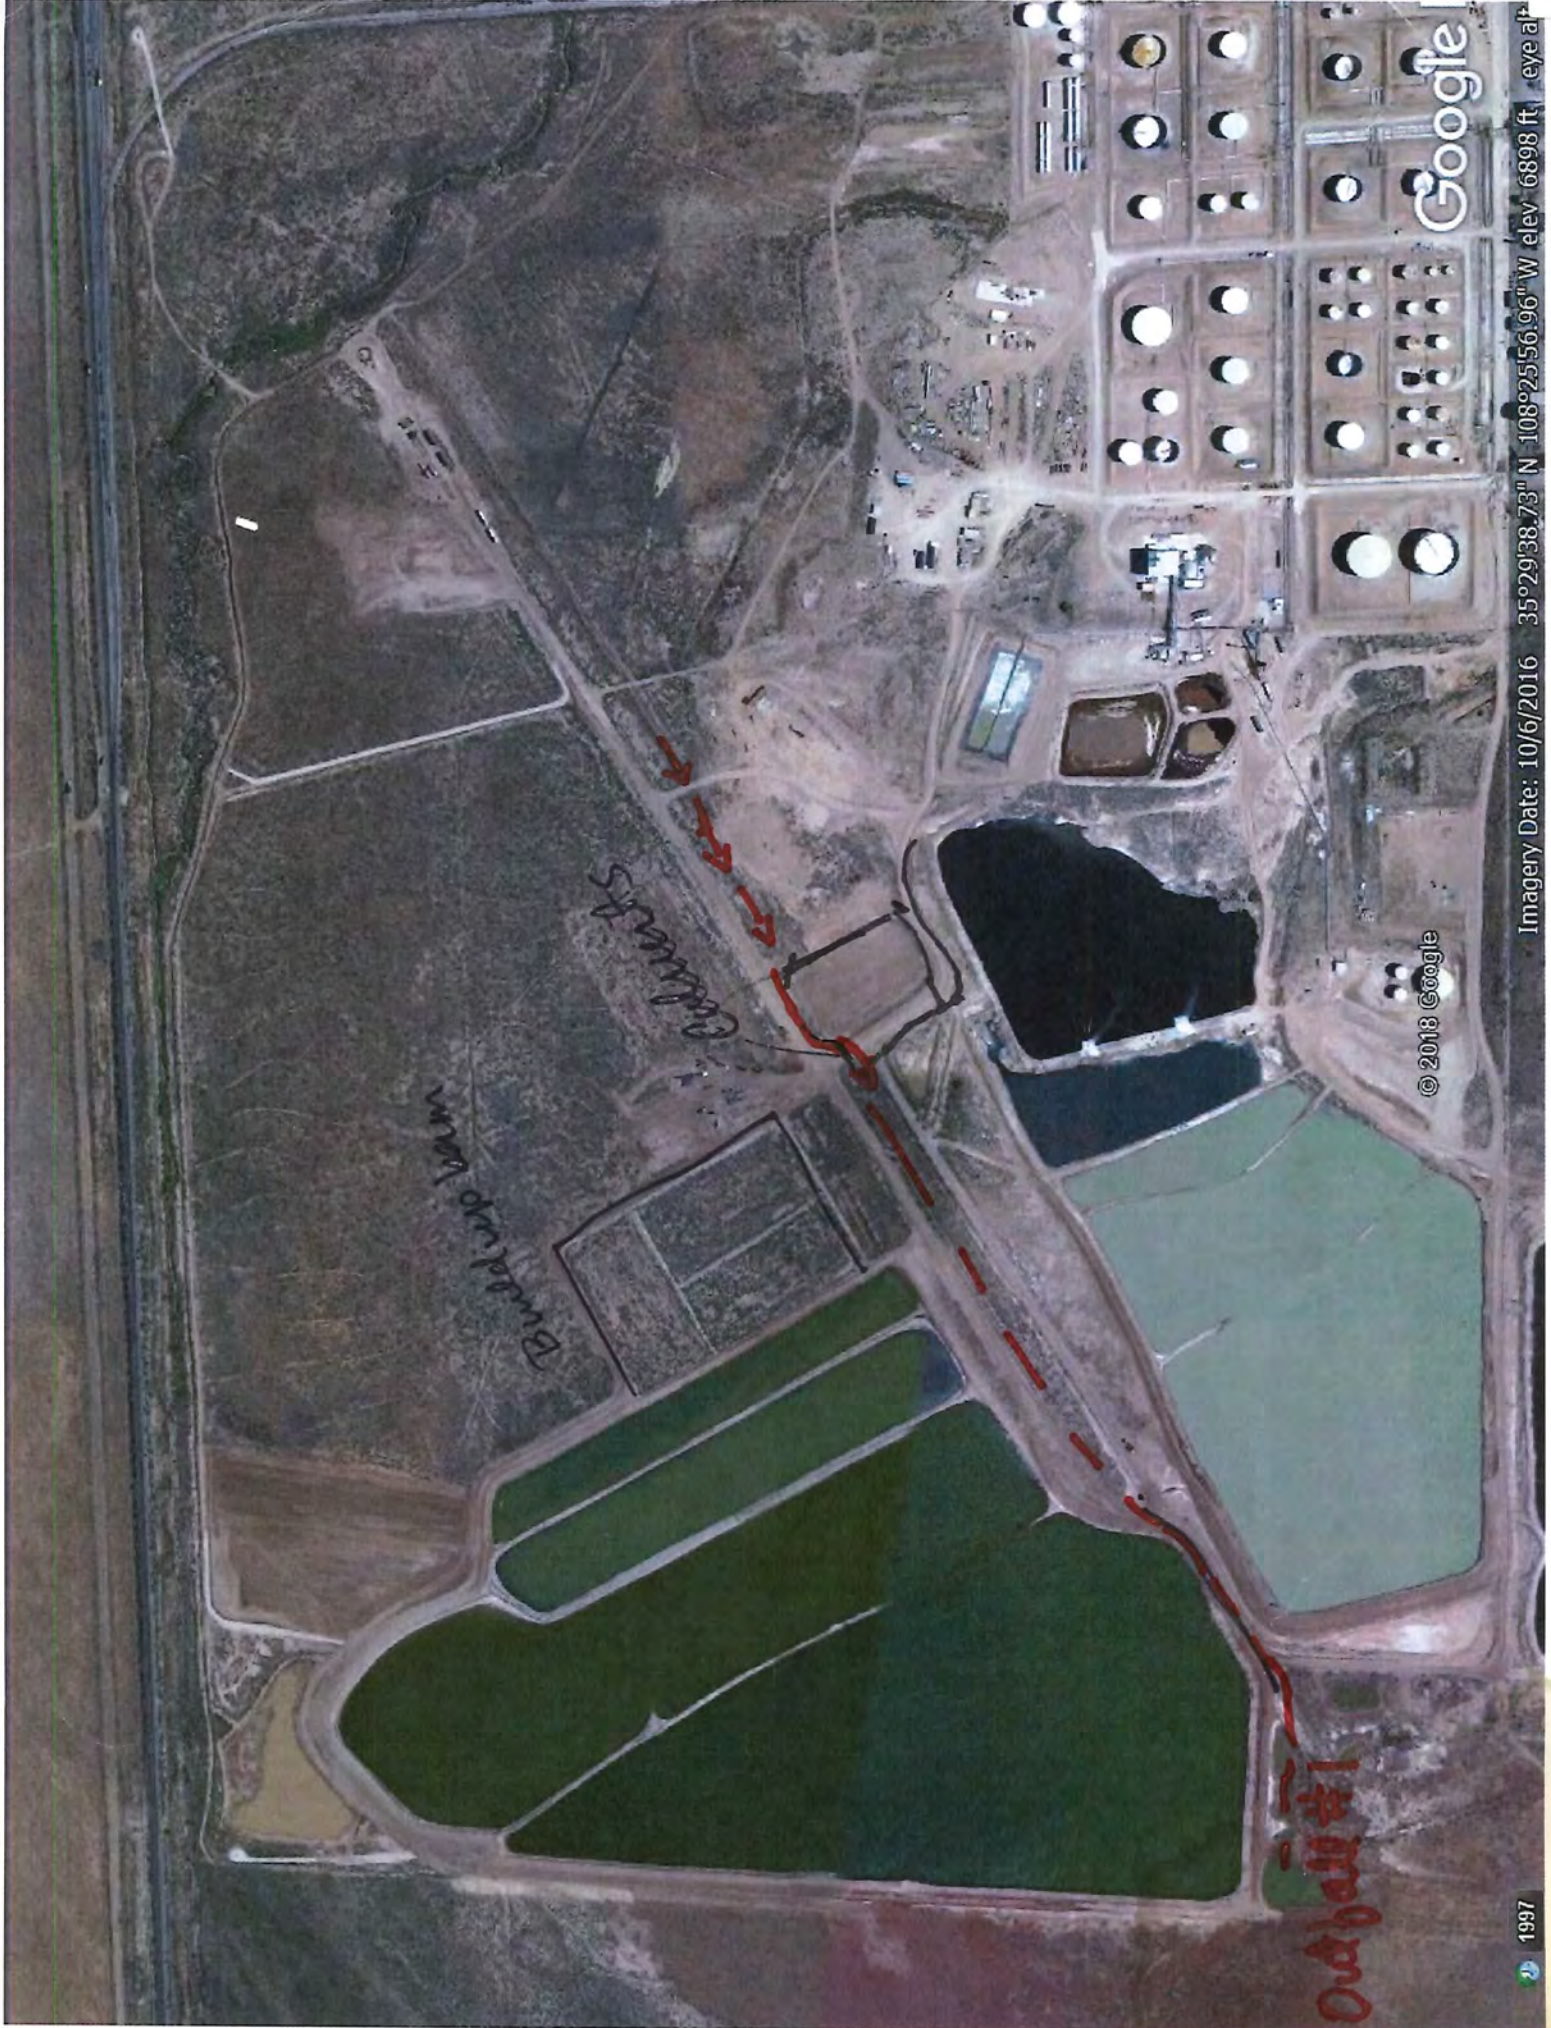
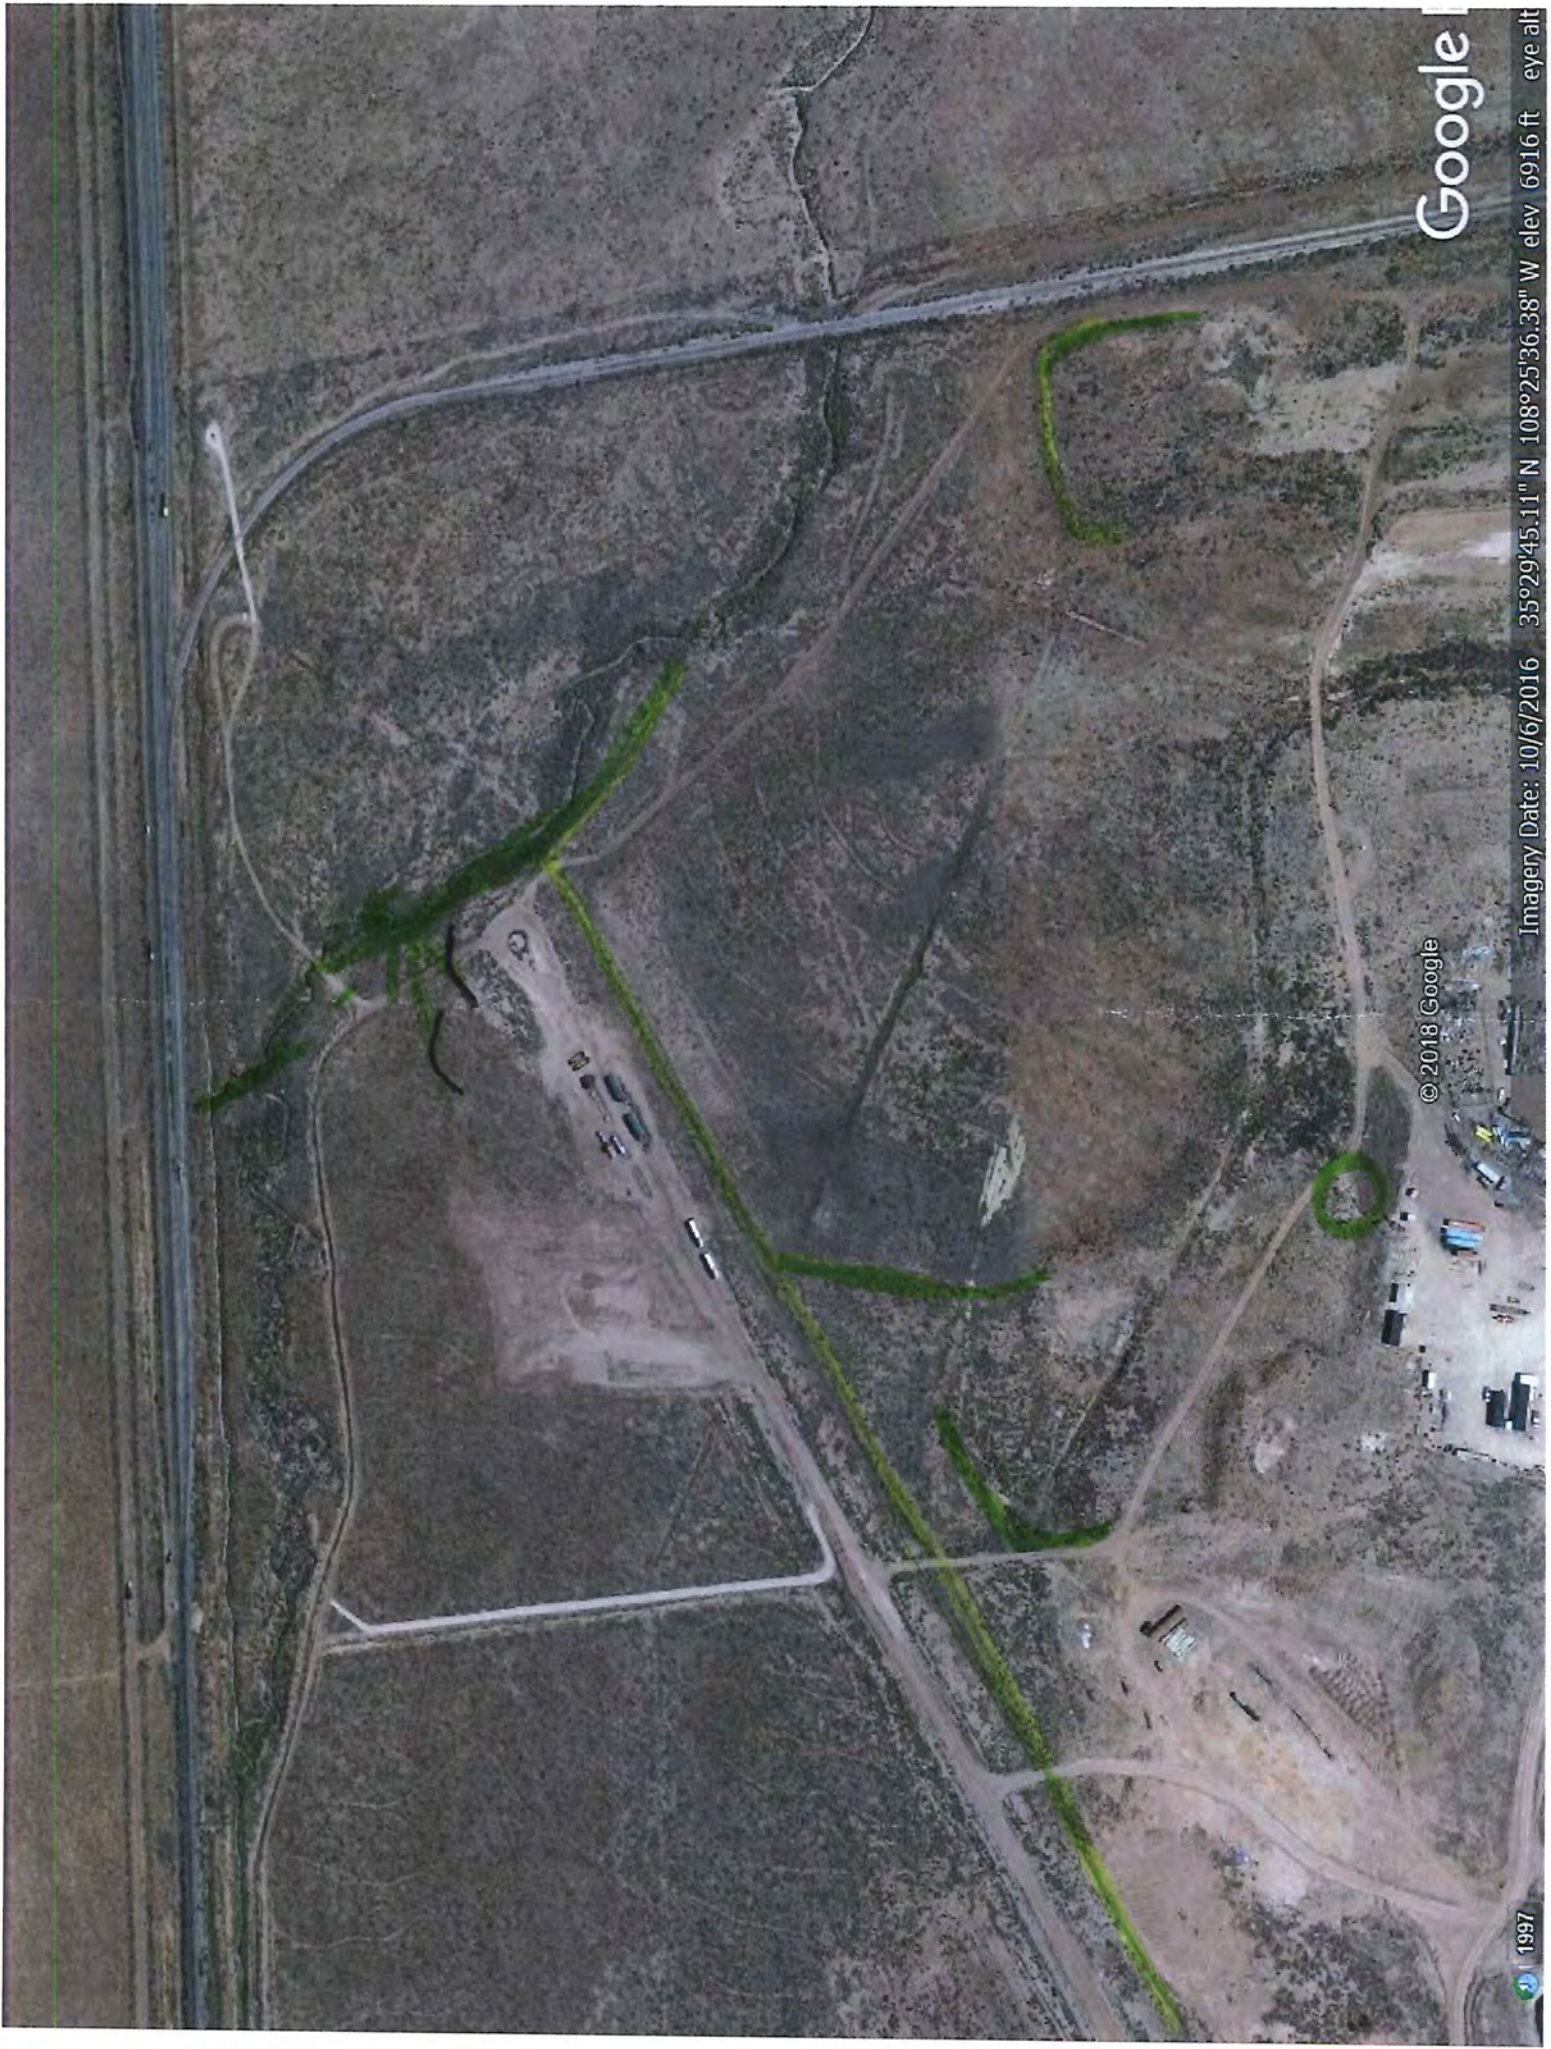
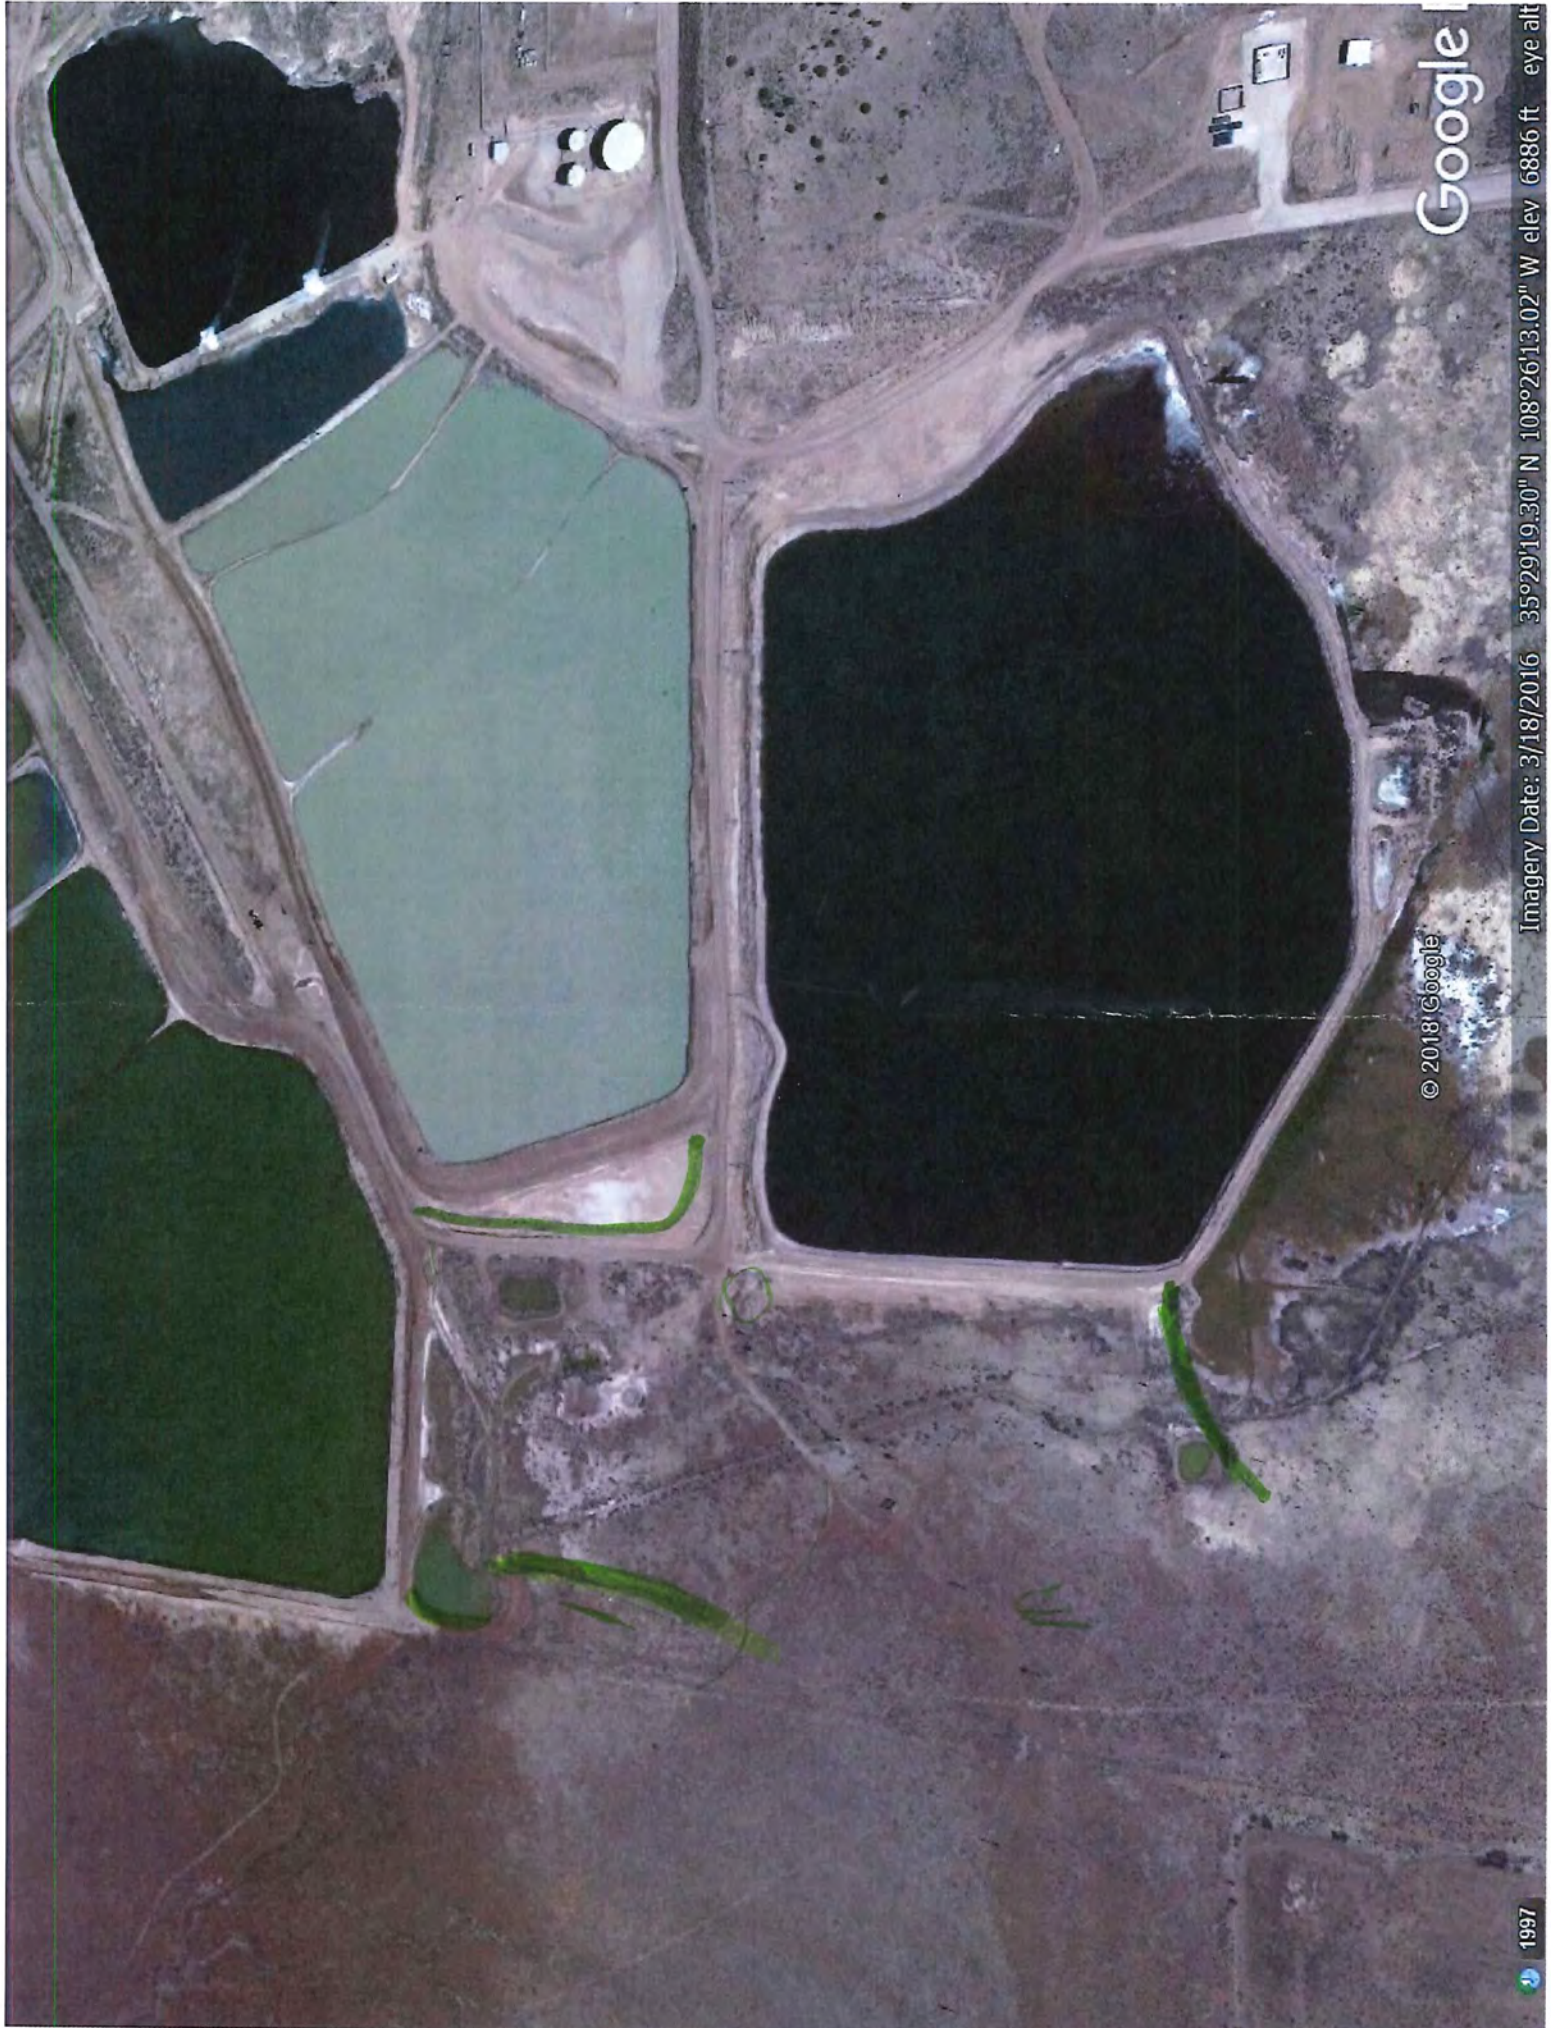
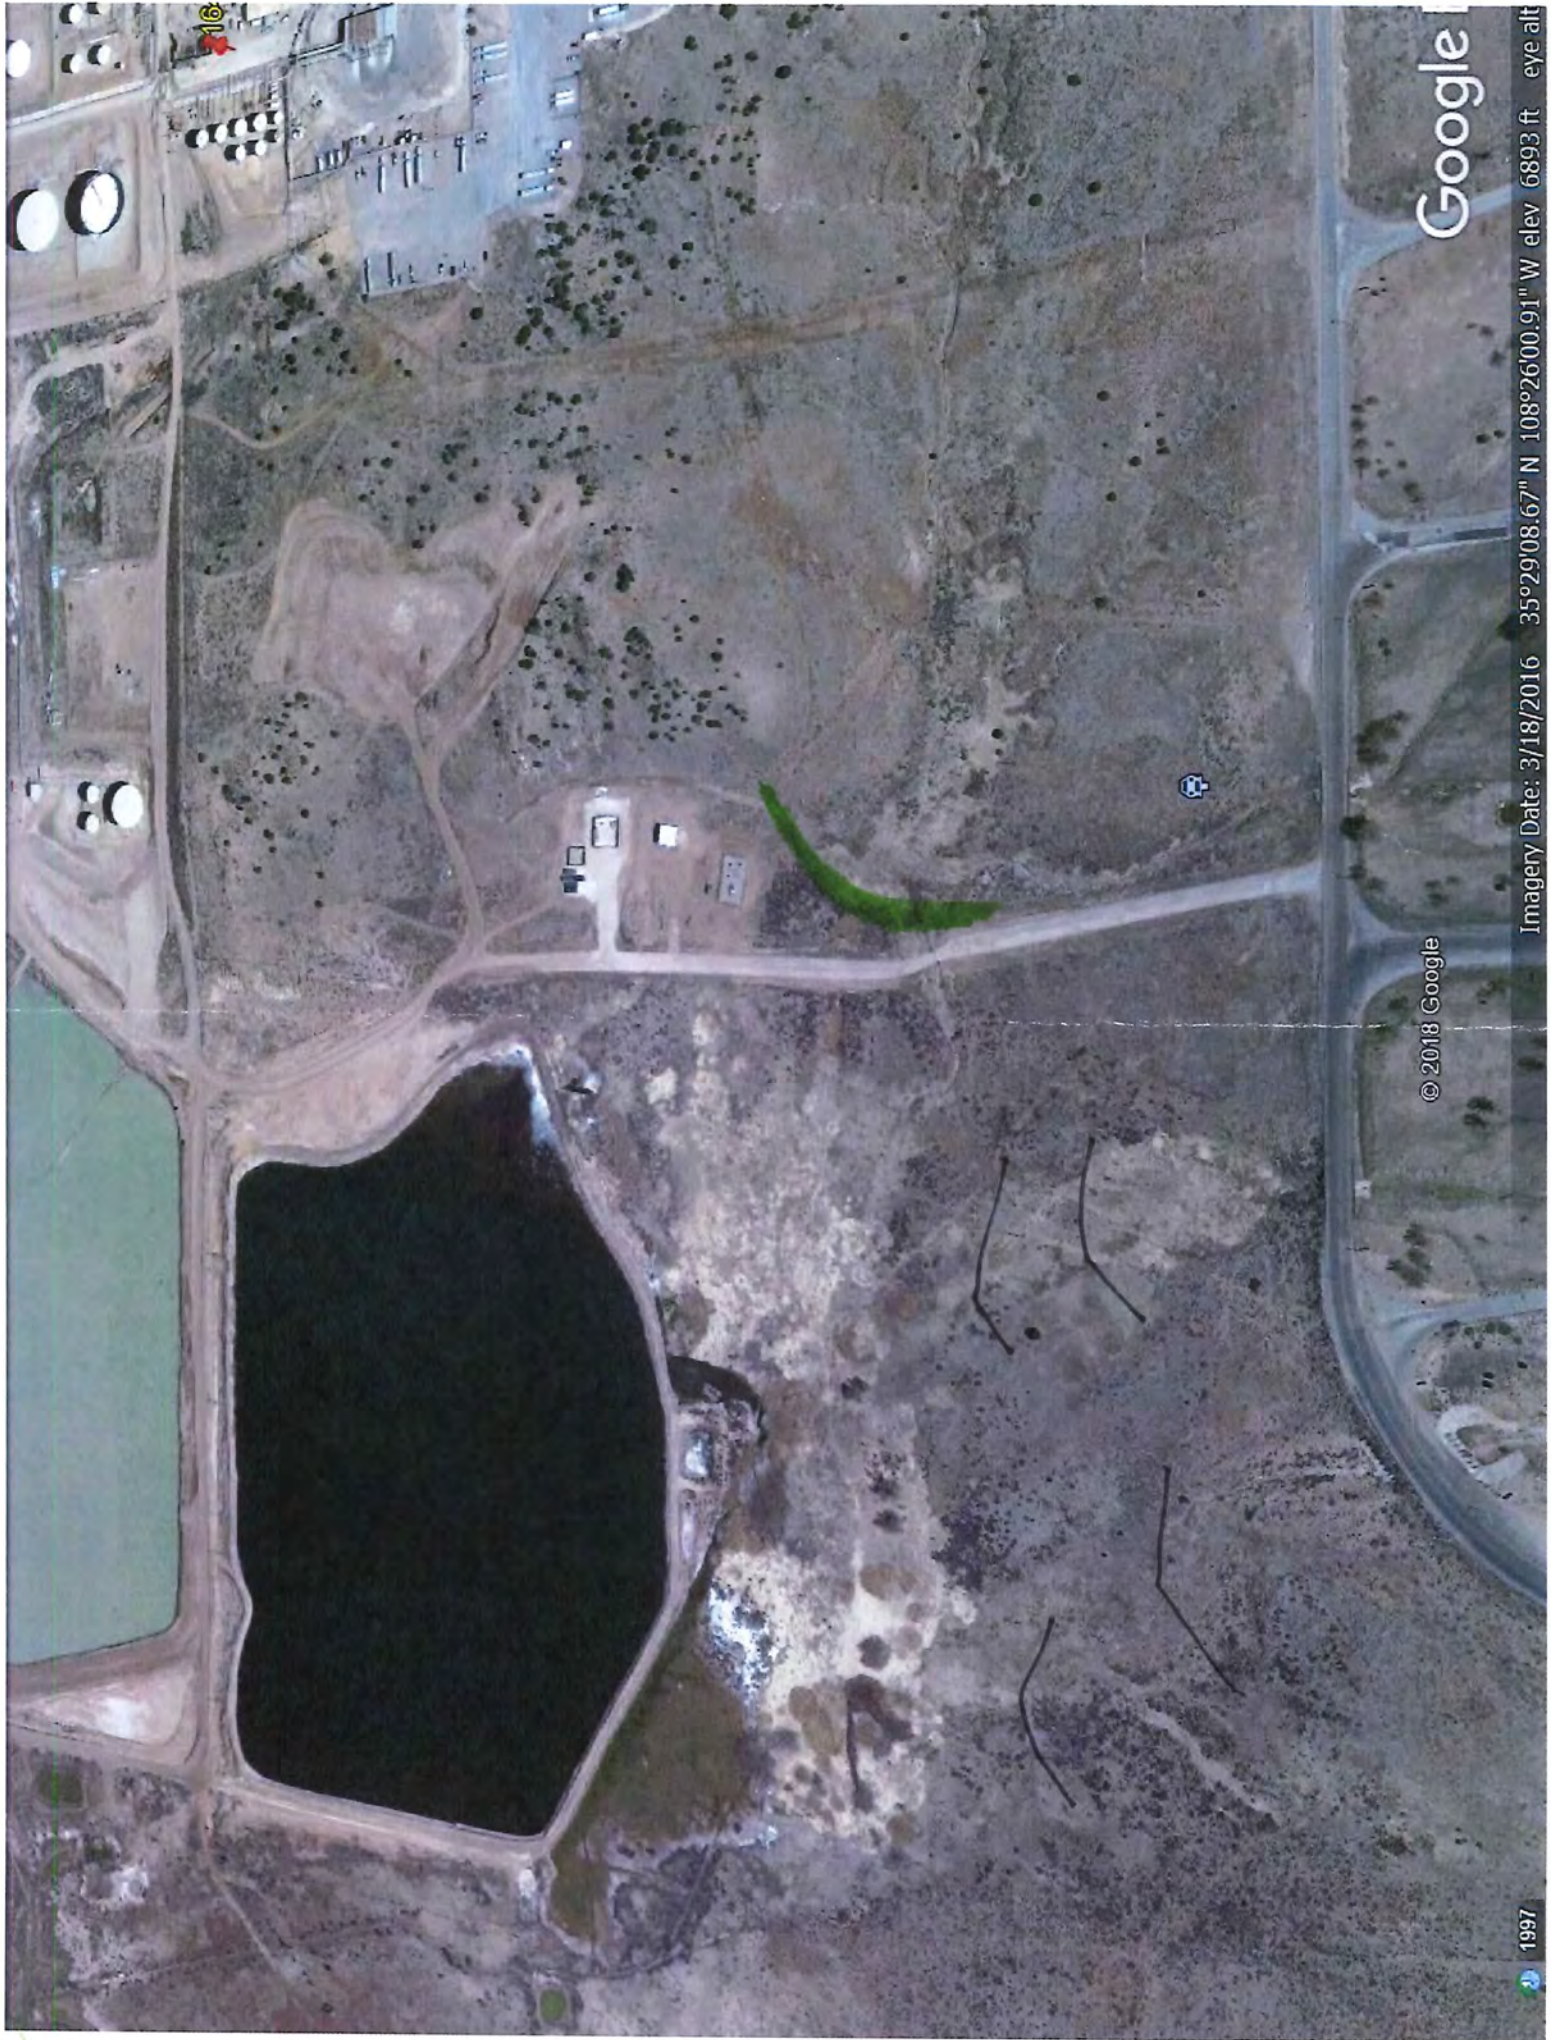
Corner of property:  
then berm eroded - need  
could back up.

Diversion pond - build  
up berms

Berms cut - Repair or ??

Outfall #2 - Erosion, Clean o  
basin, sediment, weeds, trash

East of T716.1 - Near  
shed - severe erosion

S bank of T575 berm  
erosion.

Concrete Barrier at  
Seep area needs to be  
cleaned out.

Culverts at path - clean  
out sediment

Near Internal West  
Gate - berm eroded -  
need to build back up -  
unearth valves at base  
of bermed area  
+ or replace valves

Outfall 1 - Repair  
berm on the  
west end  
Build up and repair  
berms going south of  
outfall 1 near the  
monitoring wells

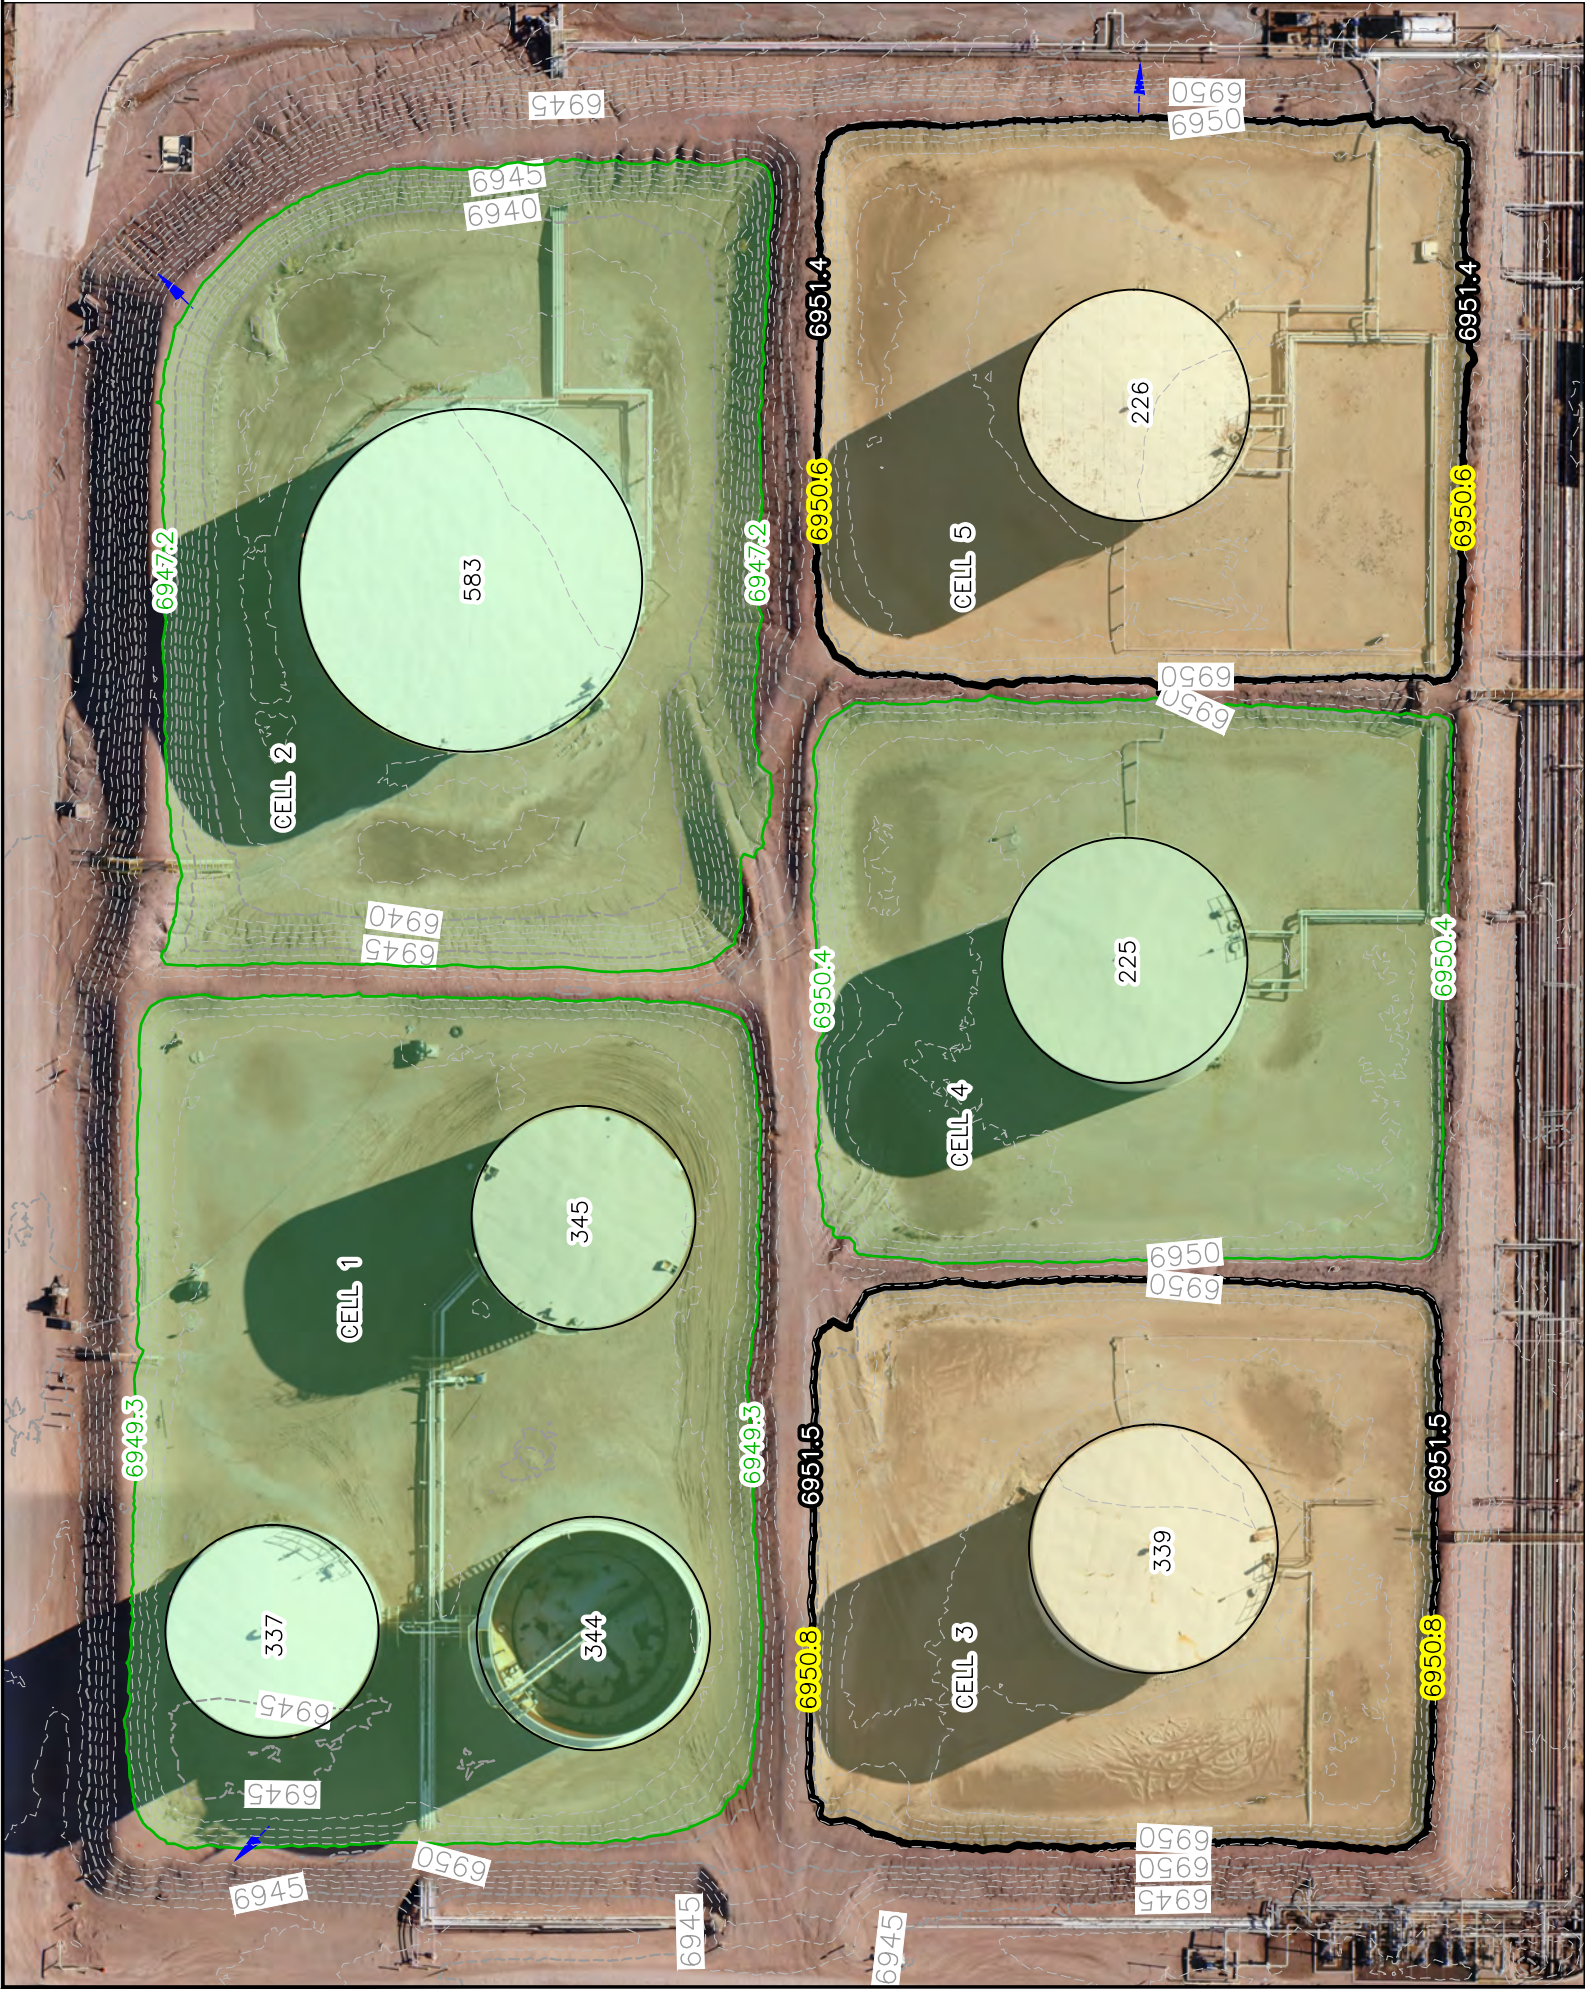
FIGURE 1

## CELLS 1-5 CONTAINMENT AREAS

For additional clarification, Figures 1-8 present the containment area for each Cell, the overtopping elevation, and the location of each overtopping point. If additional containment is needed, recommendations for raising the tank berms and the specific elevation to increase the berm height(s) for the containment are provided. Supplementary information regarding the increase in berms with insufficient volume is provided in Figures 9-16.

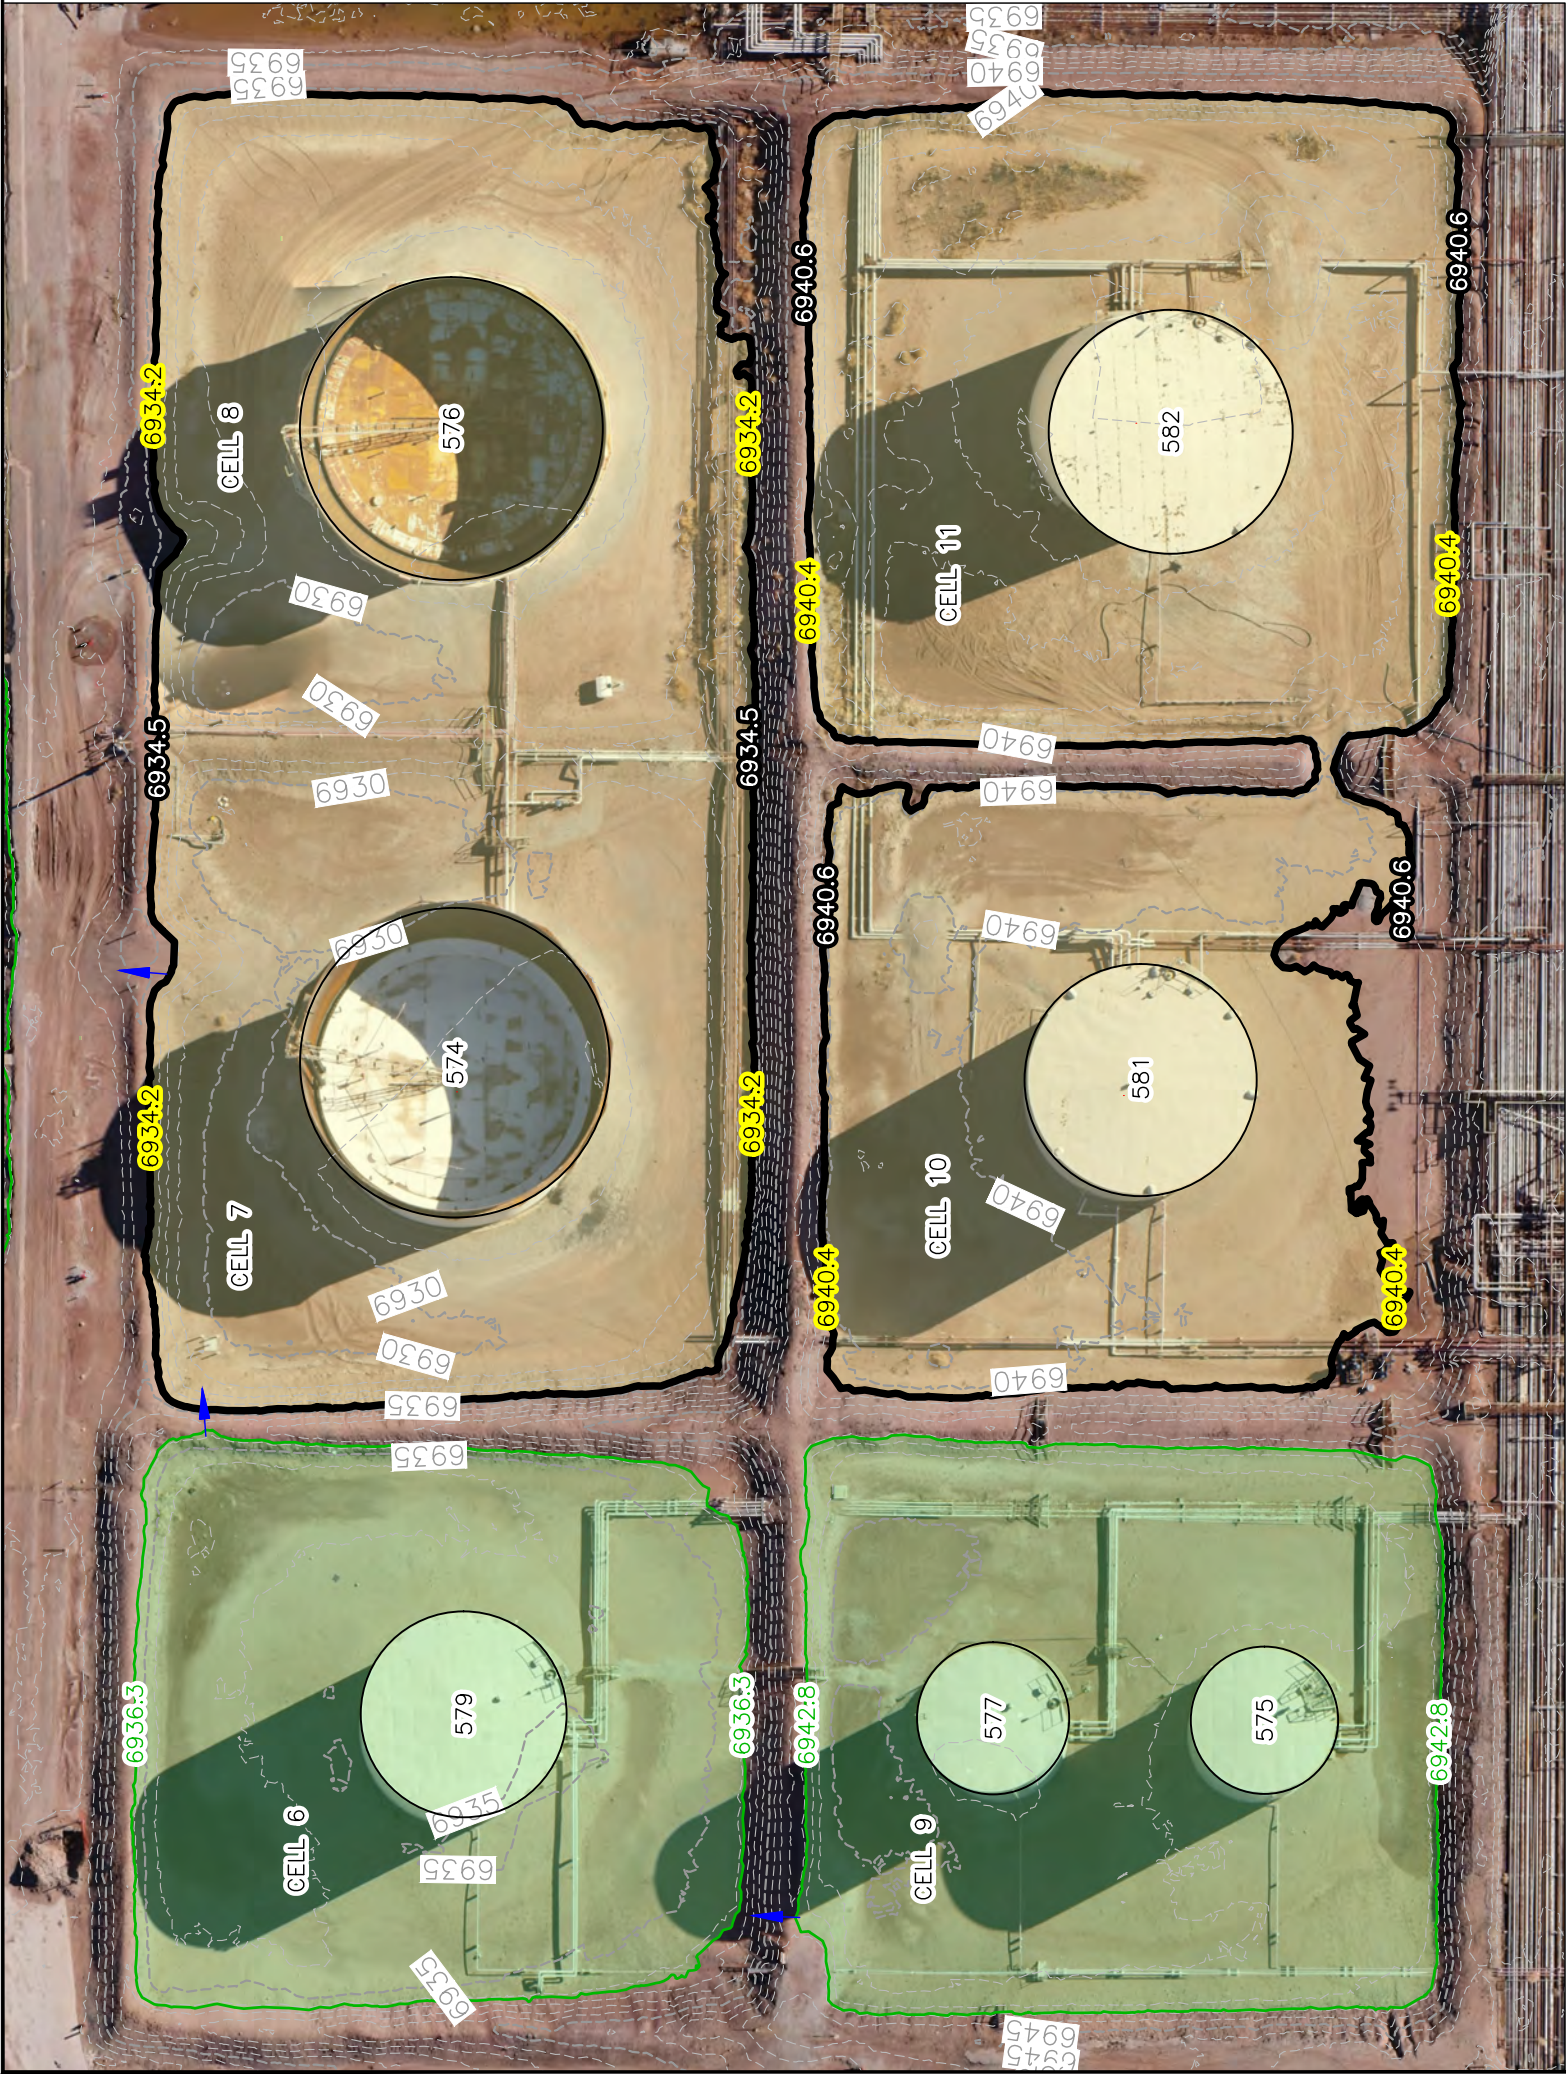
2 CELLS 6-11  
SCALE: 1" = 60'

| | CELLS 6-11<br>CONTAINMENT AREAS | |

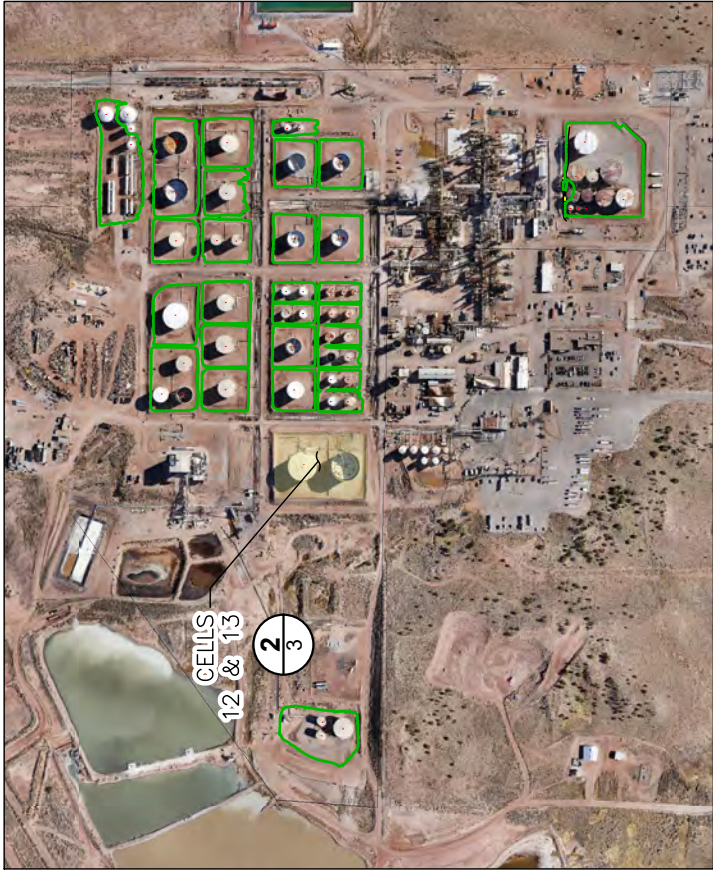
| <b>Trihydro CORPORATION</b><br>1252 Commerce Drive<br>Laramie, Wyoming 82070<br>www.trihydro.com<br>(P) 307745.7474 (F) 307745.7729 | | <b>FIGURE 3</b> | |

- 6948.15 INSUFFICIENT CONTAINMENT - EXISTING CONTAINMENT OVERTOPPING ELEVATION
- 6951.40 PROPOSED CONTAINMENT - FINAL CONTAINMENT OVERTOPPING ELEVATION TO ACHIEVE COMPLIANCE
- 6935. EXISTING CONTAINMENT ELEVATION CONTOURS (INTERVAL = 1')
- CONTAINMENT OVERFLOW LOCATION
- TANK
