**AP - 111**

**FACILITY WIDE  
BERM &  
STORMWATER  
REPAIR**

**To:** Mr. John Moore, P.E.  
**From:** Trihydro Corporation  
**Date:** March 21, 2019  
**Re:** Tank Berm Storage Containment Evaluation – Gallup Refinery

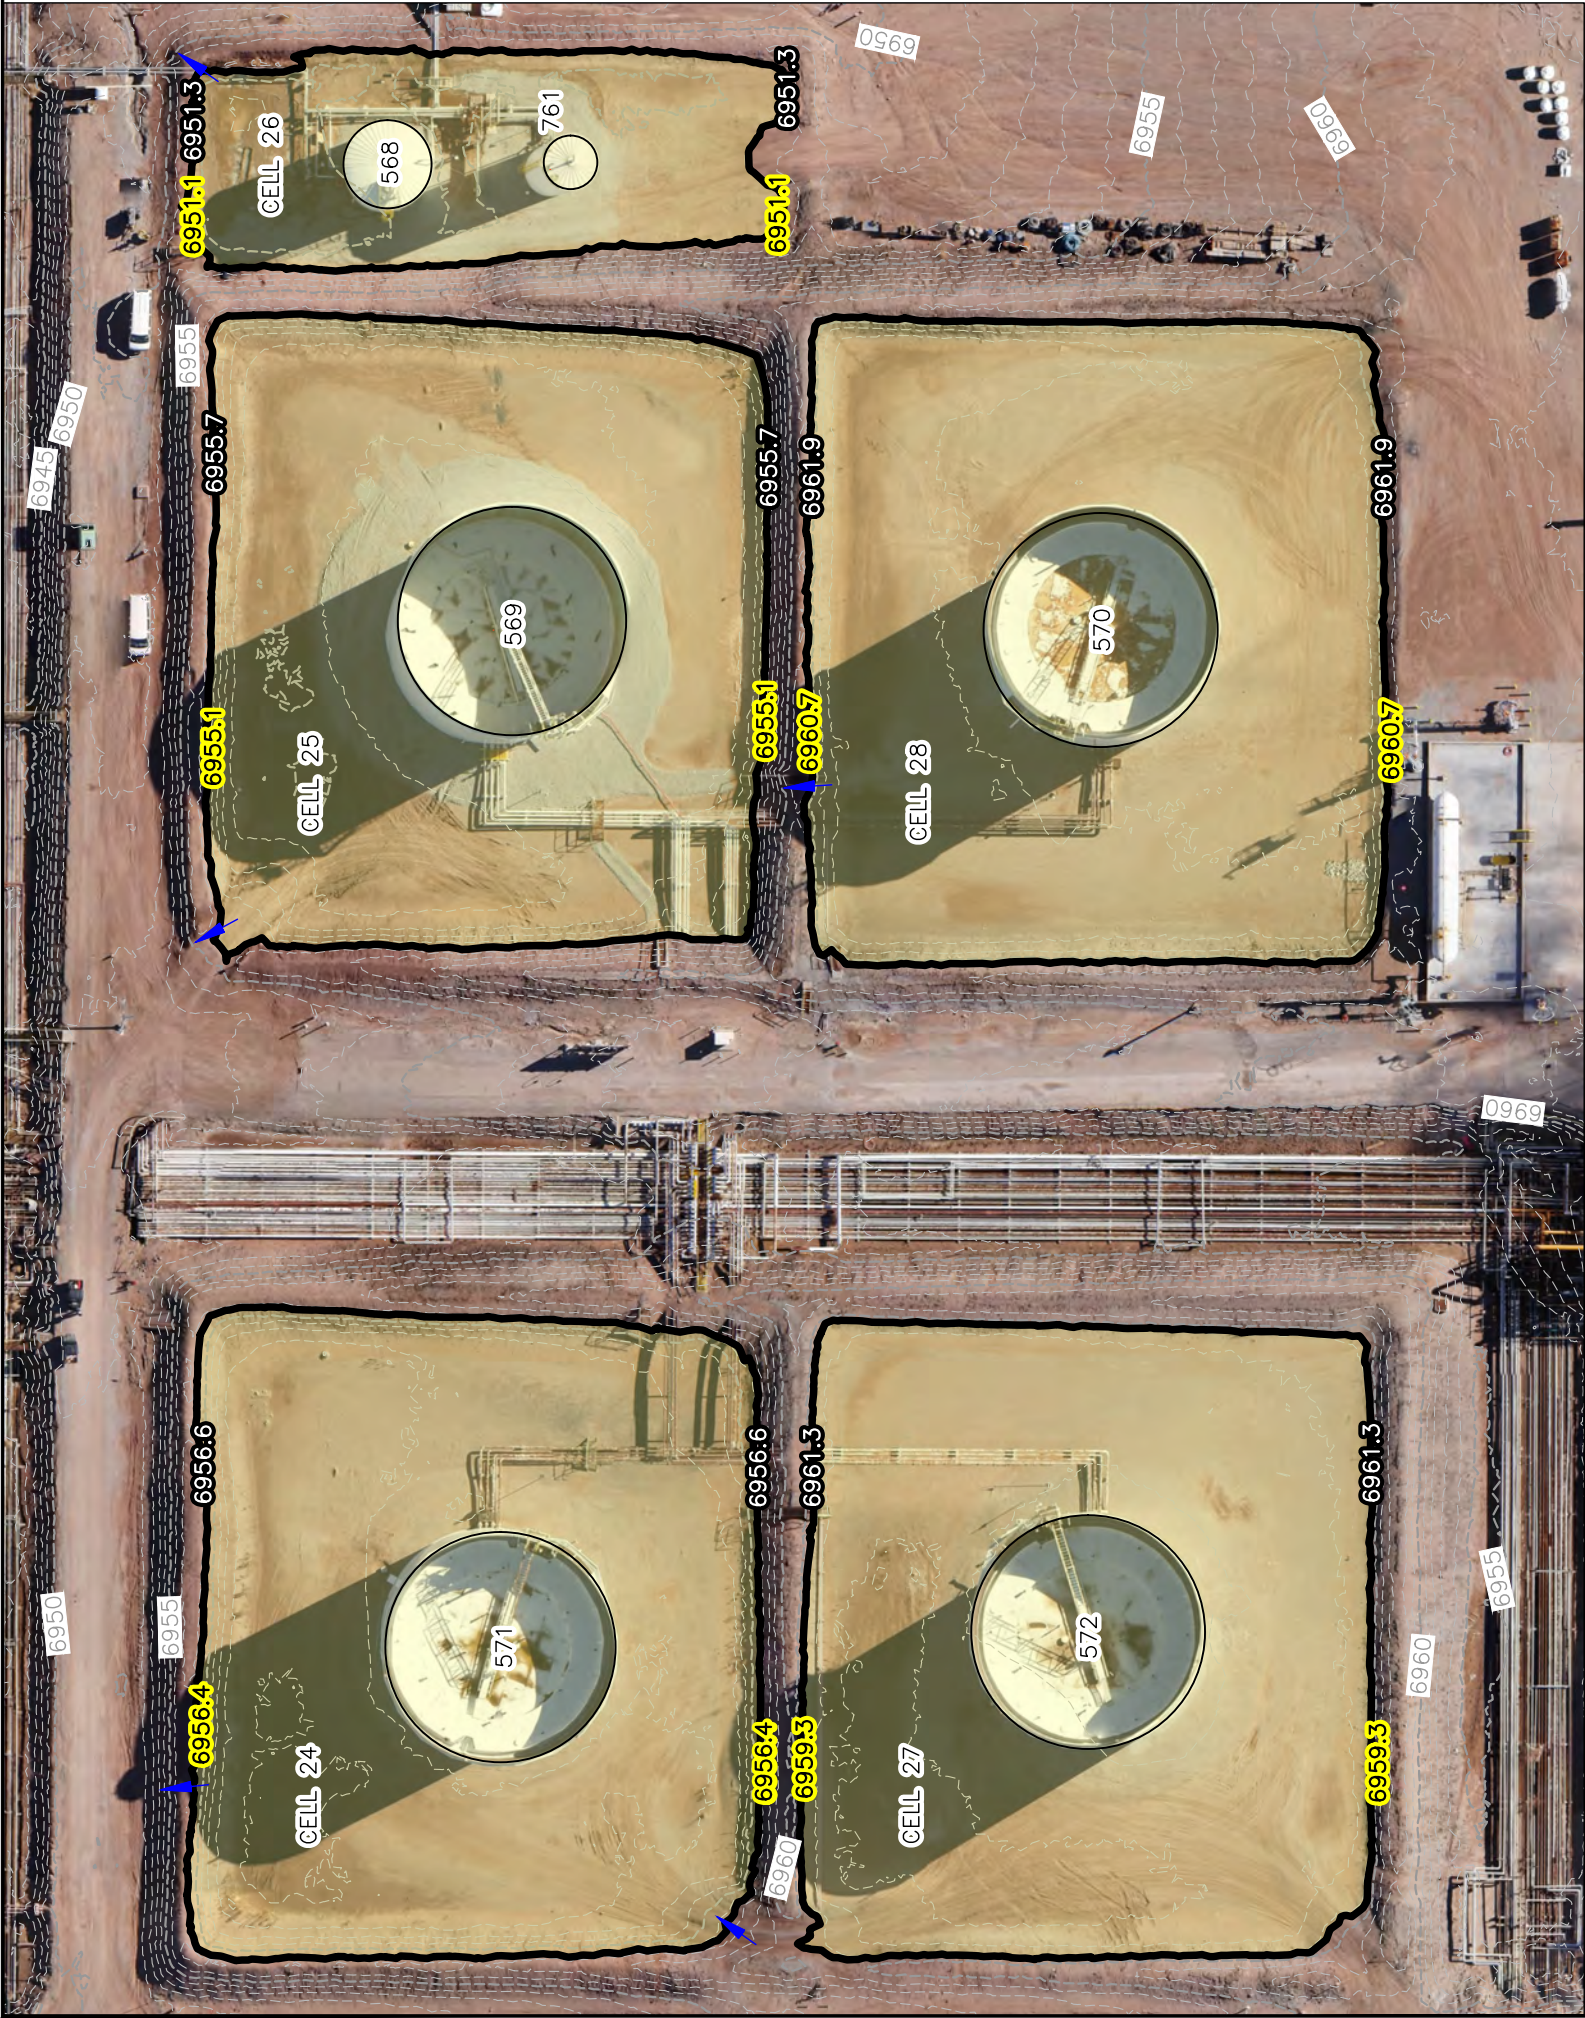
**2** CELLS 24-28  
SCALE: 1" = 60'  
0 60'

**CELLS 24-28  
CONTAINMENT AREAS**

For additional clarification, Figures 1-8 present the containment area for each Cell, the overtopping elevation, and the location of each overtopping point. If additional containment is needed, recommendations for raising the tank berms and the specific elevation to increase the berm height(s) for the containment are provided. Supplementary information regarding the increase in berms with insufficient volume is provided in Figures 9-16.

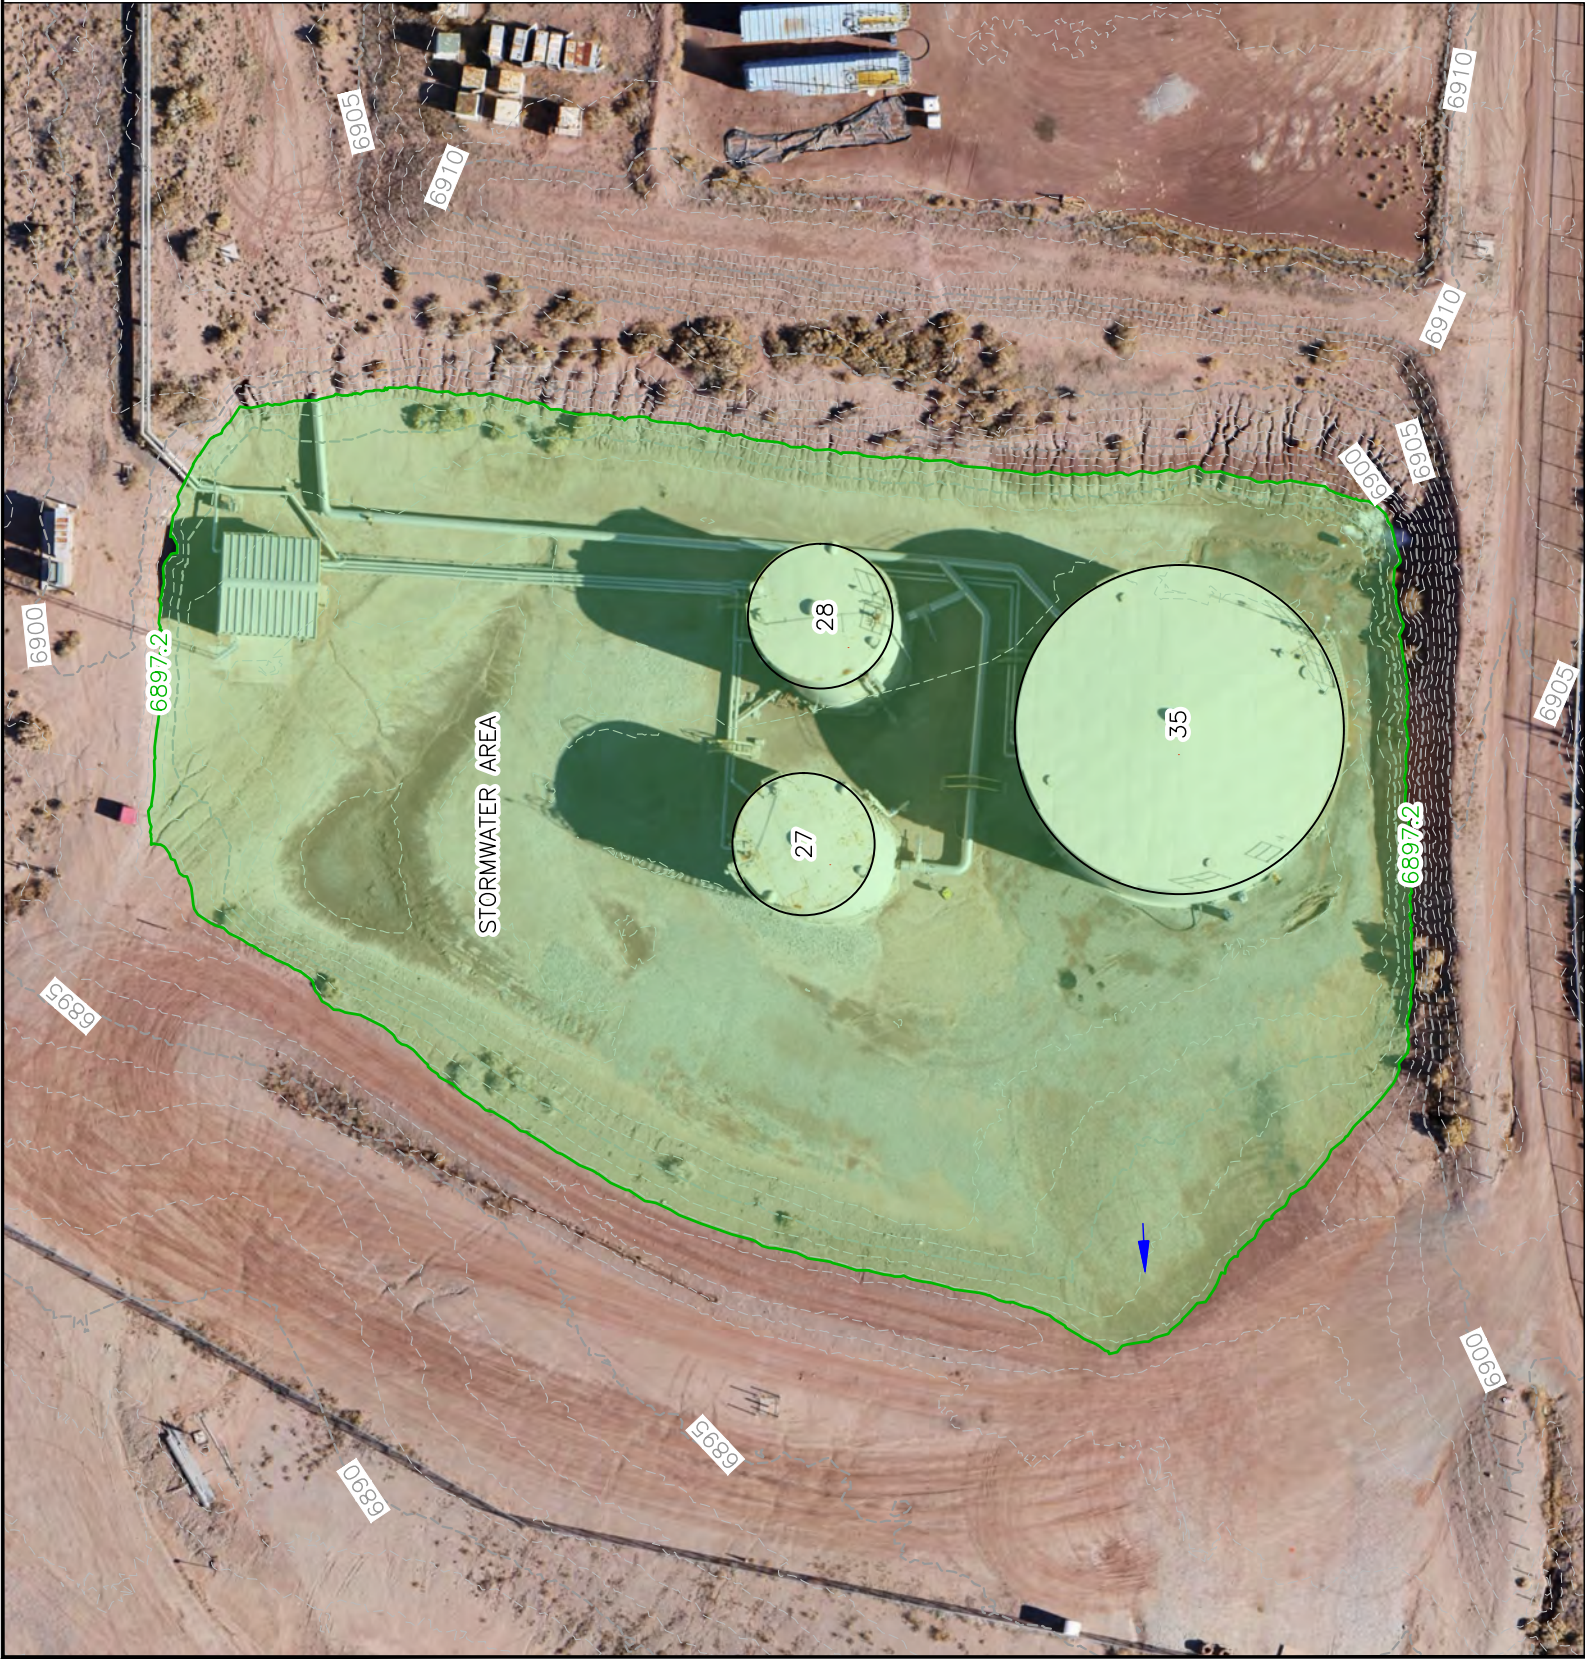
FIGURE 6

STORMWATER AREA  
CONTAINMENT AREA

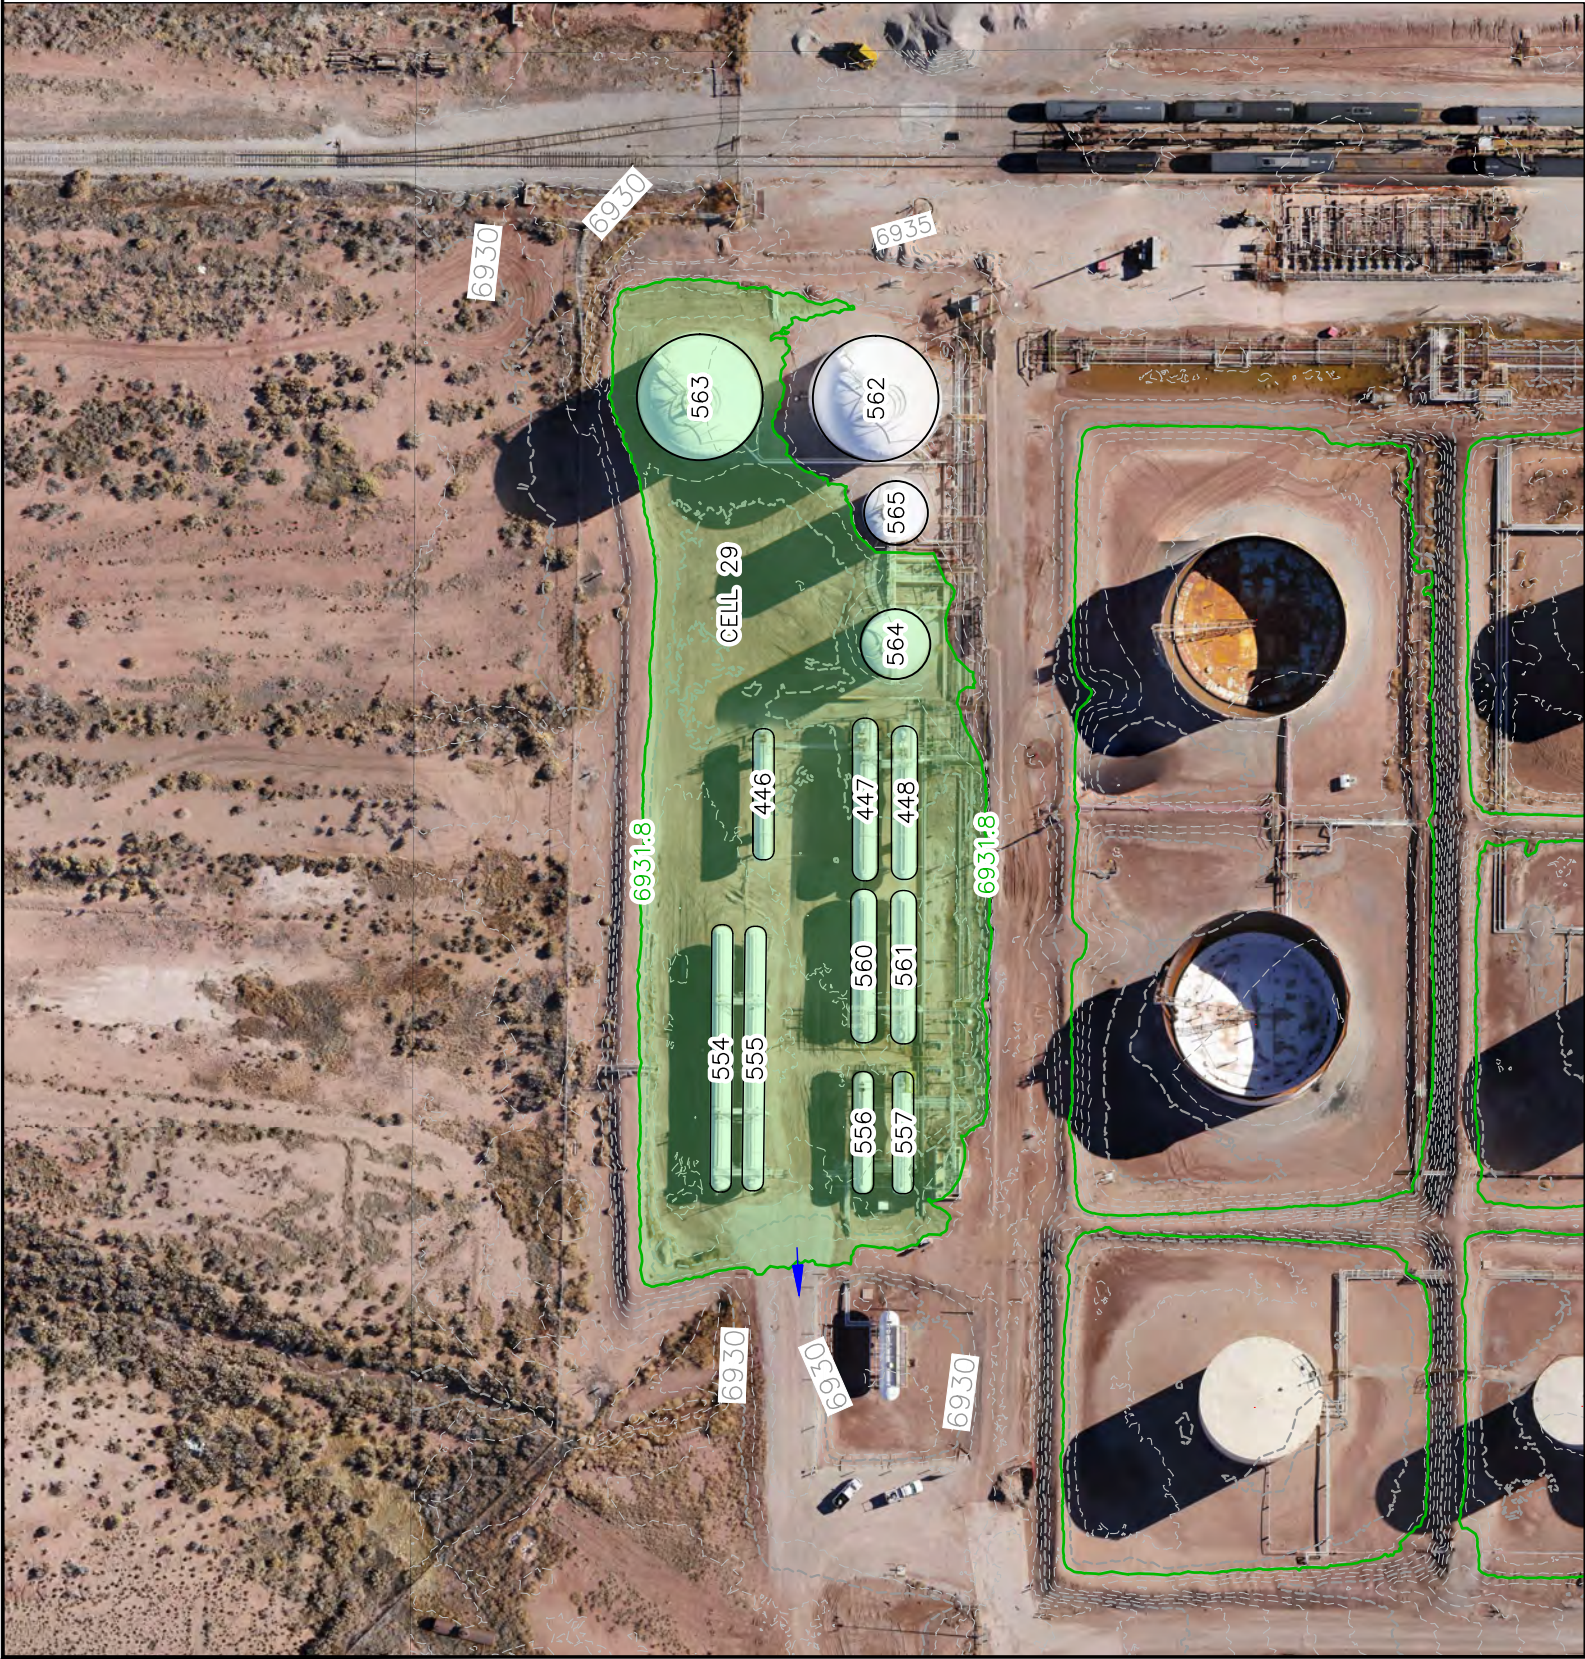
**2** **STORMWATER AREA**  
SCALE: 1" = 100'  
0 100'

| <br>1252 Commerce Drive<br>Laramie, Wyoming 82070<br>www.trihydro.com<br>(P) 307745.7474 (F) 307745.7729 | <b>FIGURE 7</b><br><b>CELL 29</b><br><b>CONTAINMENT AREA</b> | | | |

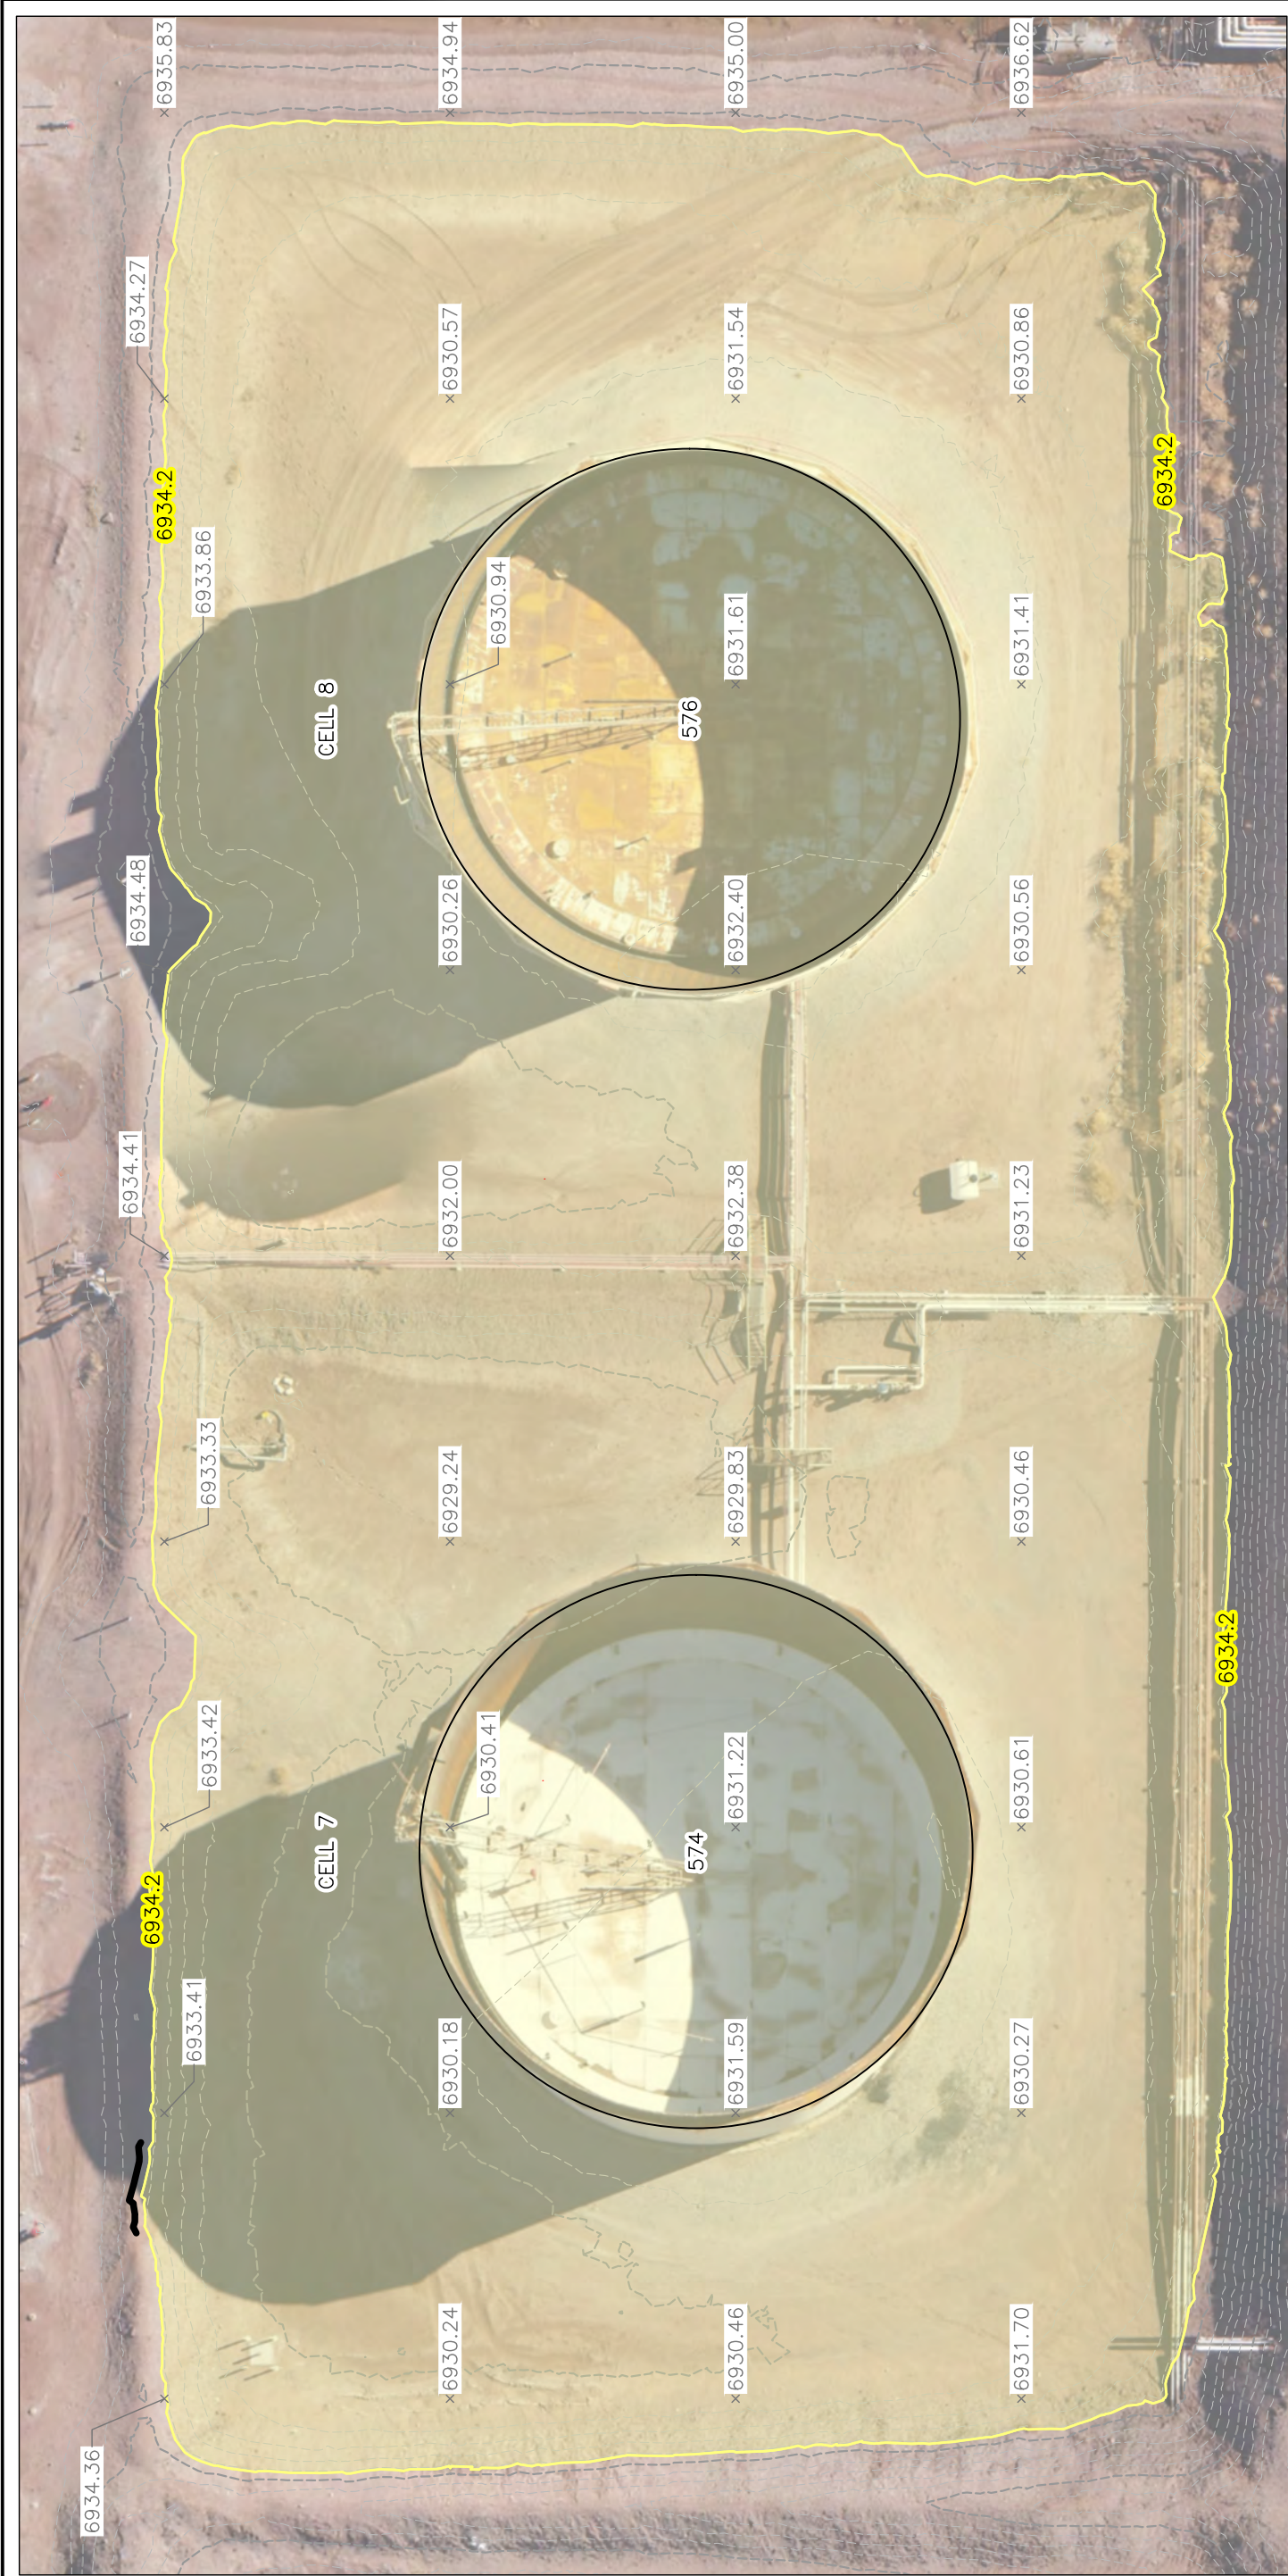
FIGURE 10

AREA WITH INSUFFICIENT CONTAINMENT VOLUME, RECOMMENDATIONS PROVIDED  
BUILD-UP AREA TO ACHIEVE ADEQUATE CONTAINMENT  
EXISTING GROUND SPOT ELEVATION

CELLS 7 AND 8 AREAS OF DETAIL

| Containment Cell | STORAGE TANK SPECIFICATIONS | | | | PRIMARY & SUPPLEMENTAL CAPACITY | | | | PRECIPITATION | | | ANALYSIS | |
|---|---|---|---|---|---|---|---|---|---|---|---|---|---|
| Cell 7/8 | 574-576 | 574 | 40,000 | 2,879 | 232,243 | 41,365 | - | 41,365 | 74,124 | 0.2 | 2,530 | (4,045) | N |

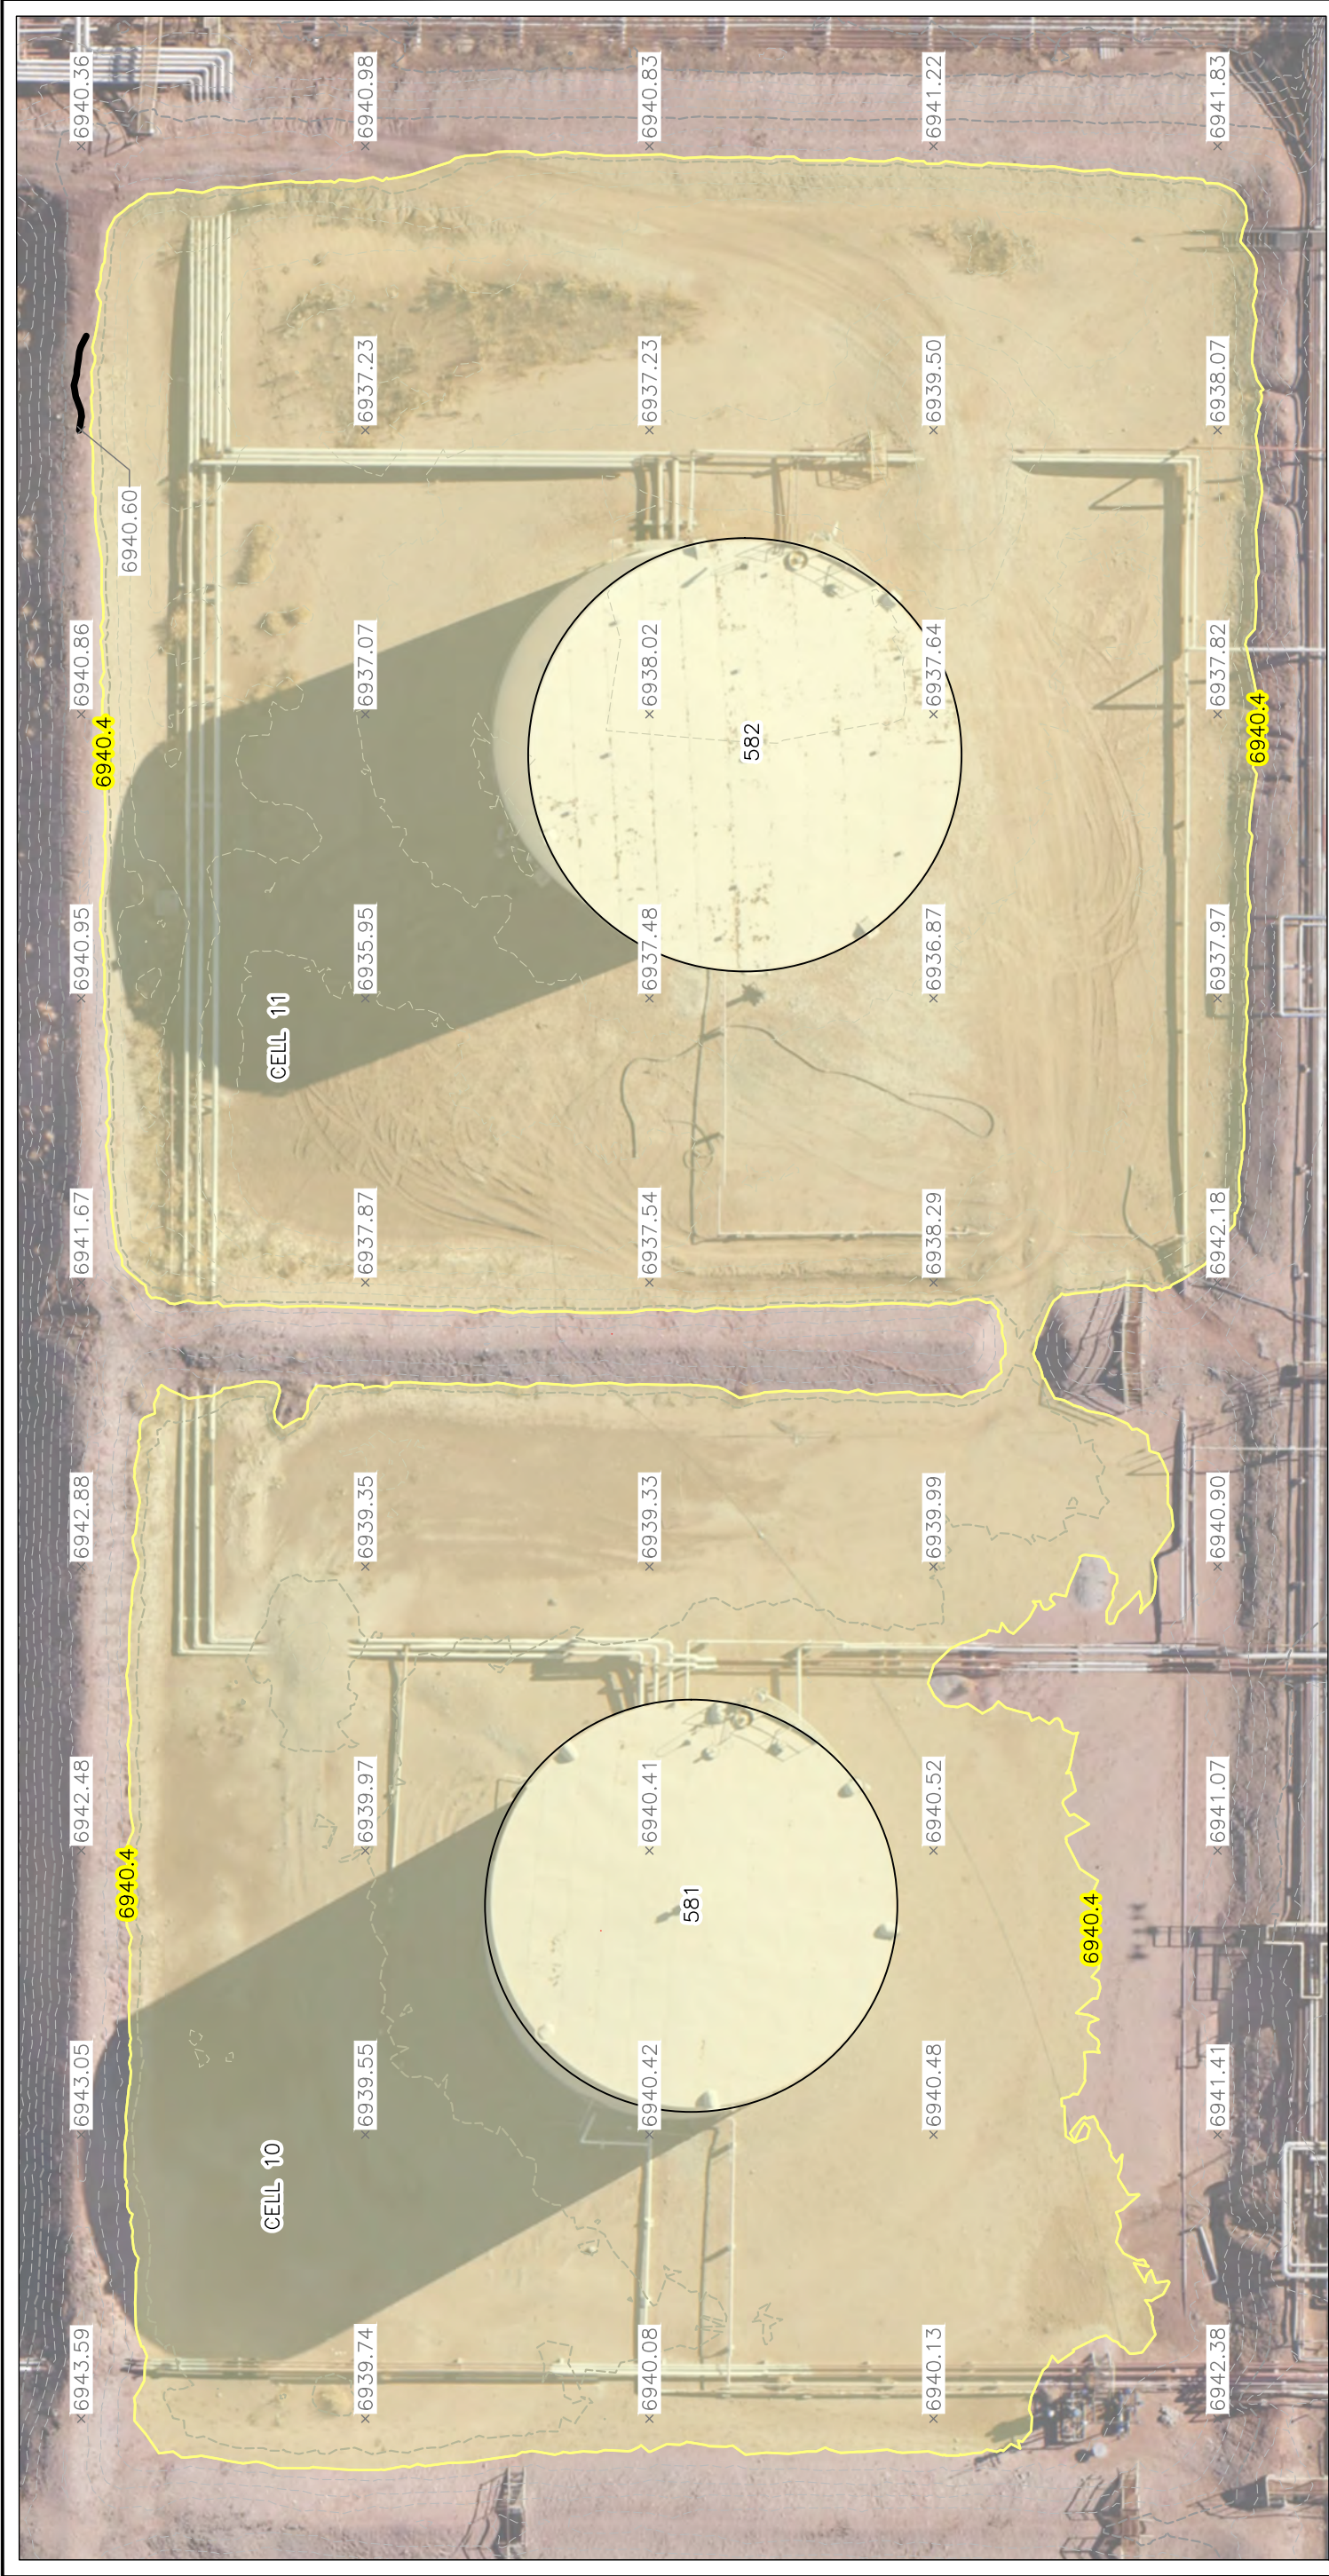
**FIGURE 11**

AREA WITH INSUFFICIENT CONTAINMENT VOLUME, RECOMMENDATIONS PROVIDED

BUILD-UP AREA TO ACHIEVE ADEQUATE CONTAINMENT

**CELLS 10 AND 11 AREAS OF DETAIL**

| Containment Cell | STORAGE TANK SPECIFICATIONS | | | | PRIMARY & SUPPLEMENTAL CAPACITY | | | | PRECIPITATION | | | ANALYSIS | |
|---|---|---|---|---|---|---|---|---|---|---|---|---|---|
| Cell 10/11 | 581-582 | 582 | 25,000 | 132 | 135,516 | 24,137 | - | 24,137 | 71,845 | 0.2 | 2,453 | (3,448) | N |
