**RE: APPROVAL WITH MODIFICATIONS
RESPONSE ACTION REPORT DGS 105 ADDITIVE TANK – RAIL CAR LOADING AREA –
GASOLINE RELEASE
WESTERN REFINING SOUTHWEST INC., GALLUP REFINERY
EPA ID # NMD000333211
HWB-WRG-20-004**

RESPONSE ACTION REPORT
DGS 105 ADDITIVE TANK – RAIL CAR LOADING
AREA – GASOLINE RELEASE
GALLUP REFINERY MARATHON PETROLEUM
COMPANY, LP
GALLUP, NEW MEXICO
EPA ID# NMD000333211

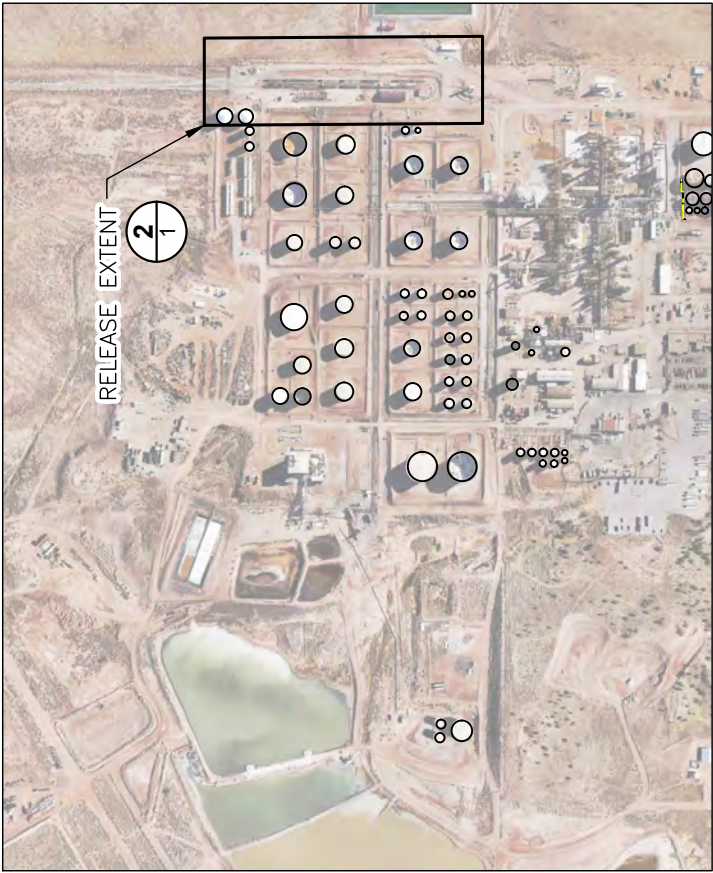
At 8:00 am on May 7, 2017, an operator observed hydrocarbon product pooling beneath the pipe rack located along the rail car loading area's west side (Figure 2). The hydrocarbon product was also observed flowing into a sewer box between the pipe rack and the rail car loading area. Notifications were immediately made to the off-site supervisor, Kurtz Fire Department, the Maintenance Department, and the Environmental Department.

- TANK
- RAIL CAR LOADING RACK
- RELEASE EXTENT
- DGS 105 ADDITIVE TANK
- RAIL RACK SUMP OR SEWER BOX

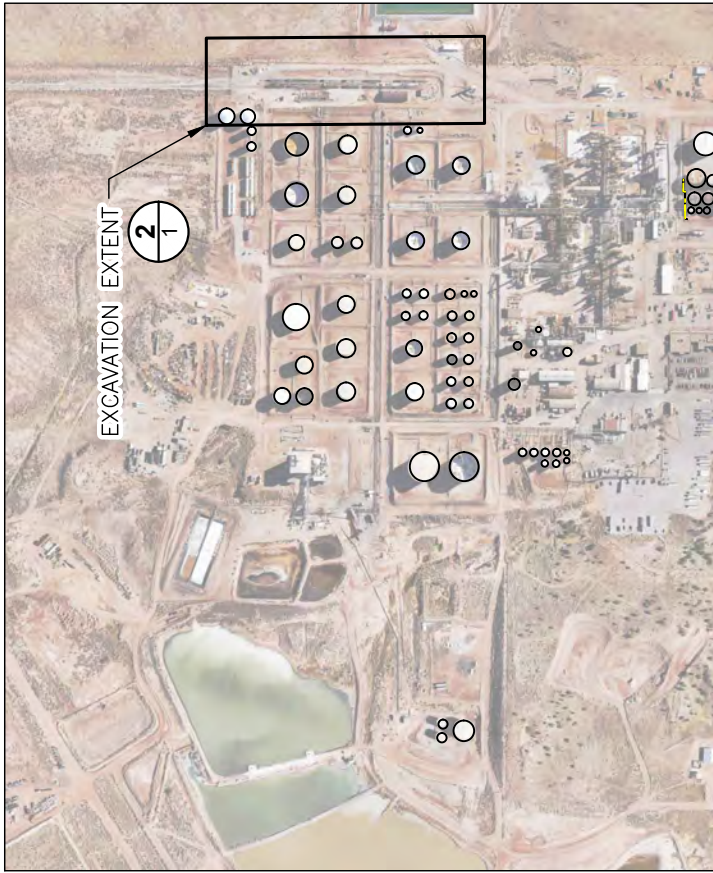
| Trihydro CORPORATION 1252 Commerce Drive Laramie, Wyoming 82070 www.trihydro.com (P) 307745.7474 (F) 307745.7729 | FIGURE 3 | | |

- TANK
- RAIL CAR LOADING RACK
- EXCAVATION EXTENT
- DGS 105 ADDITIVE TANK
- RAIL RACK SUMP OR SEWER BOX

| | EXCAVATION EXTENT | | |

In the Remediation Activities Section, *Remediation*, page 6 of 8, the Permittee states, “[f]ollowing removal of the surface gasoline, approximately 153 tons of petroleum impacted soils below the pipe rack were excavated to an 18-inch depth in an area approximately 41 feet by 97 feet (Figure 3) in November of 2018.” The gasoline release occurred in May 2017. The contaminated soils were excavated approximately 16 months after the release. During the 16-month period, residual hydrocarbons may have infiltrated into soils to depths below 18 inches bgs. Submit a work plan to advance soil borings to depths below the excavation floor and collect soil samples to determine the vertical extent of contamination.

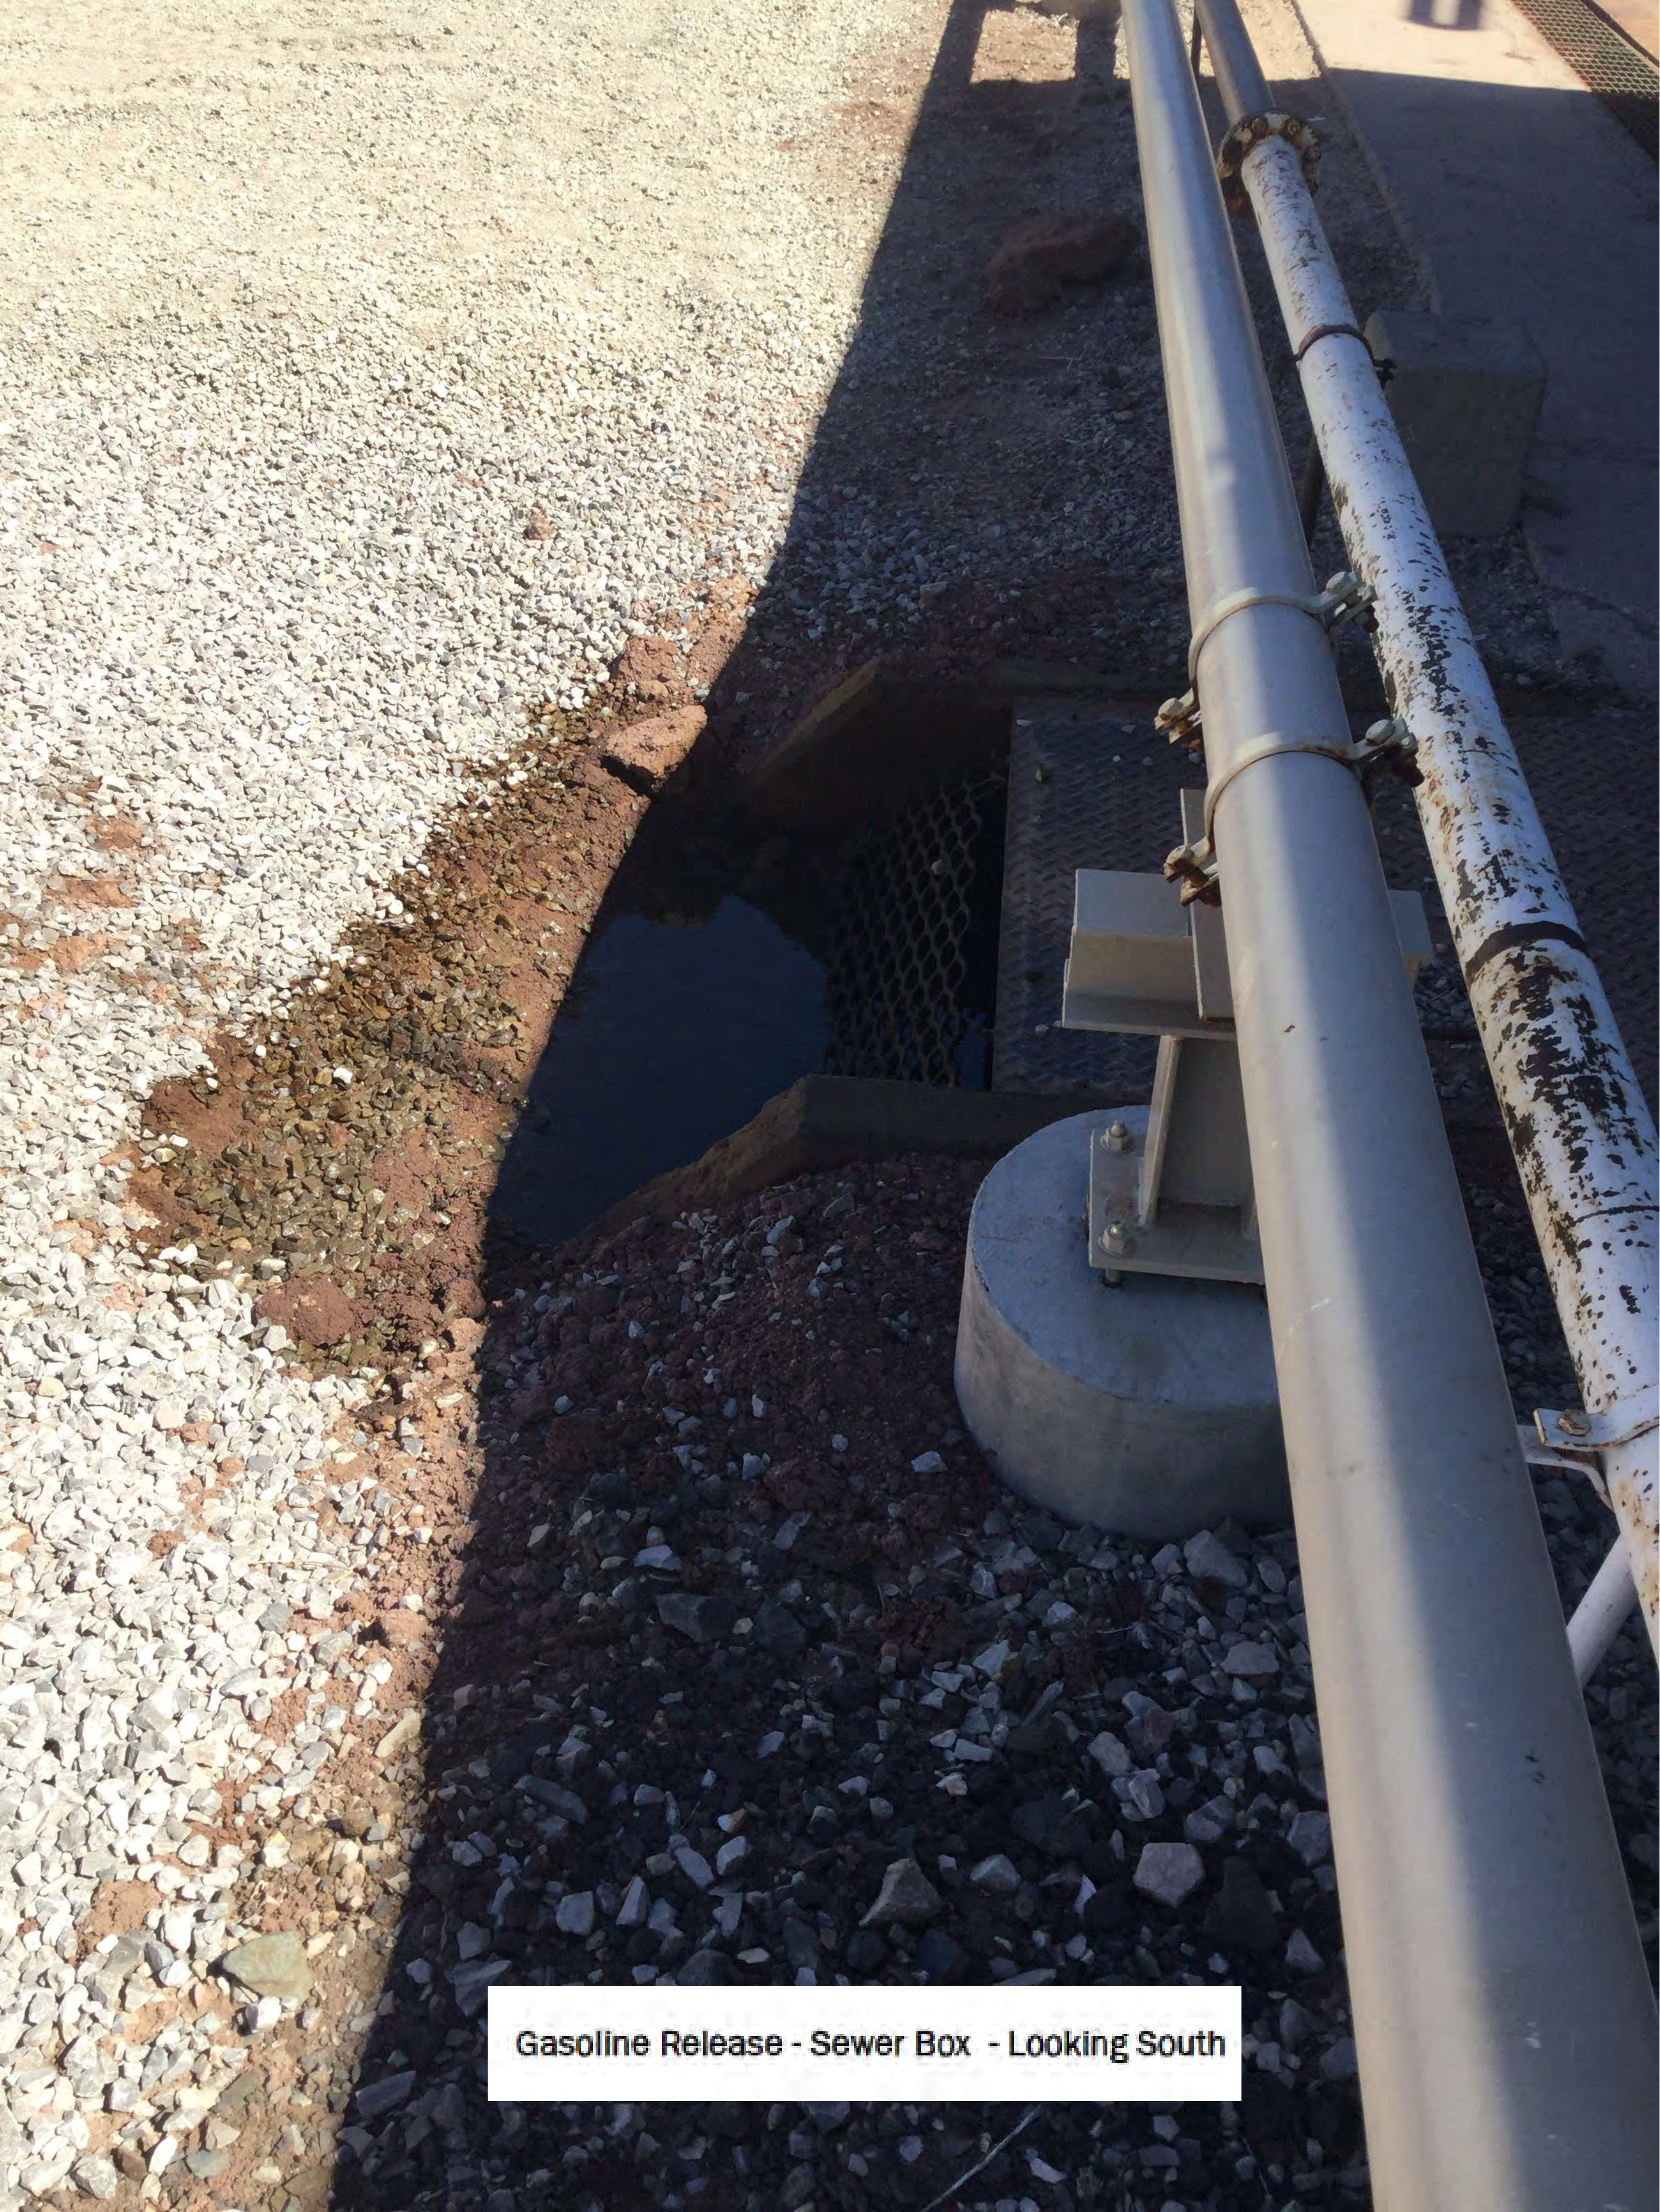
The Refinery's on-site laboratory analyzed a hydrocarbon sample from the release verifying that the product was gasoline. The Maintenance Department used a vacuum truck to recover the gasoline product from the sewer box. After the sewer box fluid level decreased, it was observed that a 3/4-inch valve from a gasoline pipeline was open near the DGS 105 additive tank and discharging into the sewer cup. The DGS 105 additive tank valves were immediately closed to stop the flow of gasoline into the box. The sewer cup had overflowed onto the soil located beneath the pipe rack and into a sewer drain between the pipe rack and railroad tracks. The sewer drain was accessed from the rail rack sump box north of the release extent and pipe box.

Gasoline Release - Sewer Box - Looking South

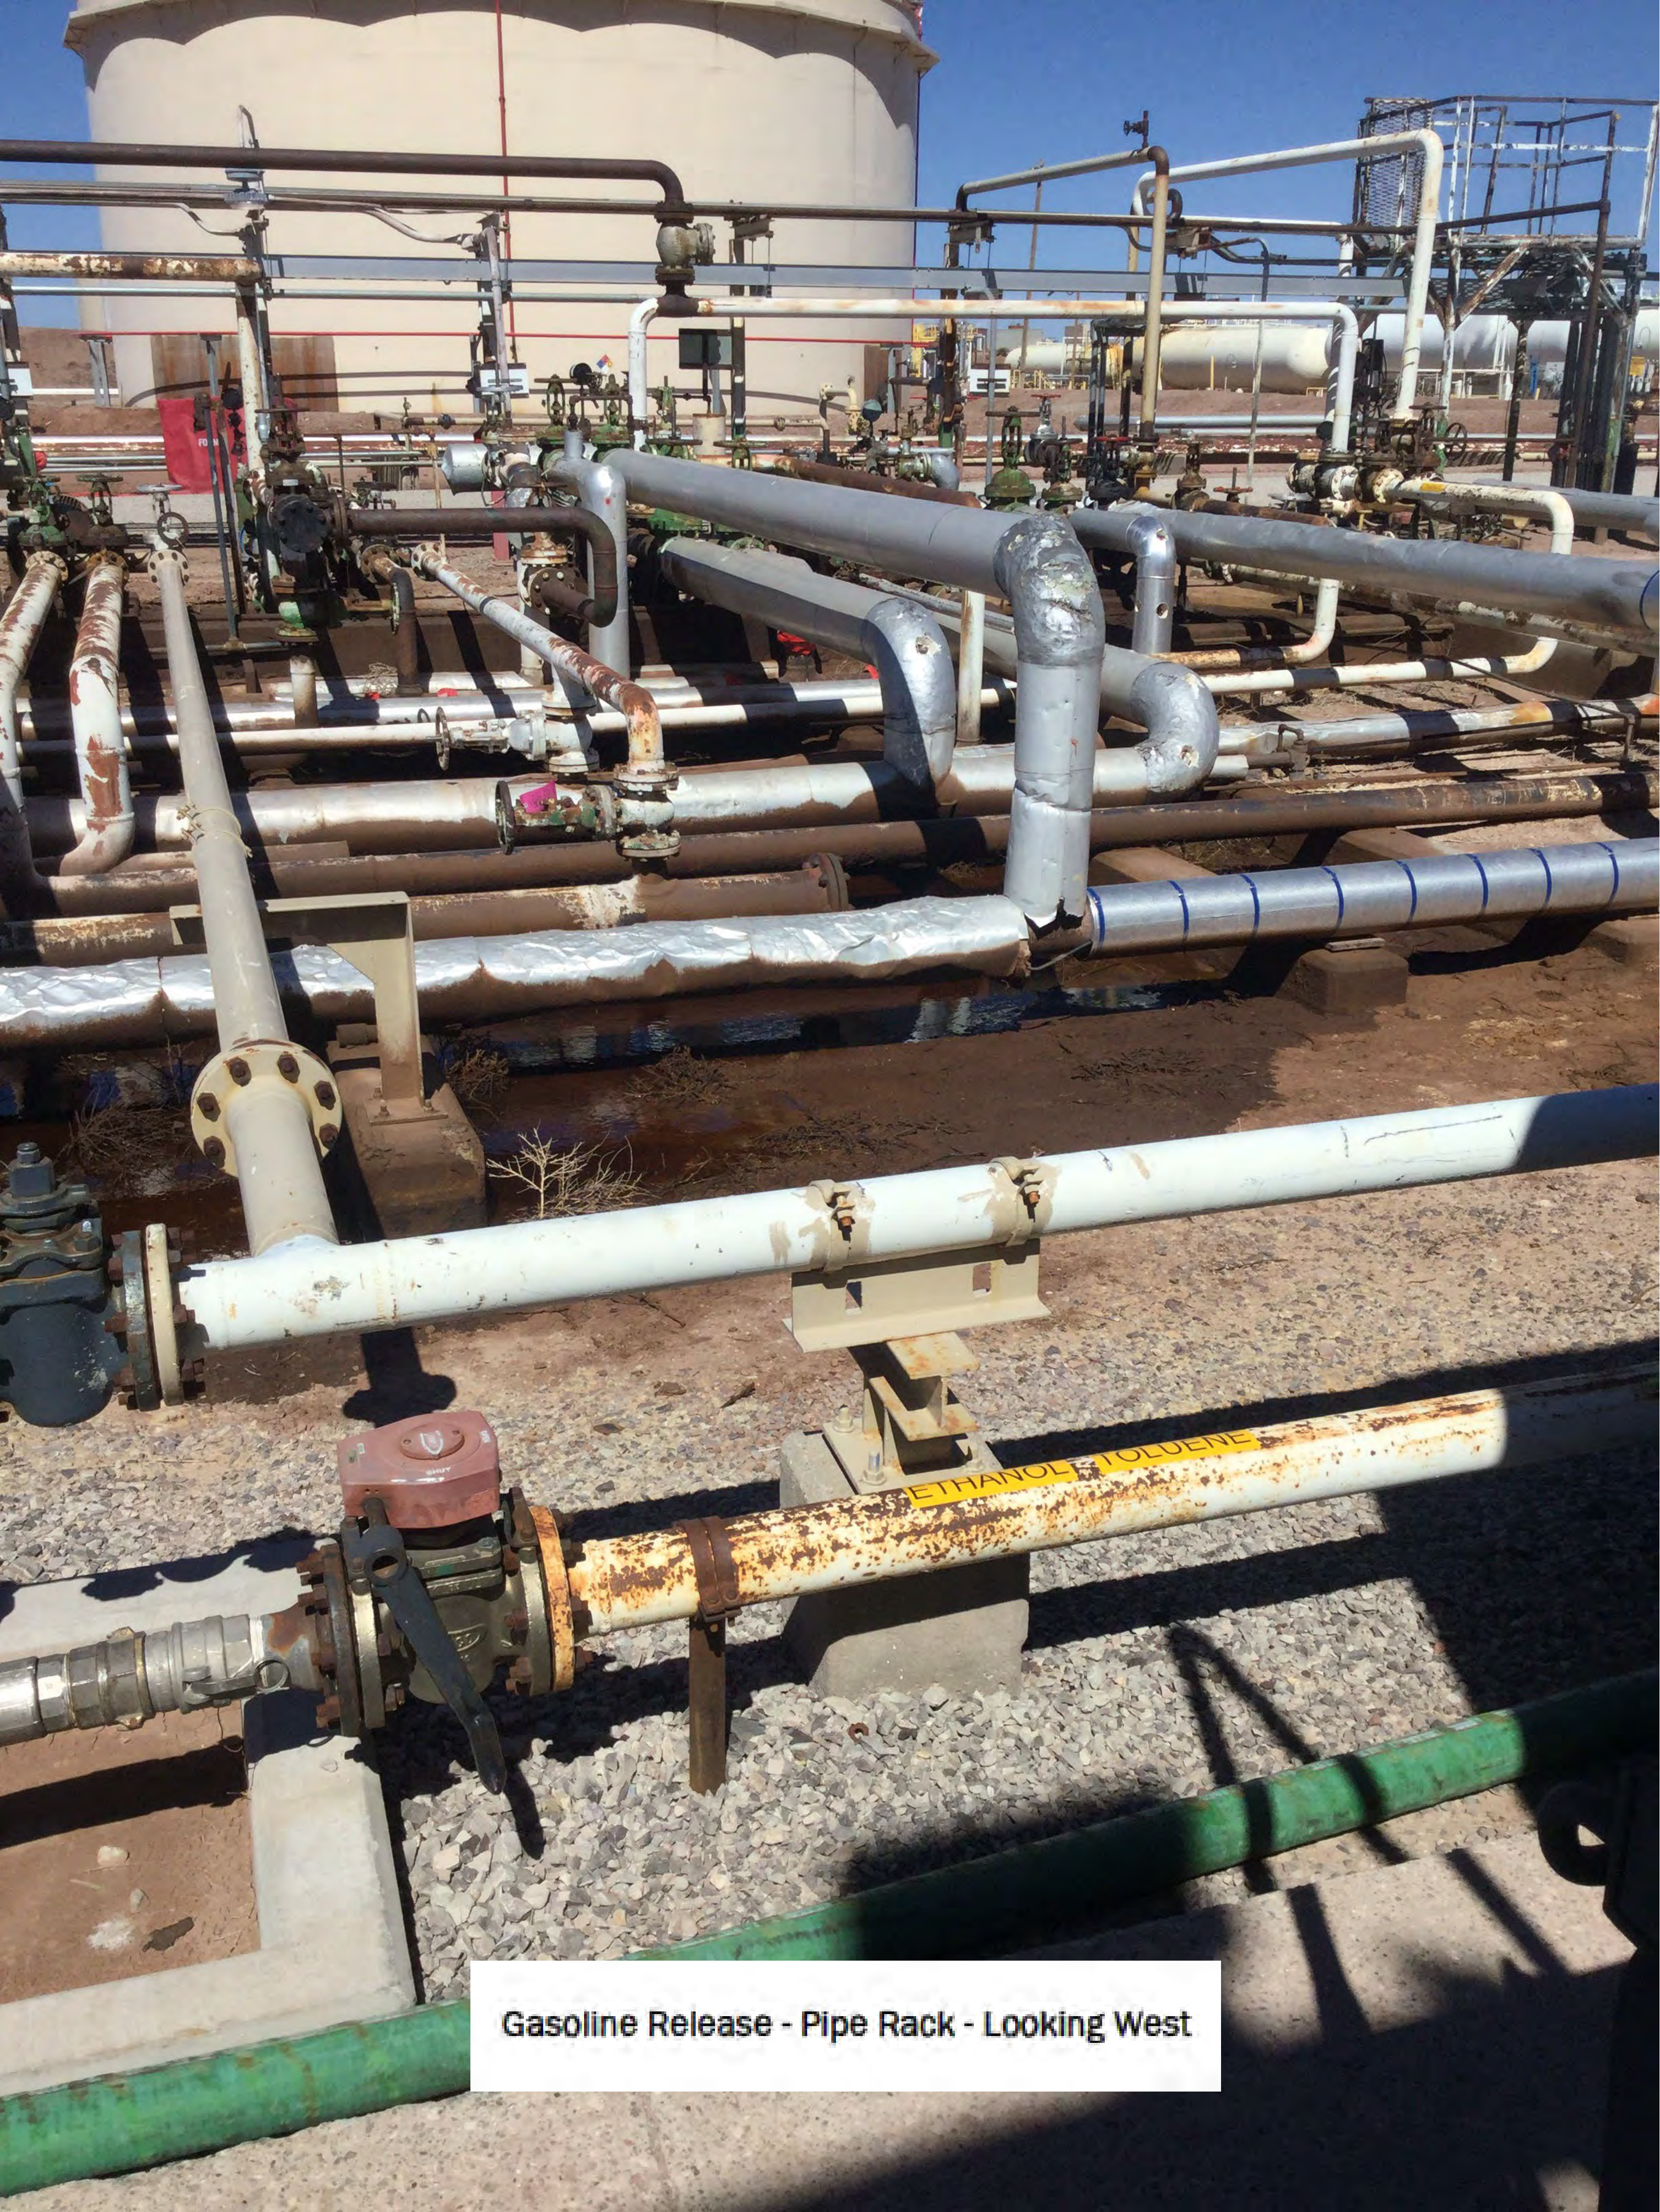
Gasoline Release - Pipe Rack - Looking West

The release remediation consisted of recovering 8,900 gallons of gasoline. In November 2018, approximately 153 tons of petroleum impacted soils beneath the pipe rack were excavated to 18 inches below ground surface. Based on the analytical data from the waste sampling, it was not anticipated that the release extended further into the subsurface. Soil confirmation samples were not collected at that time. Without confirmation sampling though, this assumption cannot be confirmed. On March 13, 2019, there was a diesel release in the same area beneath the pipe rack. Therefore, MPC recommends that soil confirmation samples be collected to determine if additional soil excavation is necessary prior to installation of the proposed concrete containment pad beneath the pipe rack.

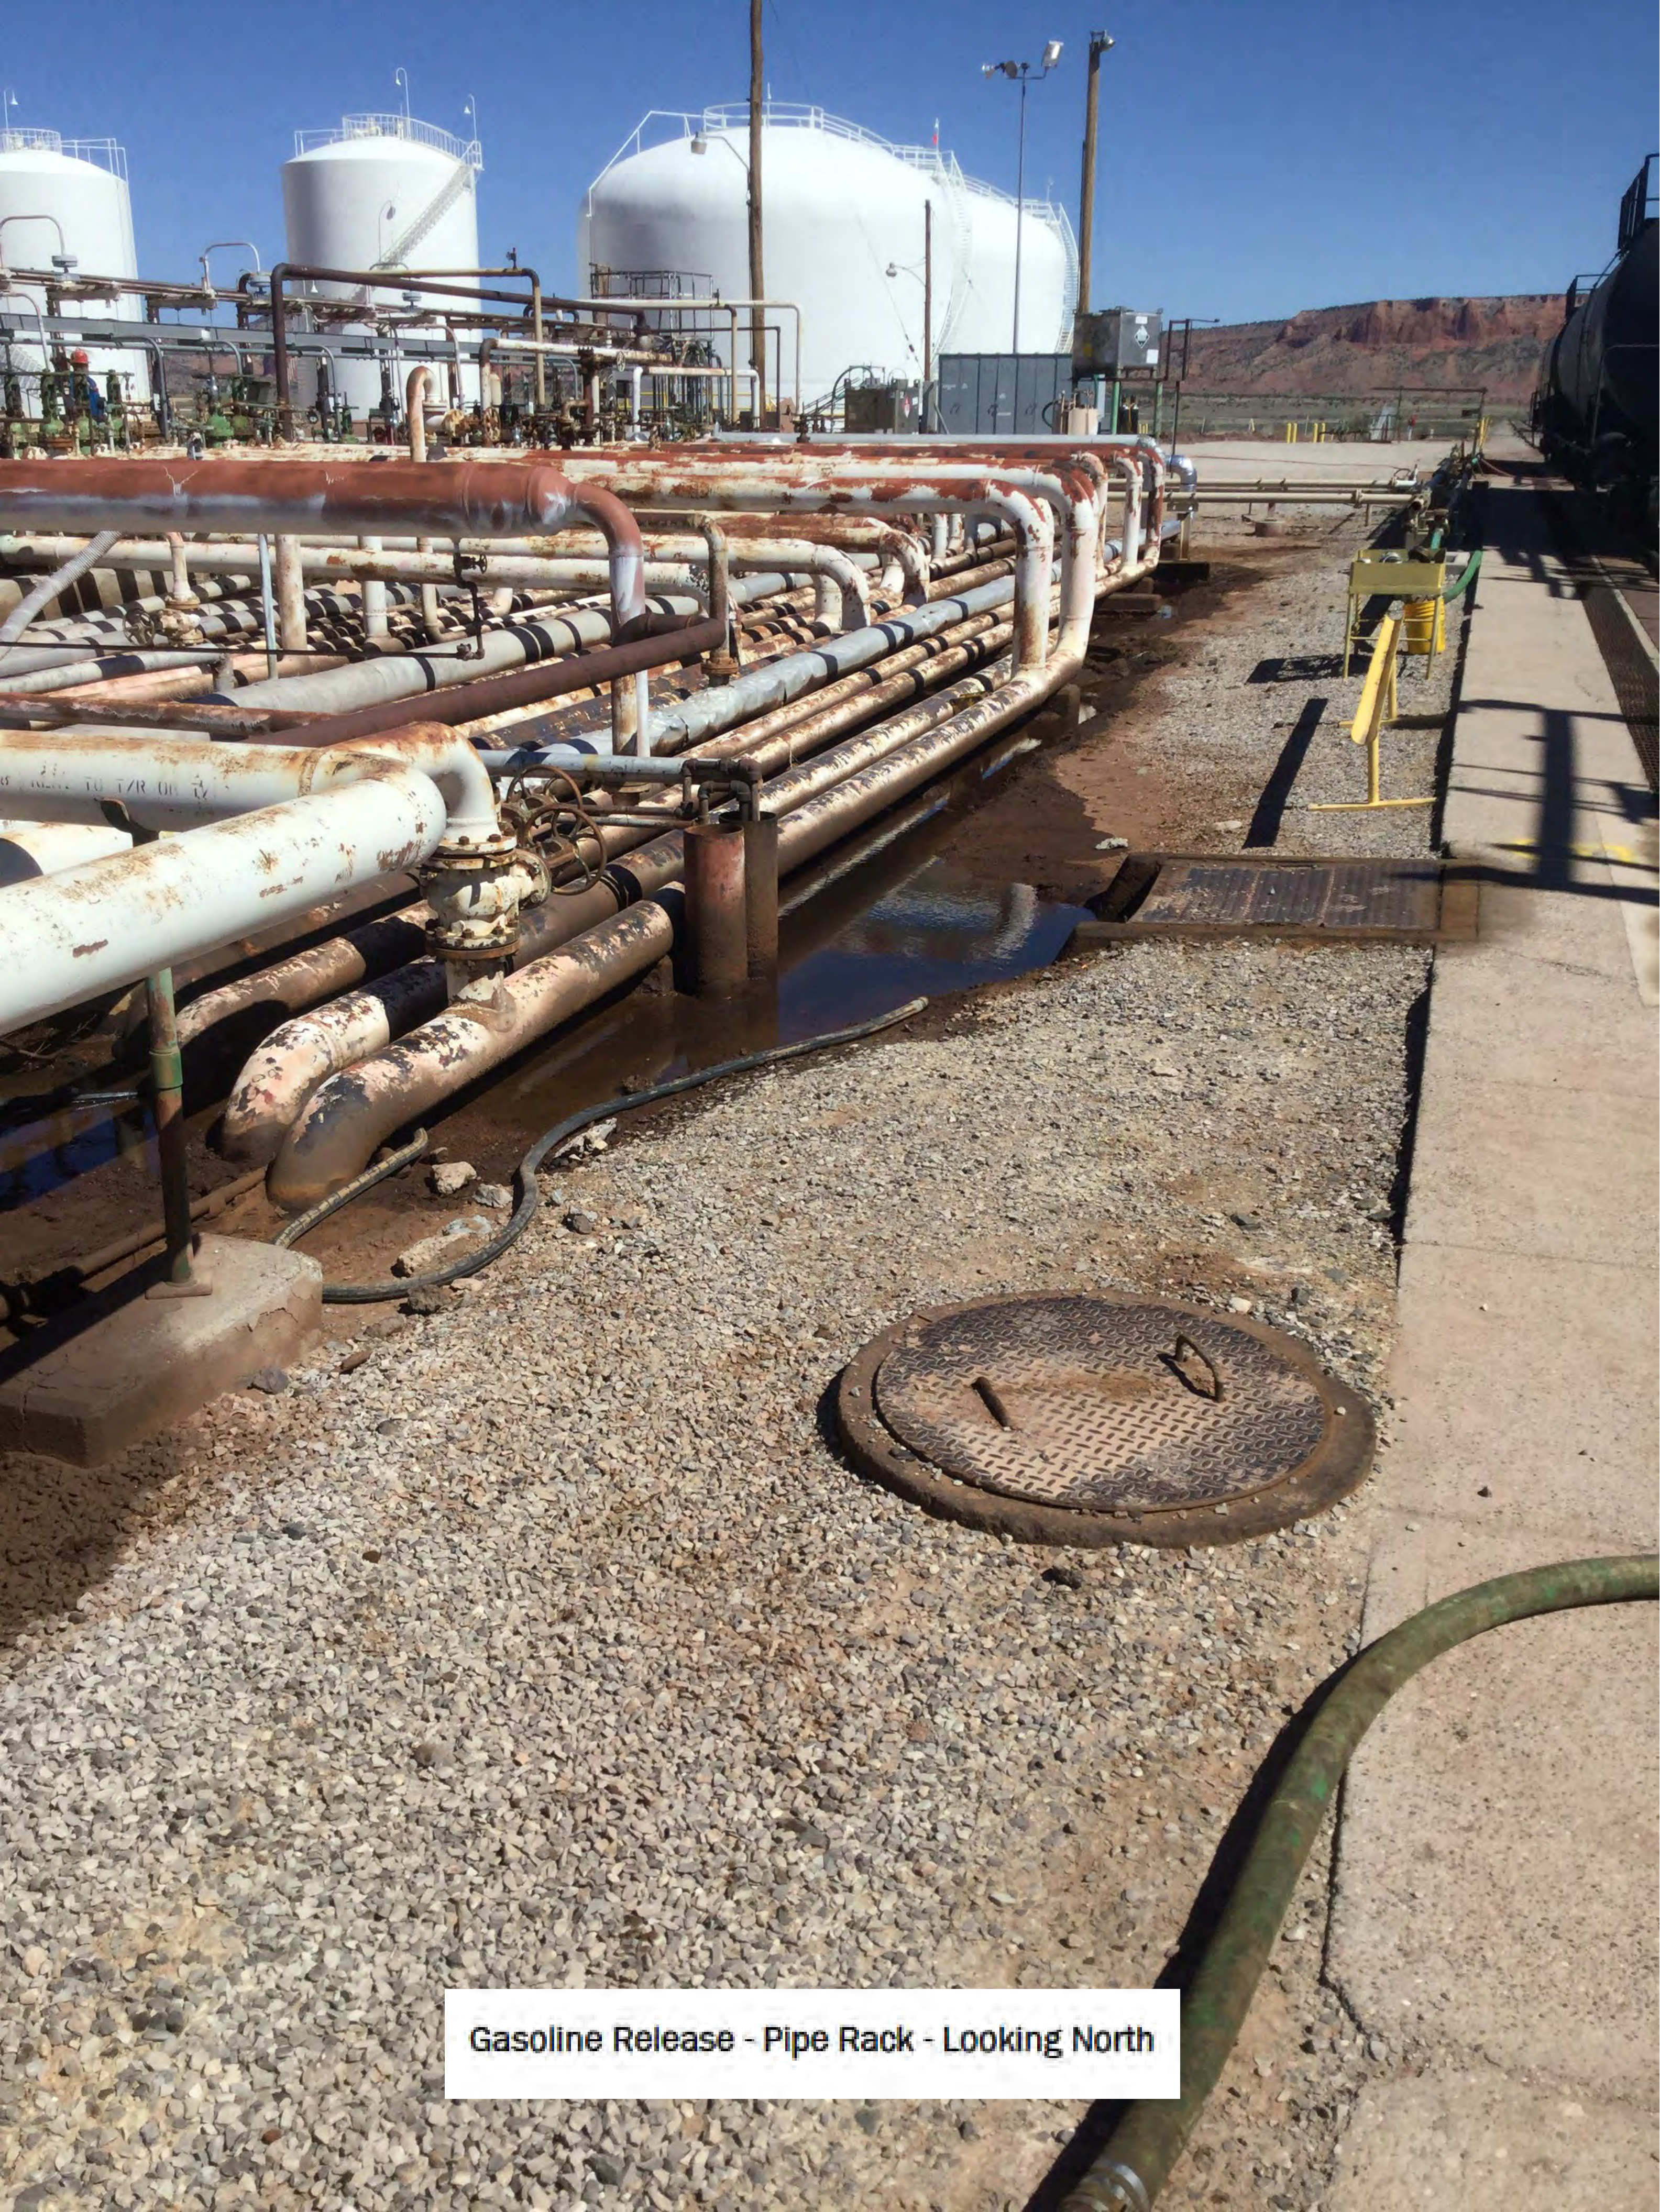
Gasoline Release - Pipe Rack - Looking North
