1R - 425-3

# DISCLOSURE REPORT

RICE OPERATING COMPANY  
JUNCTION BOX DISCLOSURE REPORT

## Vacuum K-35-1 boot

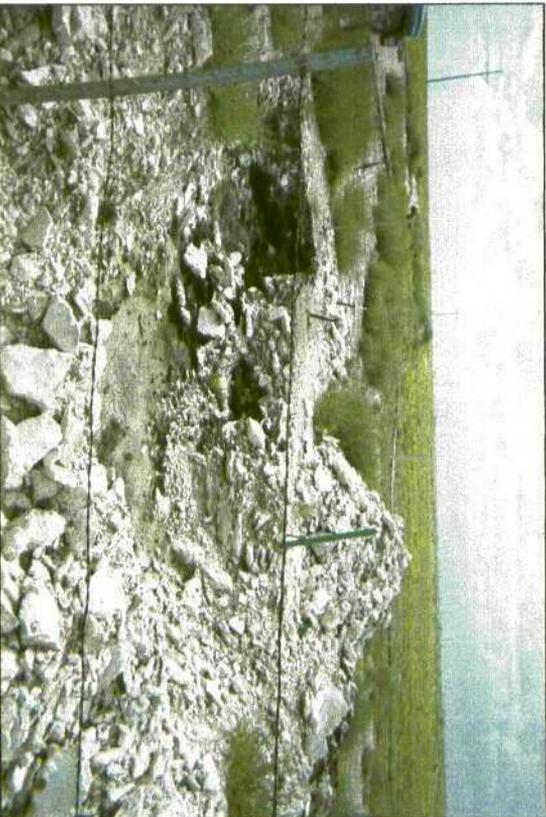
4/16/2002

box removed after NORM decontamination

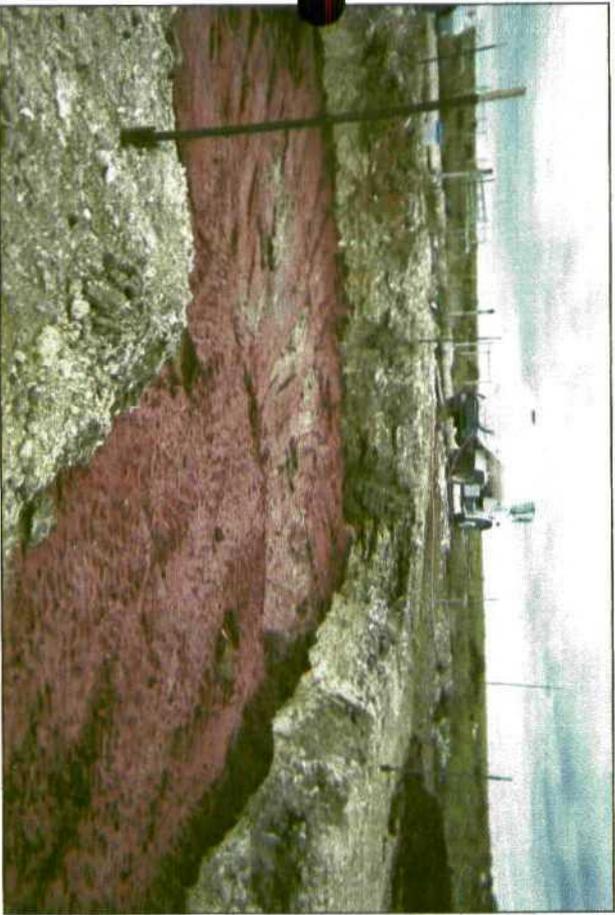
10/25/004

compacted clay at 4 ft BGS

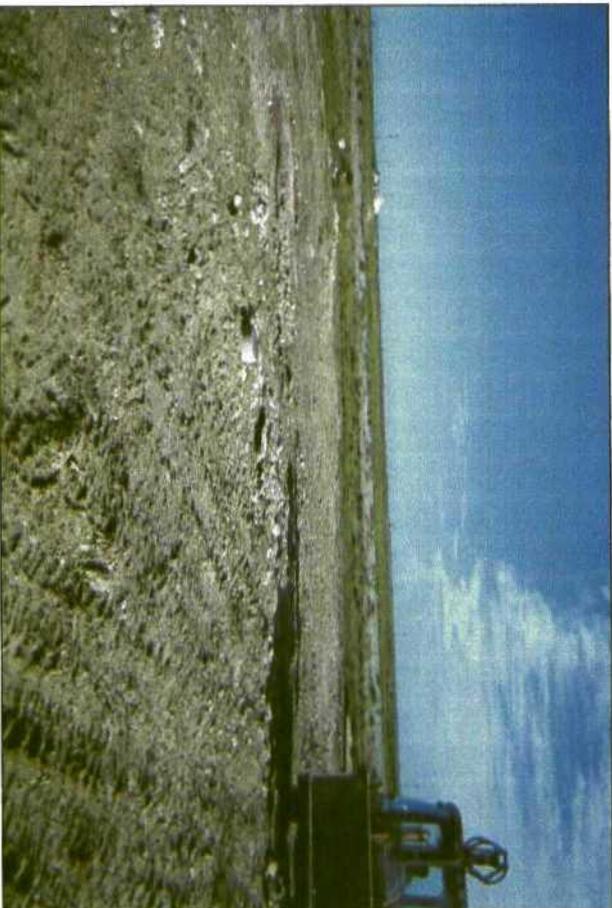
10/25/004

backfilled site with clay ID plate in center
