**RICE OPERATING COMPANY
JUNCTION BOX DISCLOSURE* REPORT**

SWD SYSTEM	JUNCTION	UNIT	SECTION	TOWNSHIP	RANGE	COUNTY	BOX DIMENSIONS - FEET		
EME	C-33	C	33	20S	36E	Lea	Length	Width	Depth
							Eliminated

EME jct. C-33

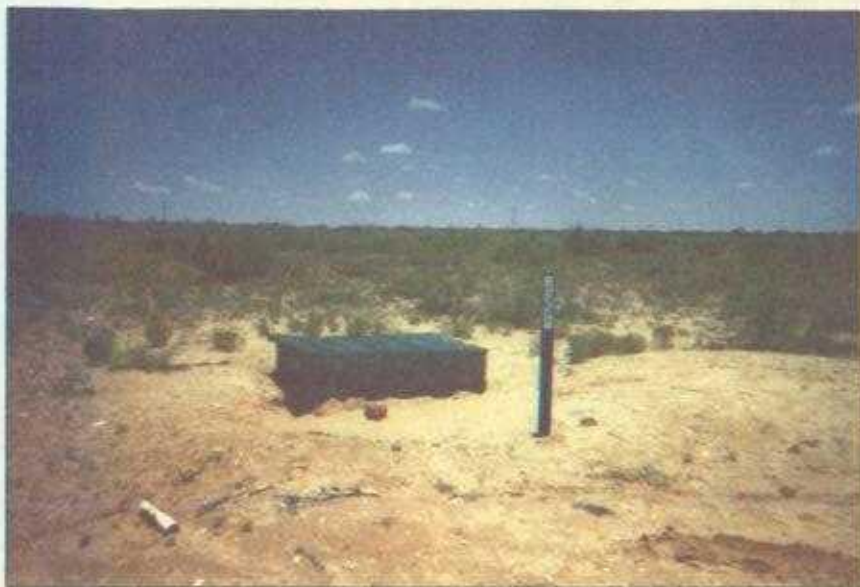
Undisturbed Junction Box 7/25/2003

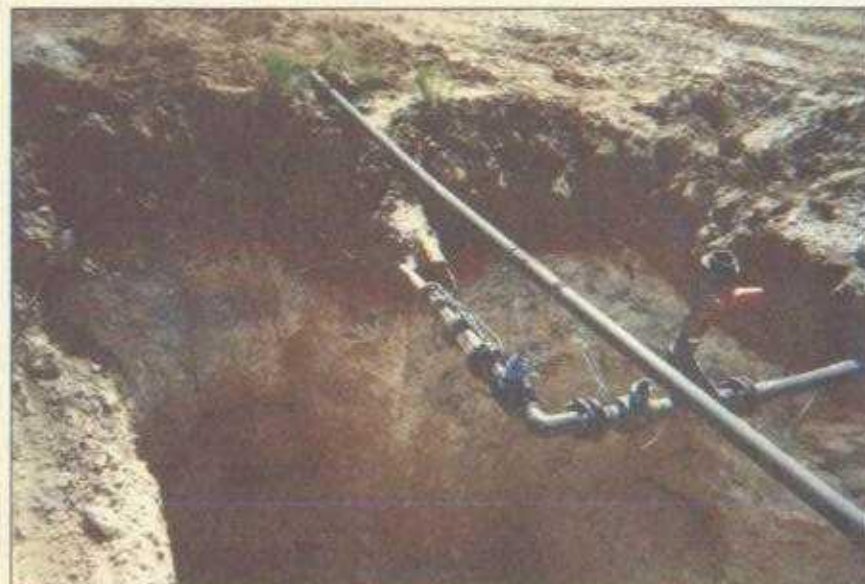
Excavation July 2003

General Description of Remedial Action: This junction box site was delineated with a backhoe and samples were tested regularly for chloride and TPH. A 12 x 12 x 12-ft deep excavation yielded no significant trends of decline of chloride concentrations vertically or laterally. There were no indications of TPH or VOC's and lab results confirmed concentrations well below NMOCD guidelines. The excavation was backfilled with the excavated soil. A soil bore was initiated on 1/13/2004 to determine the vertical extent of chloride impact. The bore was advanced to 75 ft BGS and still no conclusive trend of declination was observed (see graph). The bore hole was backfilled with the drill cuttings and an identification plate was secured to the surface for further assessment in the future. This junction will be eliminated with a line replacement in 2004.

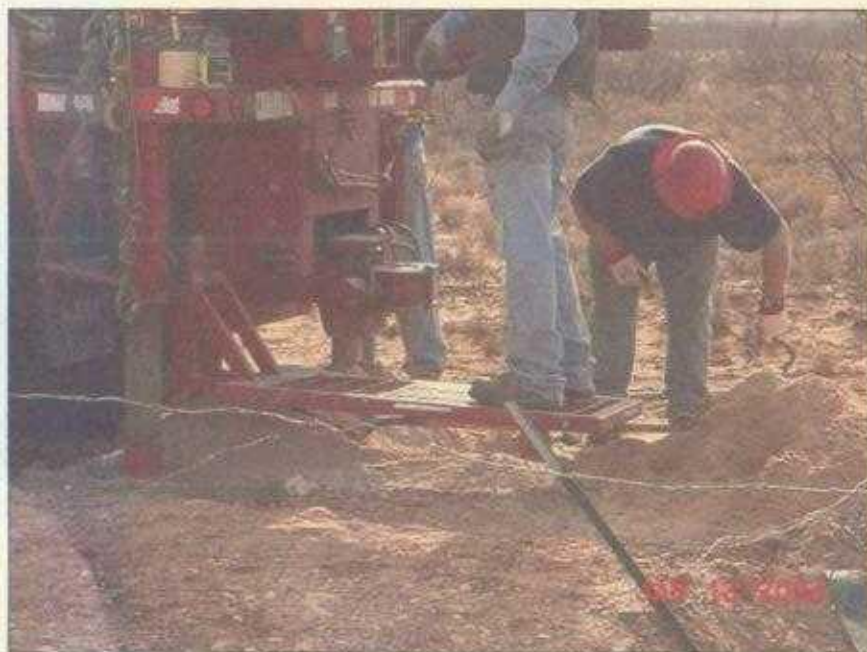
Delineation Soil Bore 1/13/2004

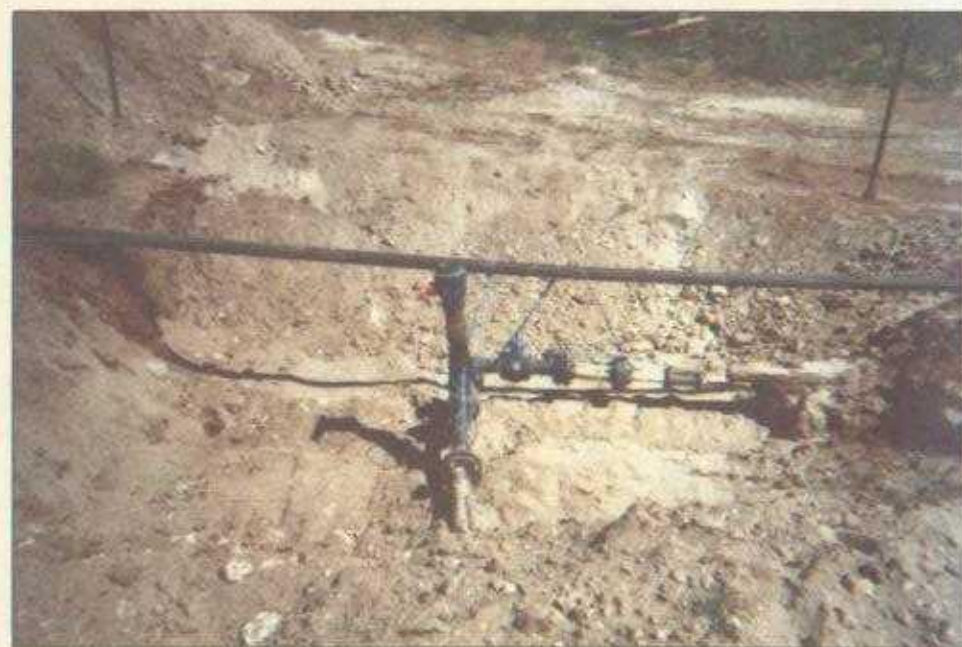
Backfilled to the pipeline 8/1/2003
