**RICE OPERATING COMPANY
JUNCTION BOX DISCLOSURE* REPORT**

SWD SYSTEM	JUNCTION	UNIT	SECTION	TOWNSHIP	RANGE	COUNTY	BOX DIMENSIONS - FEET		
EME	L-6 boot	L	6	20S	37E	Lea	Length	Width	Depth
							Moved 30 ft west

EME jct. L-6 Boot

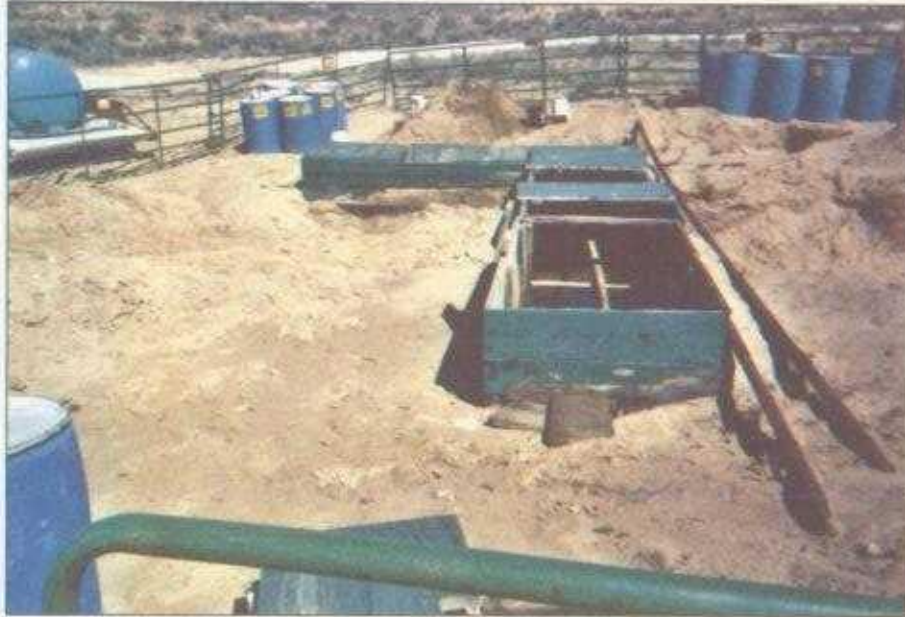
Removing NORM From Old Jct. Box (April 2003)

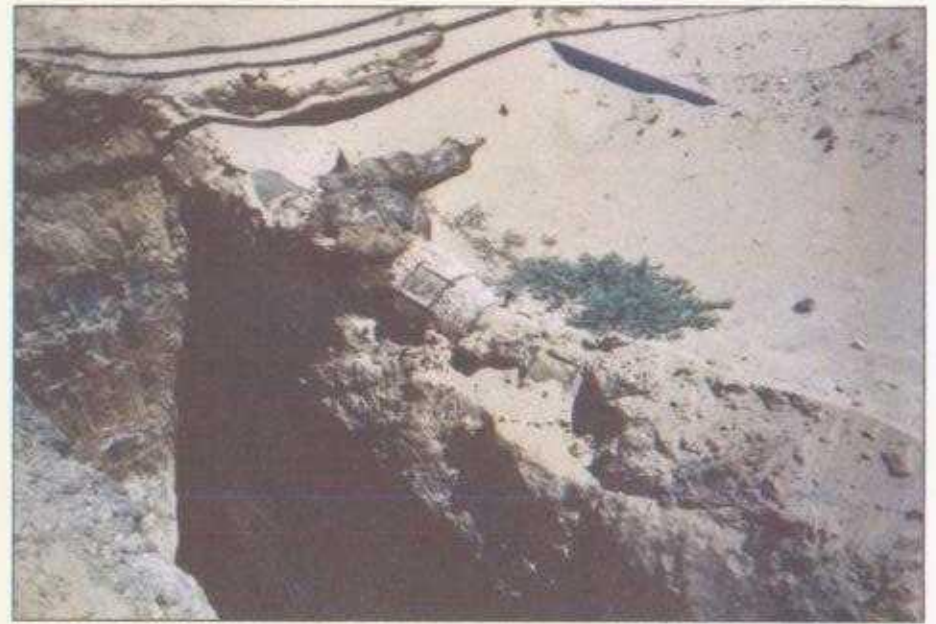
Vertical Excavation at Source (July 15, 2003)

General Description of Remedial Action: This was the site of a junction box that contained a boot. The new watertight box has been moved 30 ft west. Vertical delineation of the old location yielded consistent chloride and TPH concentrations to a depth of 12 ft. NMOCD TPH guidelines were not met. The hole has been backfilled and the location identified for further consideration at a later date.

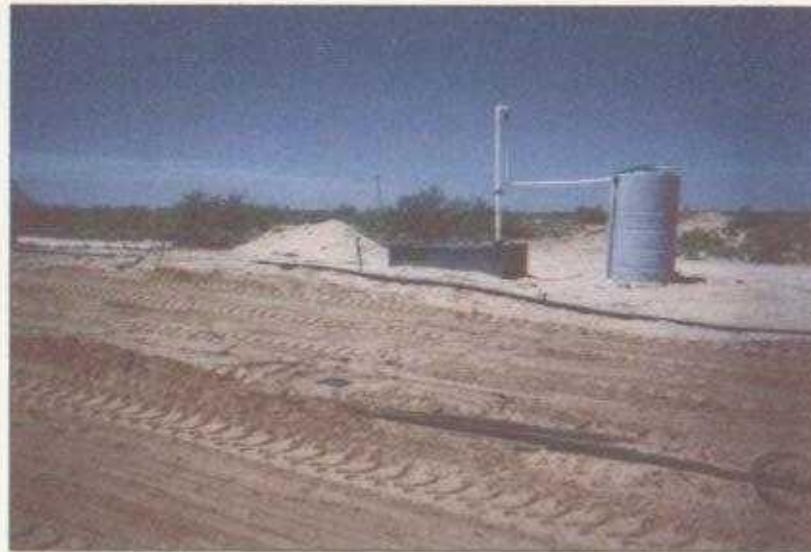
Backfilled Looking West at New Junction Box & Boot With Identification Plate in Foreground (July 28, 2003)
