**RICE OPERATING COMPANY  
JUNCTION BOX FINAL REPORT**

SWD SYSTEM	JUNCTION	UNIT	SECTION	TOWNSHIP	RANGE	COUNTY	BOX DIMENSIONS - FEET		
							Length	Width	Depth
EME	P-34	P	34	19S	36E	Lea	Moved 73 ft southwest

**EME jet. P-34**

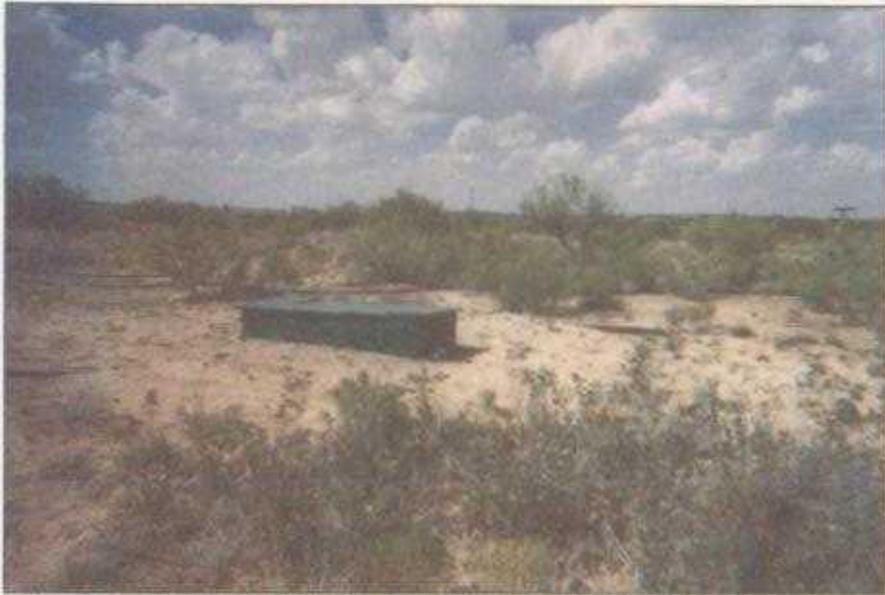
Undisturbed Junction Box Prior to NORM Removal

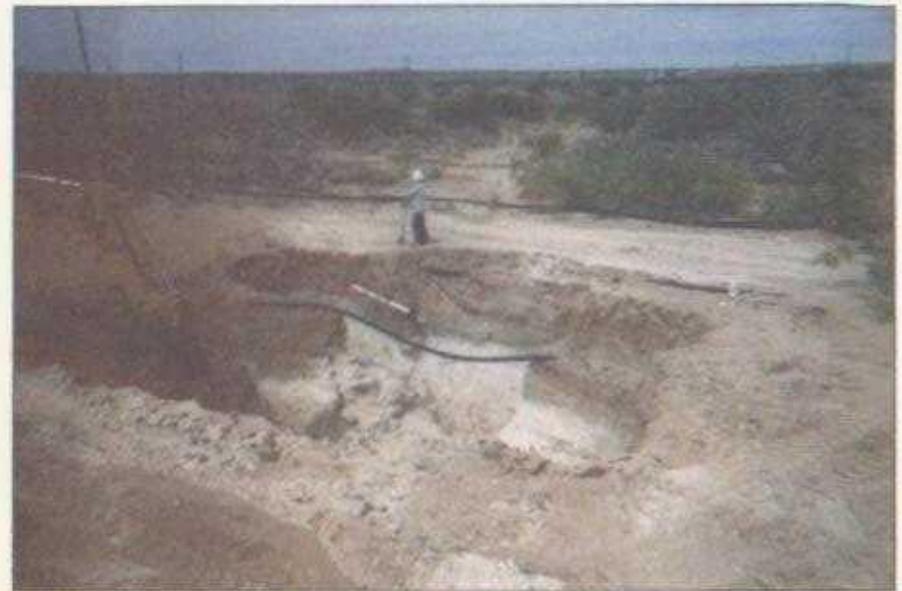
Excavation Sept. 2003

**General Description of Remedial Action:** This junction box site was delineated with a backhoe while chloride tests and PID readings were conducted at regular intervals. TPH impact was minimal and lab results confirmed concentrations well below NMOCD guidelines. Chloride concentrations exhibited a conclusive decline with depth, however, lateral trends of chloride declination were not determined within the 25 x 16 x 12-ft-deep excavation. The excavation was backfilled with the blended excavated material up to 6 ft bgs. To inhibit further downward migration of chloride impact, a 1.5 ft compacted clay barrier was installed at 6 ft bgs and extended over shelves made to surround the original excavation (see diagram). The remaining blended material was then backfilled on top of the clay up to the surface. The disturbed surface was re-seeded with native vegetation on 10/15/2003 and will be monitored for growth.

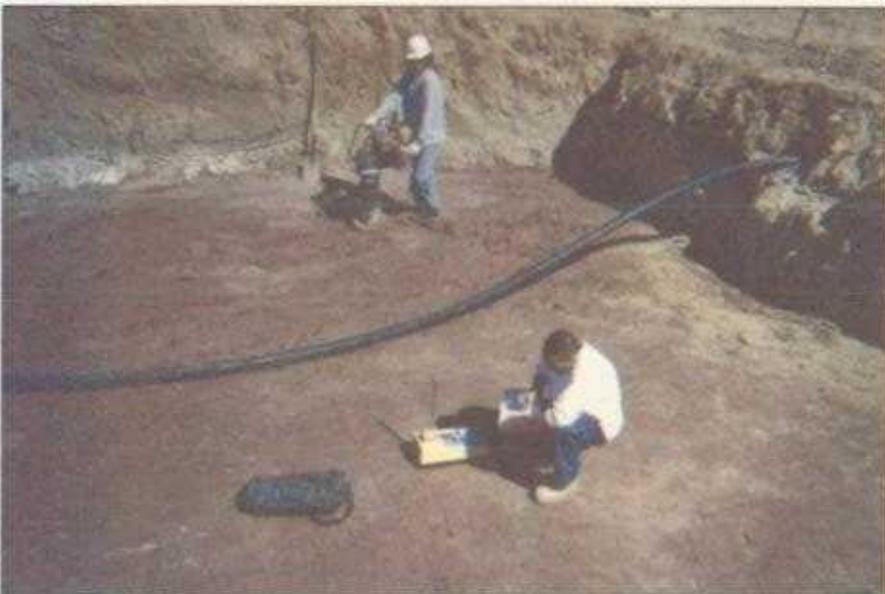
Compacting and Testing Clay Liner at 6 ft BGS 10/2/2003

Test No.	Location	Dry Density % Maximum	% Moisture	Depth
SG-1	Pit - 10' W. & 5' N. of the SE Corner	97.5	18.5

Control Density: 104.2  
ASTM: D 698

Optimum Moisture: 23.1%

Required Compaction: 95%

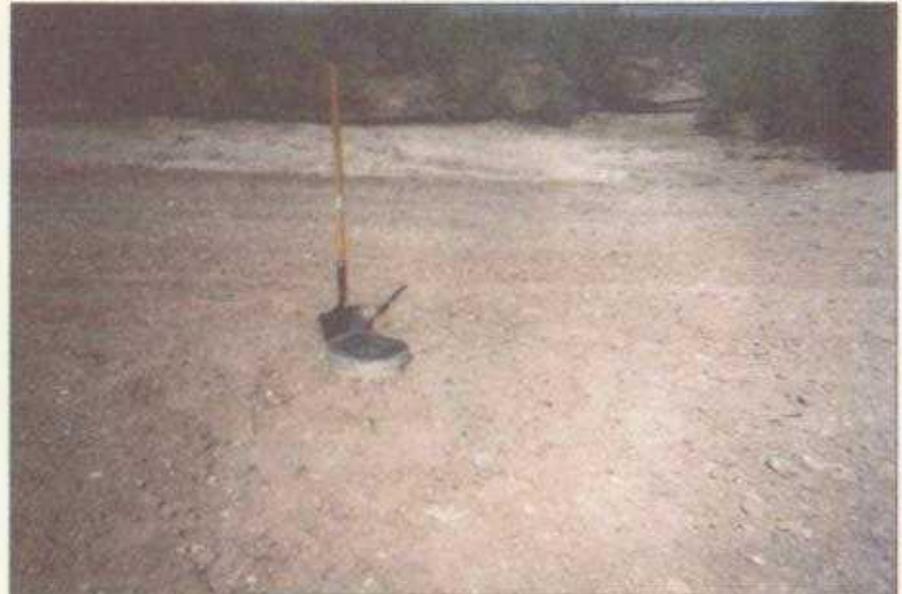
Backfilled Site with ID Plate Marking Clay Below

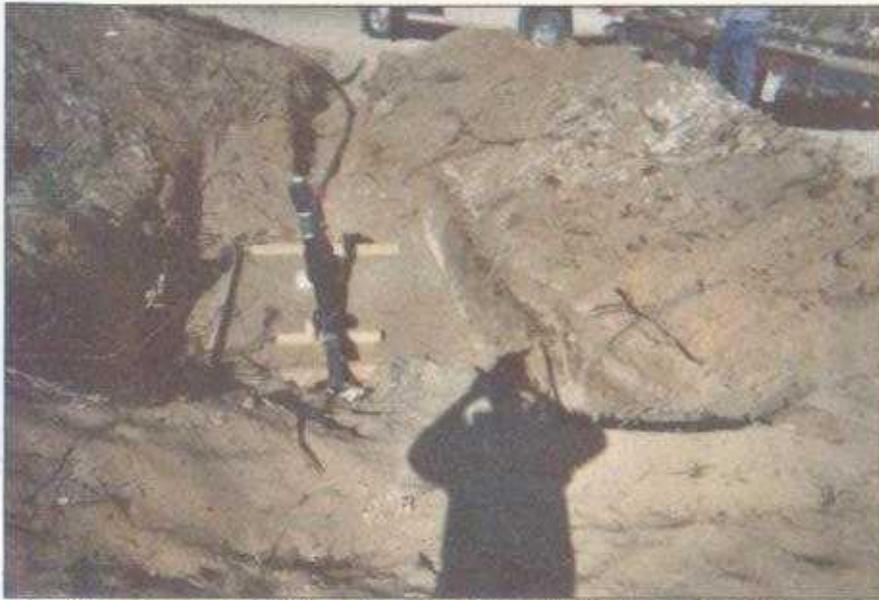
Construction of New Junction Box With New Plumbing

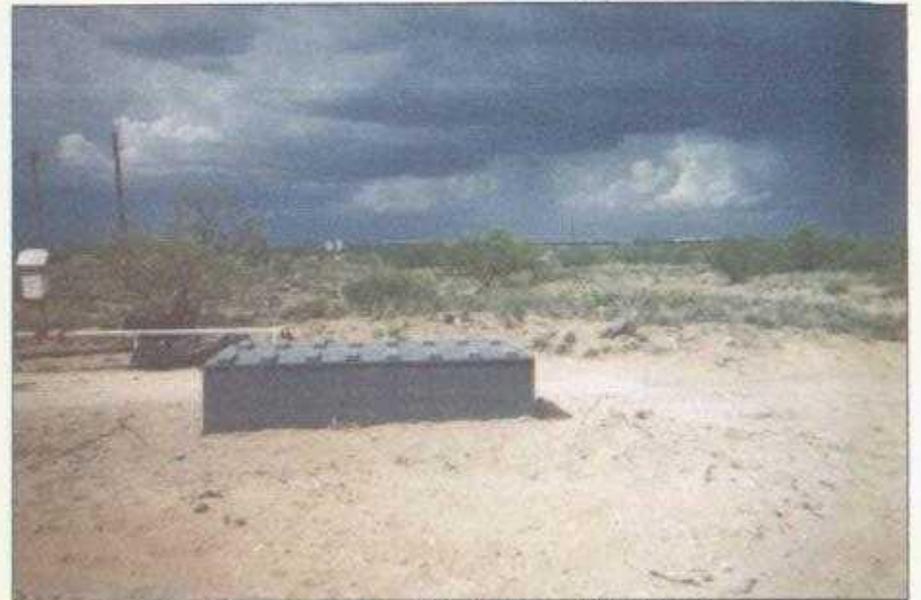
Completed Box 73 ft SW 8/29/2003

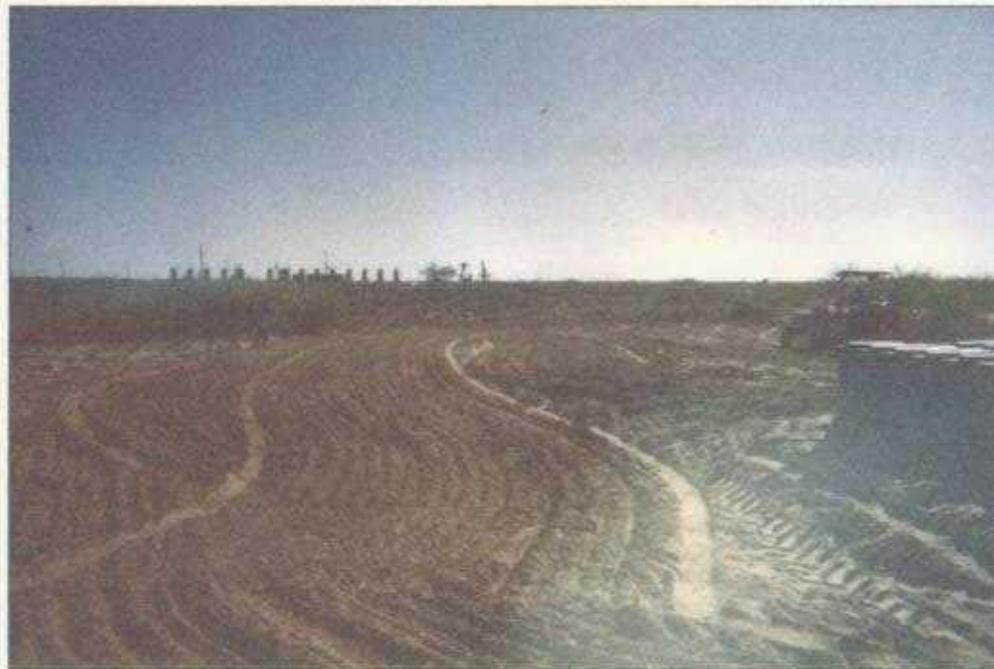
Seeding Disturbed Area 10/15/2003

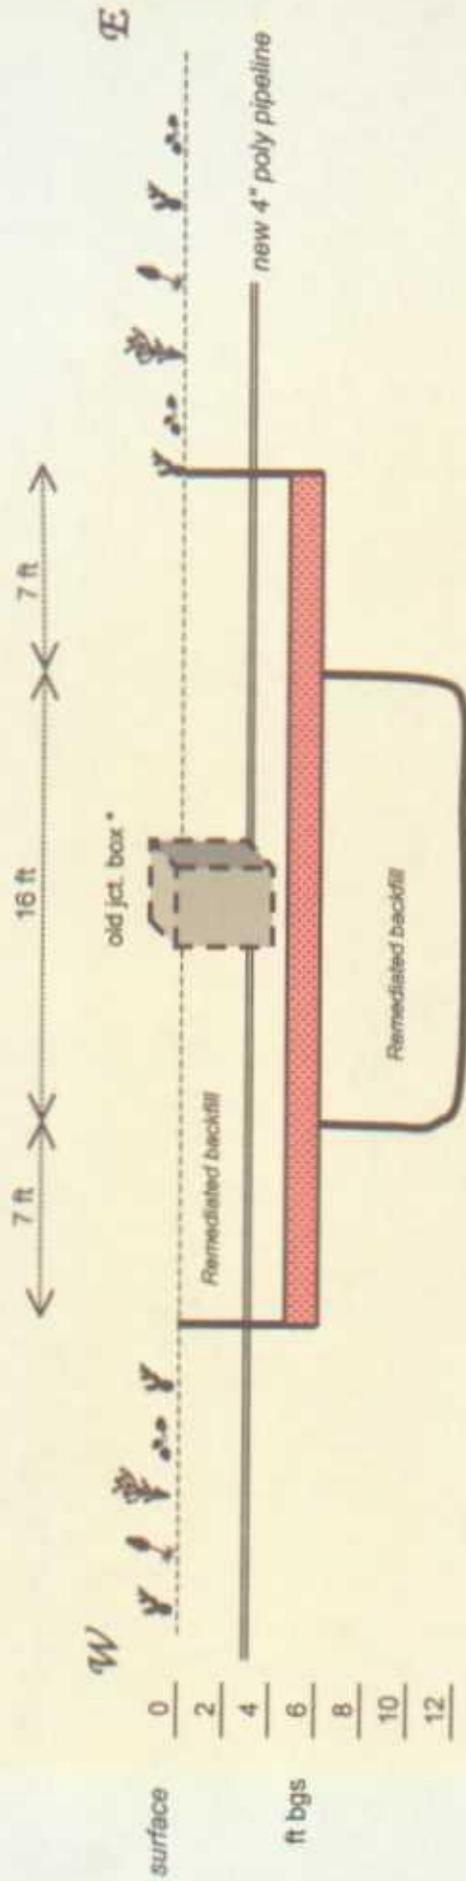
**EME jct. P-34**  
**Impact Excavation**  
**Cross-Section**

\* New junction box has been built 73 ft Southwest from old junction.

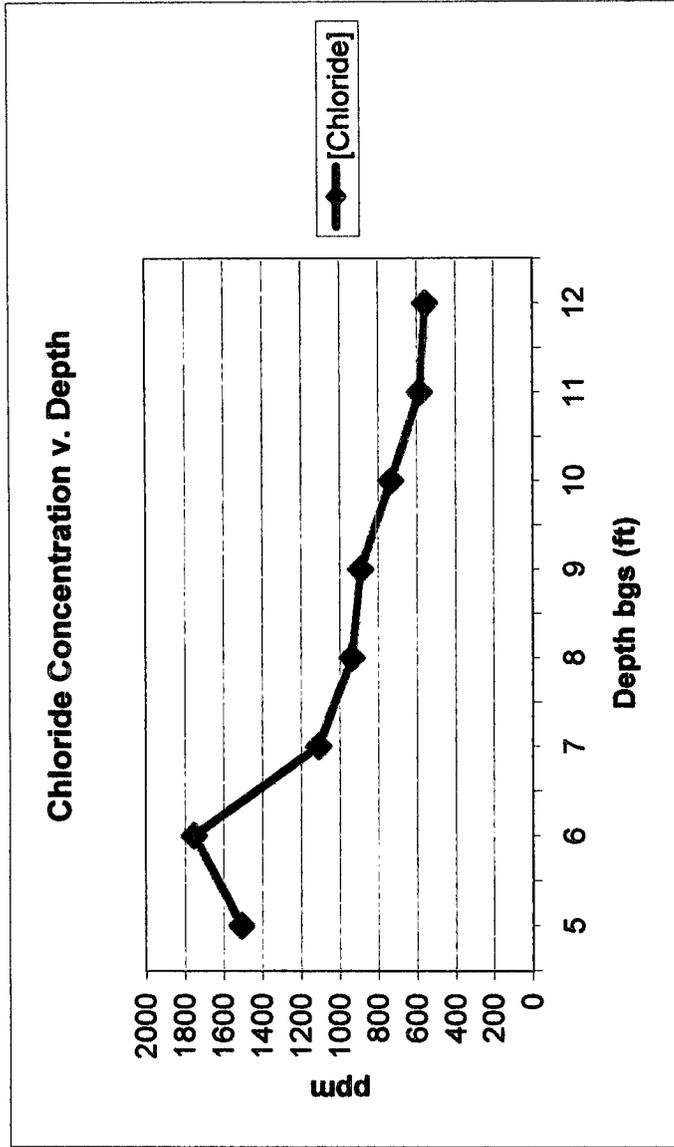
**EME jct. P-34**

5 ft North from Junction

Depth bgs (ft)	[Cl <sup>-</sup> ] ppm
5	1508
6	1753
7	1109
8	937
9	890
10	735
11	585
12	555

Groundwater = 47 ft

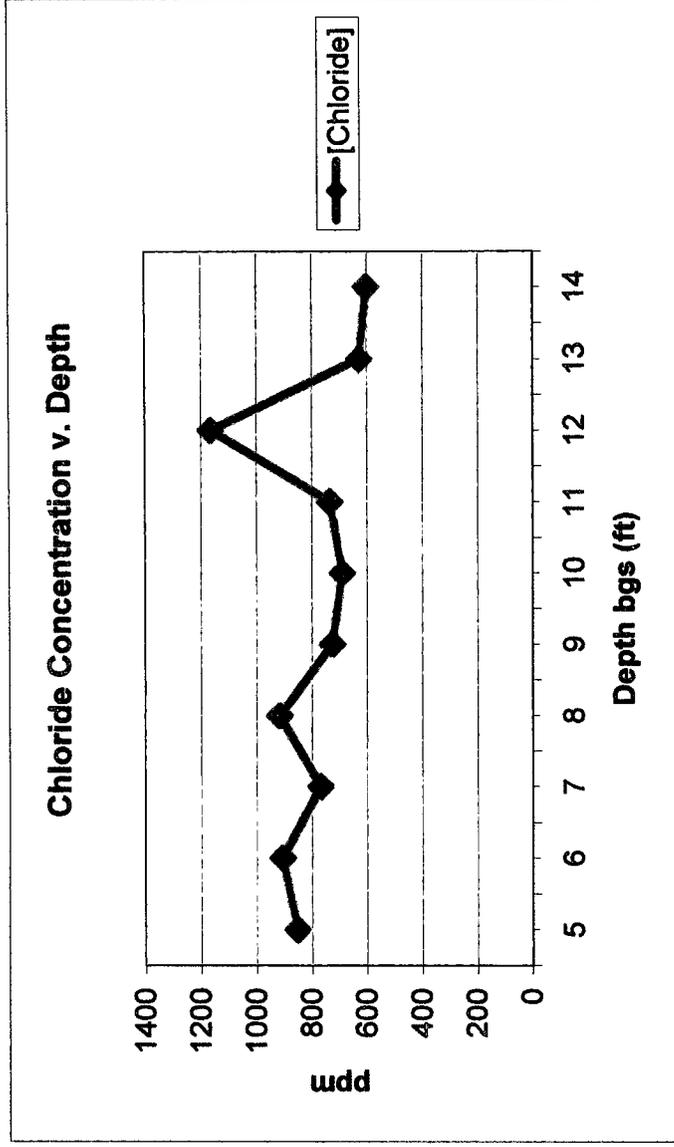
**EME jct. P-34**

Depth bgs (ft)	[Cl <sup>-</sup> ] ppm
5	852
6	907
7	769
8	917
9	726
10	690
11	735
12	1165
13	628
14	603

Groundwater = 47 ft
