EME Wallace State  
EDL

1R0427-135

# FINAL REPORT

# RICE OPERATING COMPANY JUNCTION BOX FINAL REPORT

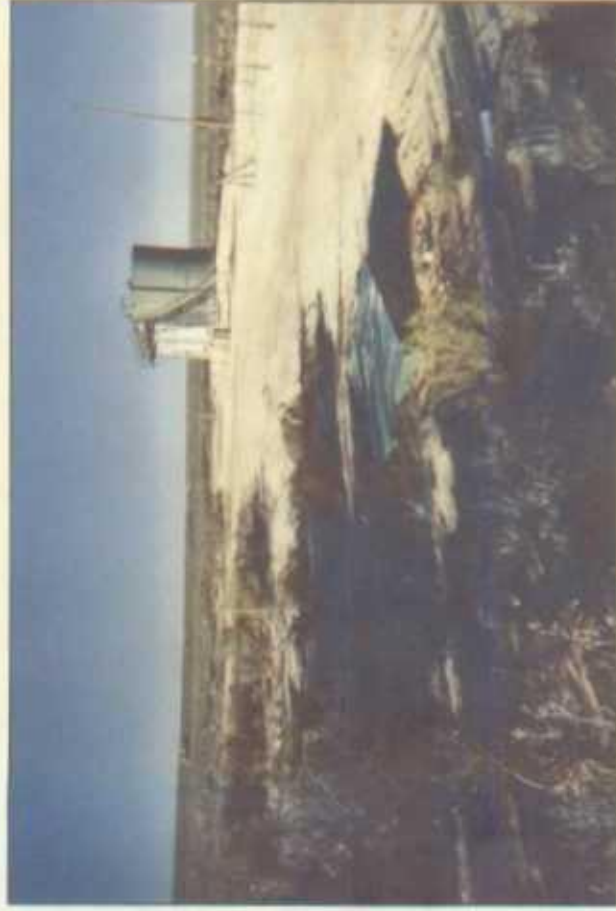
11/19/2003

Undisturbed junction box

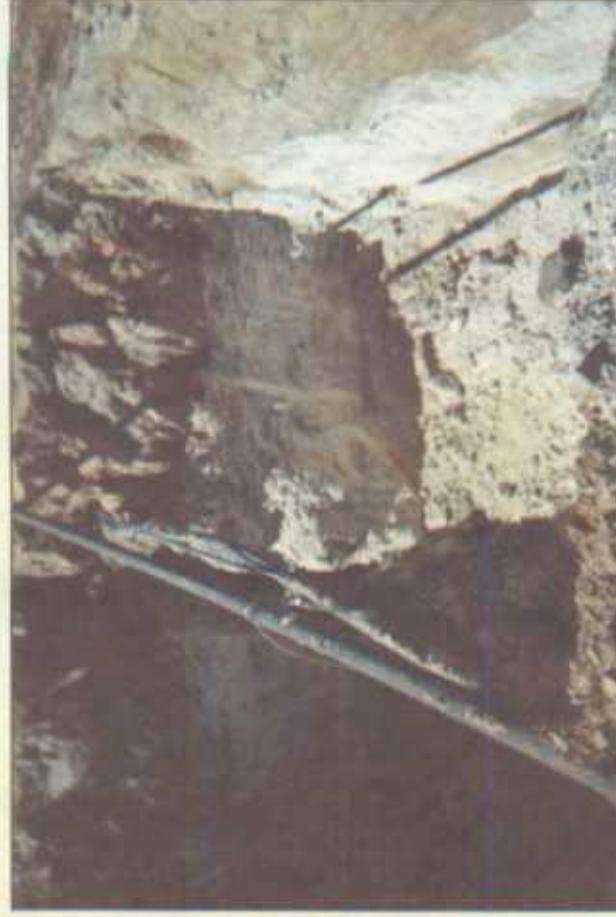
3/5/2004

20 x 20 x 12-ft-deep excavation (looking south)

General Description of Remedial Action: This EOL box was excavated with a backhoe while PID readings and chloride tests were performed at regular depth intervals.

NMOCD guidelines. The 20 x 20 x 12-ft-deep excavated was backfilled with the excavated

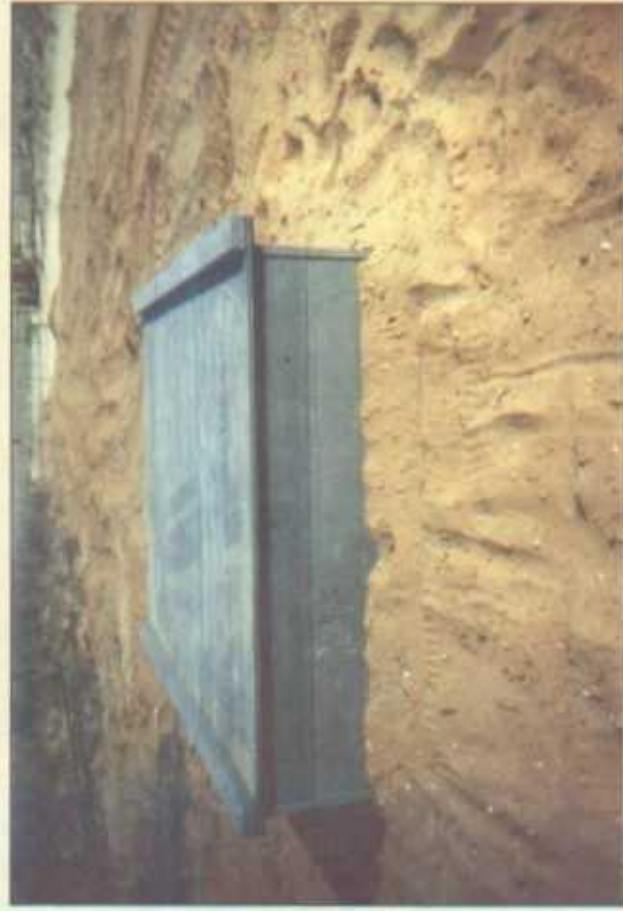
12/31/2003

Complete new junction box 60 ft south of former

has been moved and a new watertight box has been built 60 ft south.

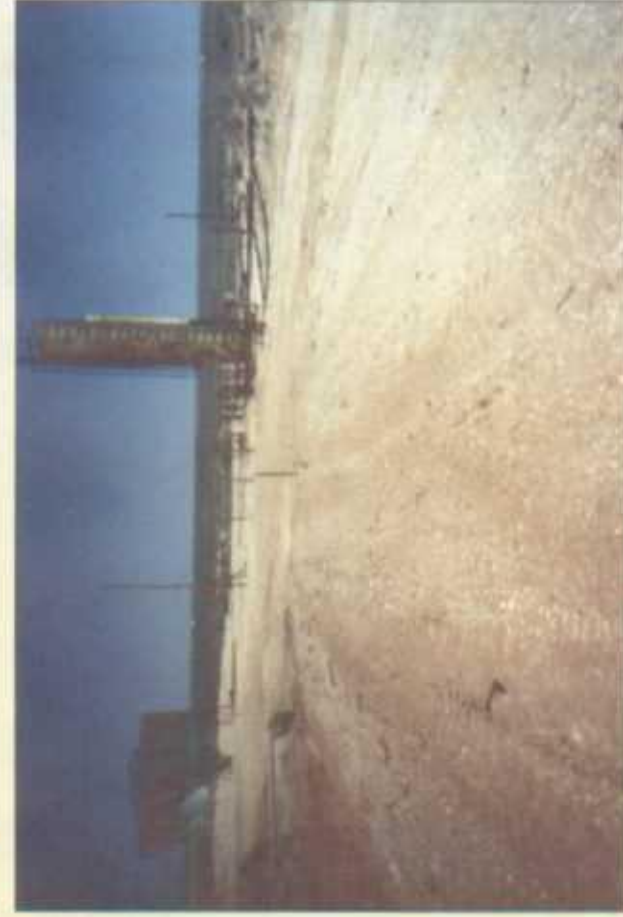
3/12/2004

Backfilled site (T-post in center)

soil that was landfarmed on site and the surface was contoured to its surroundings. The
