**RICE OPERATING COMPANY
JUNCTION BOX DISCLOSURE REPORT**

SWD SYSTEM	JUNCTION	UNIT	SECTION	TOWNSHIP	RANGE	COUNTY	BOX DIMENSIONS - FEET		
							Length	Width	Depth
EME	A-2-1	A	2	20S	36E	Lea	moved 85 ft west

EME jct. A-2-1

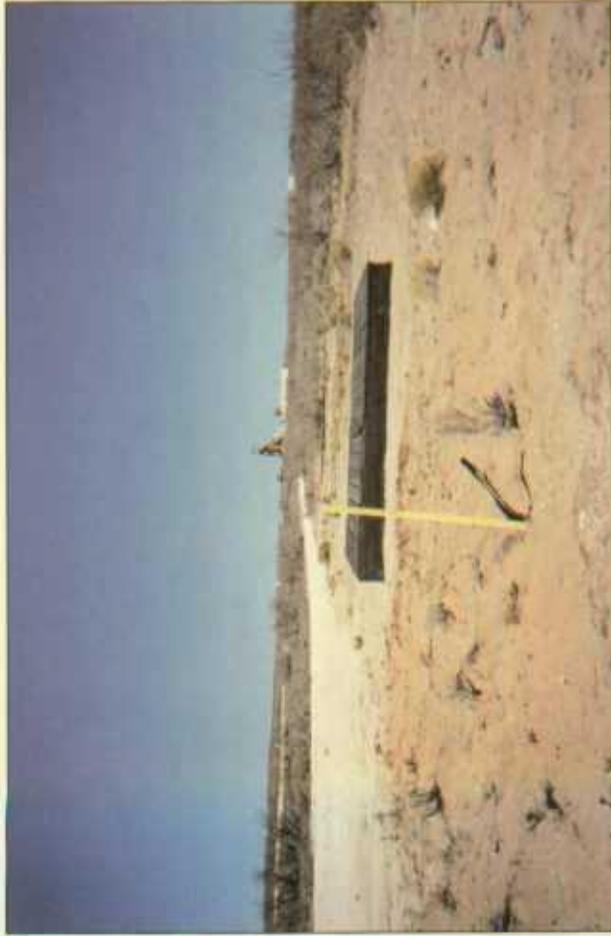
undisturbed junction box

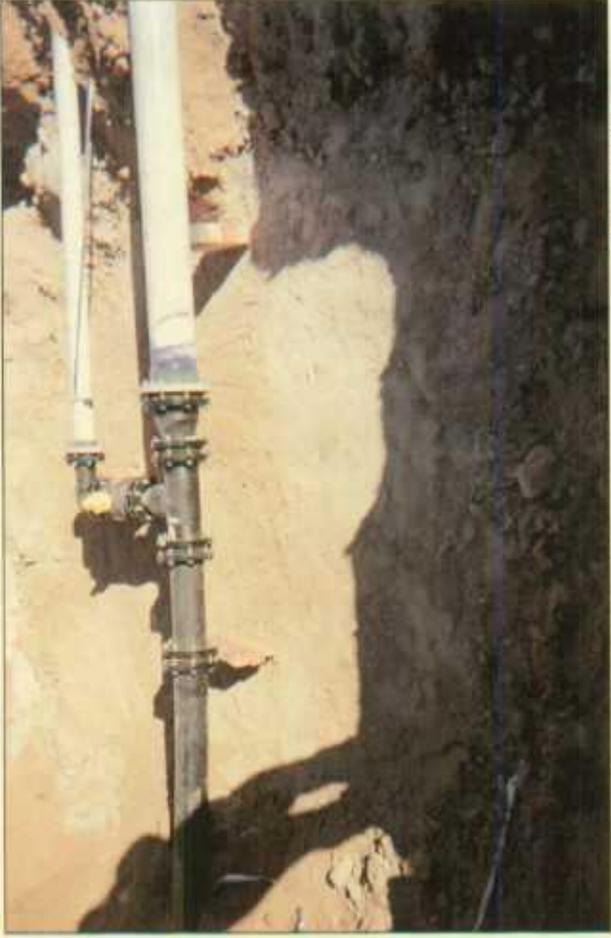
new junction 85 ft west

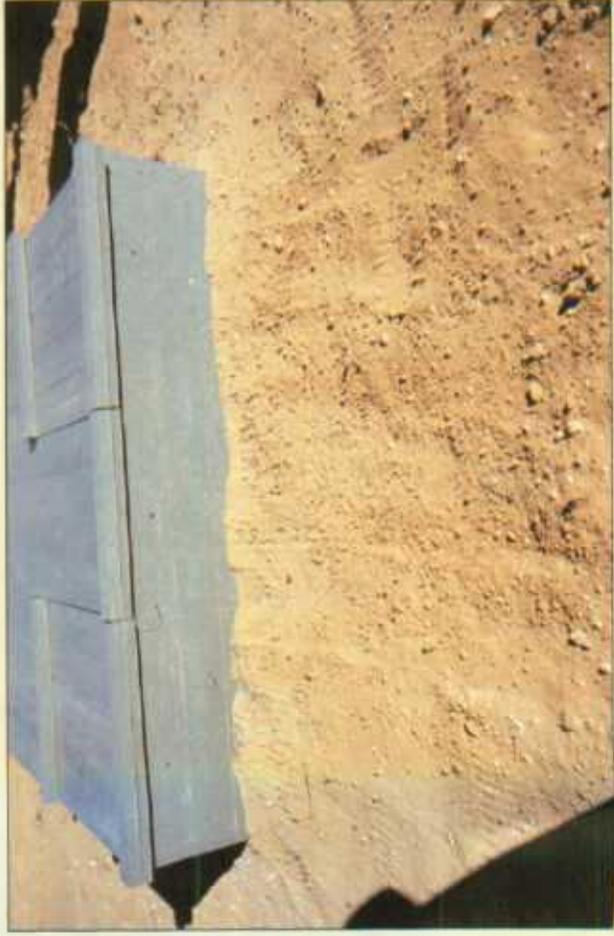
new junction box 85 ft west of former

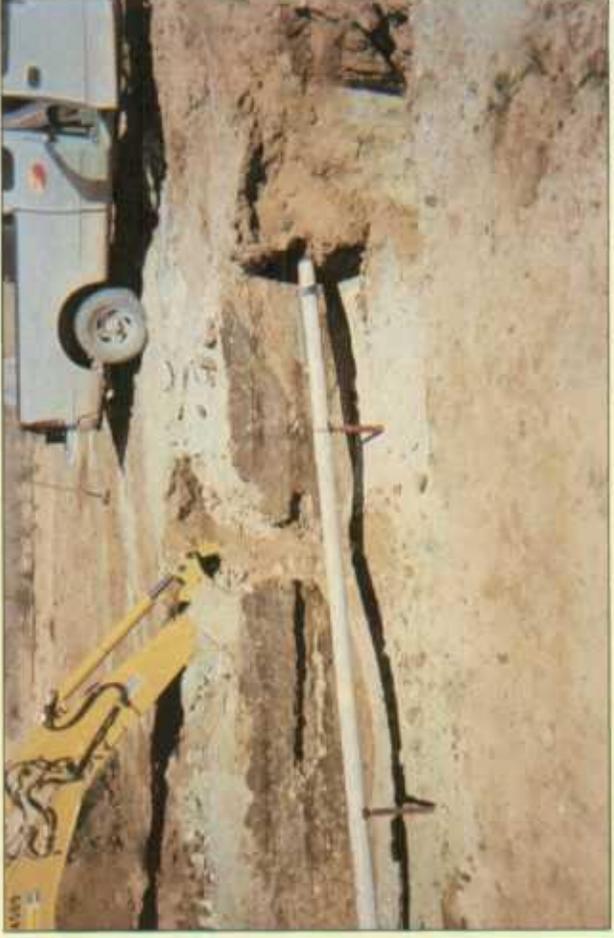
delineation & excavation at former box site

General Description of Remedial Action: This junction was moved 85 ft west during the pipeline replacement as part of the Junction Box Upgrade program. The former box site was delineated using a backhoe while chloride field tests and PID screenings were performed on soil samples at regular intervals, producing a 20 x 20 x 12-ft-deep excavation. Chloride concentrations did not significantly decline with depth and NMOCD TPH guidelines were not met. The excavated soil was blended on site and then backfilled into the hole up to 6 ft BGS. At 6 ft, a 1-ft-thick compacted clay barrier was installed to inhibit further chloride migration. The remaining spoils were backfilled on top of the clay and contoured to the surrounding surface. A new watertight junction box was built 85 ft west of this site. A identification plate has been placed on the surface to mark the presence of clay below and to identify the location of the former junction box for future environmental considerations. NMOCD has been notified of potential groundwater impact at this site.

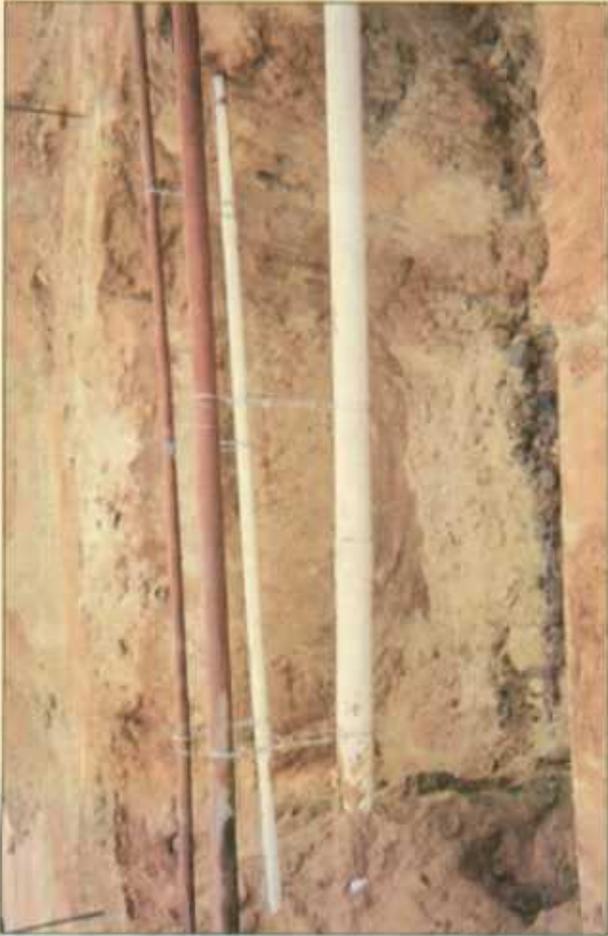
20 x 10 x 12 ft deep excavation

installing clay barrier at 6 ft BGS

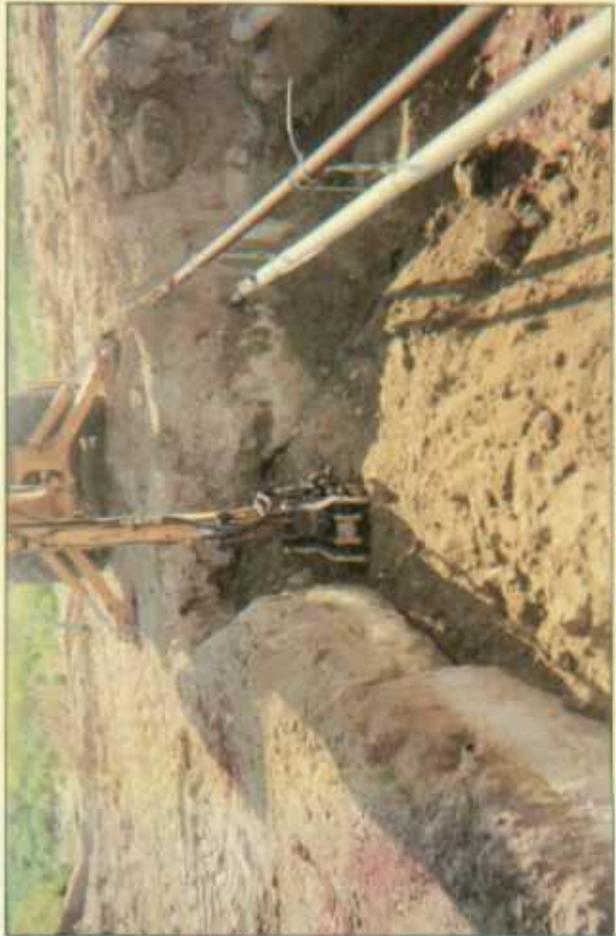
compacting backfill on top of clay

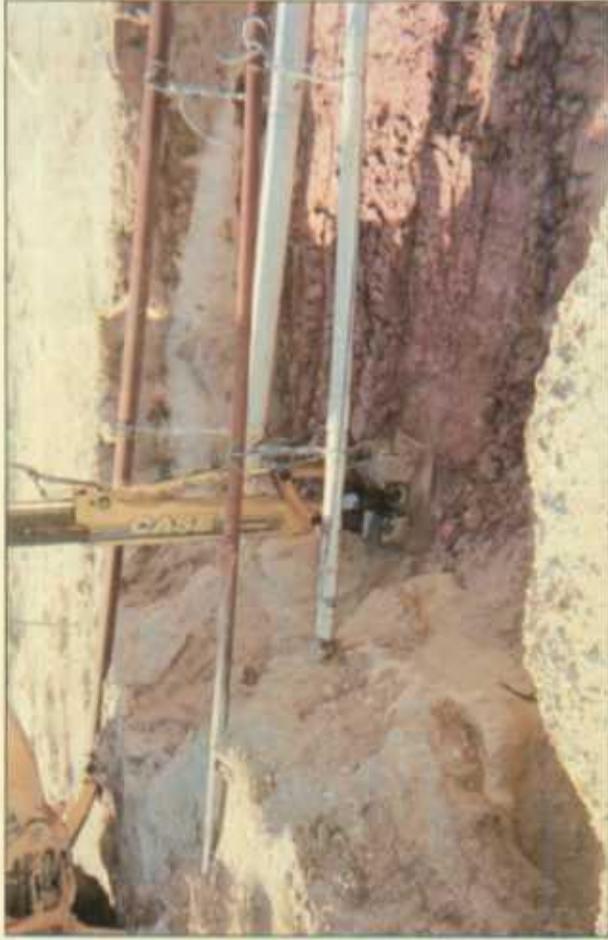
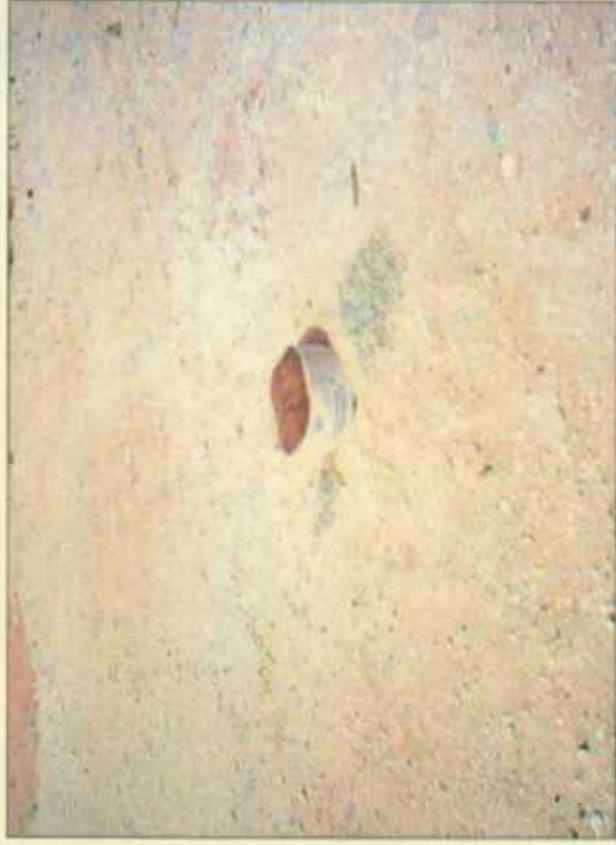
identification plate at backfilled site

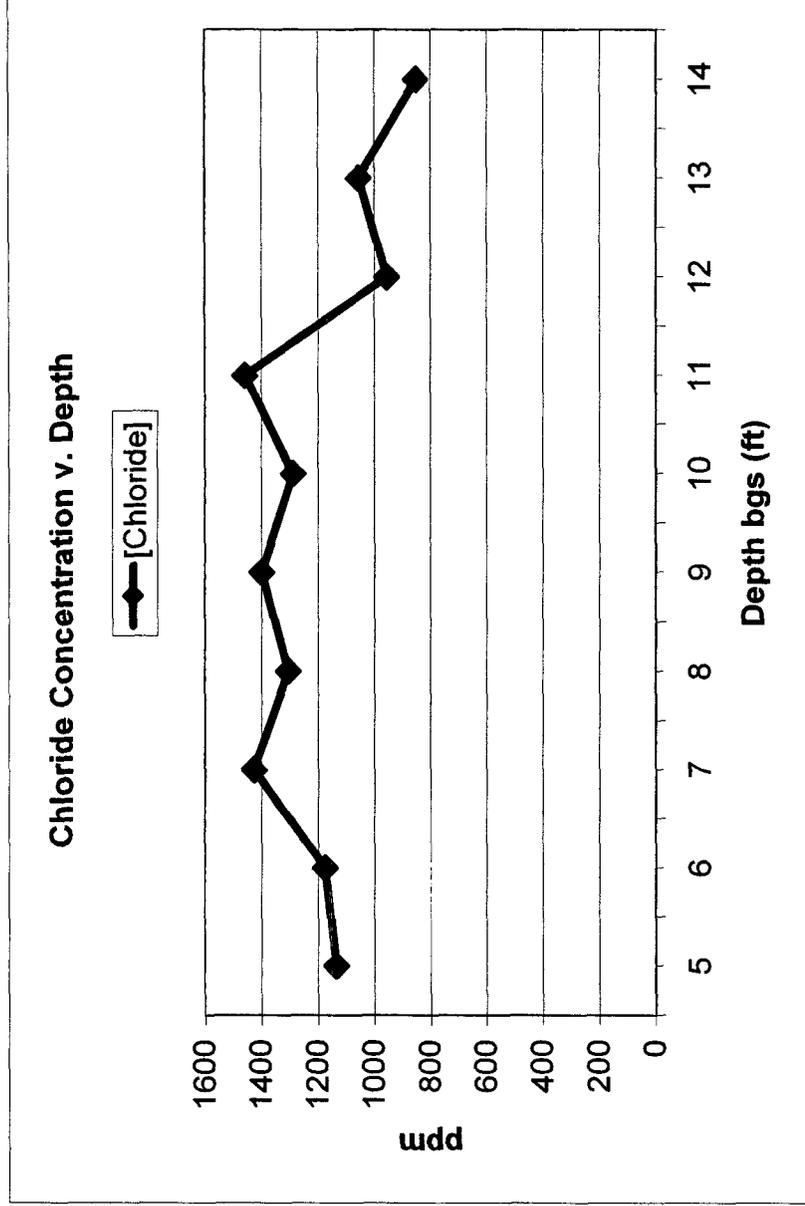
Vertical Delineation at Source

Depth bgs (ft)	[Cl ⁻] ppm
5	1135
6	1176
7	1428
8	1306
9	1400
10	1289
11	1459
12	956
13	1056
14	852

Groundwater = 50 ft

LOCATION	DEPTH (ft)	ppm	
vertical at junction box	5	1135	
	6	1176	
	7	1428	
	8	1306	
	9	1400	
	10	1289	
	11	1459	
	12	956	
	13	1056	
	14	852	
	4-wall comp.	n/a	853
	bottom comp.	12	538
backfill comp.	n/a	553
