EME F-1

**FINAL
REPORT**

**RICE OPERATING COMPANY
JUNCTION BOX FINAL REPORT**

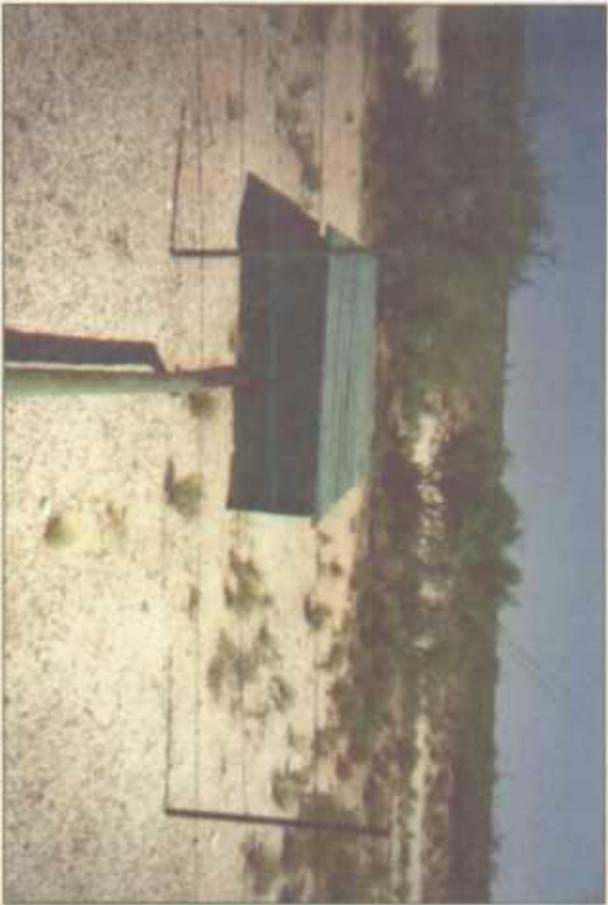
Wooden Junction Box Before NORM Removal 7/25/2003

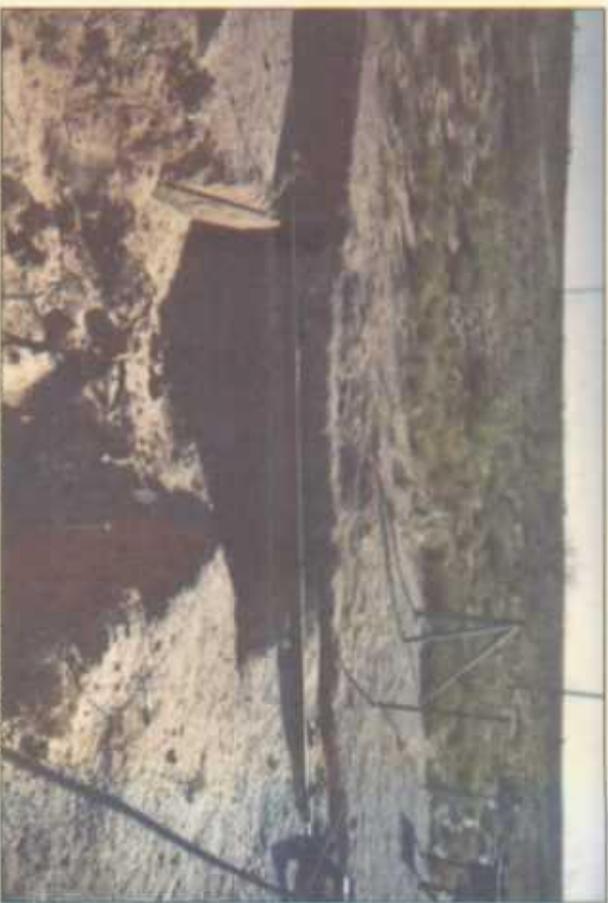
After Wood and NORM Removal 11/18/2003

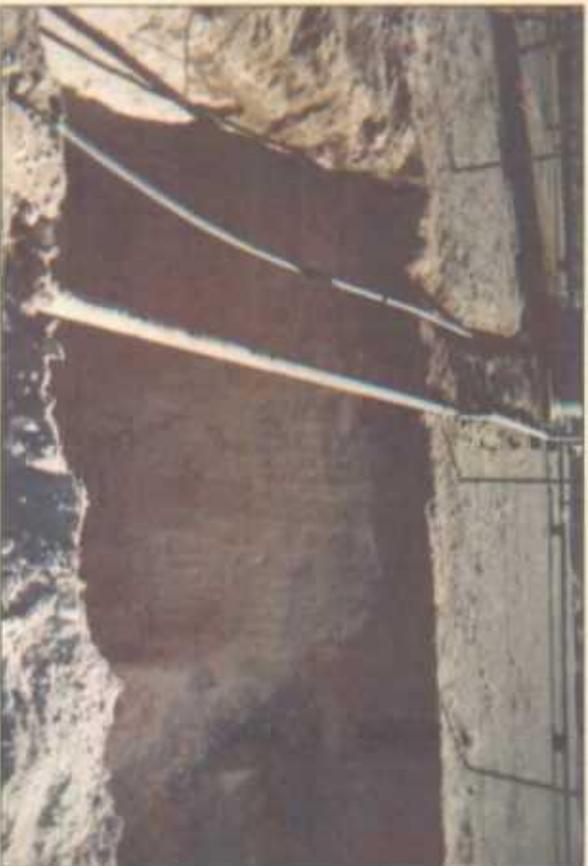
10 x 10 x 9 ft Excavation 11/19/2003

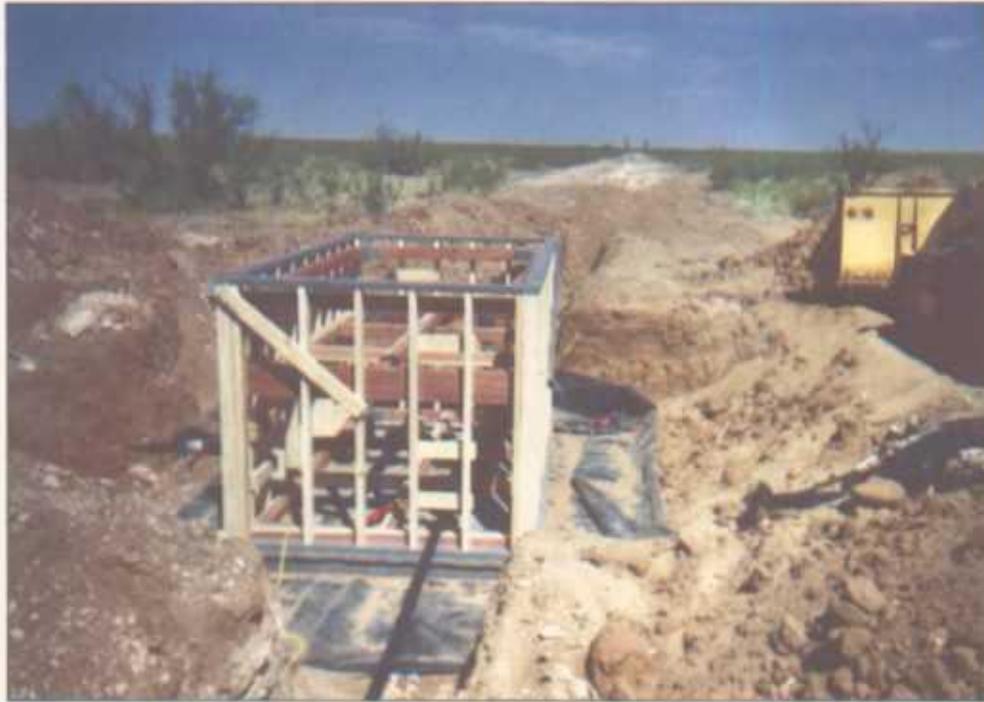
New Junction Box Construction 80 ft North

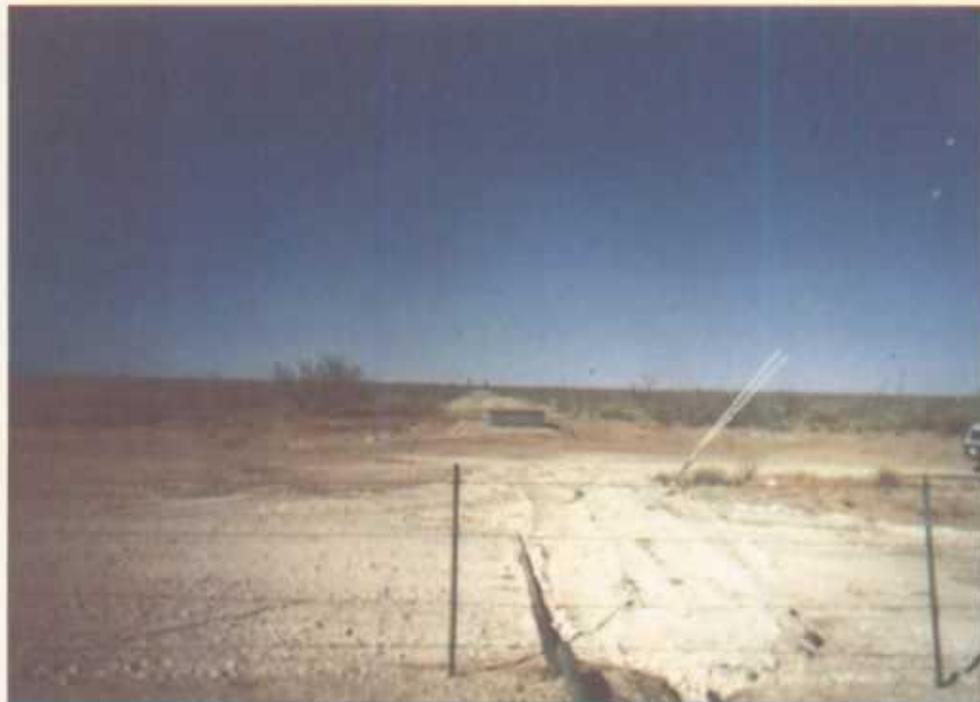
Backfilled Excavation in Foreground
New Junction Box 80 ft North in Background

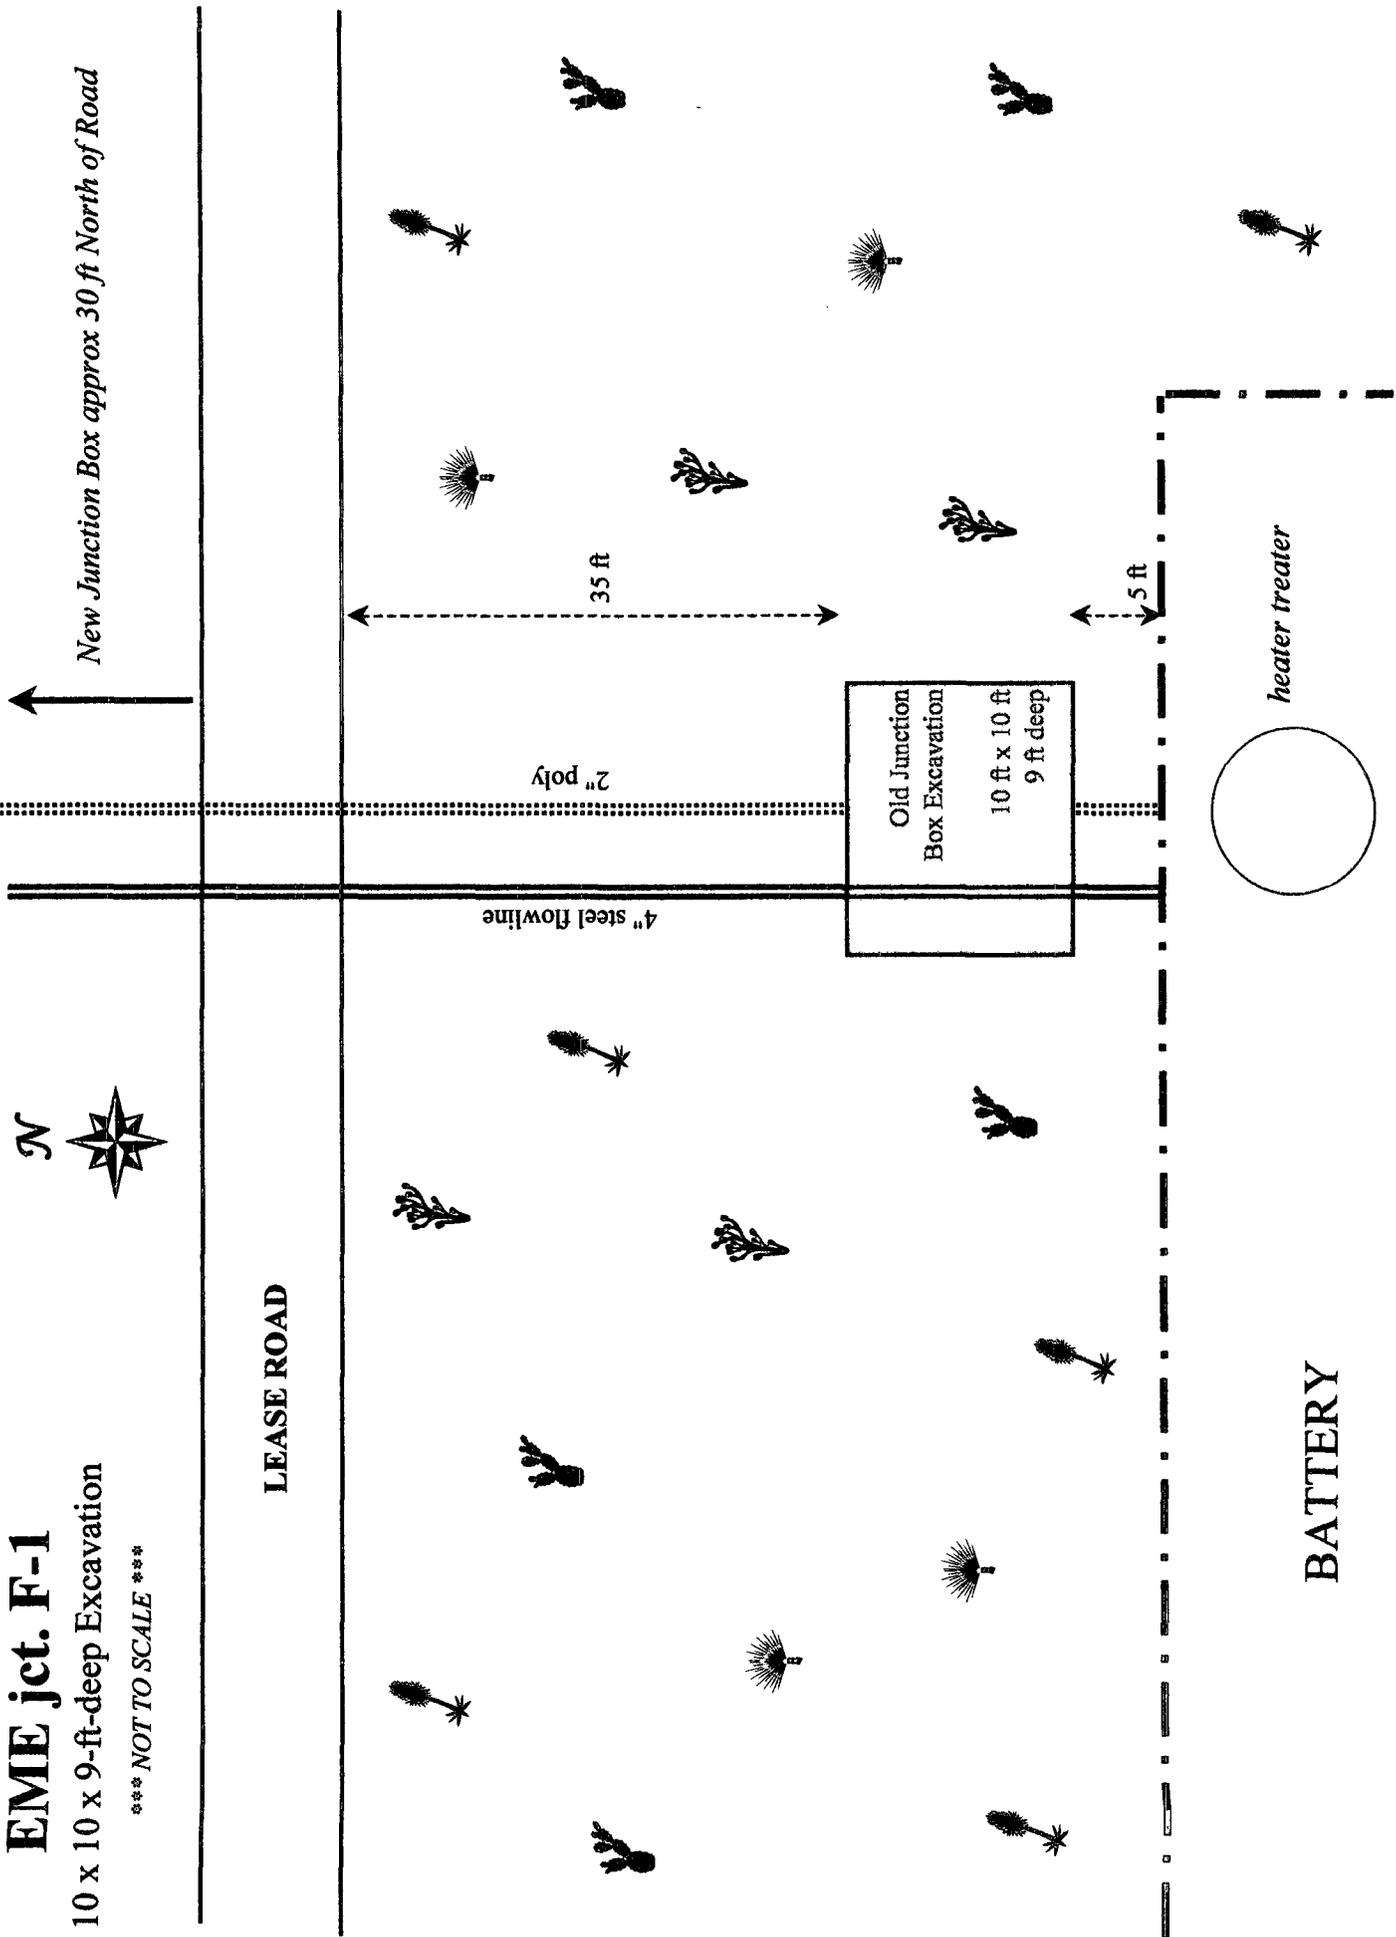
EME jct. F-1

10 x 10 x 9-ft-deep Excavation

New Junction Box approx 30 ft North of Road

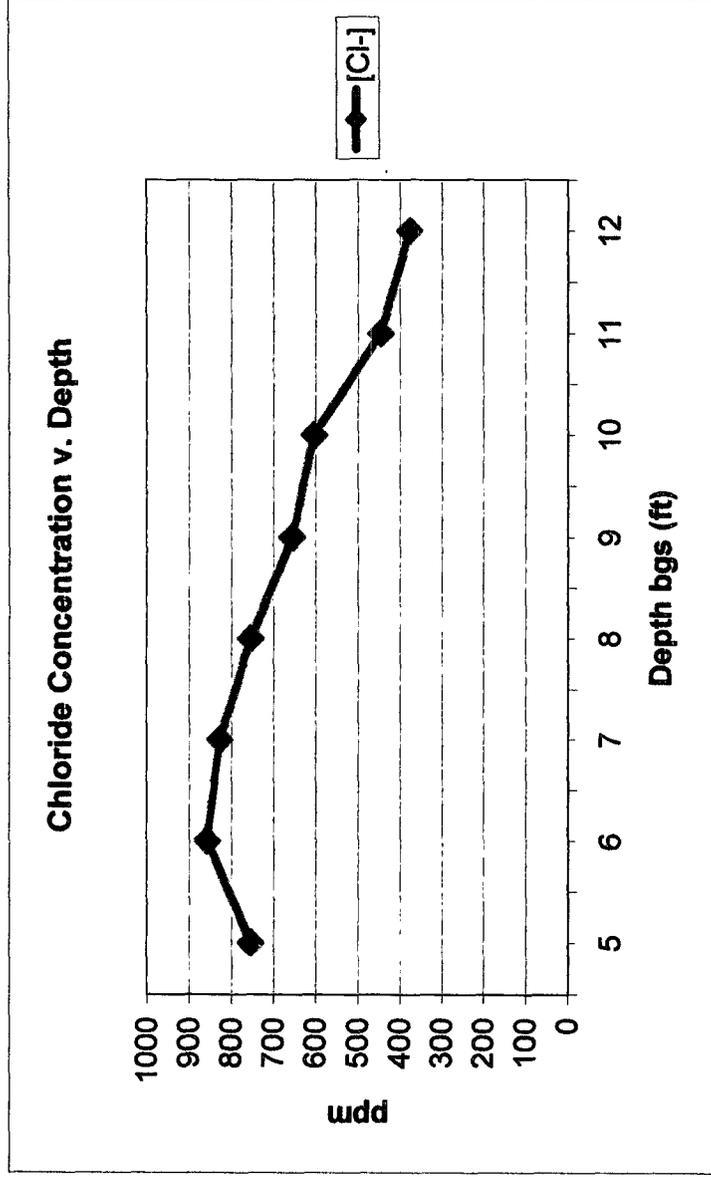
EME jct. F-1
T21S, R35E

Vertical Delineation at Source

Depth bgs (ft)	[Cl ⁻] ppm
5	754
6	858
7	828
8	754
9	655
10	604
11	446
12	377

Groundwater = 133 ft

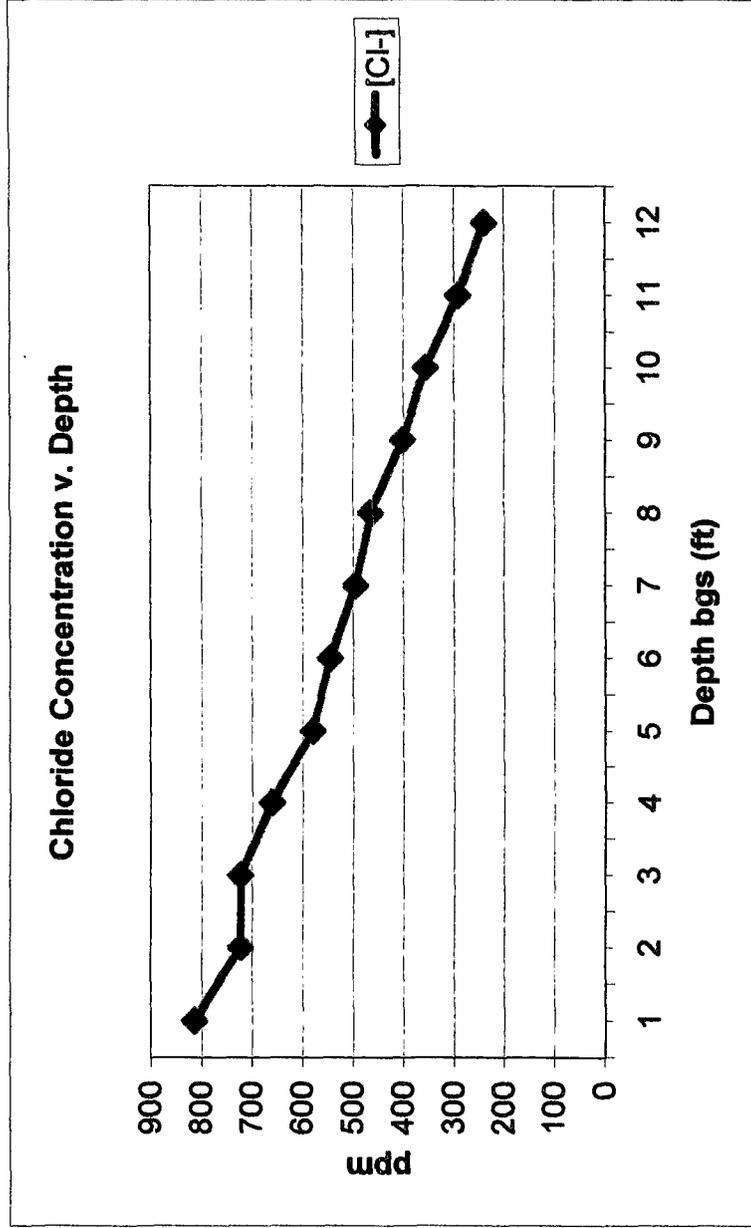
EME jct. F-1

10 ft North of Junction

Depth bgs (ft)	[Cl ⁻] ppm
1	815
2	723
3	723
4	661
5	580
6	546
7	495
8	465
9	402
10	356
11	292
12	239

Groundwater = 133 ft
