**WESTGATE SUBDIVISION,
GRIMES BATTERY and TASKER ROAD
STAGE 1 ABATEMENT PLAN INTERIM REPORT
(SITE ASSESSMENT INVESTIGATION)**

November 1998

**Shell Exploration and Production
Technology Company
Houston, Texas**

**Philip Services Corporation
Midland, Texas**

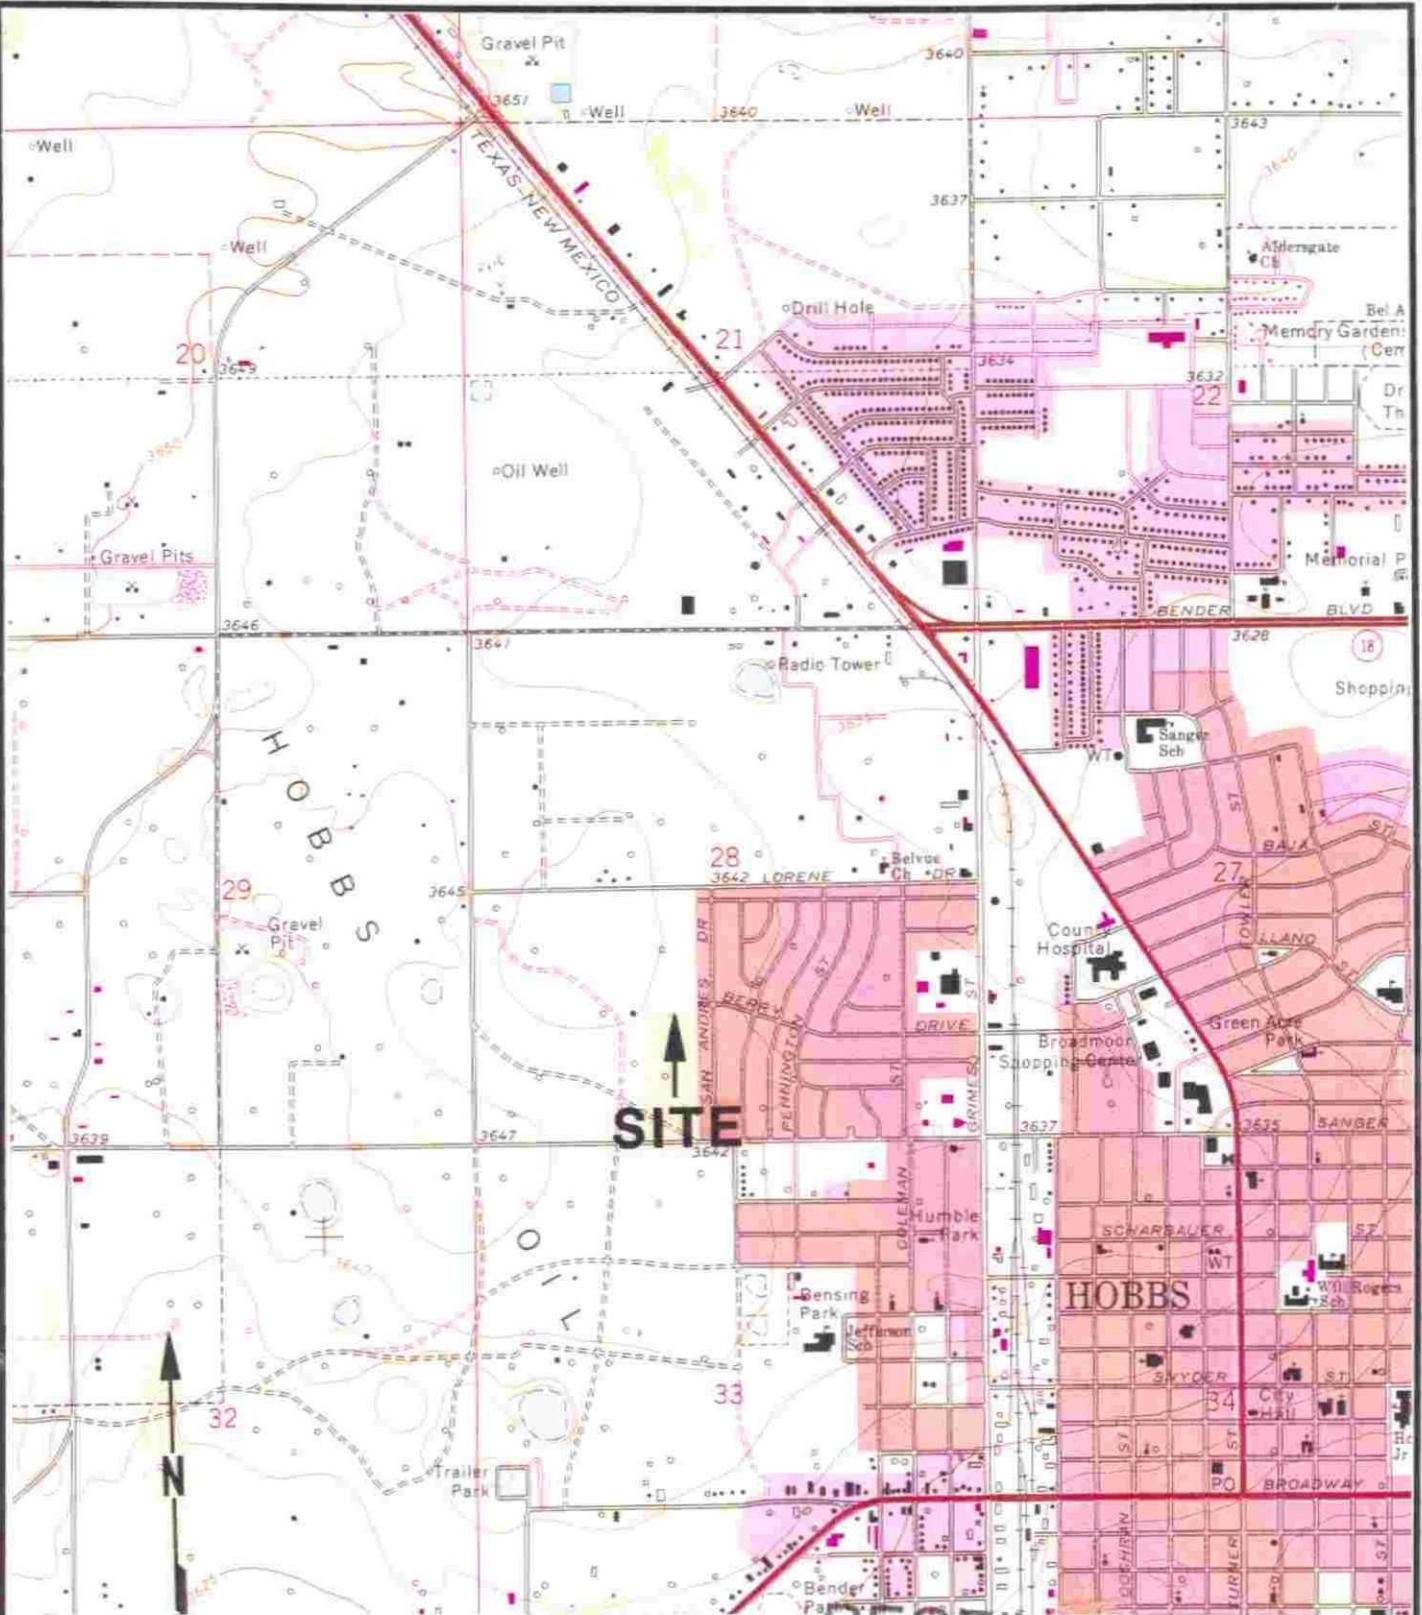
FIGURE 1

HOBBS WEST QUADRANGLE

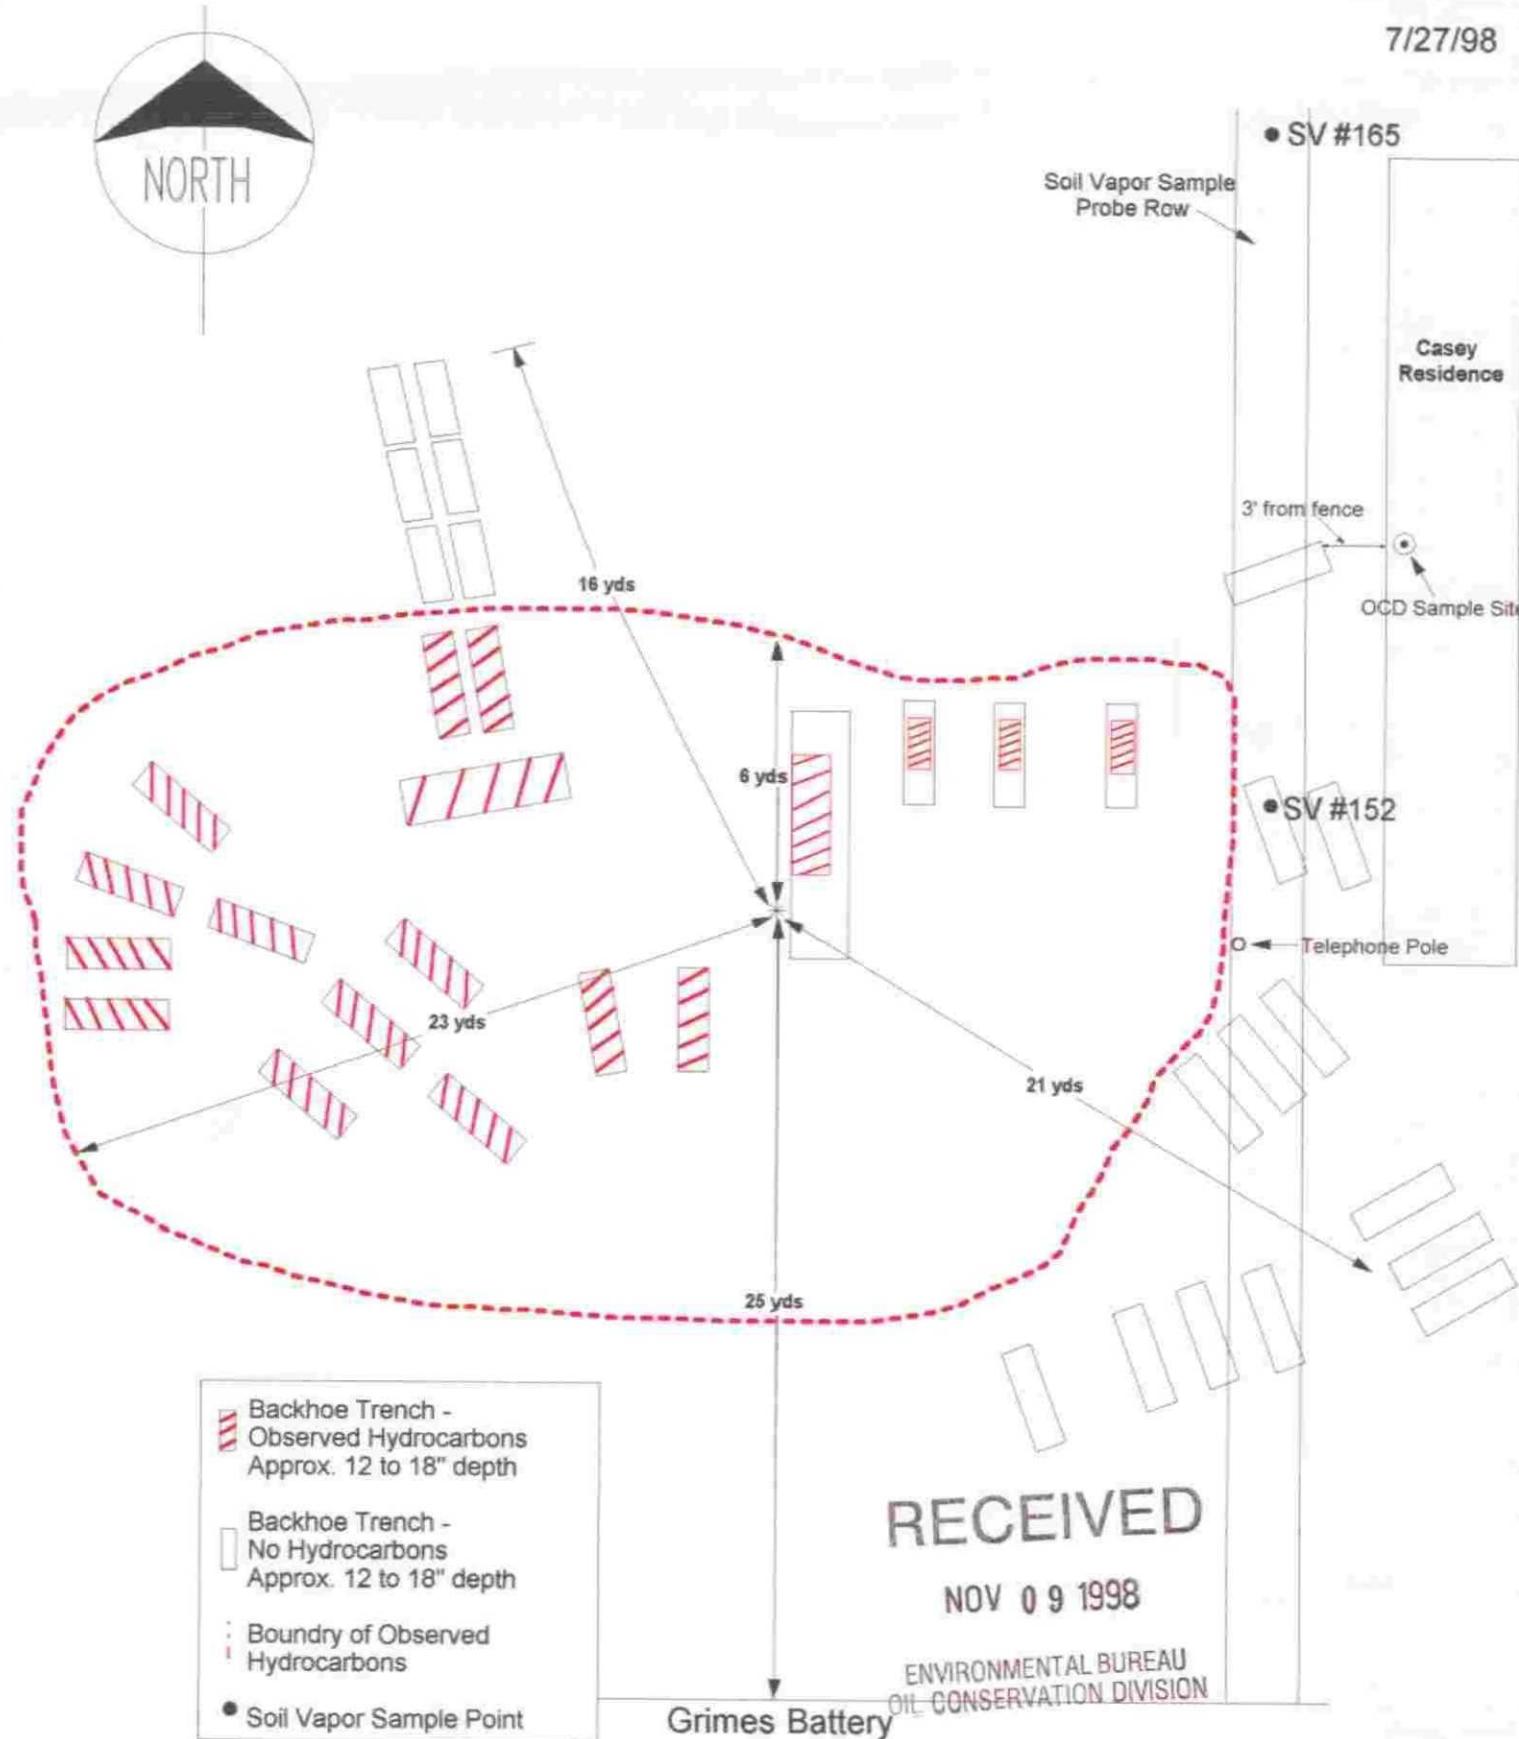
Figure 3

In addition to the sampling performed at this site, the area was trenched using a backhoe in an effort to identify the horizontal extent of the asphaltic material. The extent of asphaltic material as observed in the field is shown in **Figure 3**.

North of Grimes Battery Site
Assessment Map

The area north of the tank battery where stained soil was observed (**Figure 3**) was investigated to delineate the horizontal and vertical extent of organic and inorganic constituents by trenching using a backhoe or other equipment. Three boreholes (GSB-5, GSB-6, and GSB-7) were drilled at this location. Soils were sampled at a depth of 2-3 feet bgs, and at five-foot intervals. Soil samples were screened in the field for VOCs using a PID, and were inspected for the presence of staining or odor. Drilling and sampling continued until no PID readings, staining, and odor were observed. The sample collected at a depth of 2-3 feet bgs, the sample exhibiting the highest PID reading, and the sample collected from the bottom of the borehole were submitted for laboratory analysis for compounds listed in New Mexico Water Quality Control Commission, Title 20, Chapter 6, Part 2, Sections 3-103 and 1-101 (20 NMAC 6.2 3-103 and 1-101) as requested by the NMOCD. Laboratory analysis of these compounds was performed using USEPA methods 8260, 8270, 8080, 8081A, 150.1, 160.1, 200.7, 245.1, 335.2, 340.2, 353.3, and 418.1.

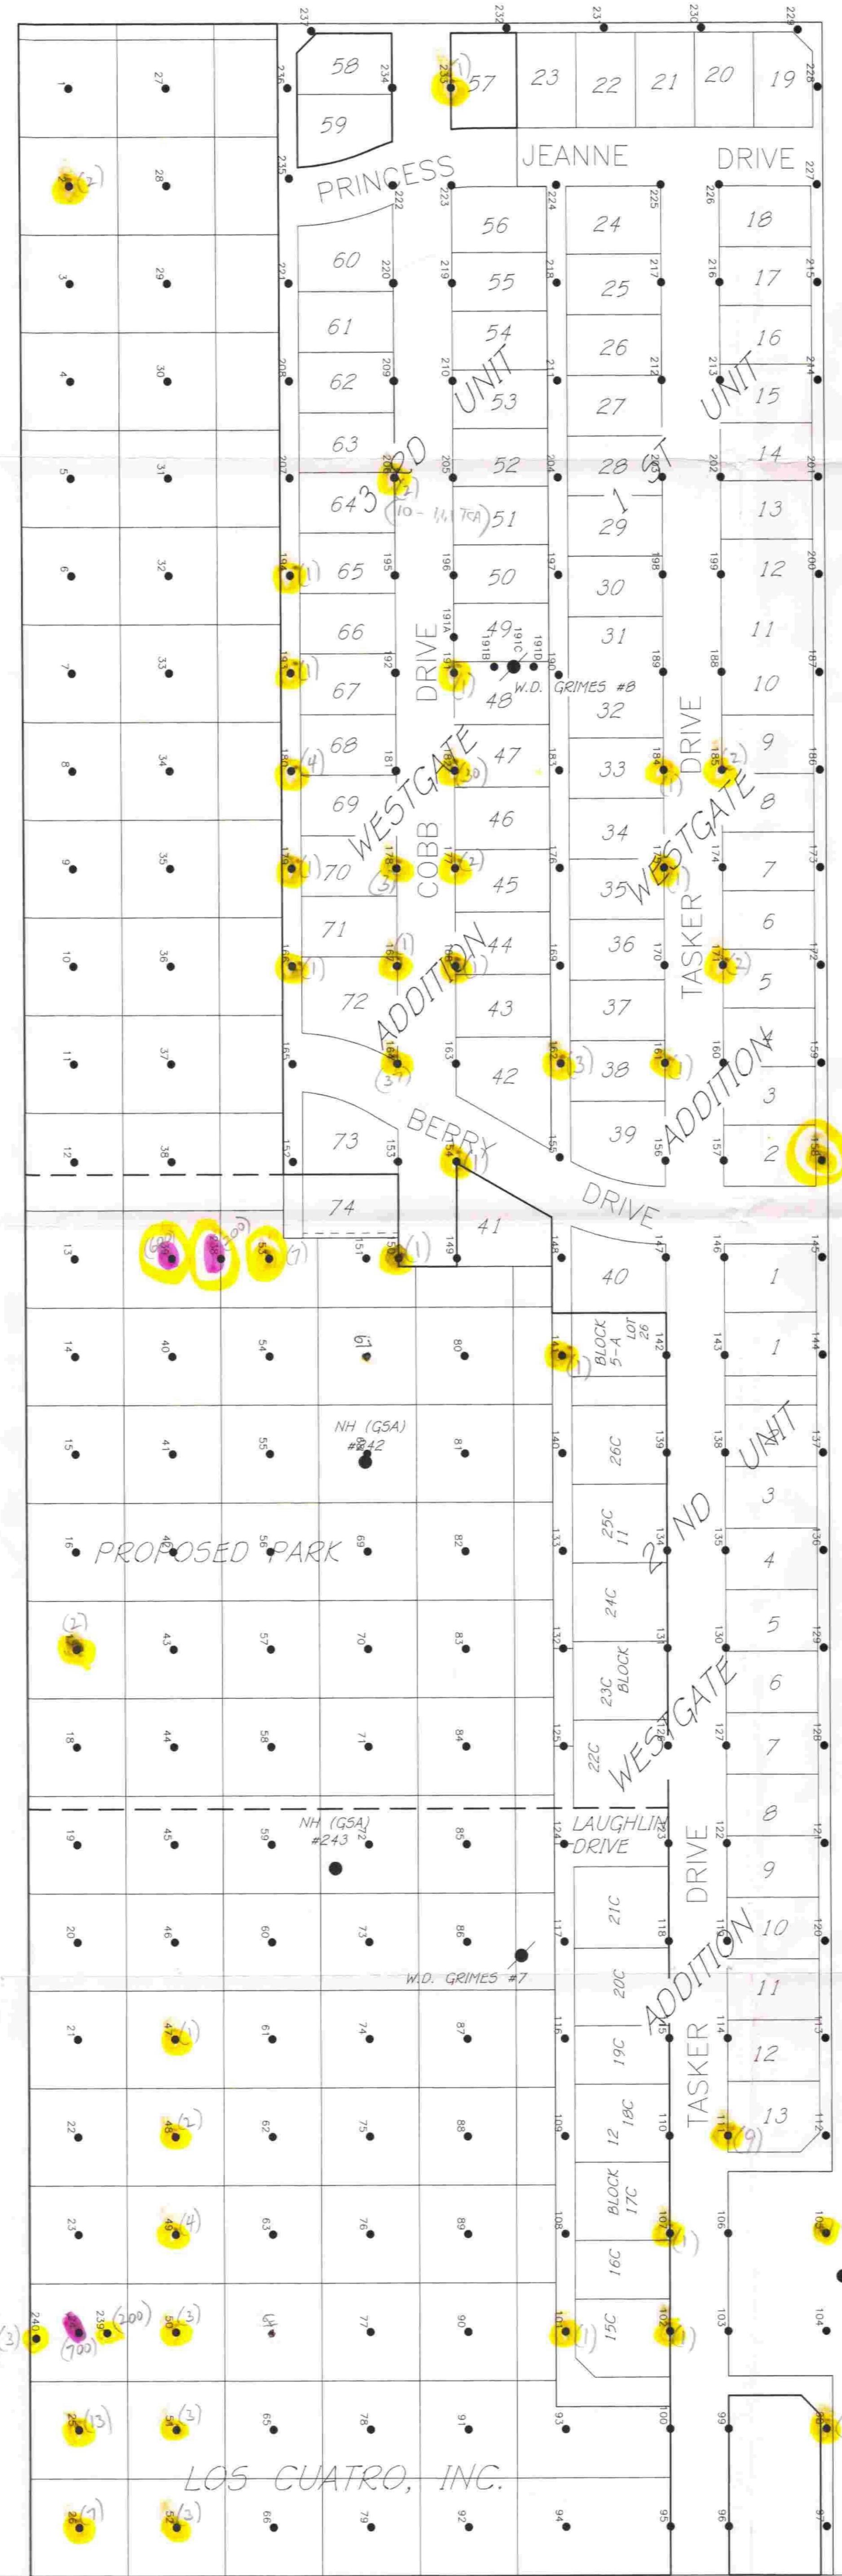
Surveyed By: LAWLESS	Drawn By: J.P./PHC	Last Rev.: 3/9/98
Date Begn: 2/11/98	Date End: 3/12/98	Sheet No.: 1
Project #: 69411038	Volume: 0000-48	Scale: 1" = 60'
FIGURE 4

A soil gas survey utilizing Direct Push Technology (DPT) was conducted by BBC International, Inc. and Transglobal Environmental GeoSampling/GeoChemistry in the Westgate Subdivision (comprised of both developed and undeveloped land). The survey was conducted from July 27, 1998 to August 20, 1998. The sample locations were spaced at 100 foot intervals across the subject area and in areas of possible former operations (**Figures 4 and 5**).

SOIL VAPOR SURVEY SAMPLE POINTS-100 FOOT GRID SPACING
FIRST, SECOND, AND THIRD UNITS OF RESIDENTIAL ADDITIONS
LOCATED IN THE WEST HALF OF SECTION 36
TOWNSHIP 18 SOUTH, RANGE 38 EAST, N.M.P.M.
LEA COUNTY, NEW MEXICO

A total of 268 soil vapor samples were collected at a depth of five feet below ground surface. The samples were analyzed in the field using a mobile laboratory for Volatile Aromatic and Halogenated Hydrocarbons (14 Analytes, EPA Method 8021) and TPH, Methane, Ethane, Propane, Butane, Pentane, and Hexane (EPA Method 8015 modified). Soil gas analytical results are discussed below in Section 5.1.

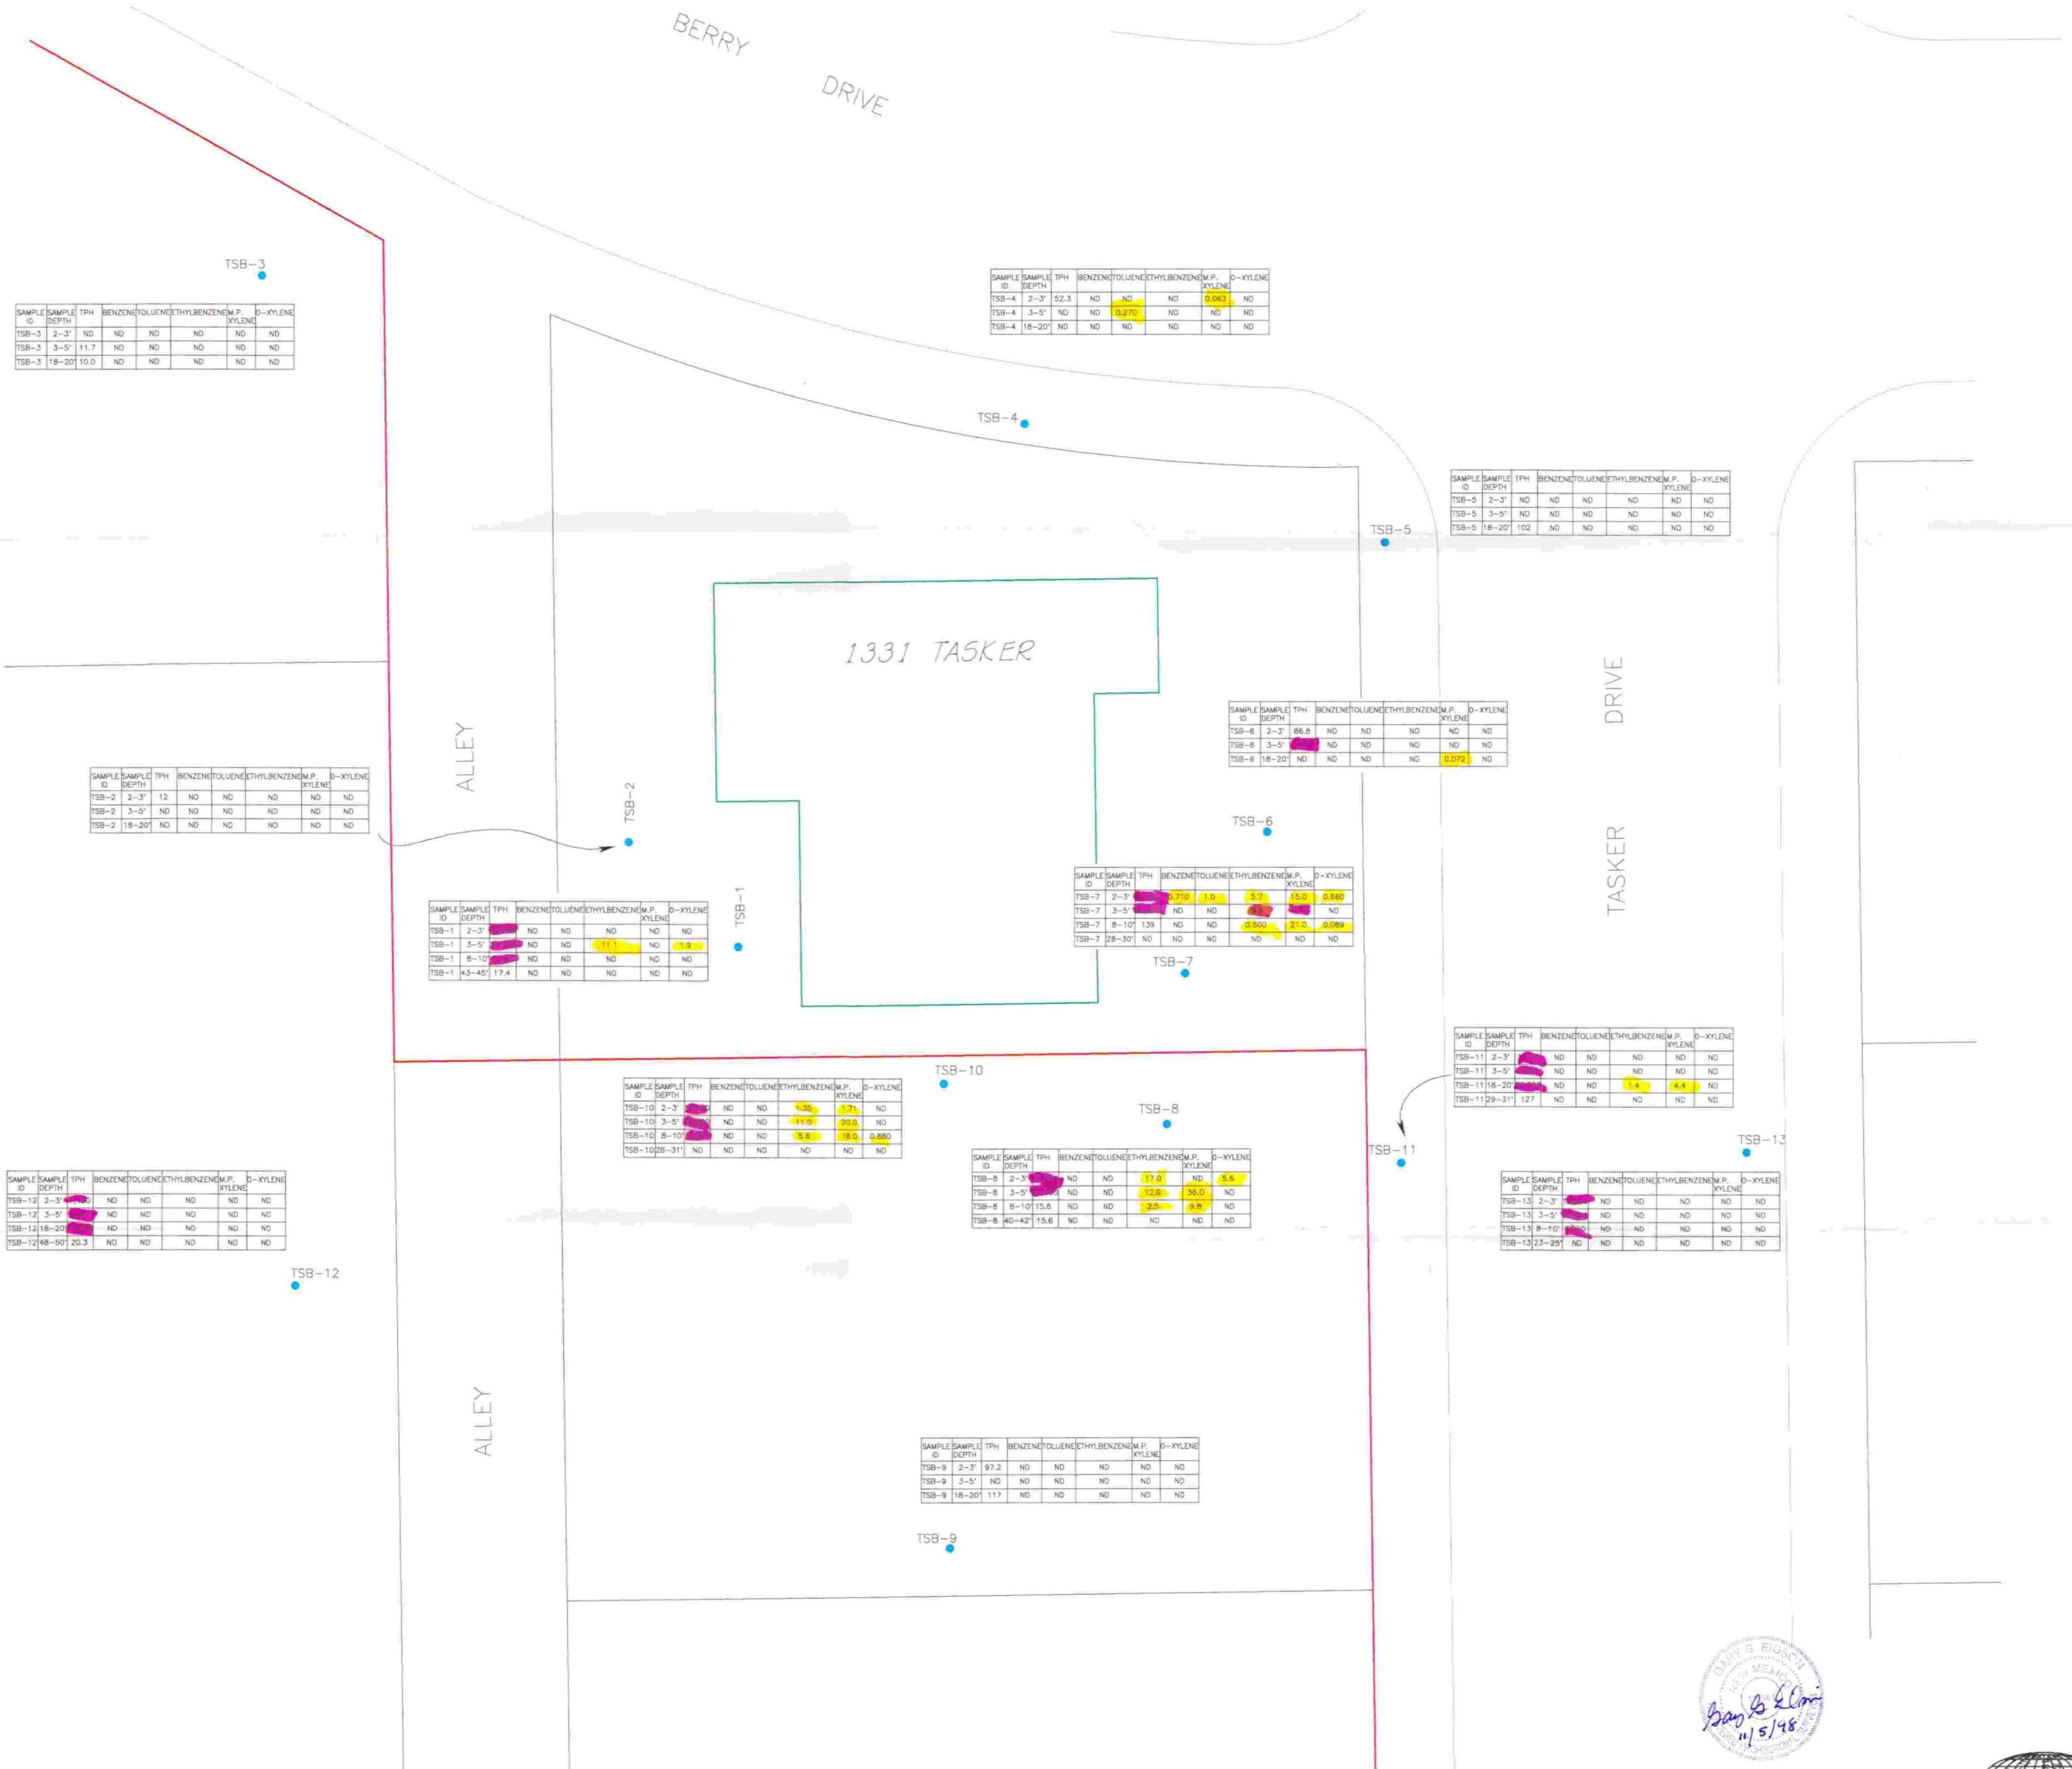
FIGURE 11

TPH and BTEX analytical results are shown on **Figures 10 and 11**.

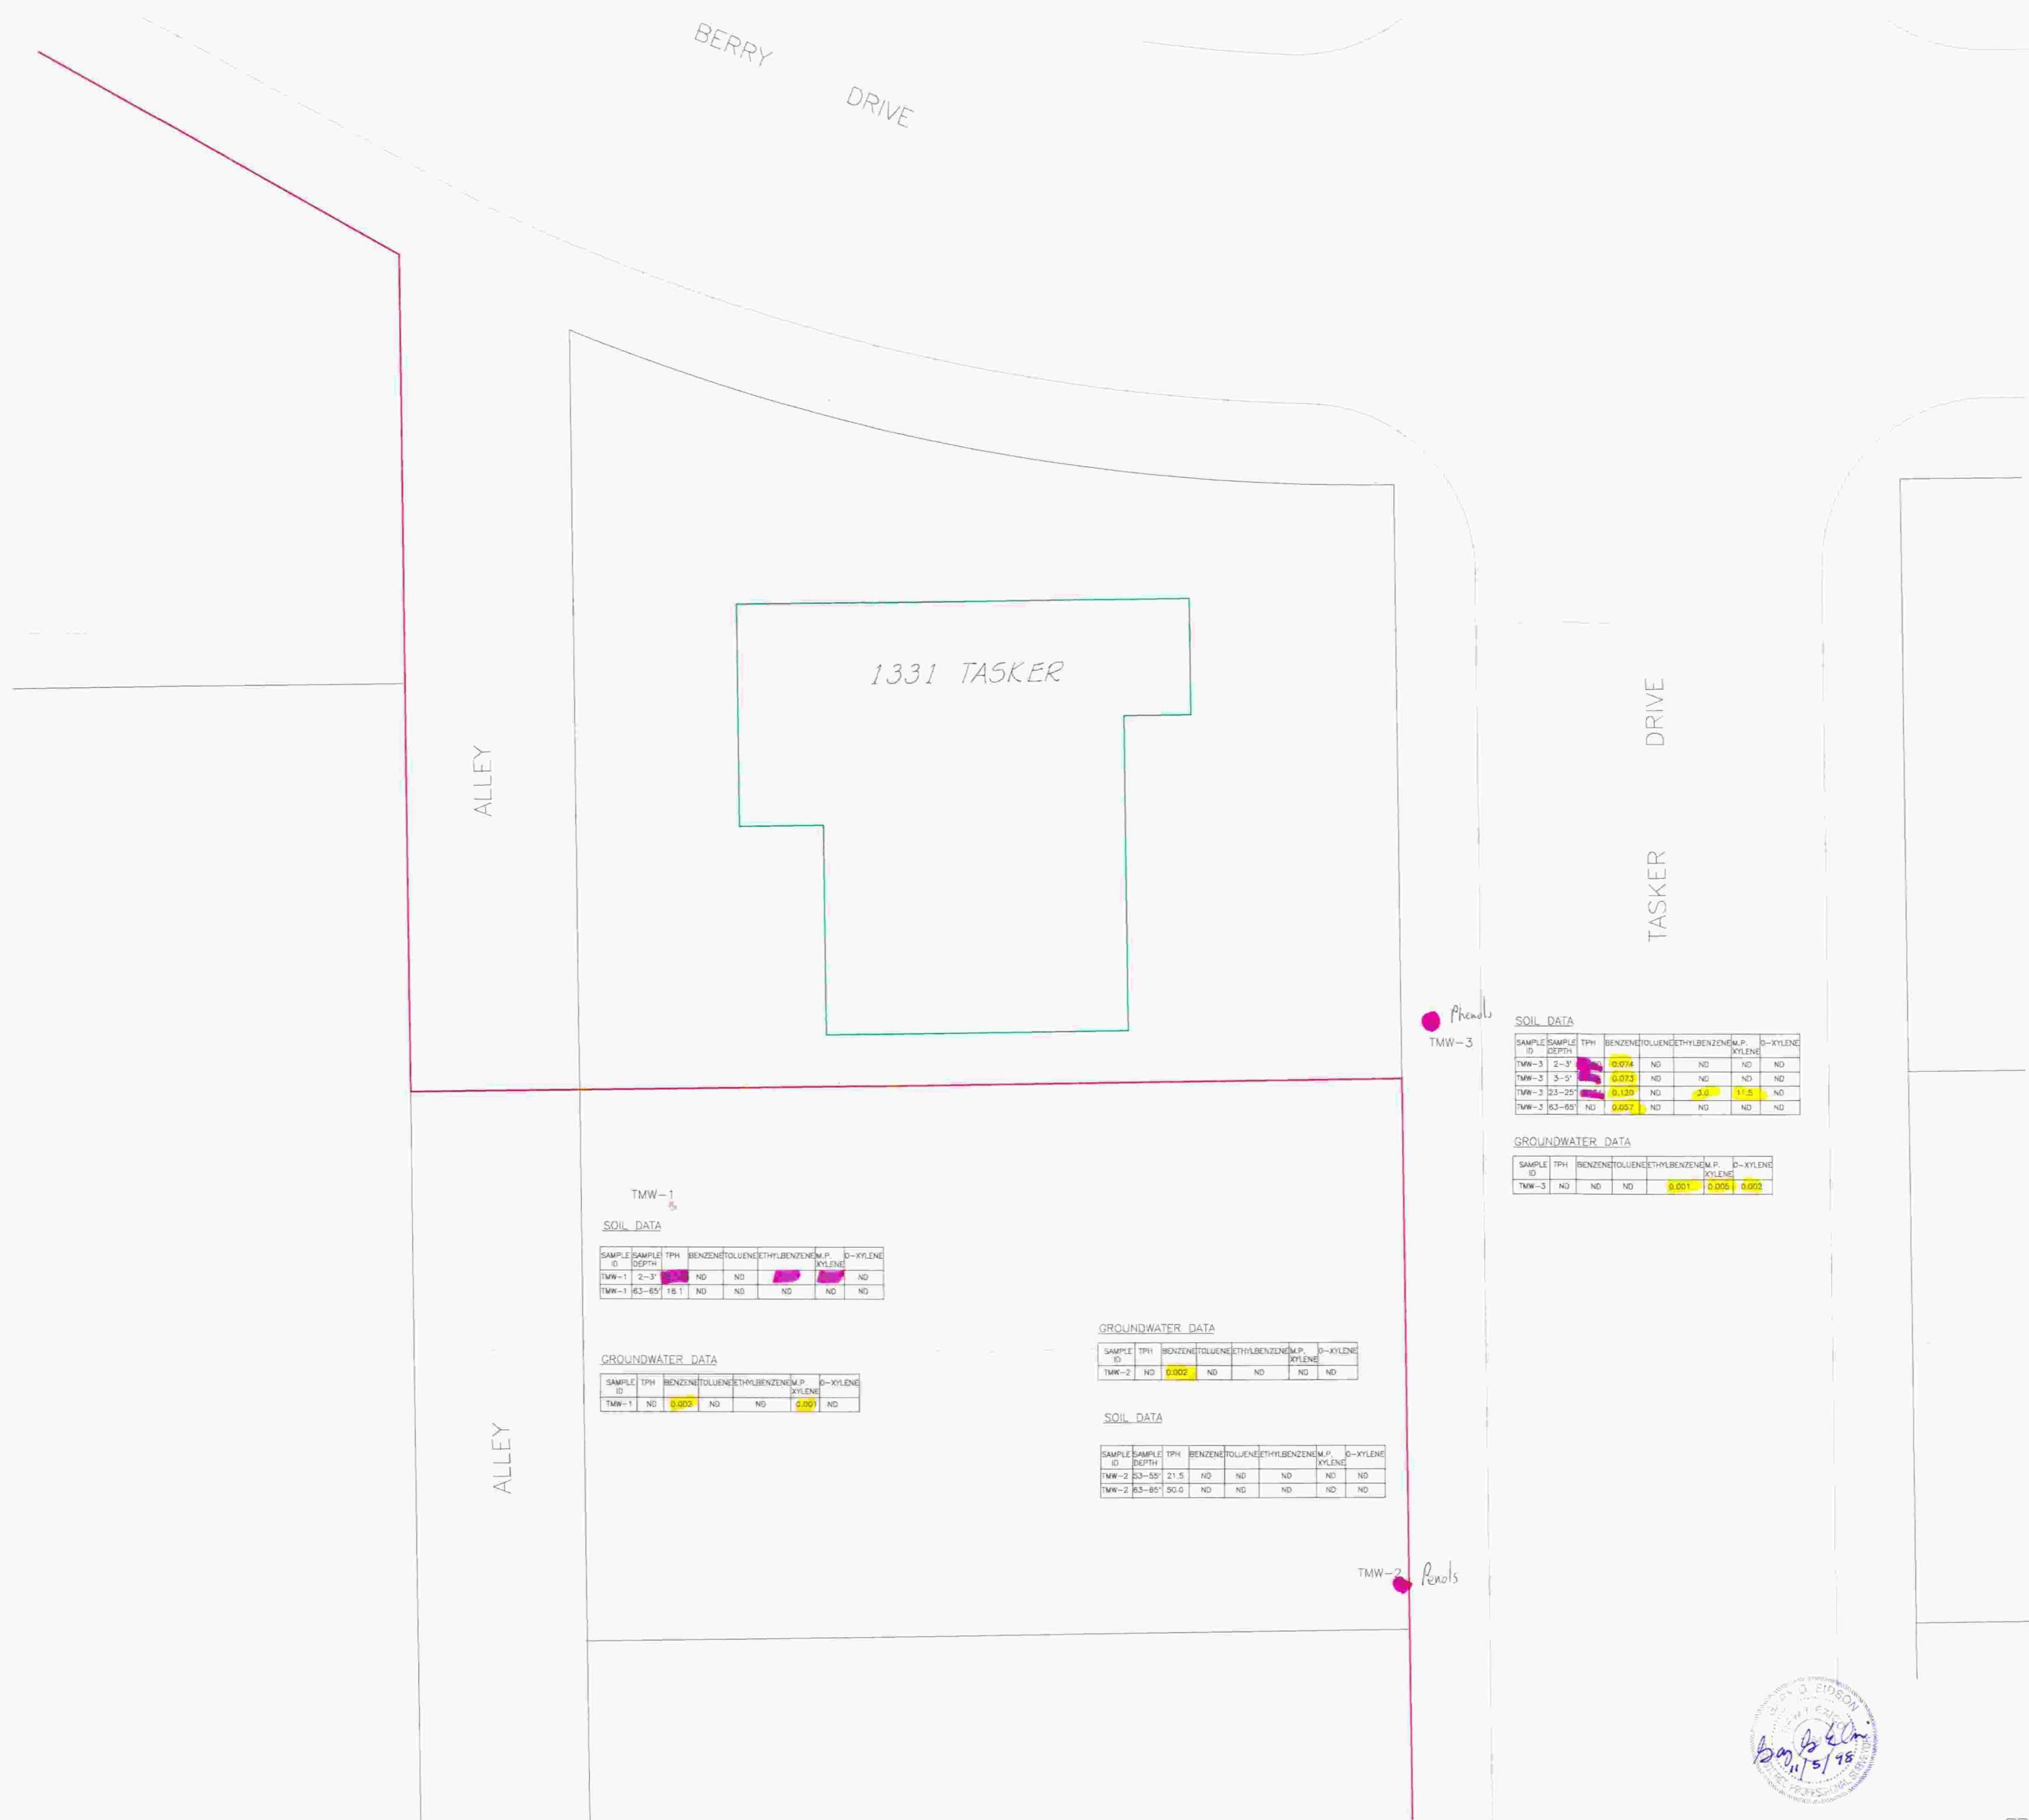
FIGURE 13

Depth to groundwater at the subject site is approximately 65 feet bgs. Groundwater elevations measured in thirteen monitor wells are shown in **Figures 12 and 13** and **Table 1**.

TPH and BTEX analytical results are shown on **Figures 12 and 13**.

MONITOR WELLS WITH TPH & BTEX DATA
(SOILS AND GROUNDWATER)
IN SECTION 28
TOWNSHIP 18 SOUTH,
RANGE 38 EAST, N.M.P.M.,
LEA COUNTY, NEW MEXICO.

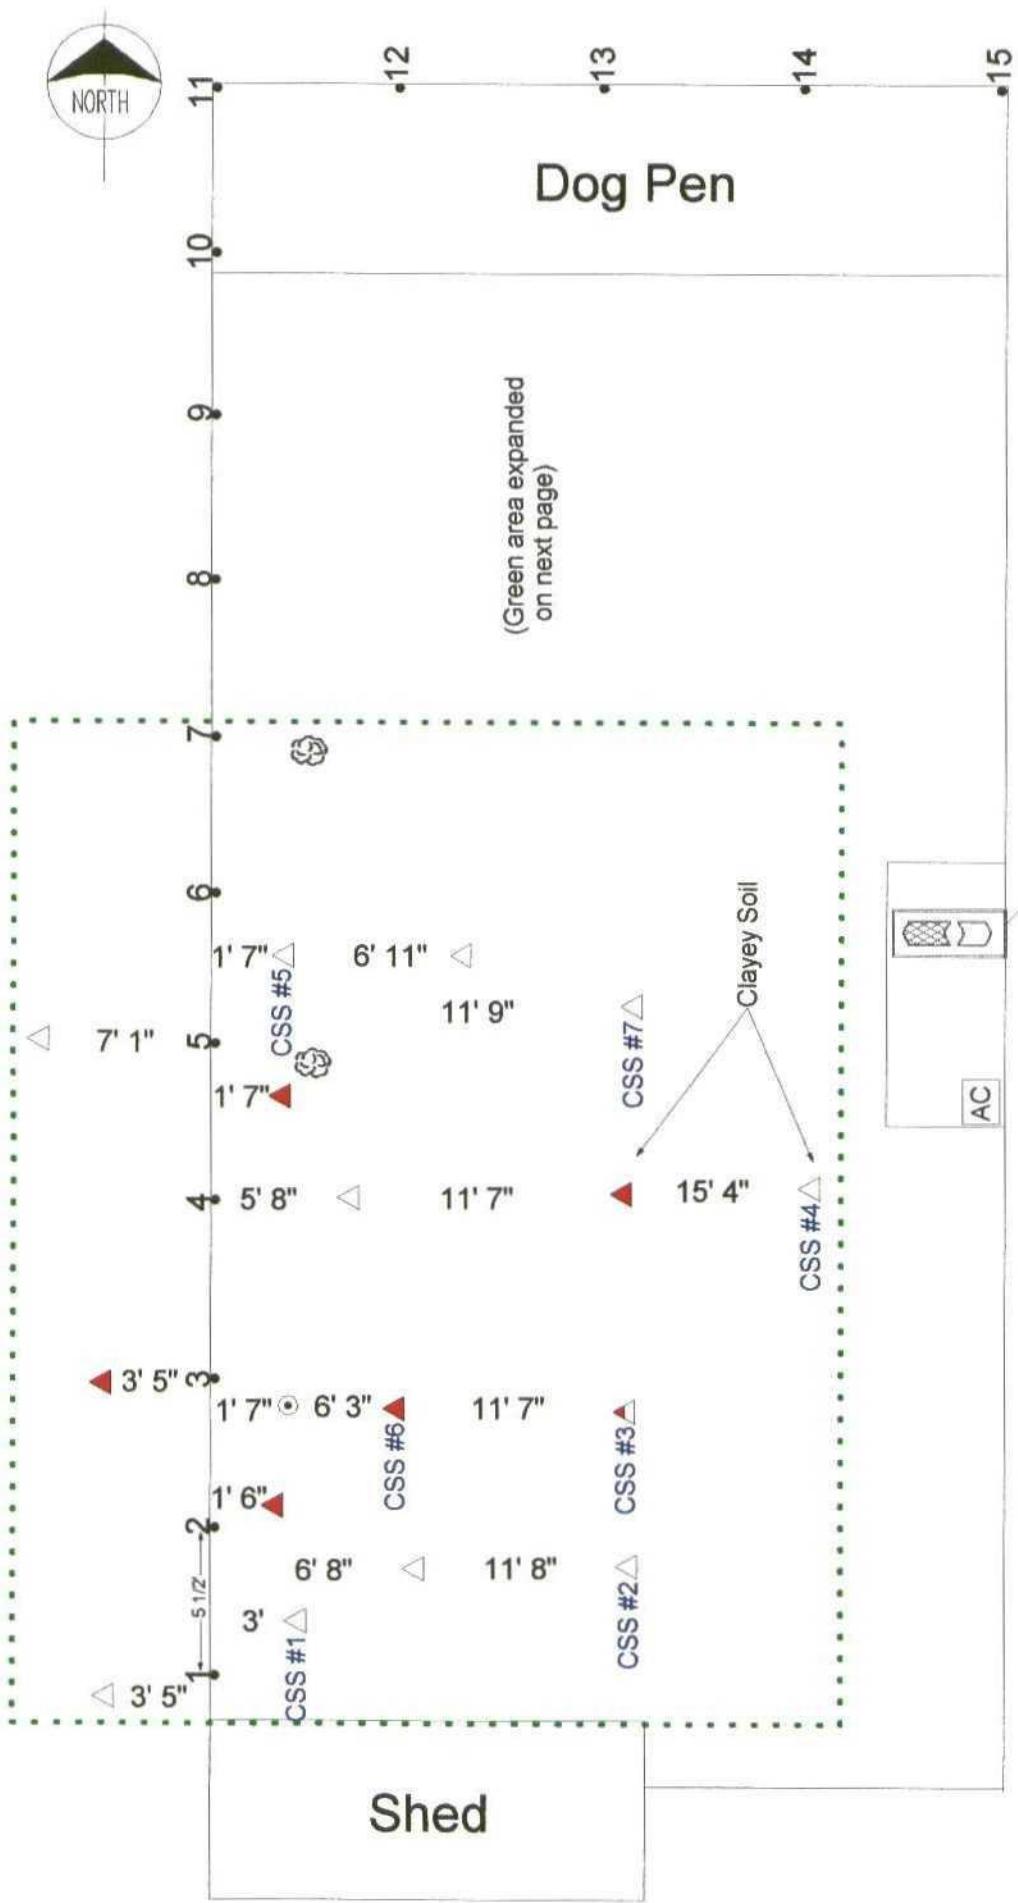
△ No Hydrocarbons	CSS = Sample Point
▲ Hydrocarbons	#1 - TPH, BTEX
● OCD Sample Site	#2 - TPH, BTEX
● Fence Post	#3 - TPH, BTEX
● Bush	#4 - TPH, BTEX
	#5 - TPH, BTEX
	#6 - Full Suite of Tests
	#7 - TPH, BTEX

Measurements = Distance from boring to fence
Average Depth of Boring = 3 feet
Depth of Hydrocarbon Layer = 8-12 inches from Surface
Average Hydrocarbon Layer Thickness = 1-2 inches

The backyard of the residence located at 1341 North Cobb Street (**Figure 6**) was investigated using auguring techniques to delineate the horizontal and vertical extent of organic and inorganic constituents.. Auguring was employed rather than drilling of a borehole due to restricted access for a drilling rig. As necessary to delineate the extent of organic and inorganic constituents., soil samples were collected by auger, screened in the field for volatile organic compounds (VOC's) using a photoionization detector (PID), and were inspected for the presence of staining or odor. Sampling continued until no PID readings, staining, and odors were observed.

Seven samples were collected from backyard of the residence located at 1341 North Cobb Street (**Figure 6**) and were submitted for laboratory analysis. The sample exhibiting the highest PID reading (CSS #6) was submitted for laboratory analysis for compounds listed in New Mexico Water Quality Control Commission, Title 20, Chapter 6, Part 2, sections 3-103 and 1-101 (20 NMAC 6.2 3-103 and 1-101) as requested by the NMOCDD. Laboratory analysis of these compounds was performed using USEPA methods 8260, 8270, 8080, 8081A, 150.1, 160.1, 200.7, 245.1, 335.2, 340.2, 353.3, and 418.1.
