Incident ID	NRM2003858408
District RP	
Facility ID	
Application ID

Site Name	Lakewood Federal #1	Site Type	Well pad
Date Release Discovered	July 20, 2019	API# (if applicable)	30-015-24231

RE: **Closure Report**
Lakewood Federal #1 Release
Unit O Section 34, T19S, R25E, Eddy County, New Mexico
Terracon Project No. AR197257

**Closure Report
Lakewood Federal #1 Release
Unit O Section 34, Township 19 South, Range 25 East
Eddy County, New Mexico
NMOCD Reference No.
Terracon Project No. AR197257
October 18, 2019**

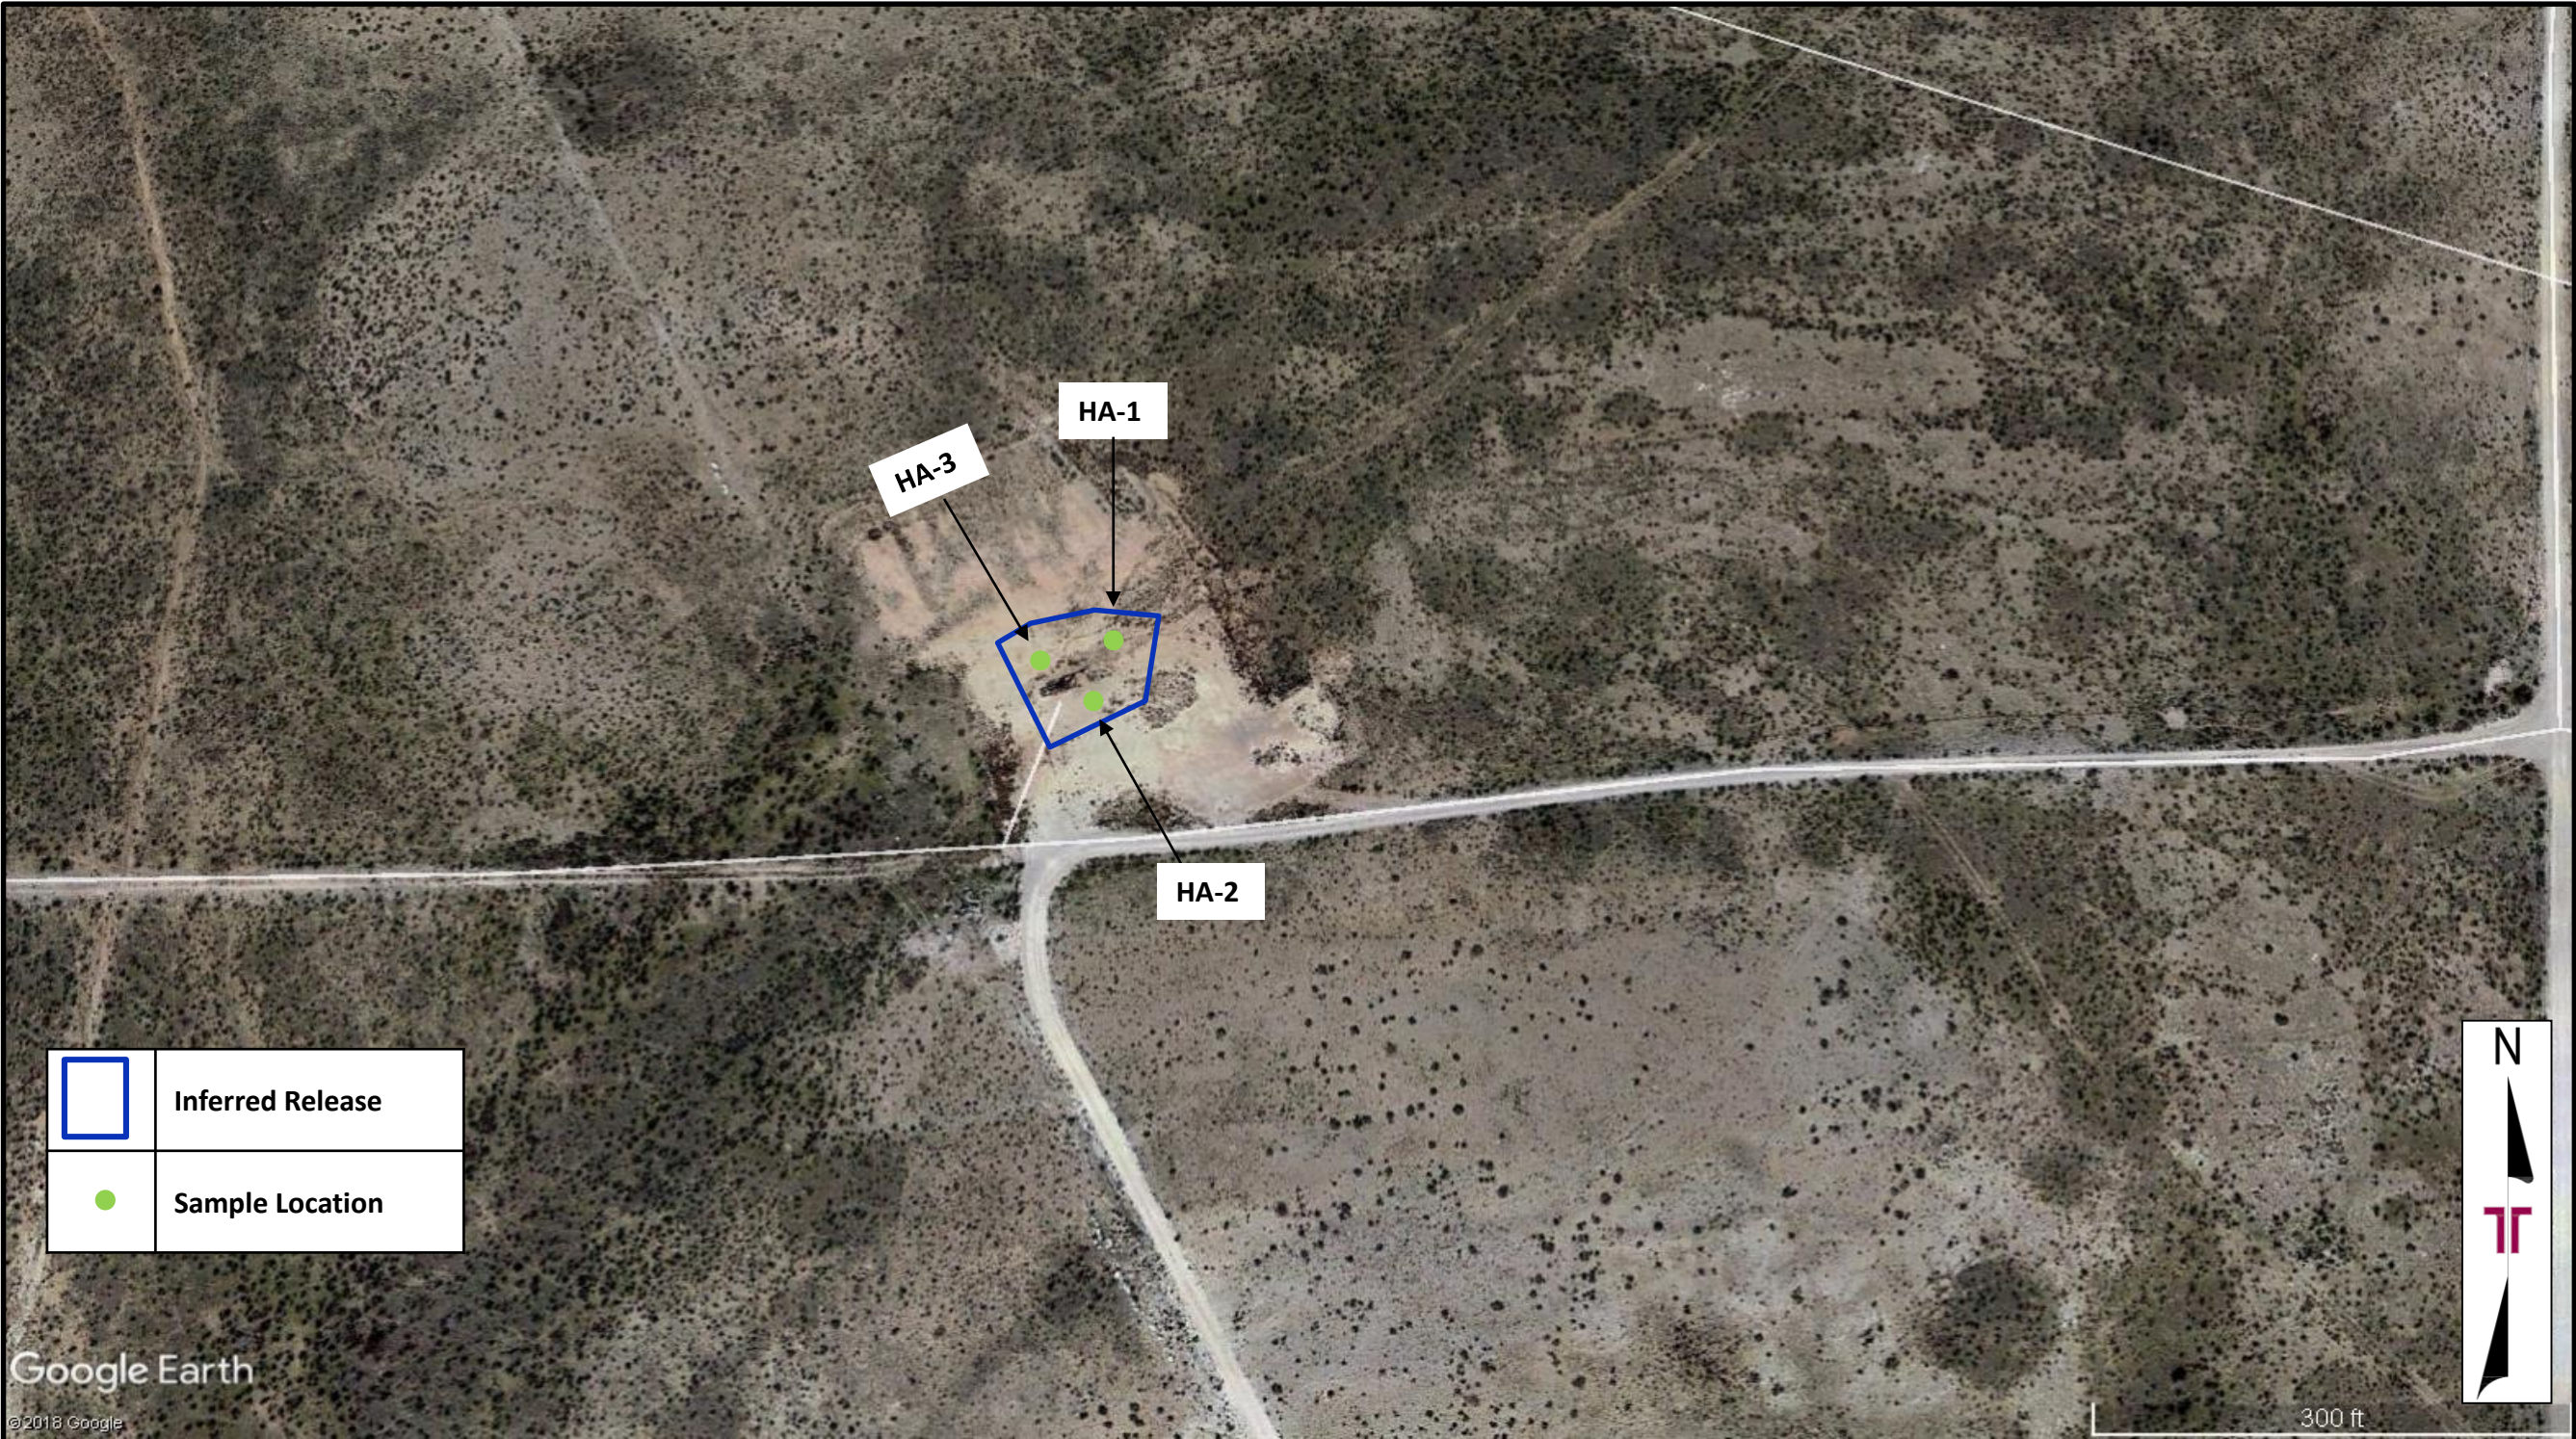
Project No.	AR197257	<div>Figure 2 – Site Diagram</div> <div>Lakewood Federal #1</div> <div>32.6114693°, -104.470482°</div> <div>Eddy County, New Mexico</div>	
Scale:	As Shown		
Source:	Google Earth		
Date:	2016		
<div>Terracon</div> <div>Consulting Engineers & Scientists</div> <div>5827 50th St. Suite 1 PH. (806) 300-0104</div> <div>Lubbock, Texas 79424 FAX. (806) 797 0947</div>

The site is an approximate 0.8-acre tract of land within the Unit O Section 34, Township 19 South, Range 25 East, Eddy County, New Mexico (hereinafter, the site). The site consists primarily of undeveloped land except for a Oil Well and the construction of a saltwater disposal (SWD) facility to the West. A Topographic Map illustrating the site location is included as Figure 1 and a Site Plan is included as Figure 2 in Appendix A.

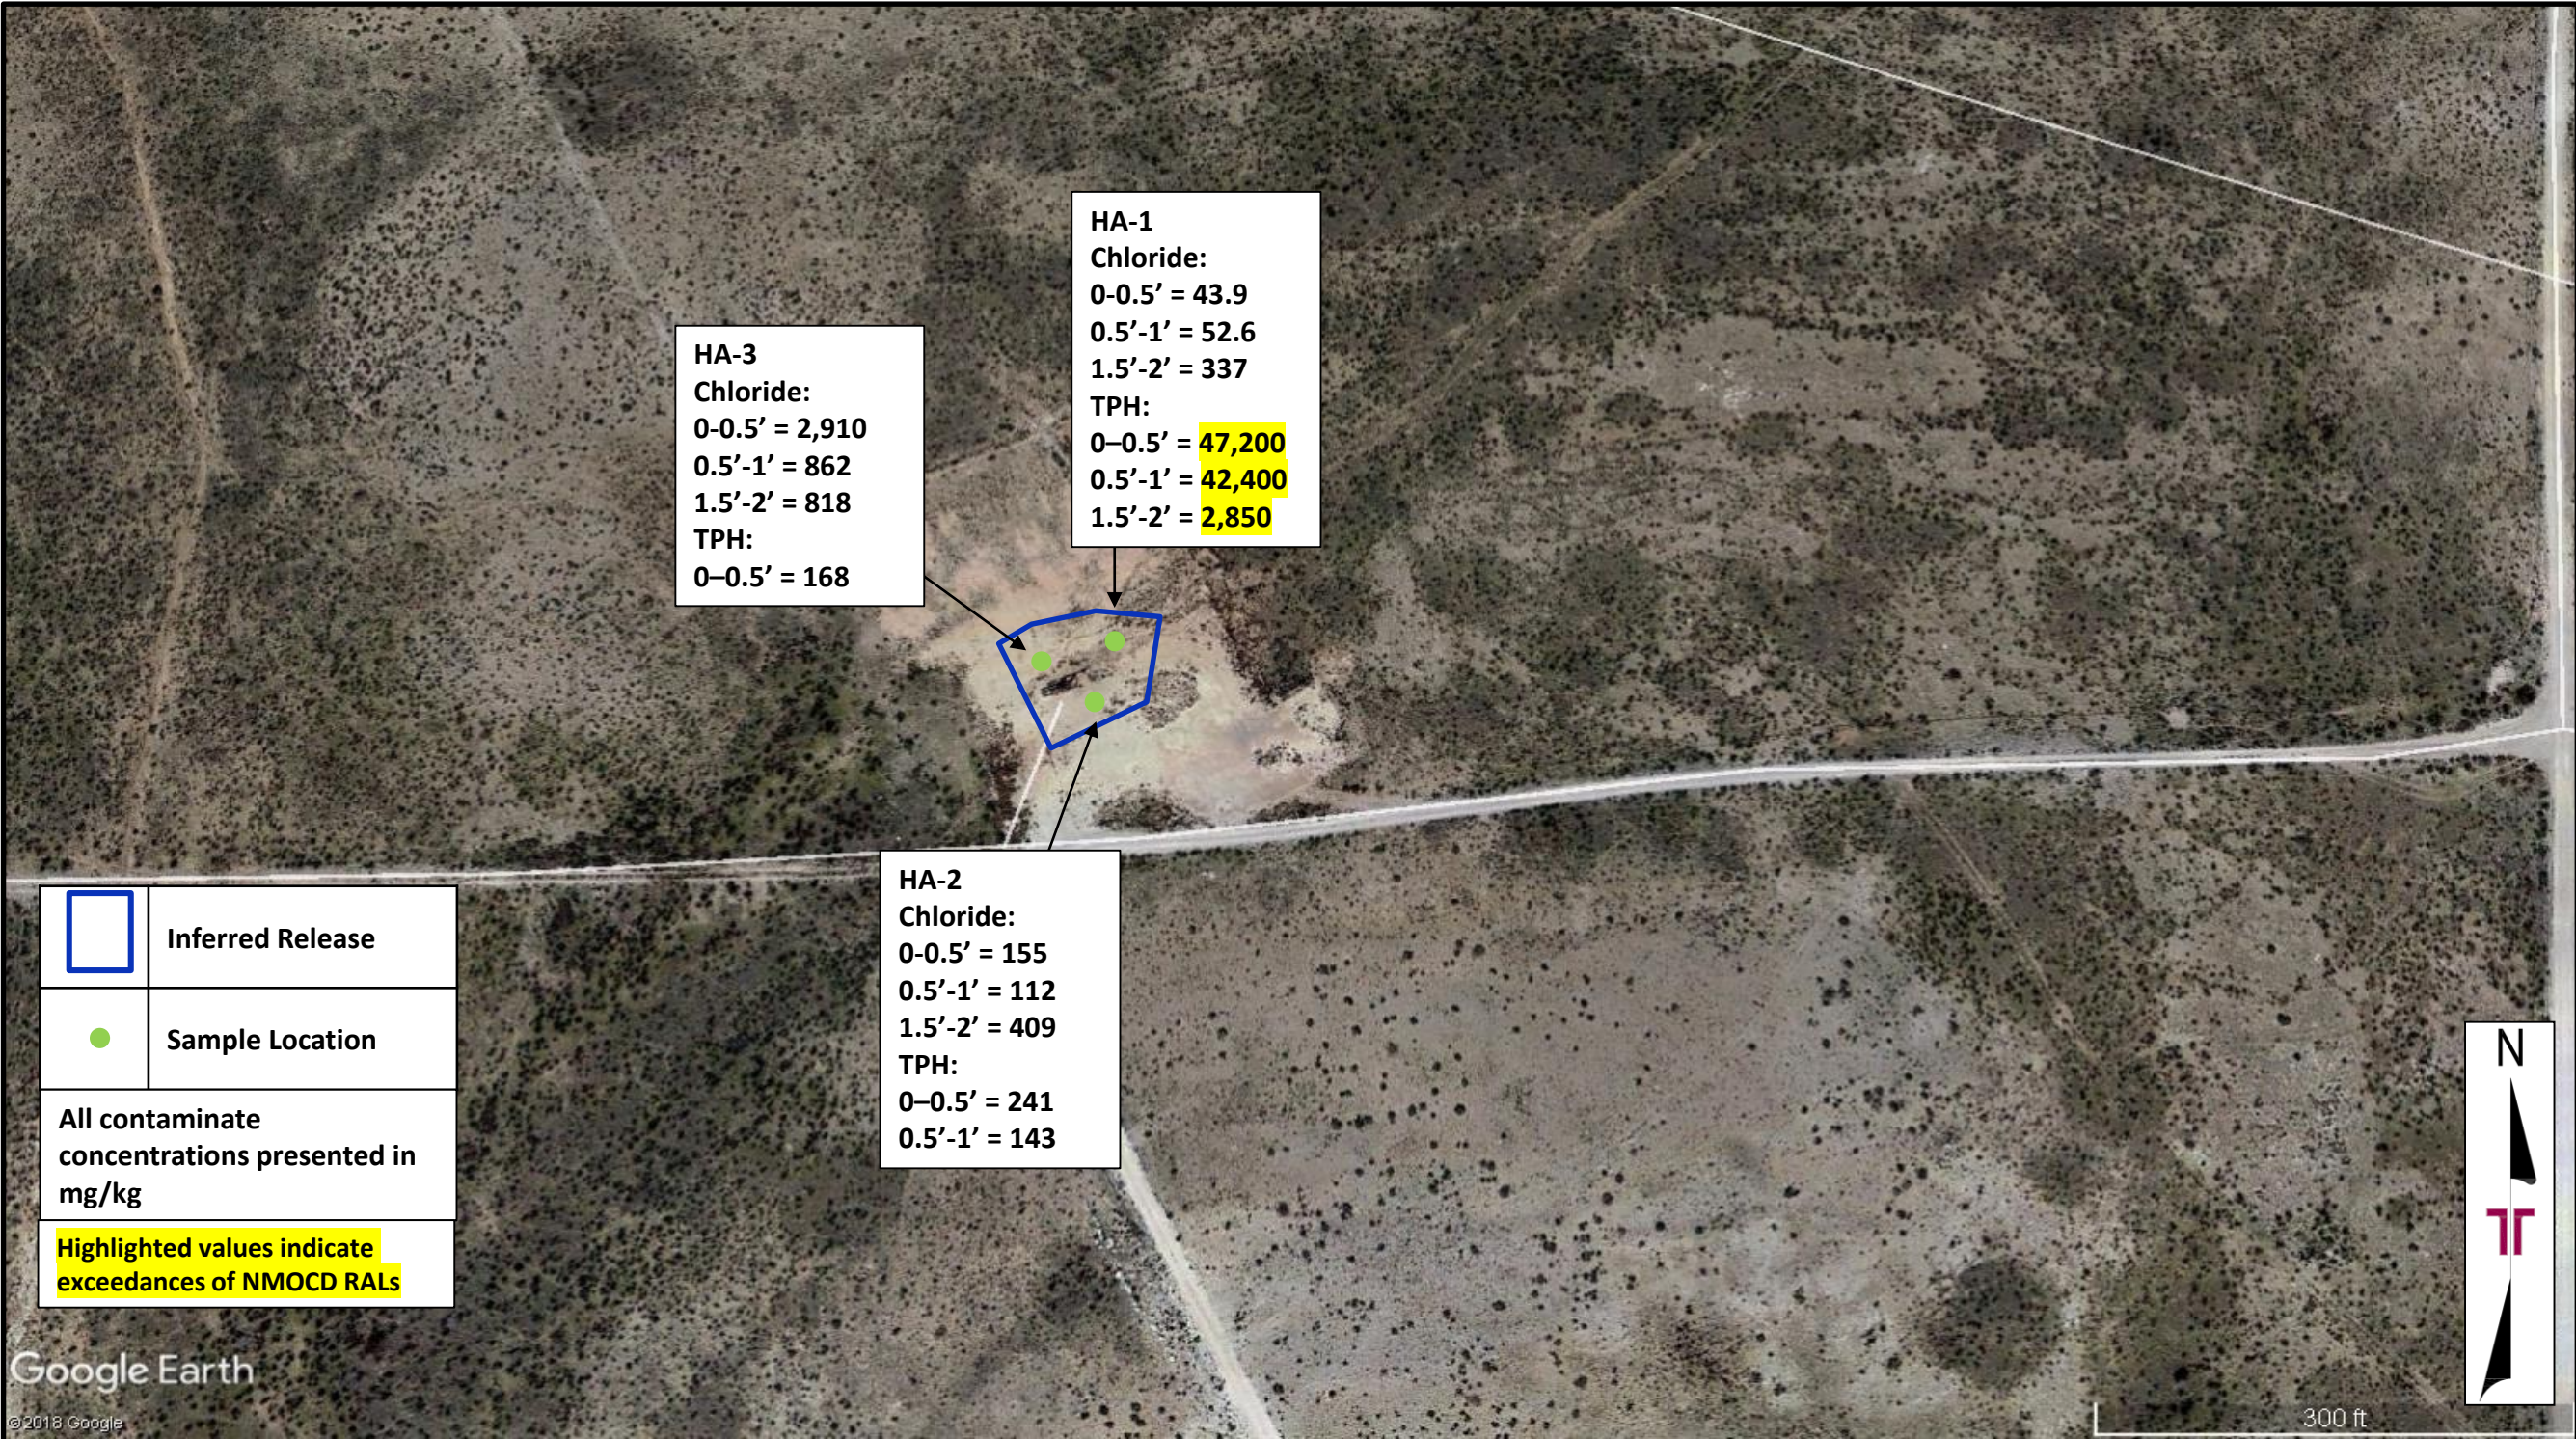
Figure 3 – Contamination Concentration Map
Lakewood Federal #1 32.6114693°, -104.470482° Eddy County, New Mexico

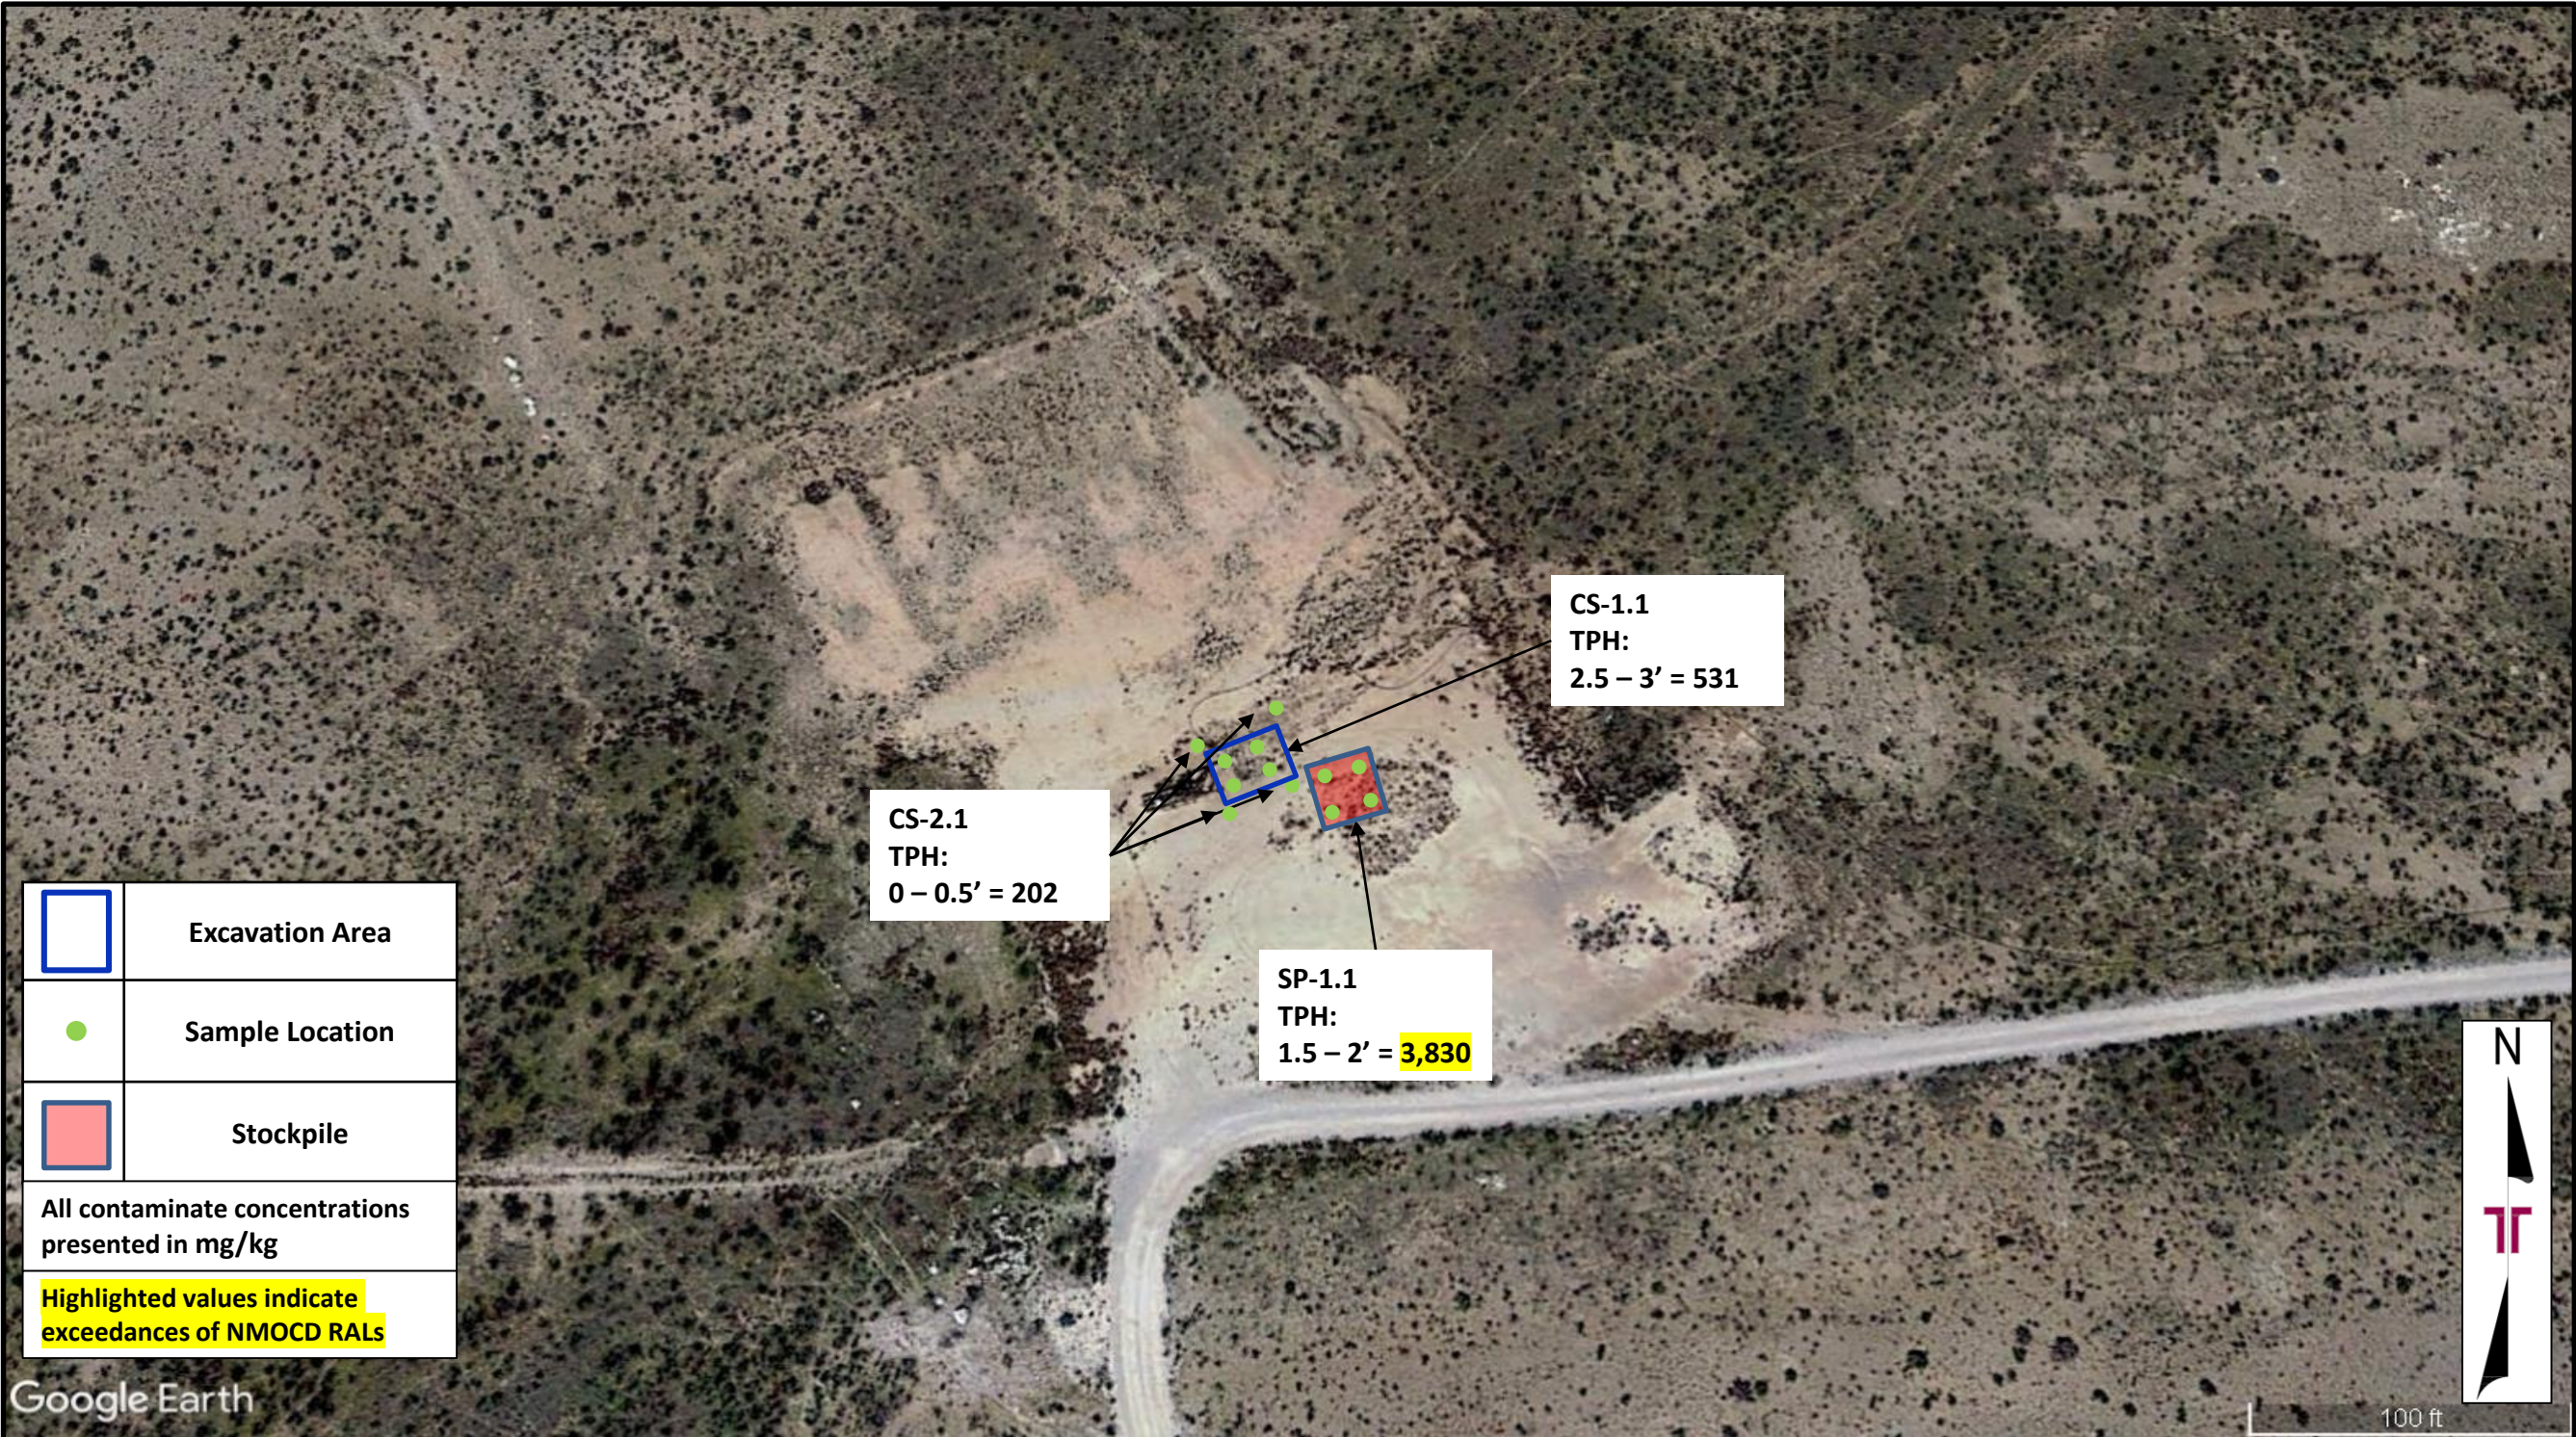
Figure 4 – Remediation Concentration Map
Lakewood Federal #1
32.6114693°, -104.470482°
Eddy County, New Mexico

Based on the review of the above confirmation analytical results, the areas within and surrounding the remediation do not exhibit concentrations above the NMOCD RAL for benzene, Total BTEX, chloride and Total TPH. The exception is the contaminated stockpile (SP-1) Based on these results below NMOCD RALs, Sections 9.0 and subsequent detail recommended closure of

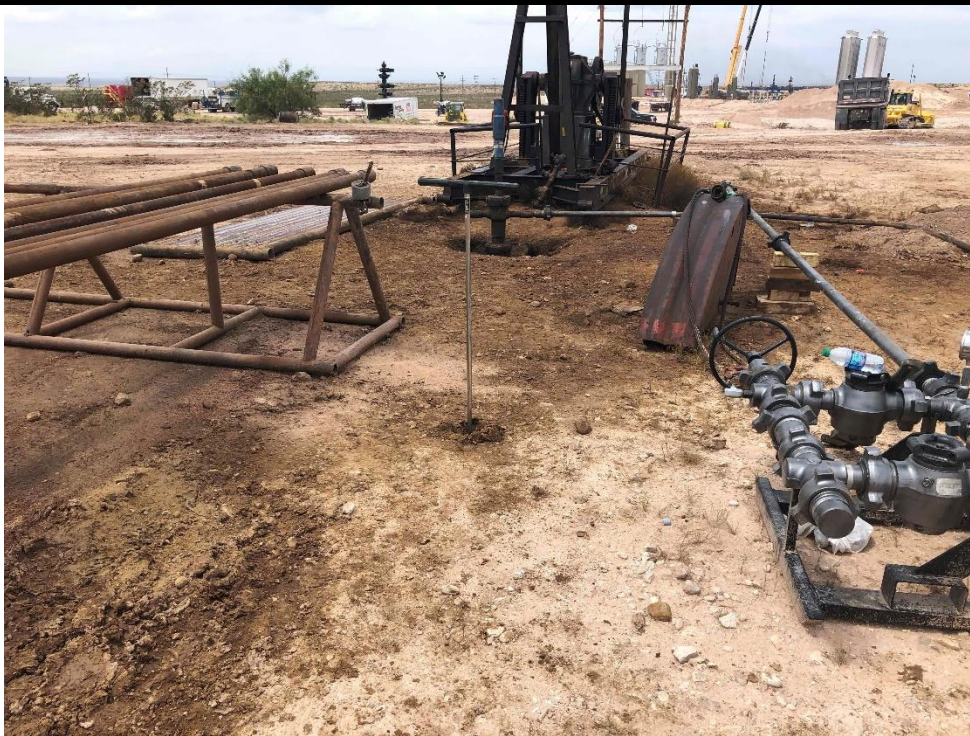
PHOTO 6: View of HA-1, facing west. 7/25/2019

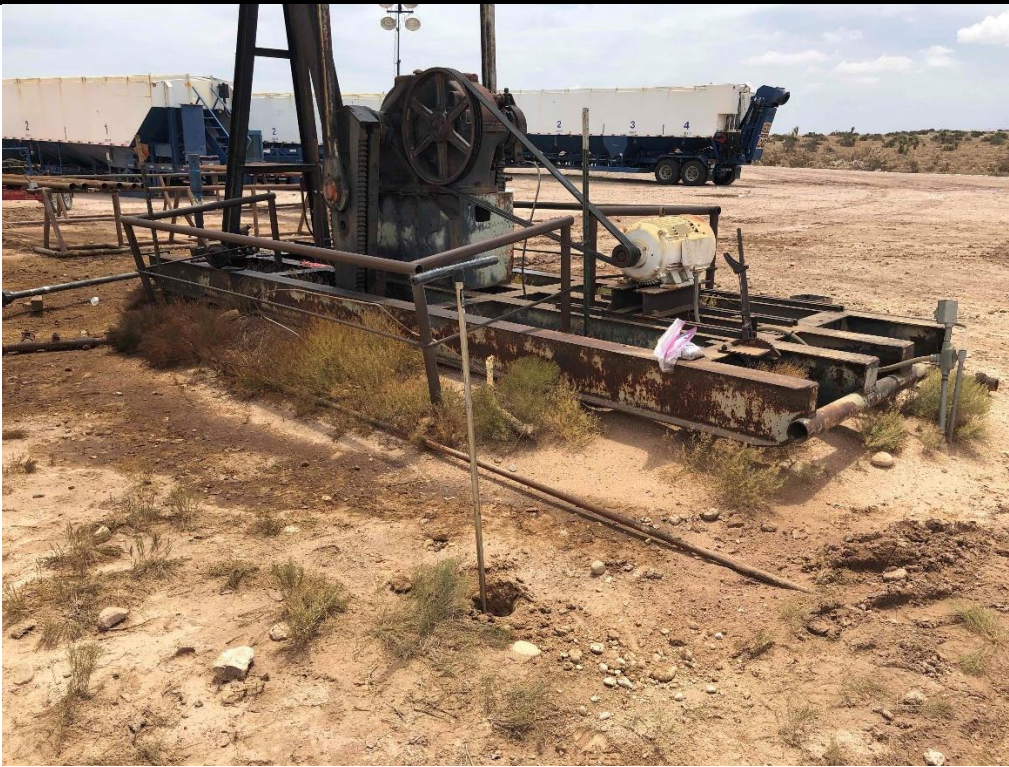
PHOTO 7: View of HA-3, facing southeast. 7/25/2019

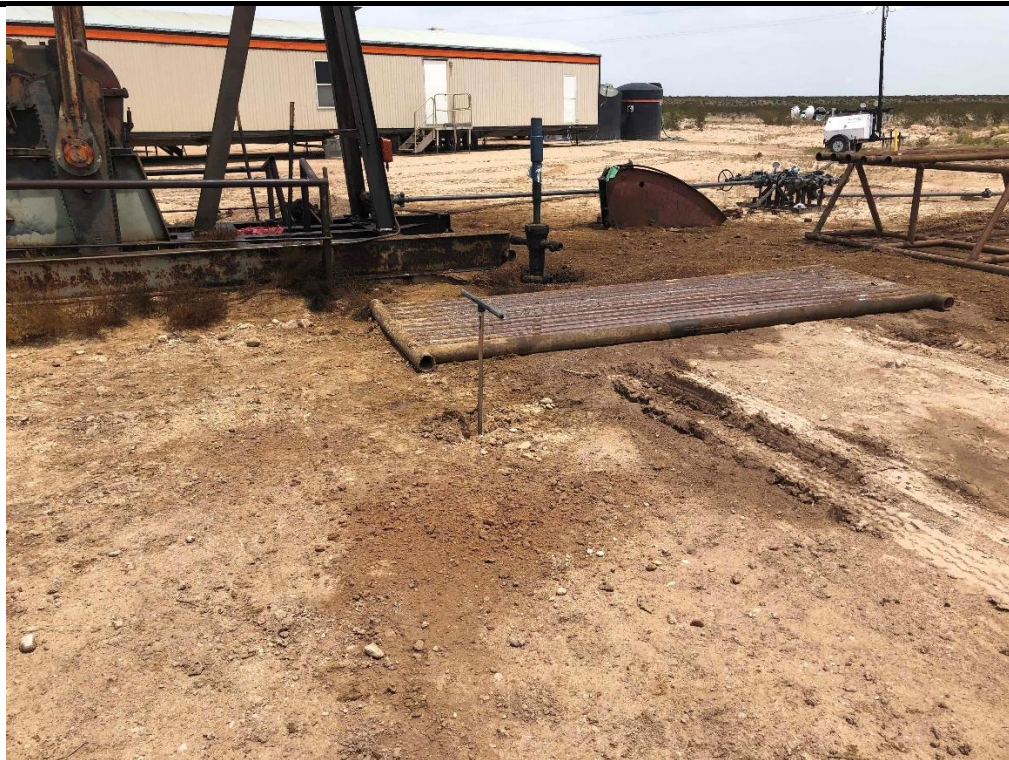
PHOTO 8: View of HA-2, facing northeast. 7/25/2019

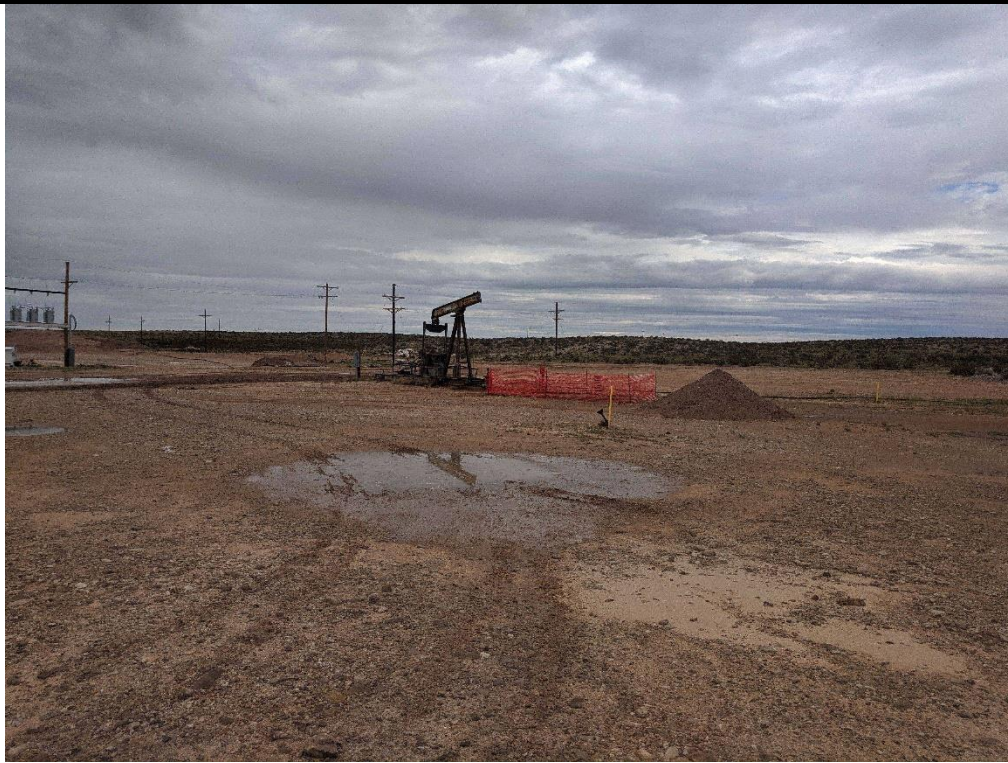
PHOTO 9: View of remediation, facing northwest. 10/10/2019

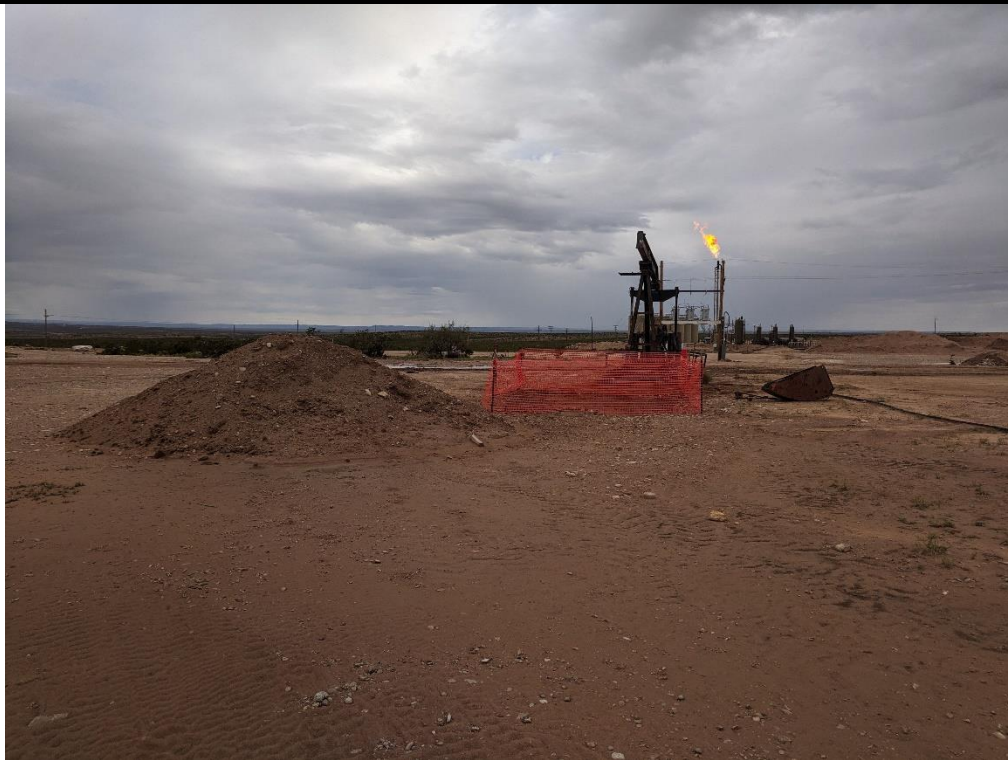
PHOTO 10: View of remediation, facing east. 10/10/2019

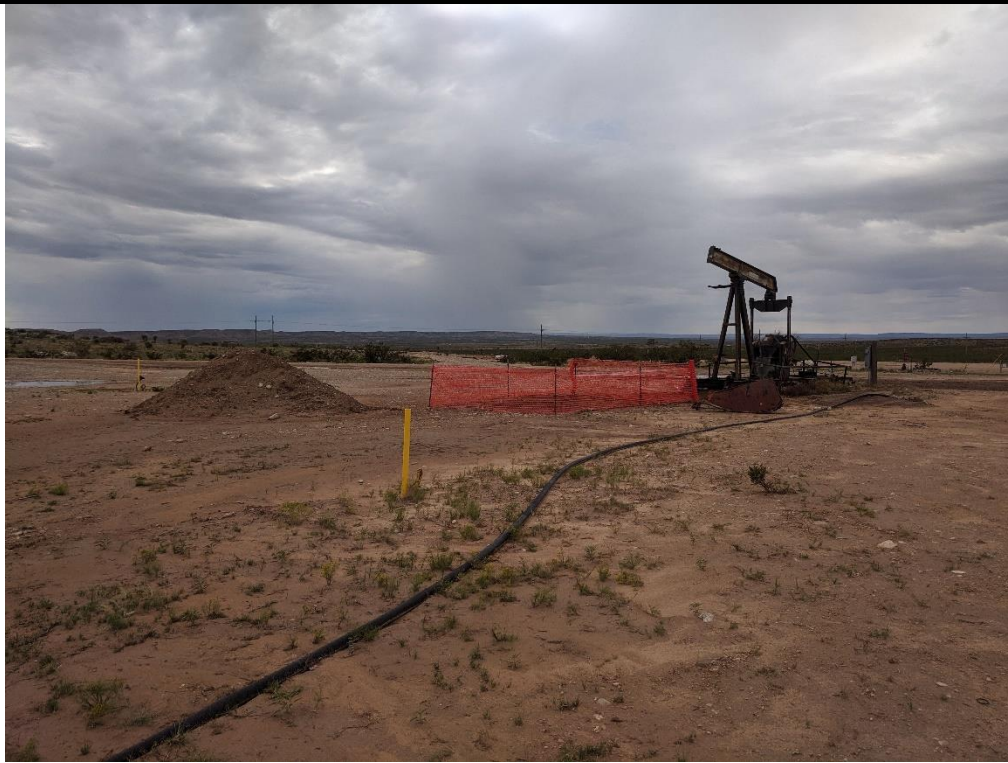
PHOTO 11: View of remediation, facing southwest. 10/10/2019

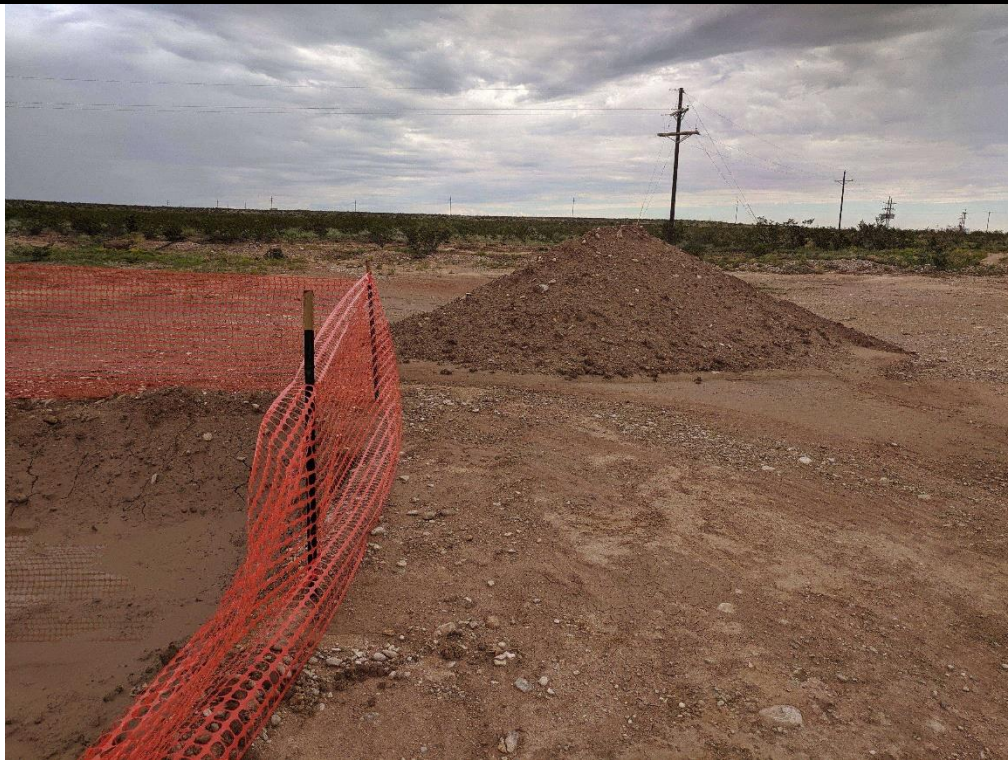
PHOTO 12: View of stockpile, facing east. 10/10/2019

response actions to be implemented at the site. Terracon recommends beginning the restoration of the above mentioned site, and disposing of the stockpiled material.

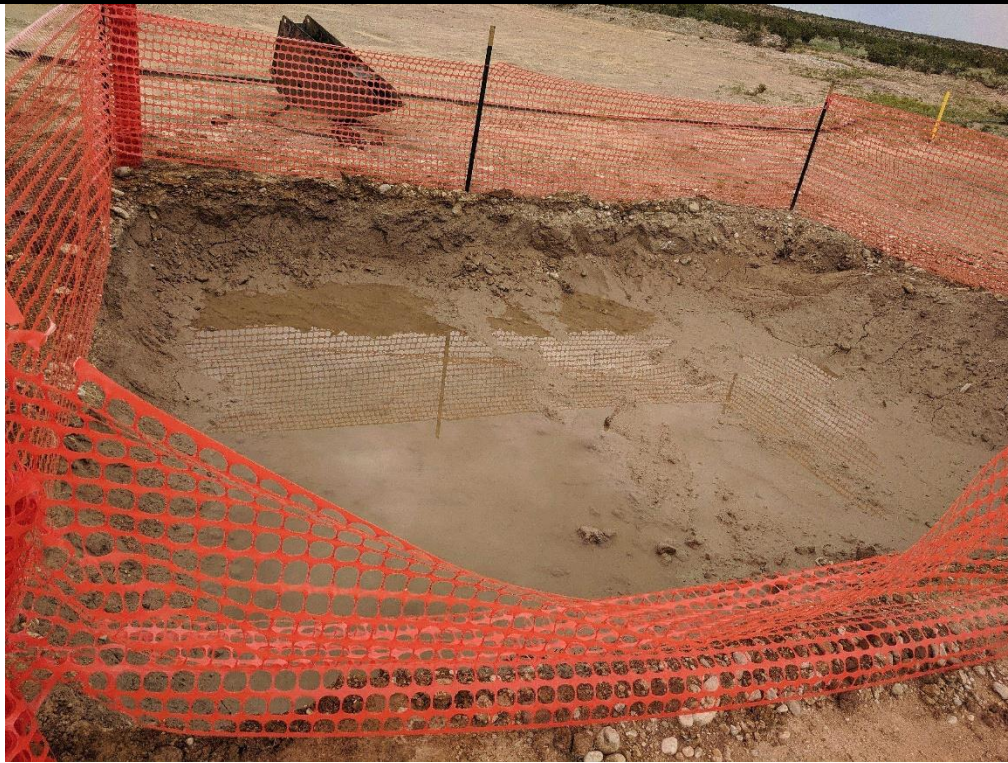
PHOTO 13: View of excavation, facing north. 10/10/2019
