Release Notification

Site Name: West Escavada Unit 305H	Site Type: Wellsite
Date Release Discovered: 2/20/2020	API# (if applicable) 30-043-21309

West Escavada Unit 305H Narrative**2/20/2020**

Enduring Resources, LLC
WEU 305H Photo Page

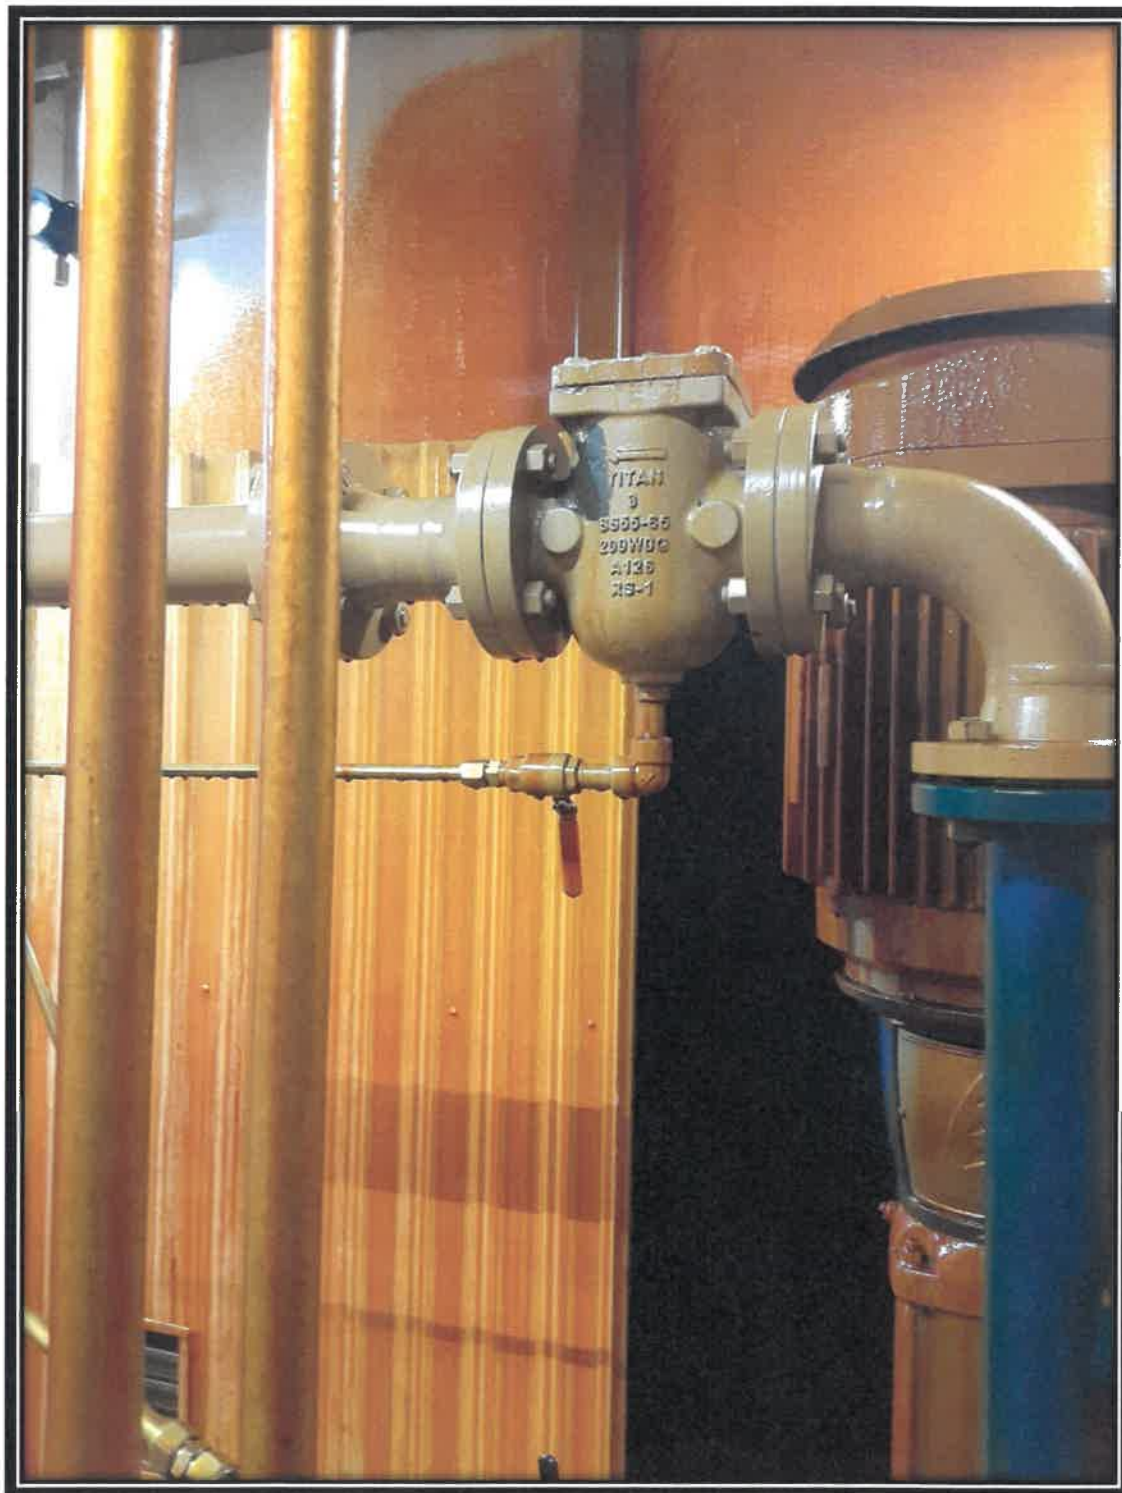
Photo 2: Release Point

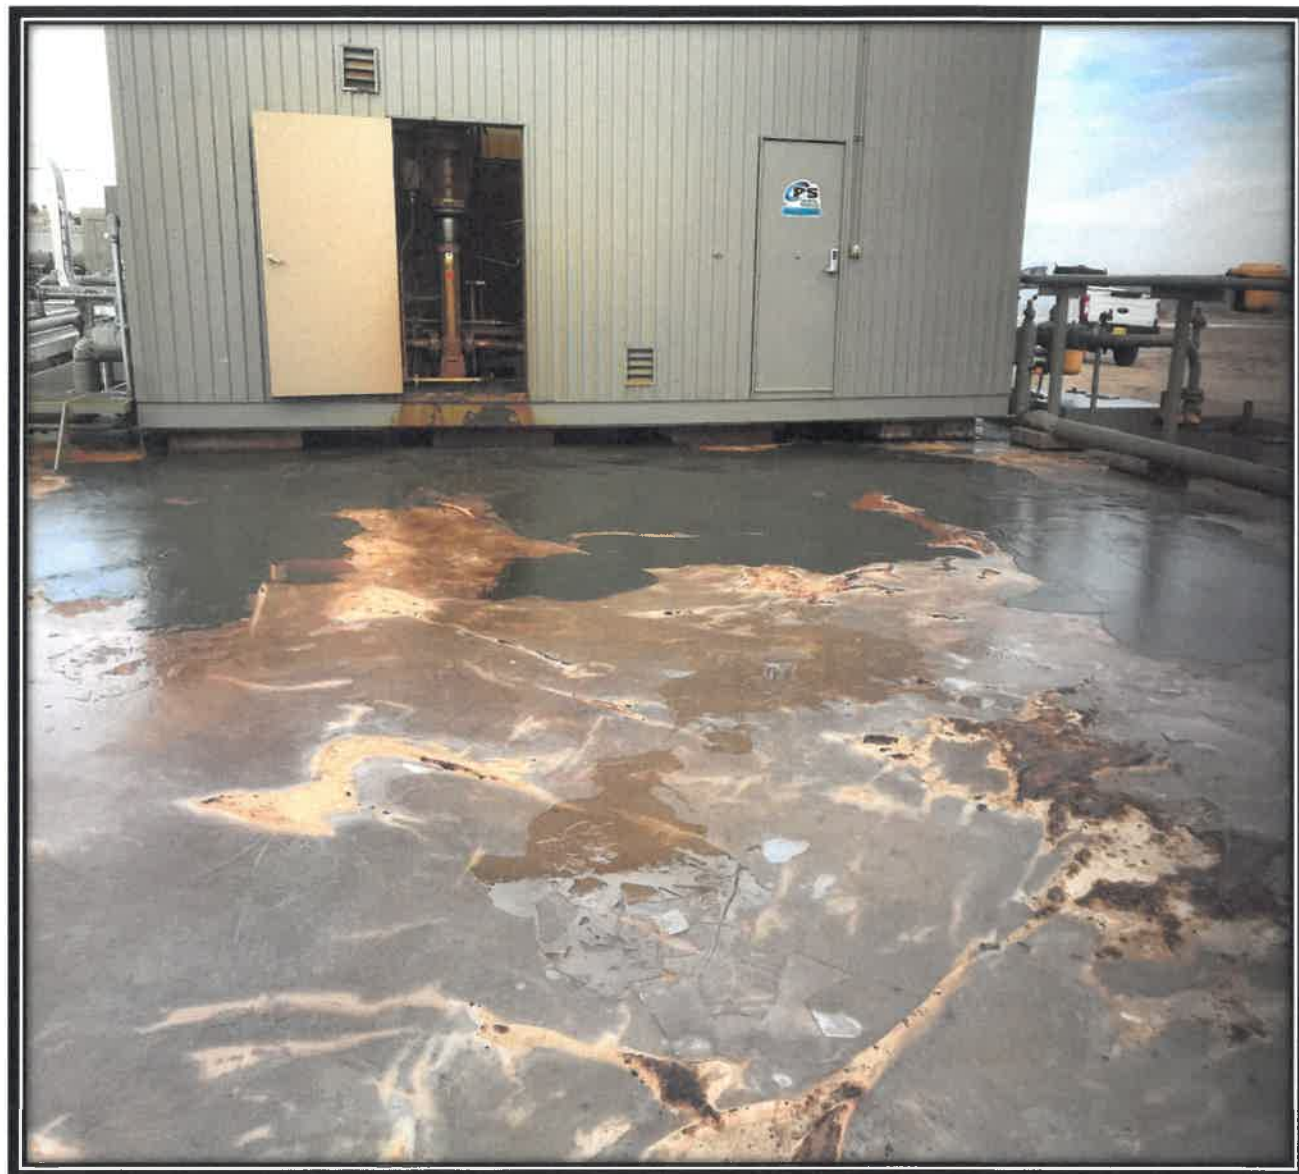
Photo 3: Photo of Release

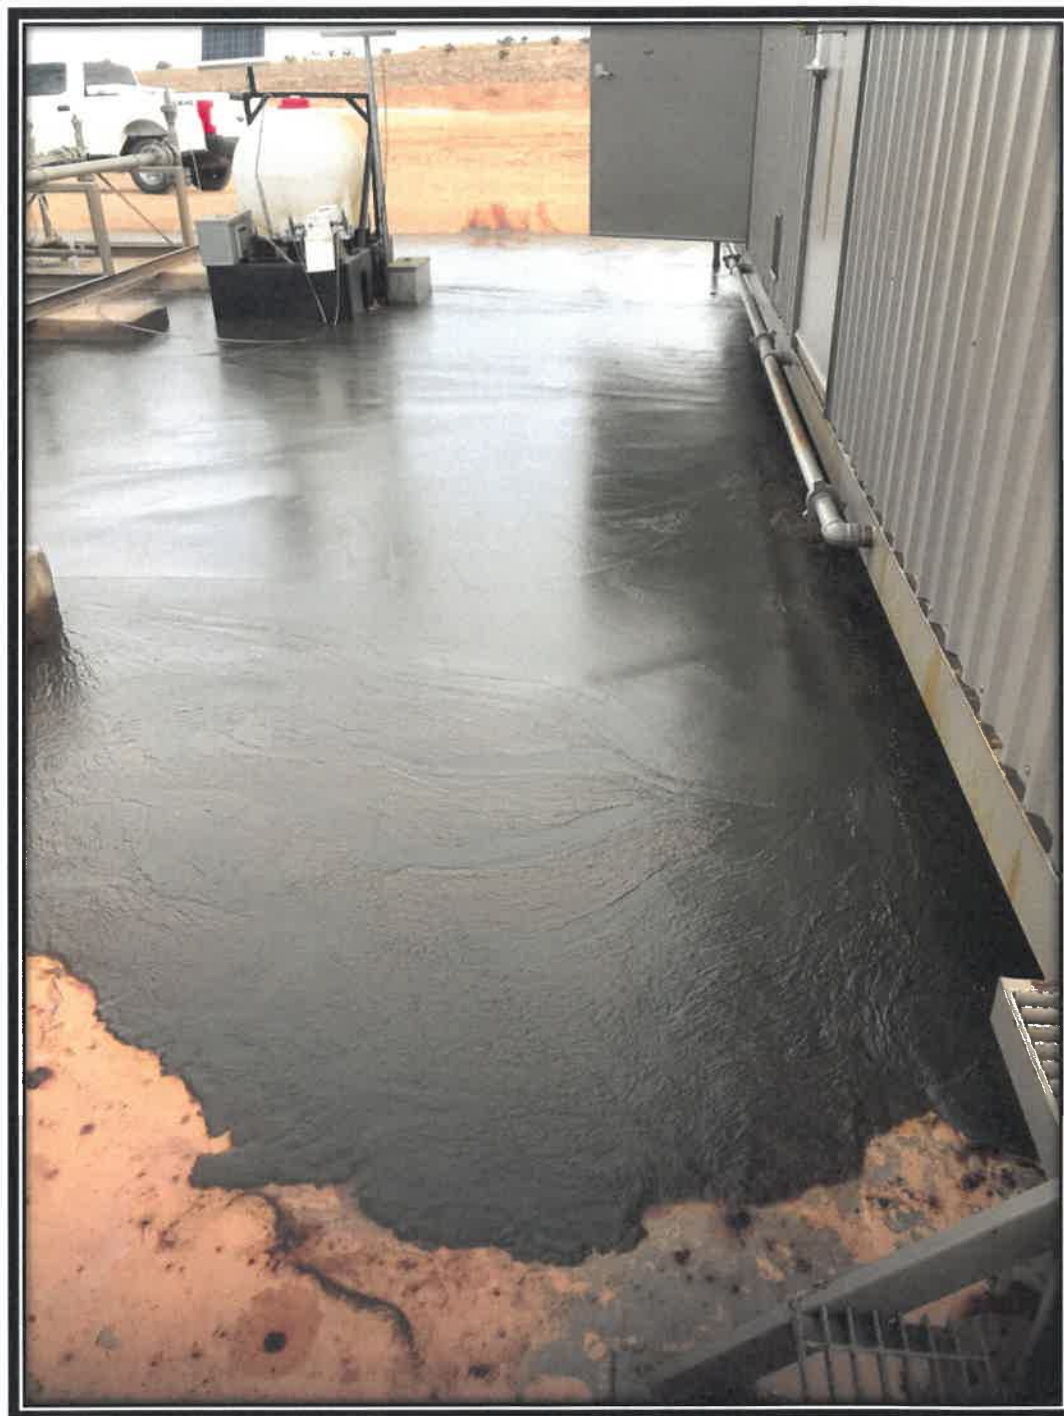
Photo 5: Photo of Release

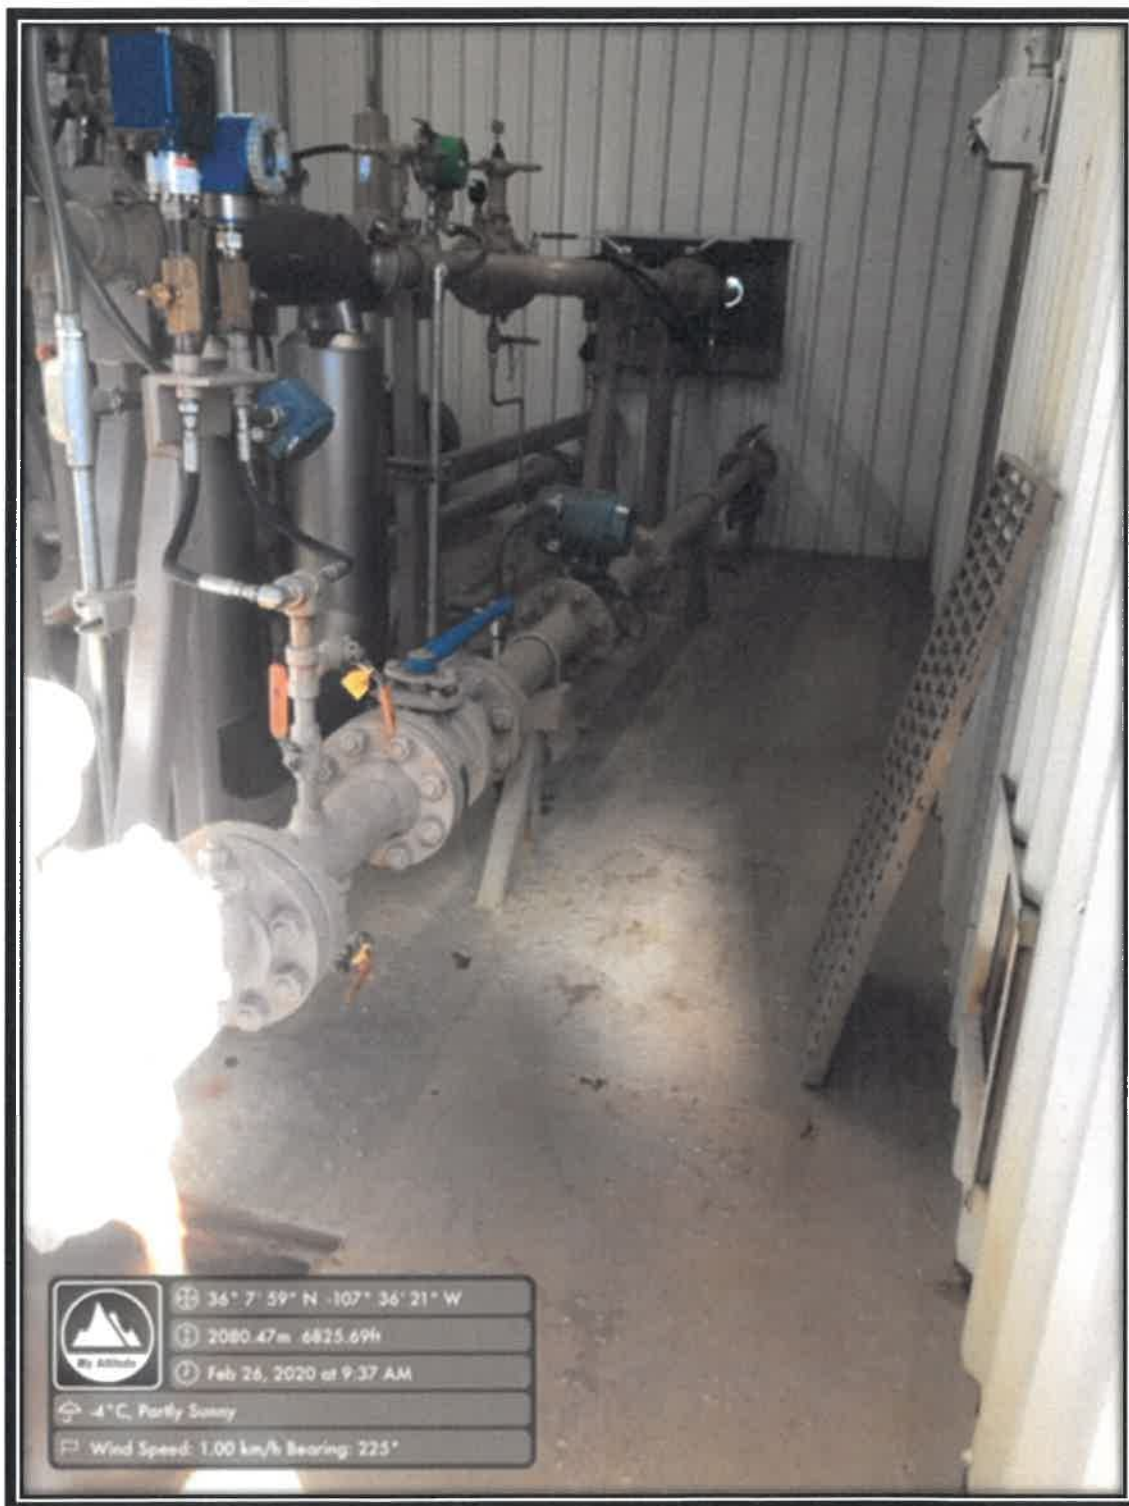
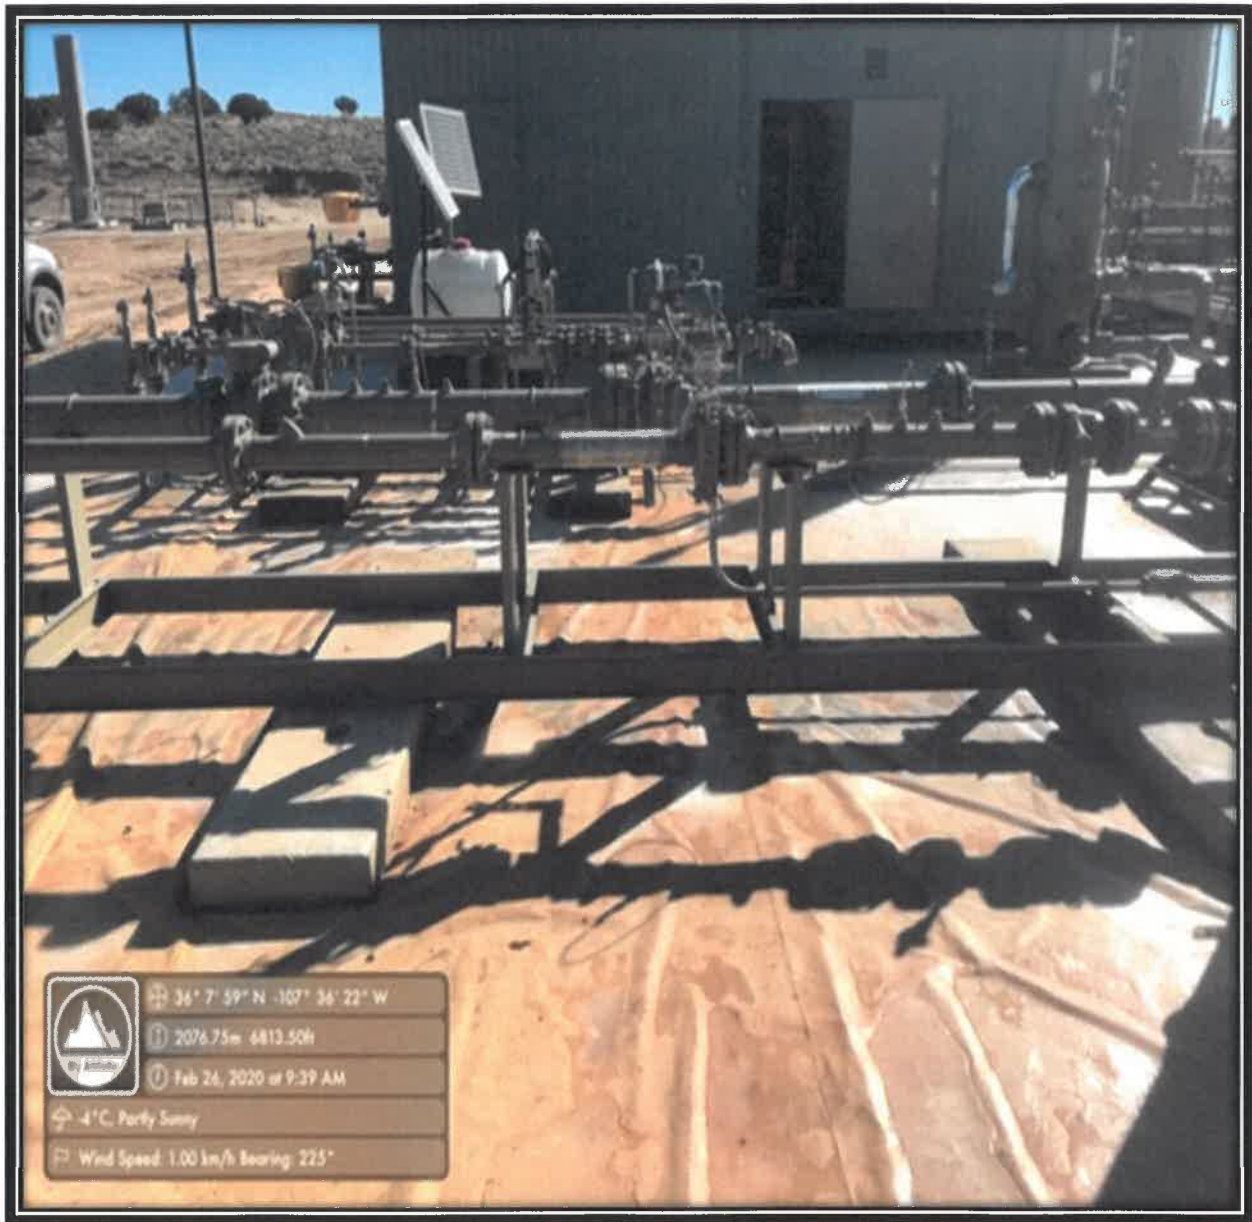
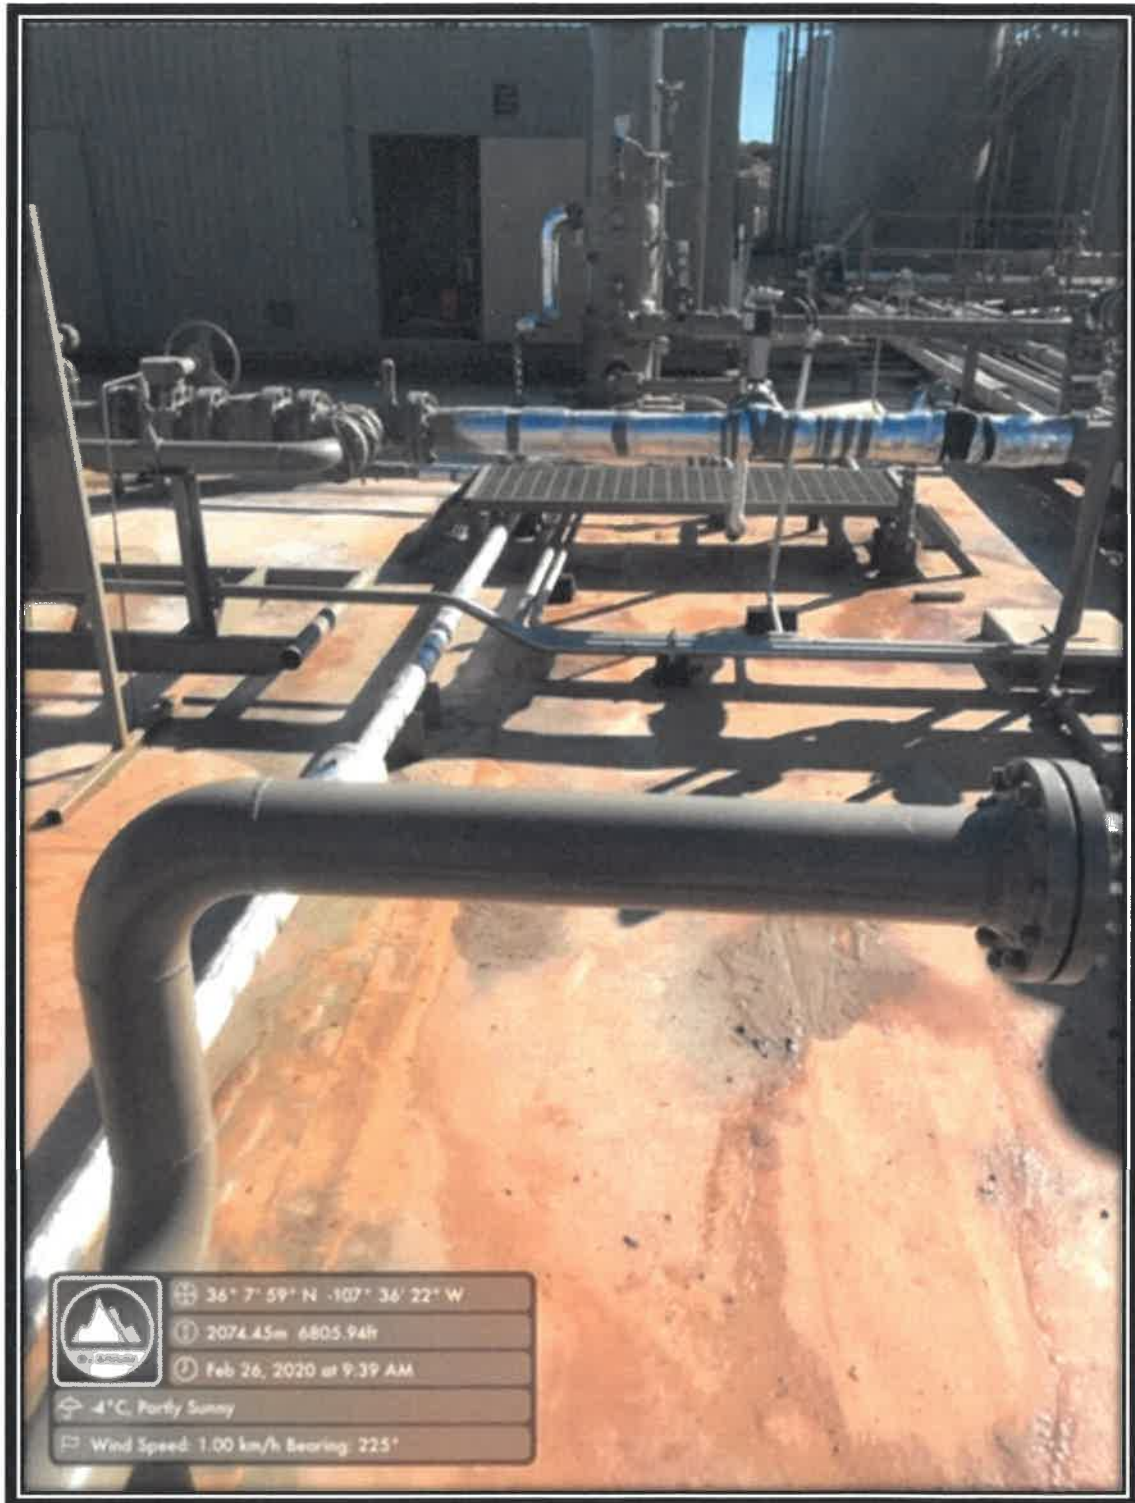
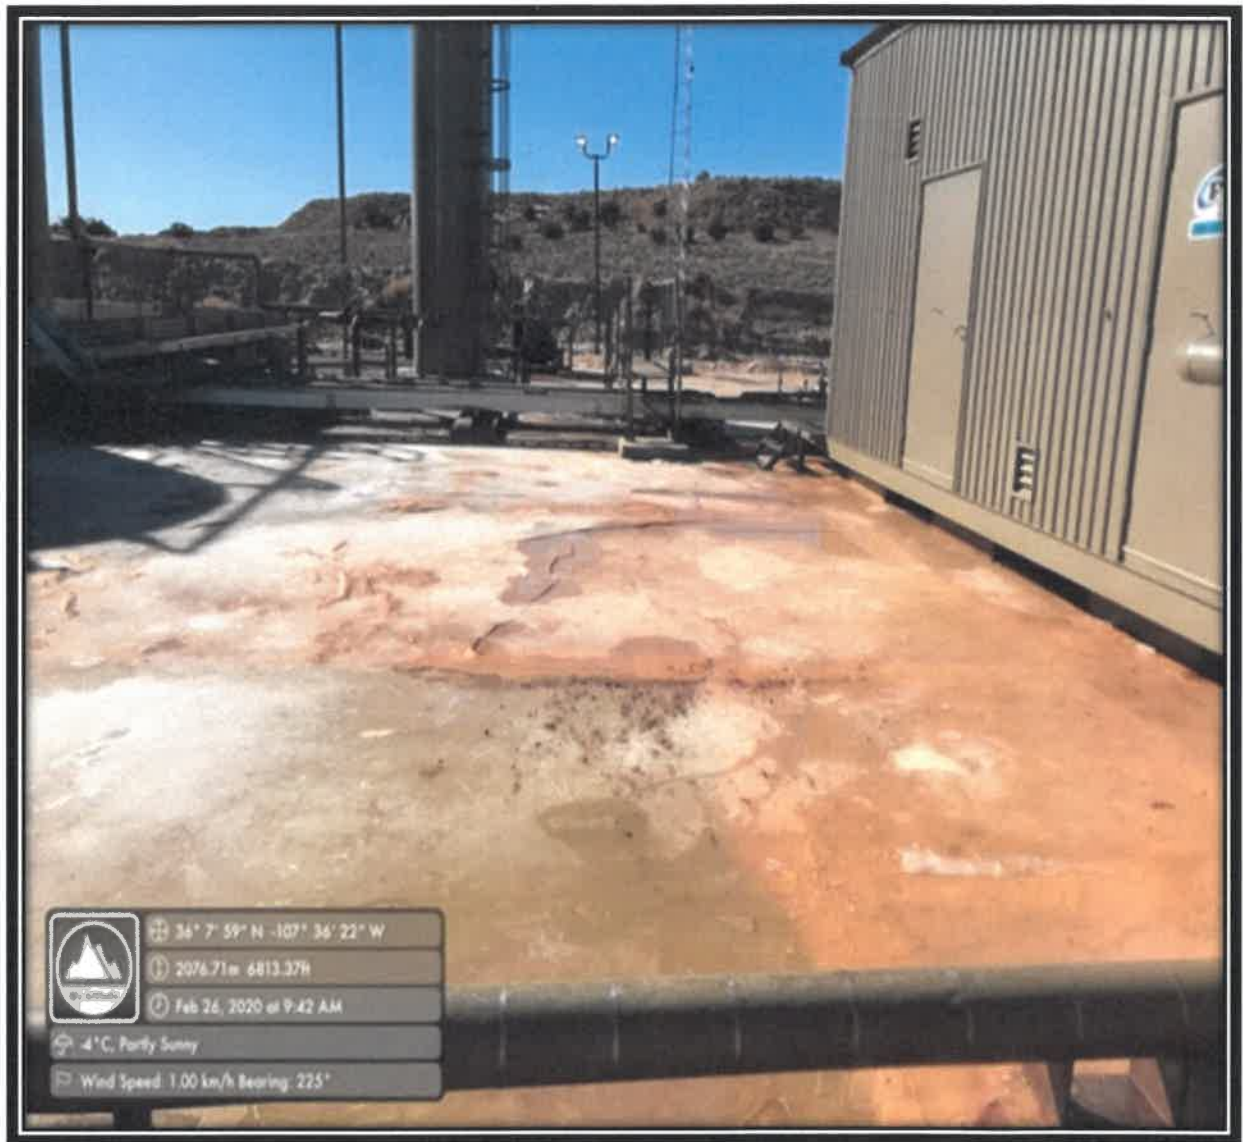
Enduring personnel was onsite at 9:30am to perform the liner inspection. The NMOCD nor the BLM was onsite to witness liner inspection. Enduring personnel did not see any integrity issues with the liner. See attached *"Photo Page"*. No further action is required.

Photos 6-9: After Clean-up

All free standing oil was sucked up recovering a total of 20 bbls. A wash crew was also on site and sprayed the liner clean.
