**Re: Lovington Paddock Unit No. 59 Well Site
Case No. 1RP-915
2018 Site Assessment Report and Work Plan
Lea County, New Mexico**

Site Assessment Report

Lovington Paddock Unit 59

Produced Water Release

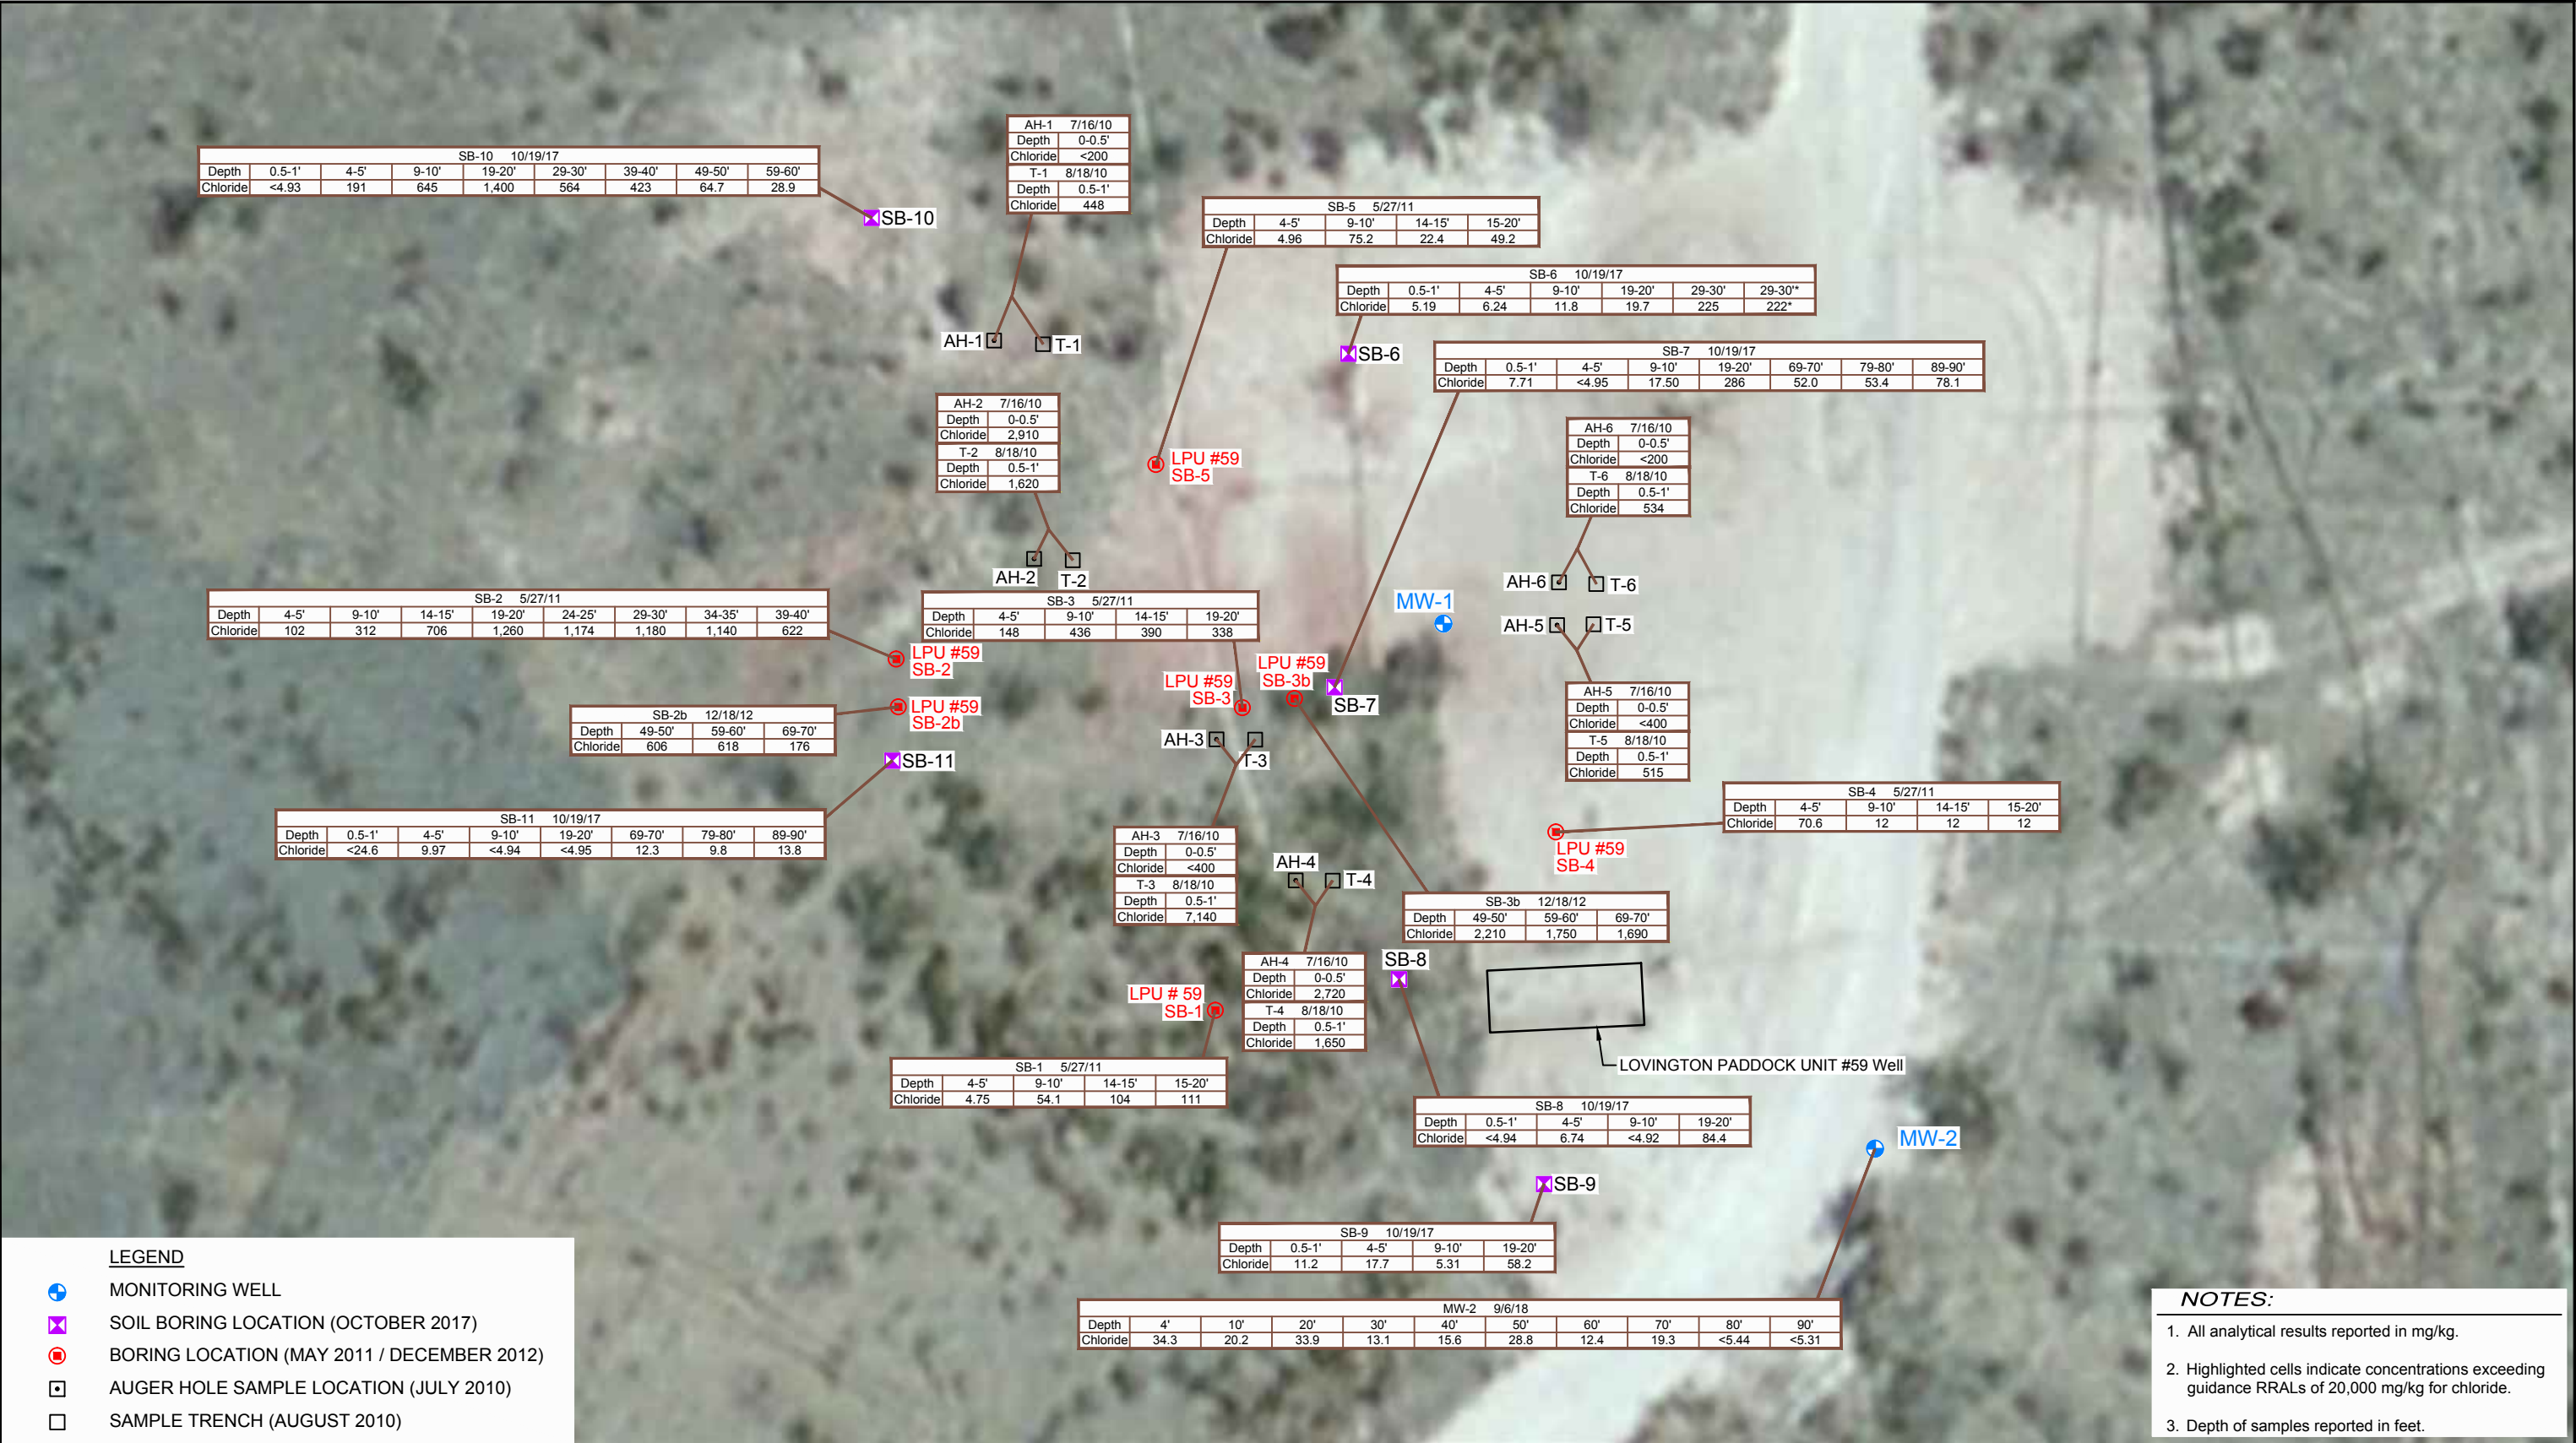
A soil analytical summary of results from 2010 through 2018 is presented in Table 1. A Chloride Analytical Results Map for Soils (2010 – 2018) is presented as Figure 4.

- Chloride concentrations above the revised Rule 19.15.29 screening limit of 20,000 mg/kg were not reported in any of the soil samples collected from MW-2.

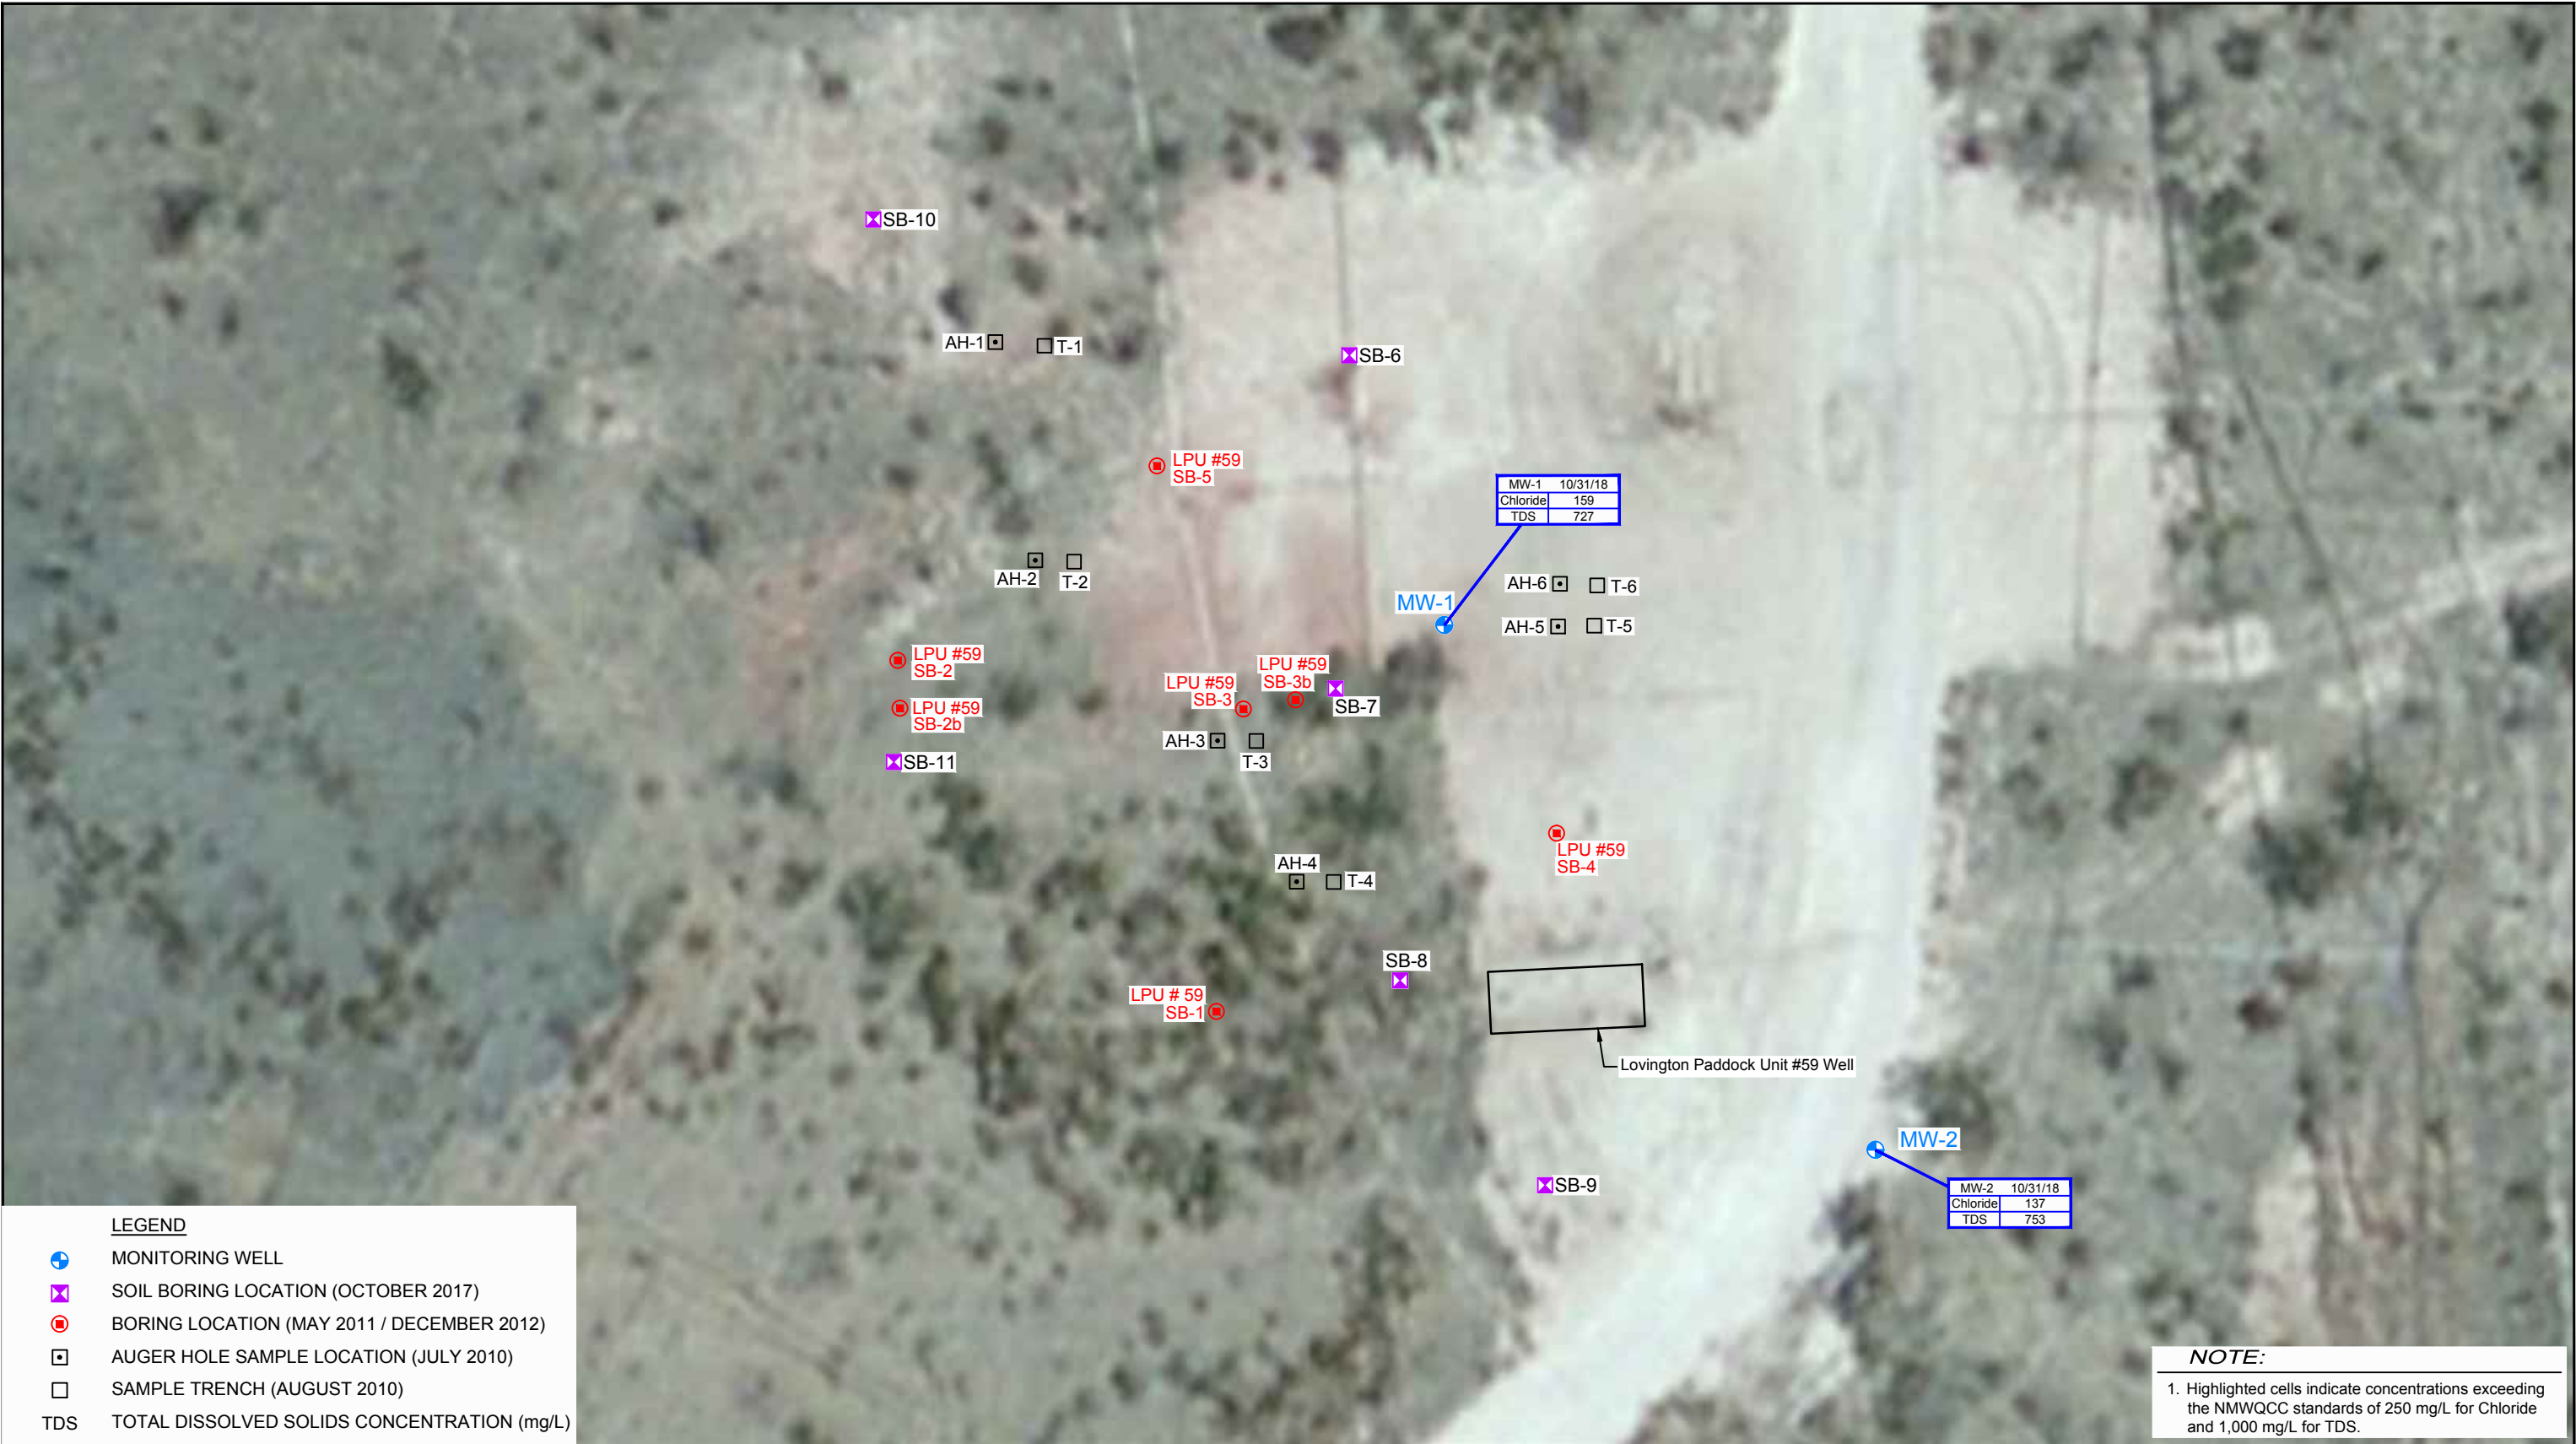
FIGURE 5

Sample ID	MW-2	10/31/18	Sample Date
	Chloride	137	Sample Result (mg/L)
	TDS	753

CHLORIDE ANALYTICAL RESULTS MAP - GROUND WATER

Chloride was detected at a concentration of 159 mg/L from MW-1 and 137 mg/L from MW-2, which are both below the 250 mg/L standard. TDS was reported at a concentration of 727 mg/L from the

sample collected from MW-1 and 753 mg/L from the sample collected from MW-2, which are below the 1,000 mg/L standard.
