Release Notification

Latitude 32.	388707		(NAD 83 in a	Longitude <u>-103.190151</u> n decimal degrees to 5 decimal places)
Site Name A	dobe State F	Battery	·	Site Type Tank Battery
Date Release	Discovered	4/27/2020		API# (if applicable)
Unit Letter	Section	Township	Range	County
L	17	228	37E	Lea

Adobe State Battery Spill 4/27/2020

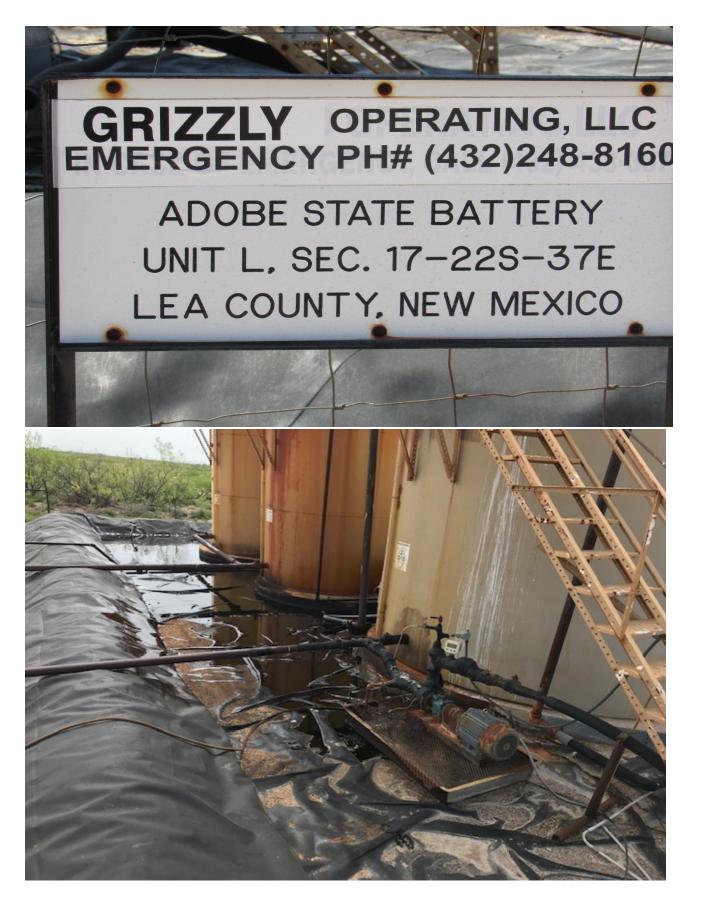
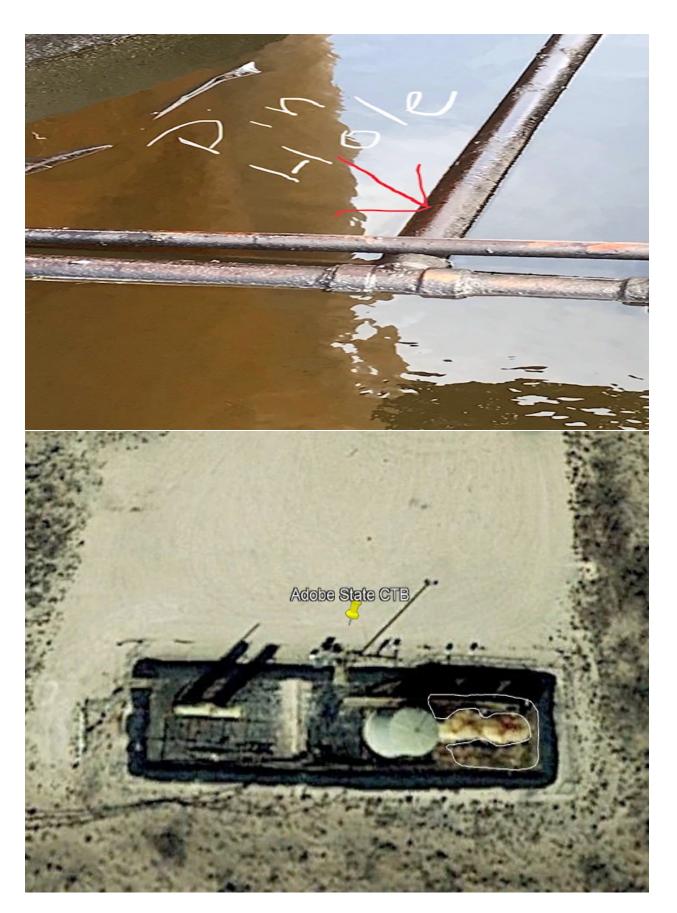
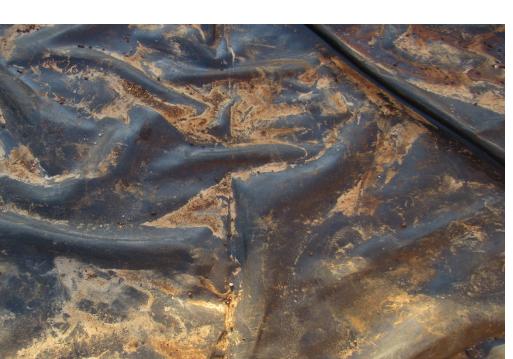
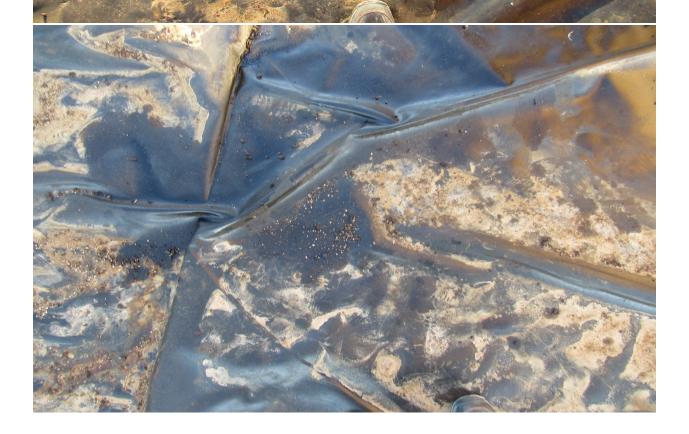
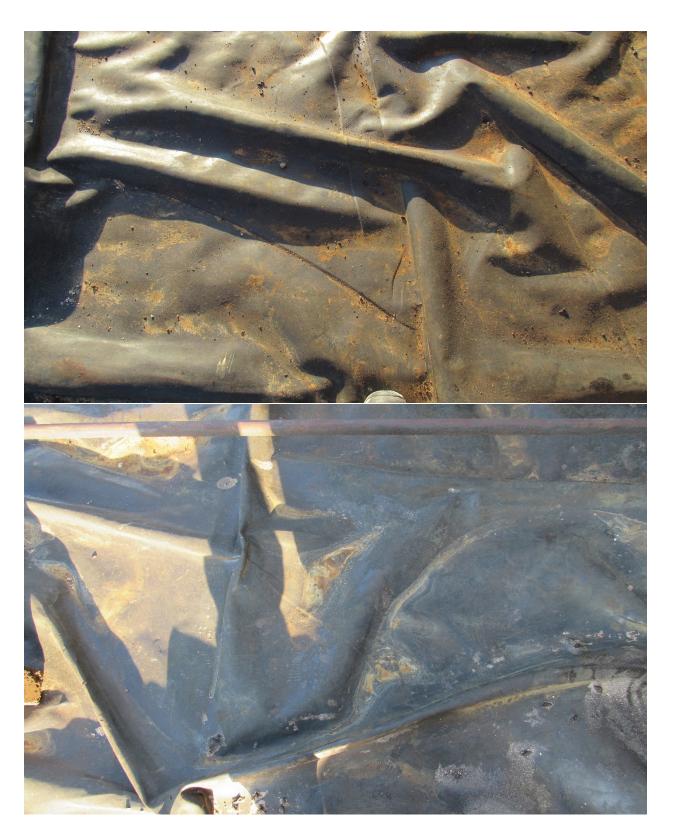
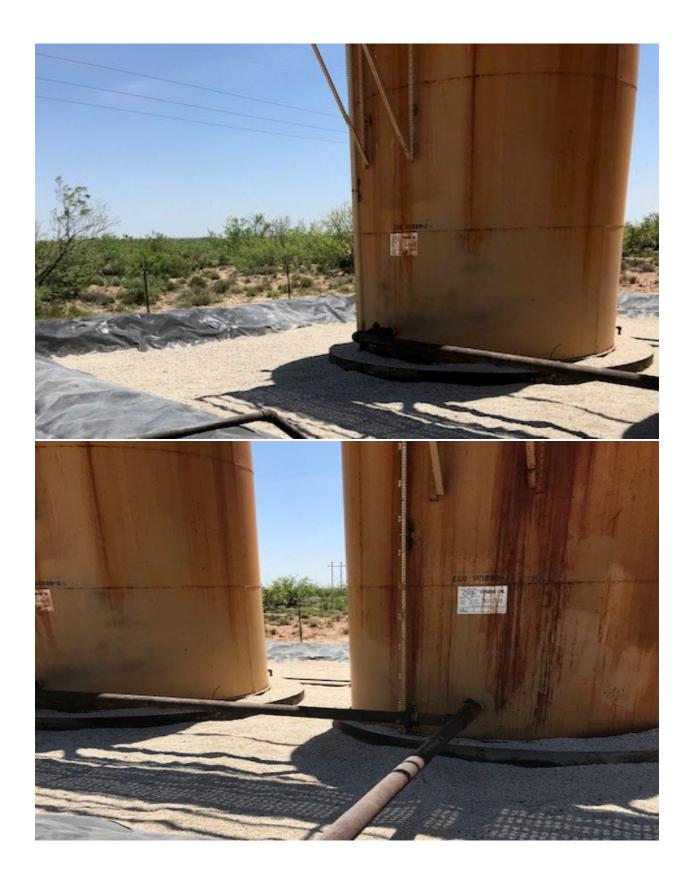
Corrosion on a flowline inside a lined containment, the corrosion was a small pinhole that released oil from the production tank to the lined containment. All liquid was contained inside the berm and nothing was released outside.

On 4/27/2020 at 11:20 AM we found a pinhole had developed from corrosion in the circulating line, causing oil to leave Tank # 1 and into the lined berm of the battery.

Pictures are attached of the spill, the pinhole, the clean inspected berm and the new gravel installed.

We immediately isolated the flowline and called a vac truck to pick up the liquid.

We removed all dirt and pea gravel from the containment and had the liner washed to allow for a proper inspection.

The liner was inspected and we found no holes, so we put new fresh pea gravel into the berm.
