Remediation Summary and Soil Closure Request

ETC Texas Pipeline, Ltd. F-16 Pipeline (2-18-2020)

Lea County, New Mexico
Unit Letter D, Section 6, Township 22 South, Range 37 East
Latitude 32.426647 North, Longitude 103.207744 West
NMOCD Reference No. 1RP-pending

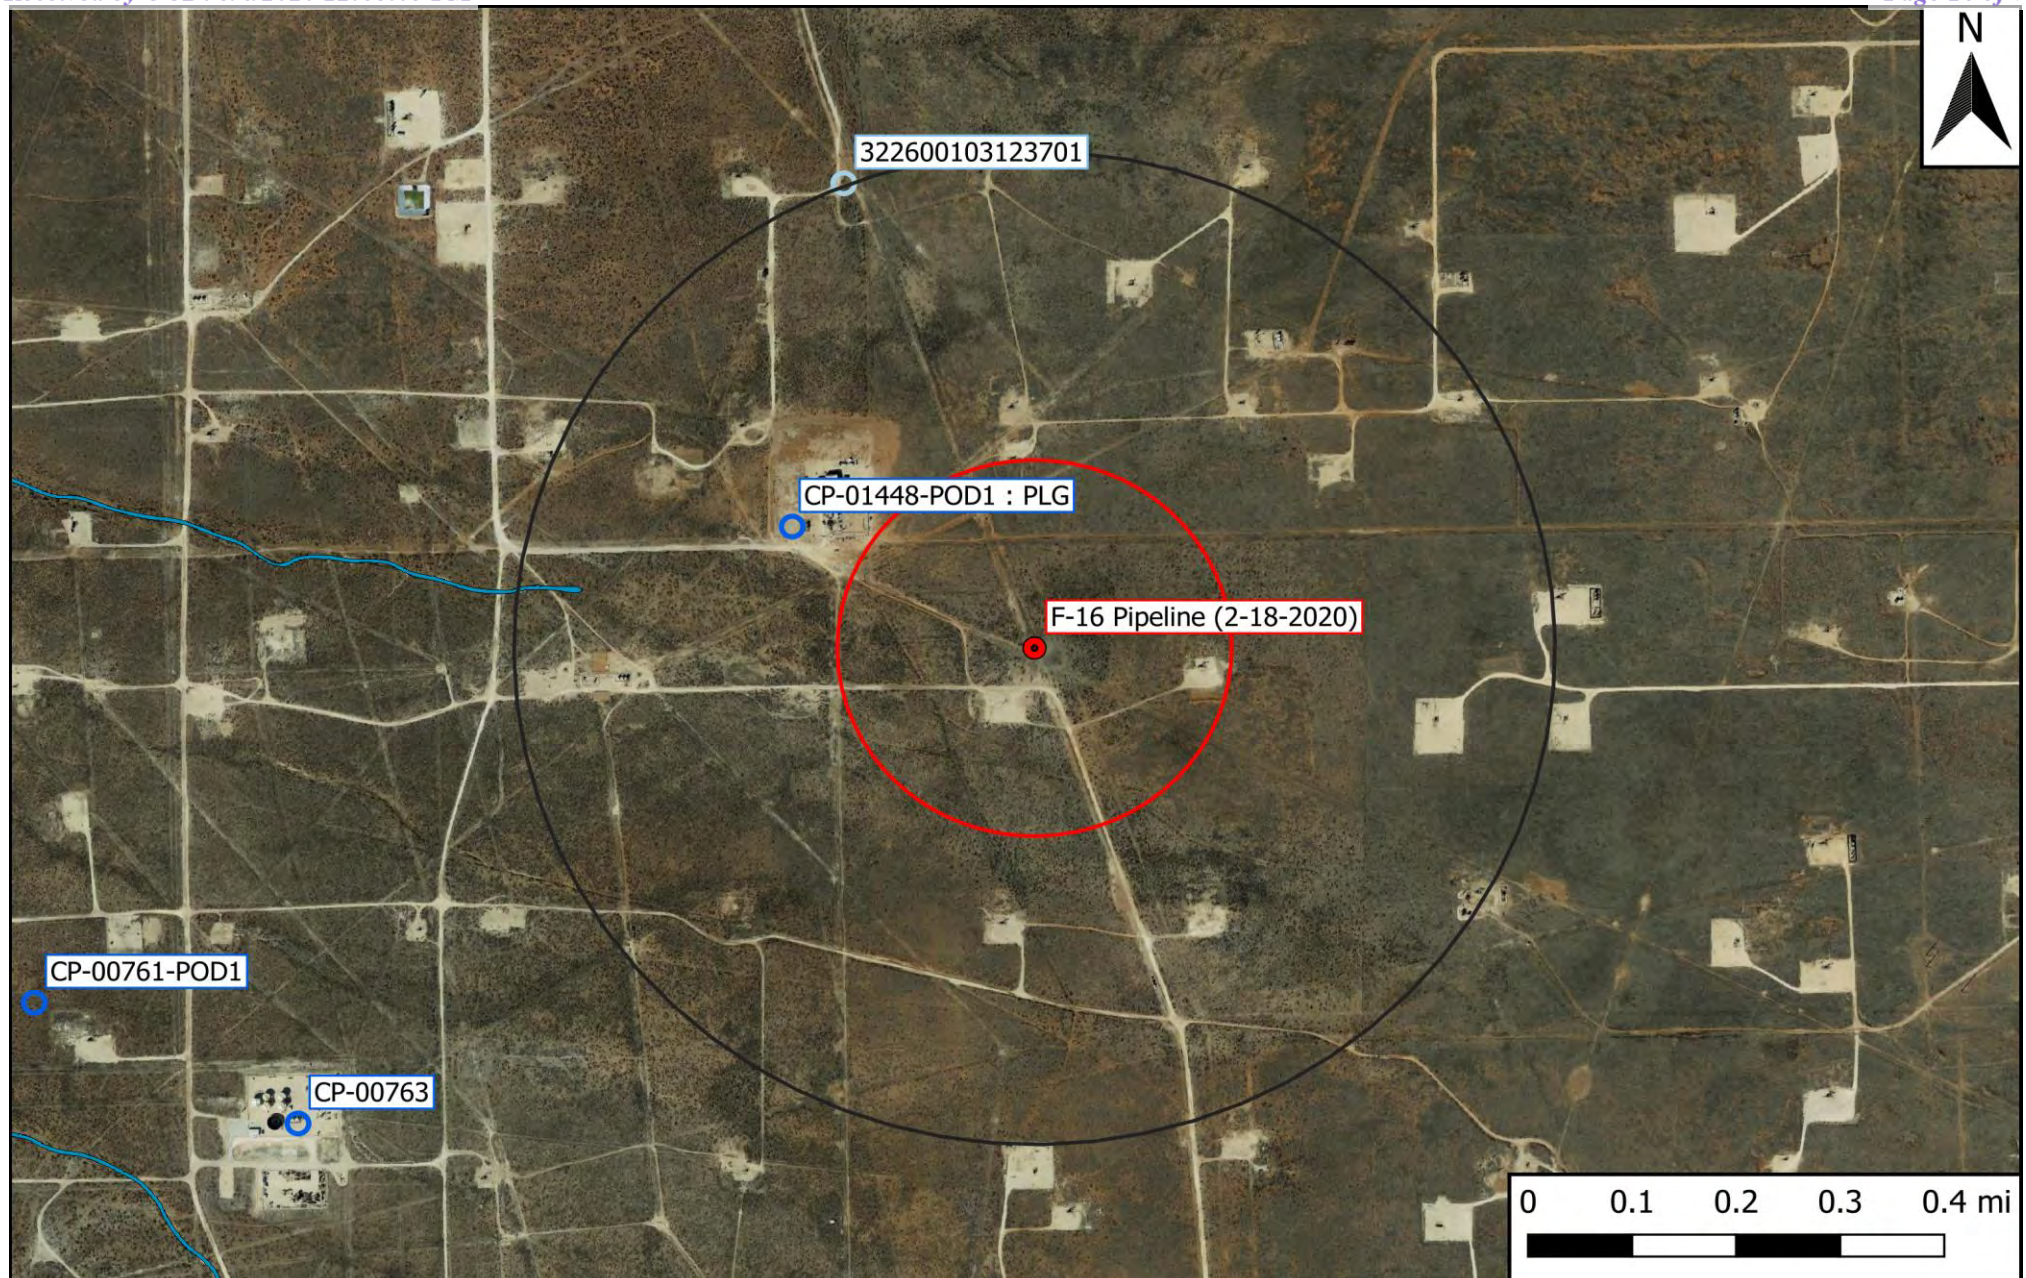
Figure 2

Aerial Proximity Map

NMOCD Siting Criteria data was gathered from available resources including Bureau of Land Management (BLM) shapefiles; topographic maps; NMOSE and USGS databases; and aerial imagery. The results are depicted on Figures 1 & 2.

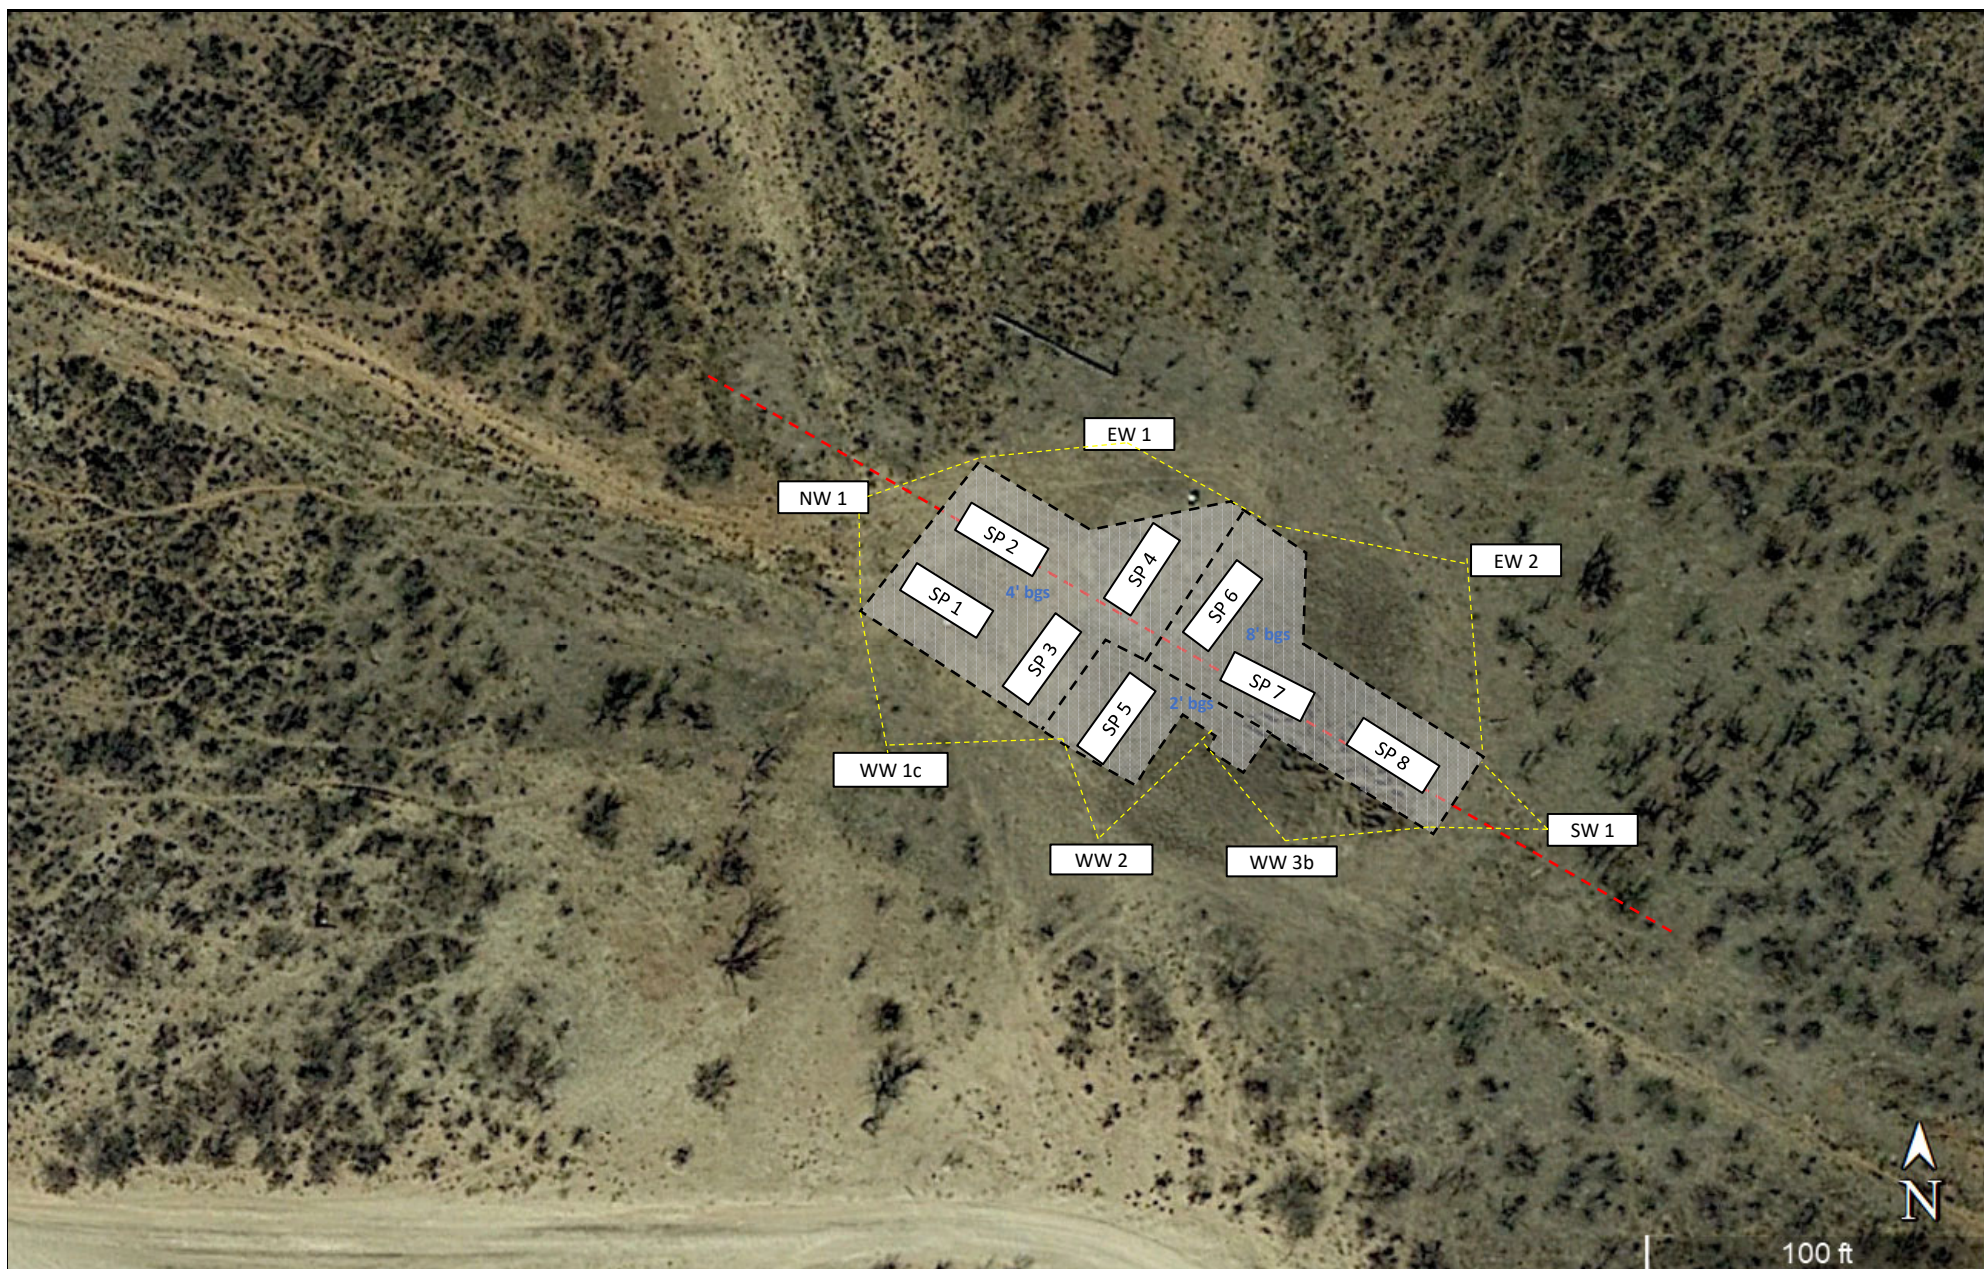
Figure 3

Site and Sample Location Map

- NW 1 Composite Sample Location
- Excavated Area
- Buried Pipeline

A "Site & Sample Location Map" is provided as Figure 3. A "Soil Chemistry Table" is provided as Table 1. Laboratory Analytical Reports are provided in Appendix C. Field data and soil profile logs, if applicable, are provided as Appendix B.

The final dimensions of the excavated area were approximately 150 ft. in length, 24 to 80 ft in width and ranged from 2 to 8 ft. in depth. During the course of remediation activities approximately 864 cubic yards of impacted soil were transported to an NMOCD-approved surface waste facility for disposal.

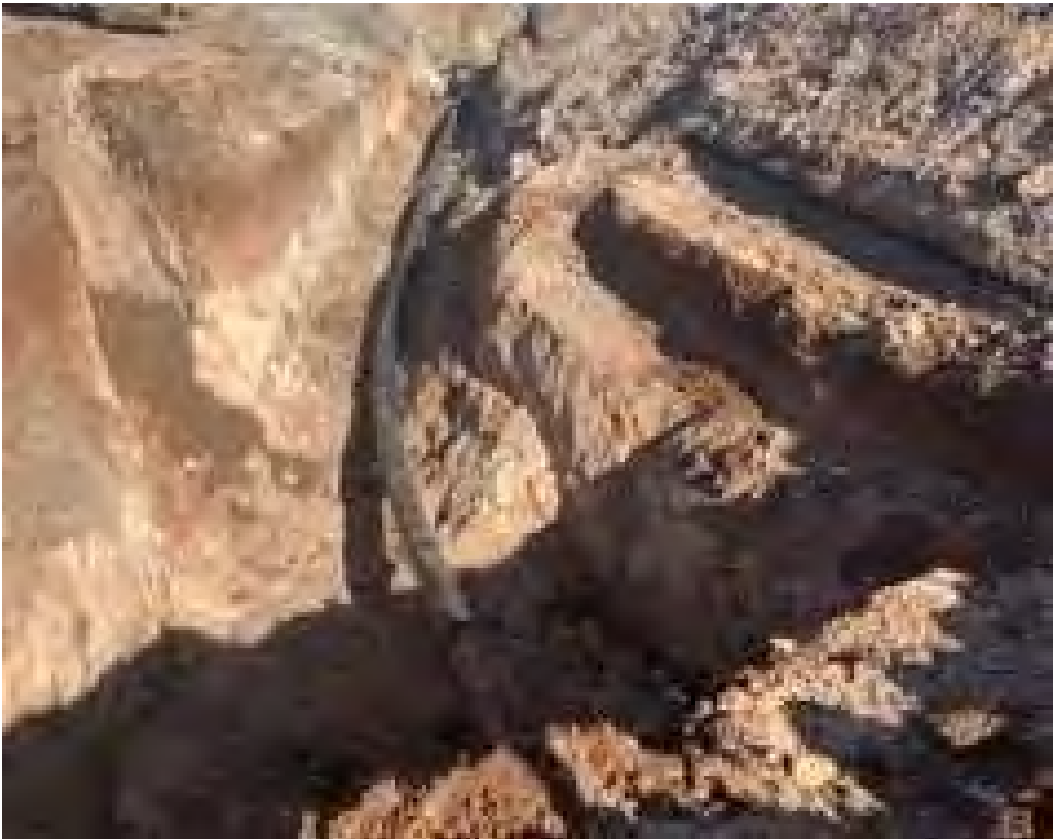
Photo Number: #7

Photo Direction: Northwest	
Photo Description: View from southern end across excavation
