RE: Closure Request
PLU 421 Battery
Incident Number NRM1935235986
Eddy County, New Mexico

LT Environmental, Inc. (LTE), on behalf of XTO Energy, Inc. (XTO), presents the following Closure Request detailing site assessment, soil sampling, and remediation activities at the Poker Lake Unit 421 Battery (Site) in Unit P, Section 27, Township 25 South, Range 30 East, in Eddy County, New Mexico (Figure 1). The purpose of the site assessment and soil sampling activities was to confirm the presence or absence of impacts to soil from a release of crude oil at the Site. Based on field observations, field screening, and laboratory analytical results from soil sampling activities, XTO is submitting this Closure Request and requesting no further action (NFA) for Incident Number NRM1935235986.

PHOTOGRAPHIC LOG

PLU 421 Battery

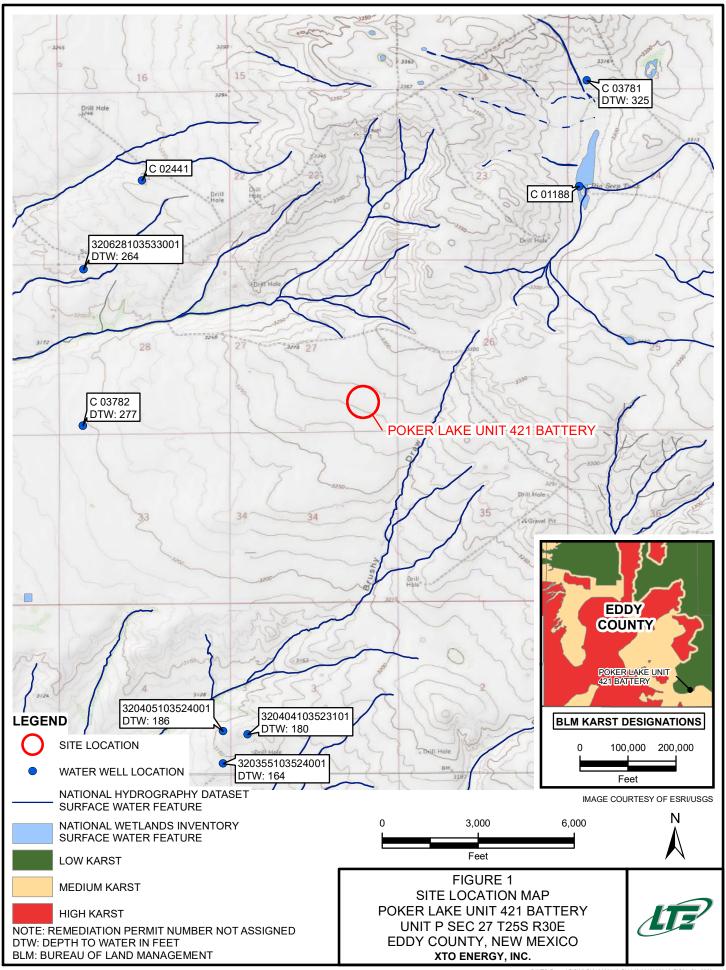
Figure 1 Site Location Map

Site, NMOSE well C-03781 has a reported depth to groundwater of 325 feet bgs. South-southwest of Site, three USGS wells; 320405103524001, 320404103523101, and 320355103524001 have reported depth to groundwater ranging between 164 feet to 186 feet bgs. Based on the groundwater data from nearby wells, a regional trend suggests groundwater at the Site is greater than 100 feet bgs. All wells used for depth to groundwater determination are depicted on Figure 1.

The closest continuously flowing water or significant watercourse to the Site is an intermittent stream, located approximately 2,218 feet southeast of the Site. The Site is greater than 200 feet from a lakebed, sinkhole, or playa lake and greater than 300 feet from an occupied residence, school, hospital, institution, church, or wetland. The Site is greater than 1,000 feet to a freshwater well or spring and is not within a 100-year floodplain or overlying a subsurface mine. The Site is not underlain by unstable geology (low potential karst designation area). Site receptors are identified on Figure 1.

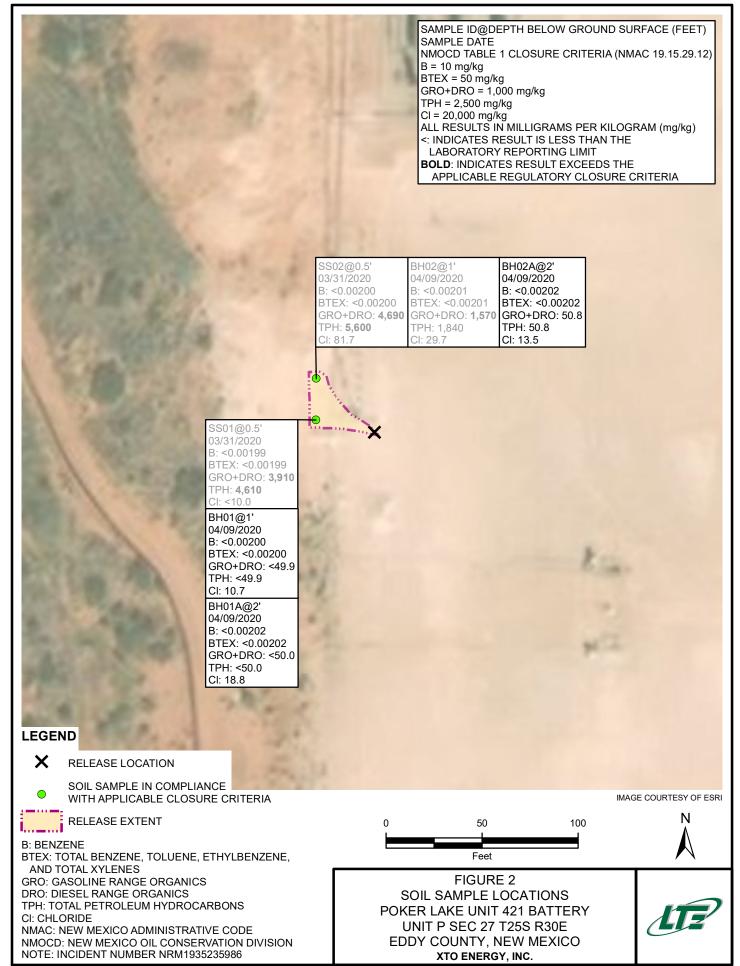
On March 31, 2020, LTE personnel visited the Site to evaluate the release extent. LTE personnel collected and field screened two preliminary soil assessment samples at two locations (SS01 and SS02) within the release extent. The release extent and preliminary soil sample locations were mapped utilizing a handheld Global Positing System (GPS) as presented on Figure 2.

According to laboratory analytical results, TPH-GRO, TPH-DRO, and TPH were reported at concentrations exceeding the Closure Criteria in the preliminary assessment soil samples SS01 and SS02, both located in the western area of the well pad. Based on visible staining in the release area, field screening results, and laboratory analytical results, soil delineation and excavation appeared to be warranted for the release area.

Delineation was conducted on April 9, 2020, to assist in confirming the presence or absence of impacted soil within the footprint of the release. Two boreholes (BH01 and BH02) were advanced to a depth of two feet bgs in the locations of SS01 and SS02, respectively and two discrete soil samples were collected from each borehole utilizing hand auger equipment. Delineation soil samples were collected at one foot and two feet bgs. Soil from the boreholes was field screened for volatile aromatic hydrocarbons and chloride utilizing a PID and Hach© chloride QuanTab© test strips, respectively. Field screening results and observations for each pothole were logged on lithologic/soil sampling logs, which are included in Attachment 2. The locations of delineation boreholes (BH01 through BH02) are presented on Figure 2. The discrete delineation soil samples were collected, handled, and analyzed as described above at Xenco in Carlsbad, New Mexico. Laboratory analytical results indicated TPH-GRO, TPH-DRO, and TPH were above Closure Criteria in BH02, collected at 1 foot bgs. Laboratory analytical results indicated benzene, BTEX, TPH-GRO, TPH-DRO, TPH, and chloride concentrations were compliant with the Closure Criteria in BH01/BH01A and BH02A.

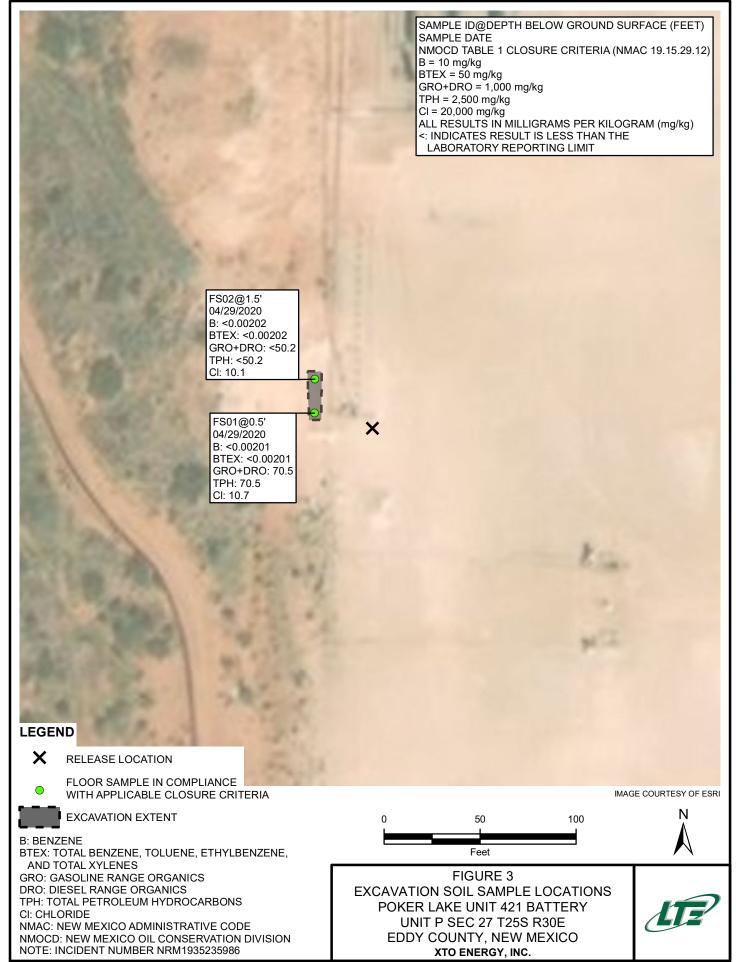
Following removal of impacted soil, LTE collected 5-point composite soil samples at least every 200 square feet from the sidewalls and floor of the excavations. The 5-point composite samples were collected by placing five equivalent aliquots of soil into a 1-gallon, resealable plastic bag and homogenizing the samples by thoroughly mixing. A total of two composite soil samples (FS01 and FS02) were collected from the excavations. The samples were collected at depths of approximately 0.5 feet and 1.5 feet bgs and included representative soil from the floor and sidewalls of the excavation. The excavation soil samples were collected, handled, and analyzed as described above. The locations of final excavation confirmation samples are presented on Figure 3.

The excavation extents totaled approximately 190 square feet. A total of approximately 7 cubic yards of impacted soil were removed during the excavation activities. The impacted soil was transported and properly disposed of at the R360 Facility located in Hobbs, New Mexico. After completion of confirmation sampling, the excavation was secured with fencing.

Laboratory analytical results indicated benzene, BTEX, TPH-GRO, TPH-DRO, TPH, and chloride concentrations were compliant with the Closure Criteria at the completion of the excavation activities in all composite floor soil samples. In addition, analytical results for 3 soil samples from the two boreholes (BH01A and BH02/BH02A) indicate benzene, BTEX, TPH-GRO, TPH-DRO, TPH, and chloride concentrations were compliant with Closure Criteria. The laboratory analytical results are summarized in Table 1 and the laboratory data reports are provided in Attachment 3.

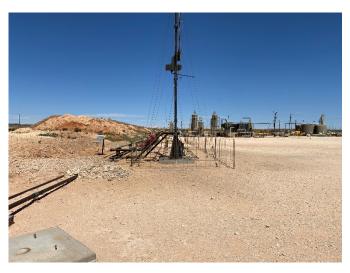
Photograph 1: View of flare facing north.

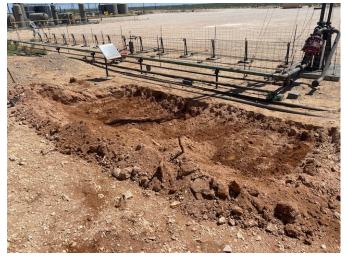
Photograph 3: View of final excavation facing northeast.

On April 29, 2020, LTE oversaw excavation activities to remediate impacted soil as indicated by visual observations, field screening results, and preliminary soil sample results. Excavation activities were performed using track-mounted backhoe and transport vehicle in the above referenced impacted areas near SS01, SS02, and BH02 at 1 foot bgs. The excavations were located on the western area of the well pad. Photographic documentation was conducted during the visit to the Site and is included in Attachment 1.
