Huber Federal #10 CTB

Closure Report

API No. 30-015-44848

Incident #NRH2002849703

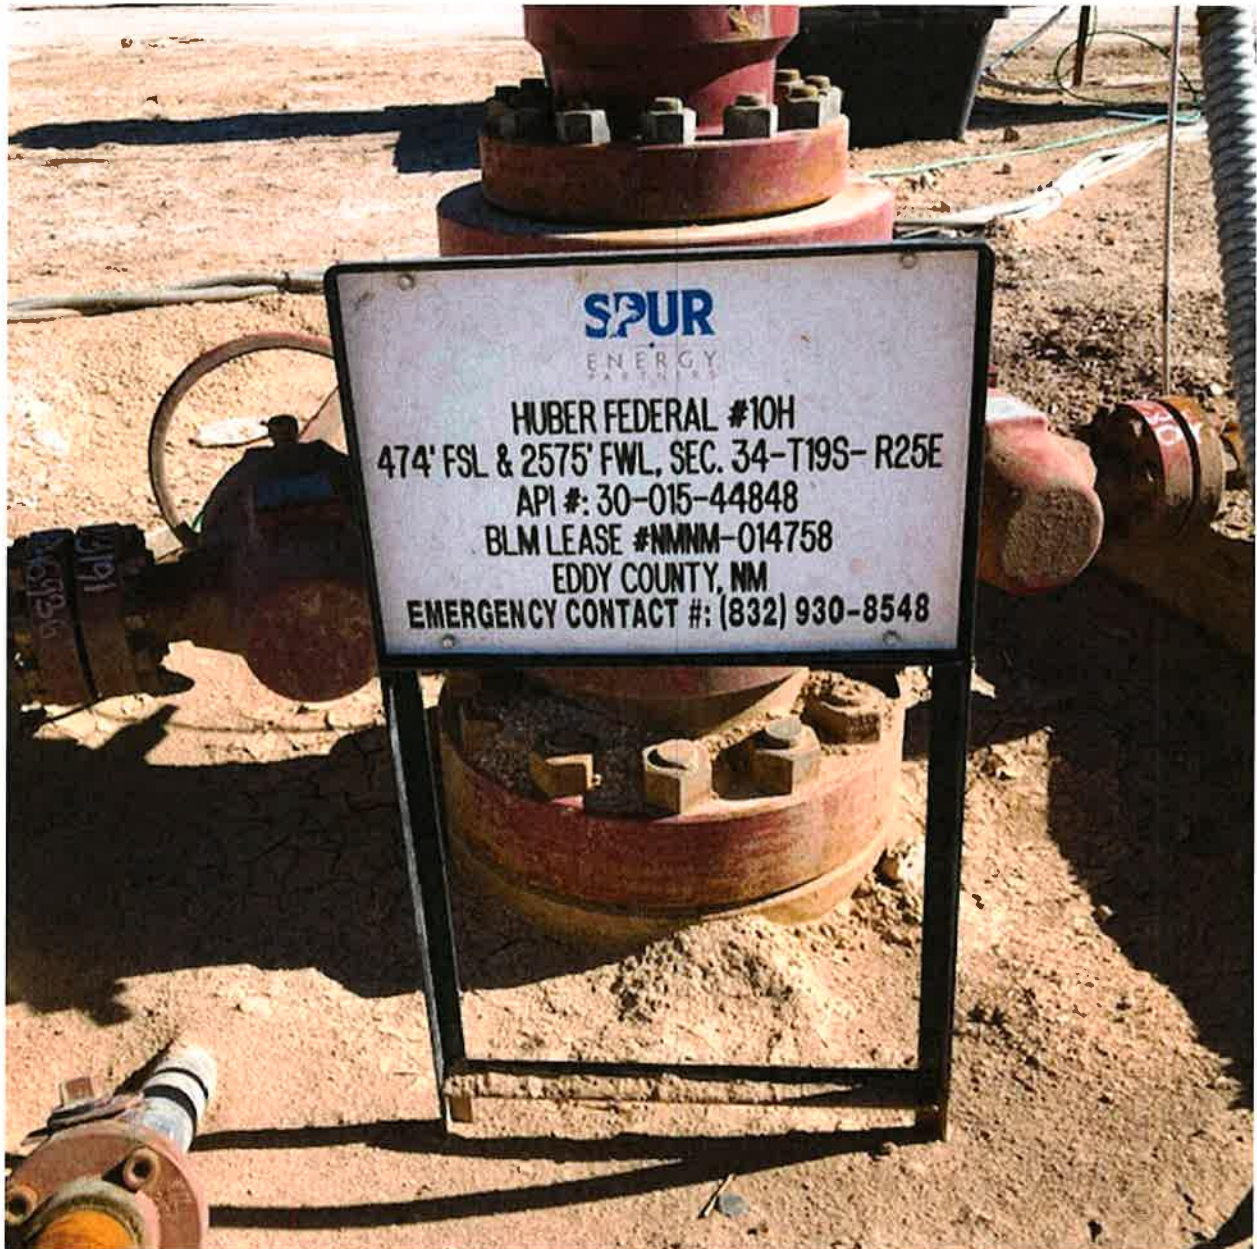
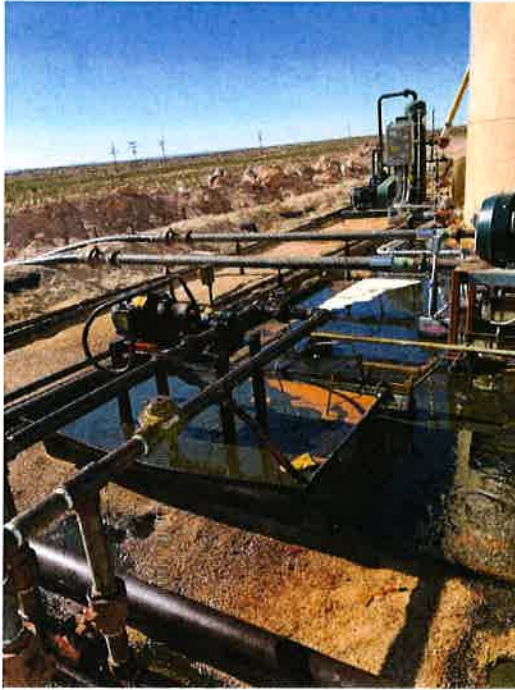
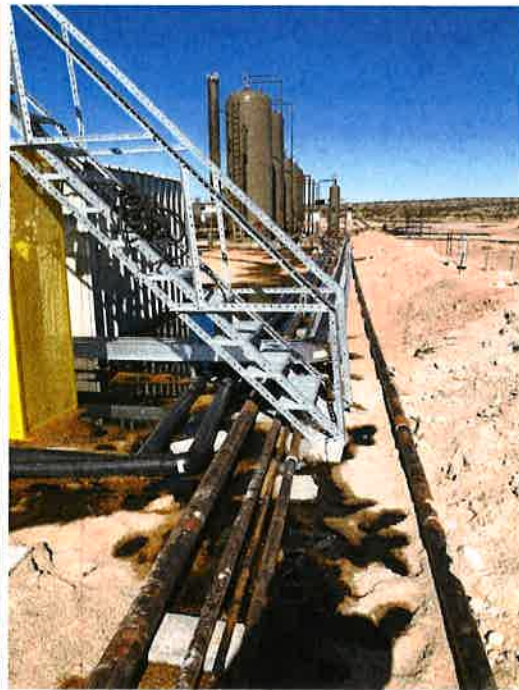
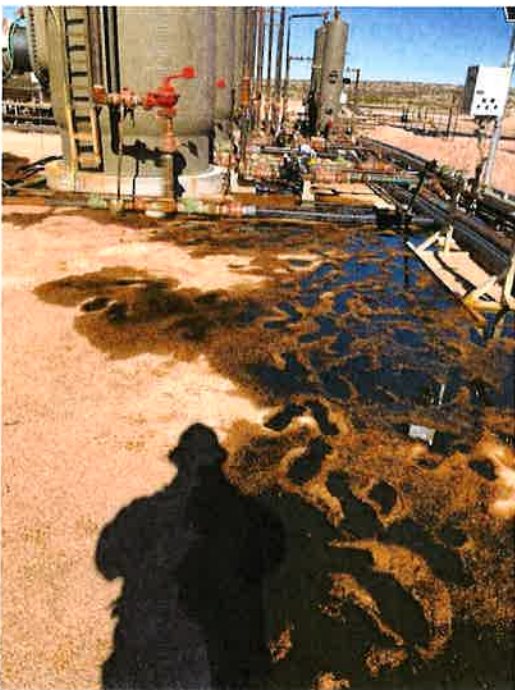
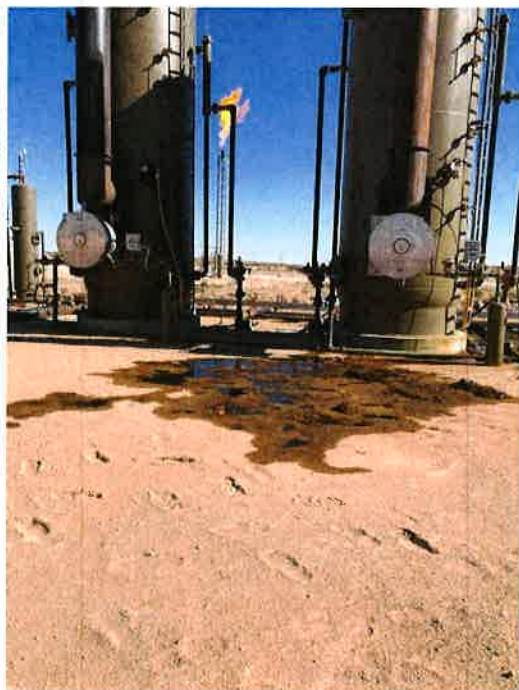
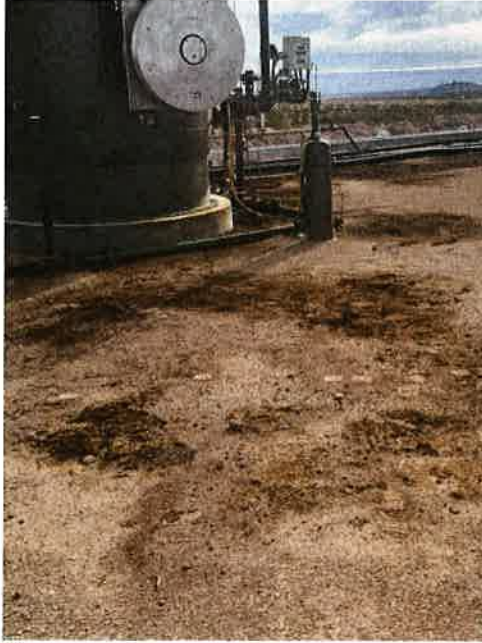
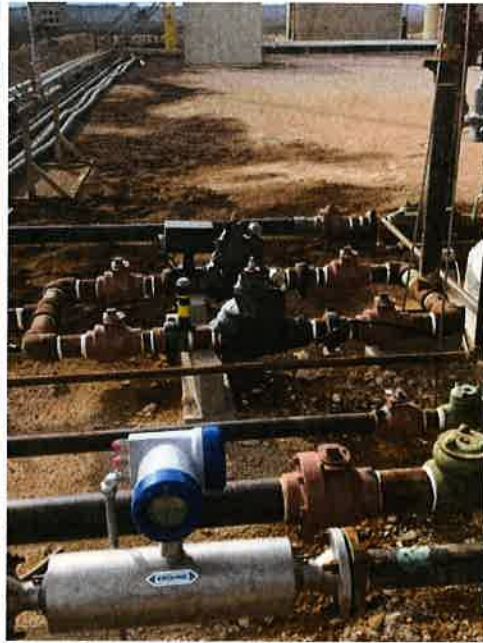
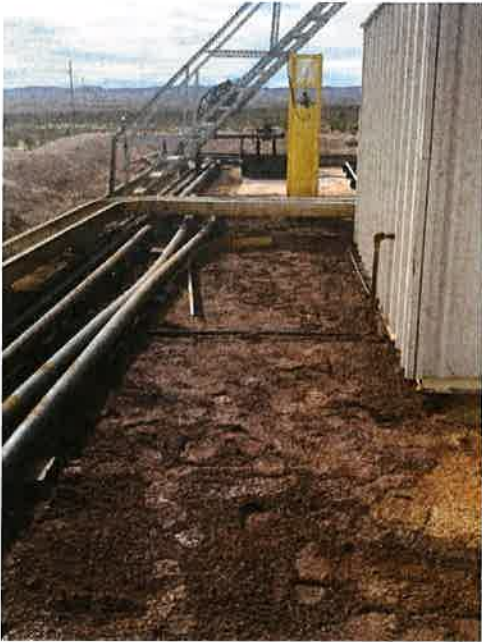
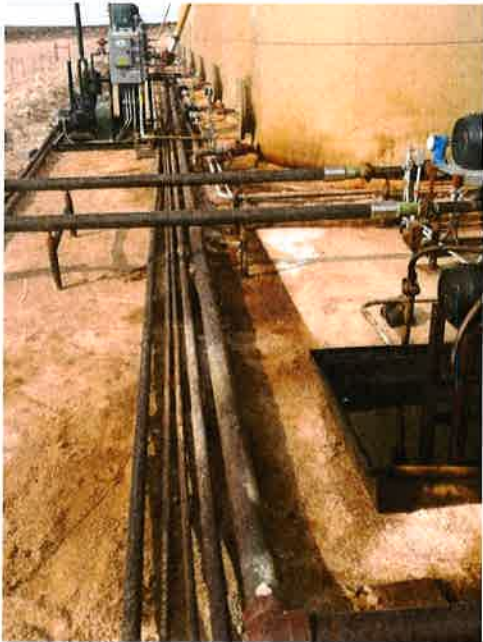
**SPUR ENERGY PARTNERS
HUBER FEDERAL 10 CTB
BEFORE PHOTOS**

This site is located in Eddy County. The release was discovered on December 21st, 2019. The release was caused due to the recirculating pump at the facility had blown the mechanical seal and released oil into the lined facility. Approximately 5bbls of crude oil was released into the lined containment. A vacuum truck was dispatched to the site and approximately 3.5bbls of fluid was recovered and hauled to an approved disposal site. Estimated area of impact is 85' x 6' or 510 sq. ft.
