Release Notification

Site Name Lambe 2C	Site Type Gas Well
Date Release Discovered 12/17/18 @ 10:30am	API# 30-045-30747

RE: Lambe 2C (30-045-30747) Site Characterization and Remediation plan

- Figure 1 – Site Location Map
- Figure 2 – Initial Site Investigation Map
- Figure 3 – Monitoring Well Borehole Map
- Table 1 – Soil Analytical Results
- Table 2 – Water Analytical Results
- Attachment 1 – Photo Log
- Attachment 2 - Soil Boring Logs
- Attachment 3 – Laboratory Analytical Reports

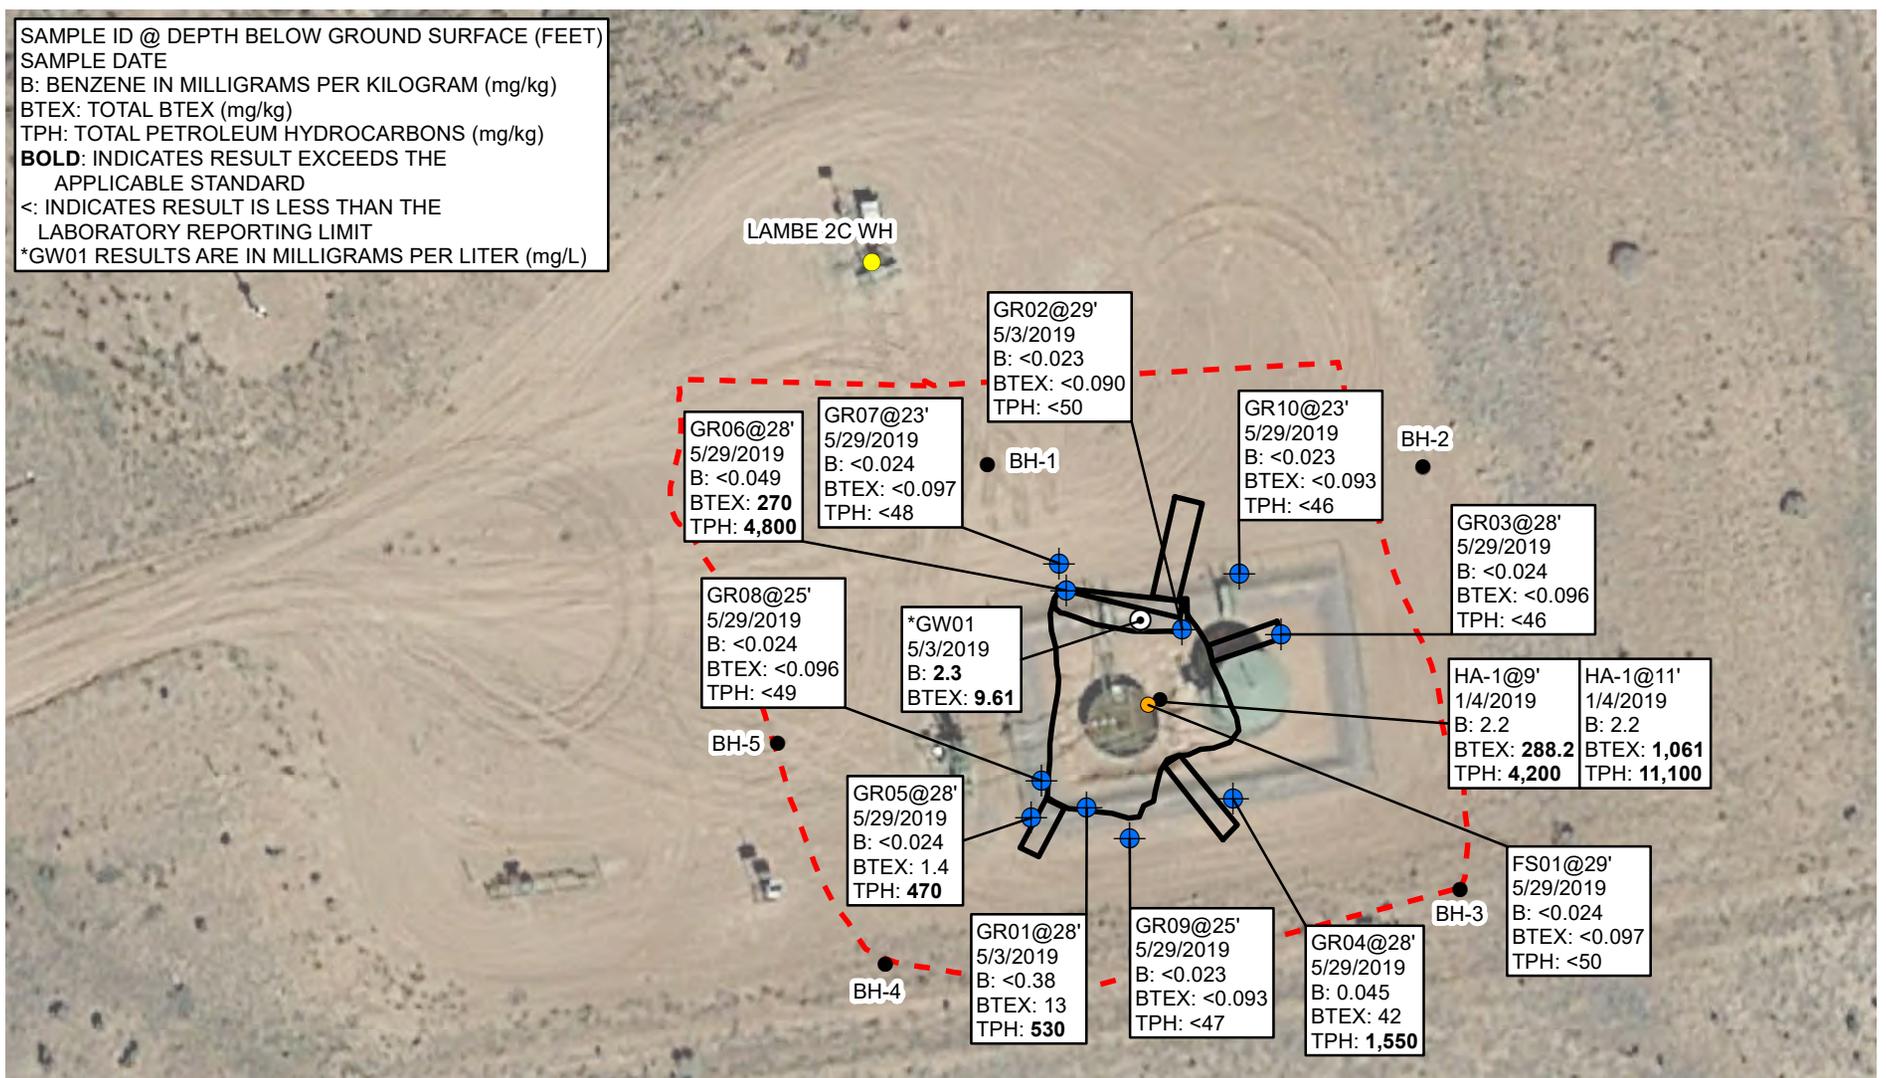
- WELLHEAD
- BOREHOLE
- COMPOSITE SOIL SAMPLE
- ⊕ DISCRETE SOIL SAMPLE
- ⊙ GROUNDWATER GRAB SAMPLE
- EXCAVATION EXTENT 05/03/2019
- BASE OF EXCAVATION

SAMPLE ID @ DEPTH BELOW GROUND SURFACE (FEET)
 SAMPLE DATE
 B: BENZENE IN MILLIGRAMS PER KILOGRAM (mg/kg)
 BTEX: TOTAL BTEX (mg/kg)
 TPH: TOTAL PETROLEUM HYDROCARBONS (mg/kg)
BOLD: INDICATES RESULT EXCEEDS THE APPLICABLE STANDARD
 <: INDICATES RESULT IS LESS THAN THE LABORATORY REPORTING LIMIT
 *GW01 RESULTS ARE IN MILLIGRAMS PER LITER (mg/L)

Field-identified soil impacts consisting of visual staining, hydrocarbon odors, and/or elevated field screening results were observed in the hand auger borehole HA-1 (9 to 11.5 ft bgs), excavation grab samples (GR01 @ 28', GR04 @ 28', GR05 @ 28', and GR06 @ 28'), and in monitoring well borehole sample MW01 @ 25'-30'. The TPH concentrations exceeding the NMOCD remediation action level ranged from 180 mg/kg in monitoring well borehole MW01 @ 25'-30' to 11,100 mg/kg in hand auger borehole HA-1 @ 11'. A benzene concentration of 20 mg/kg was detected in hand auger borehole HA-1 @ 11'. Total BTEX concentrations exceeding the NMOCD remediation action level ranged from 276 mg/kg in excavation grab sample GR06 @ 28' to 1,061 mg/kg in hand auger borehole HA-1 @ 11'.

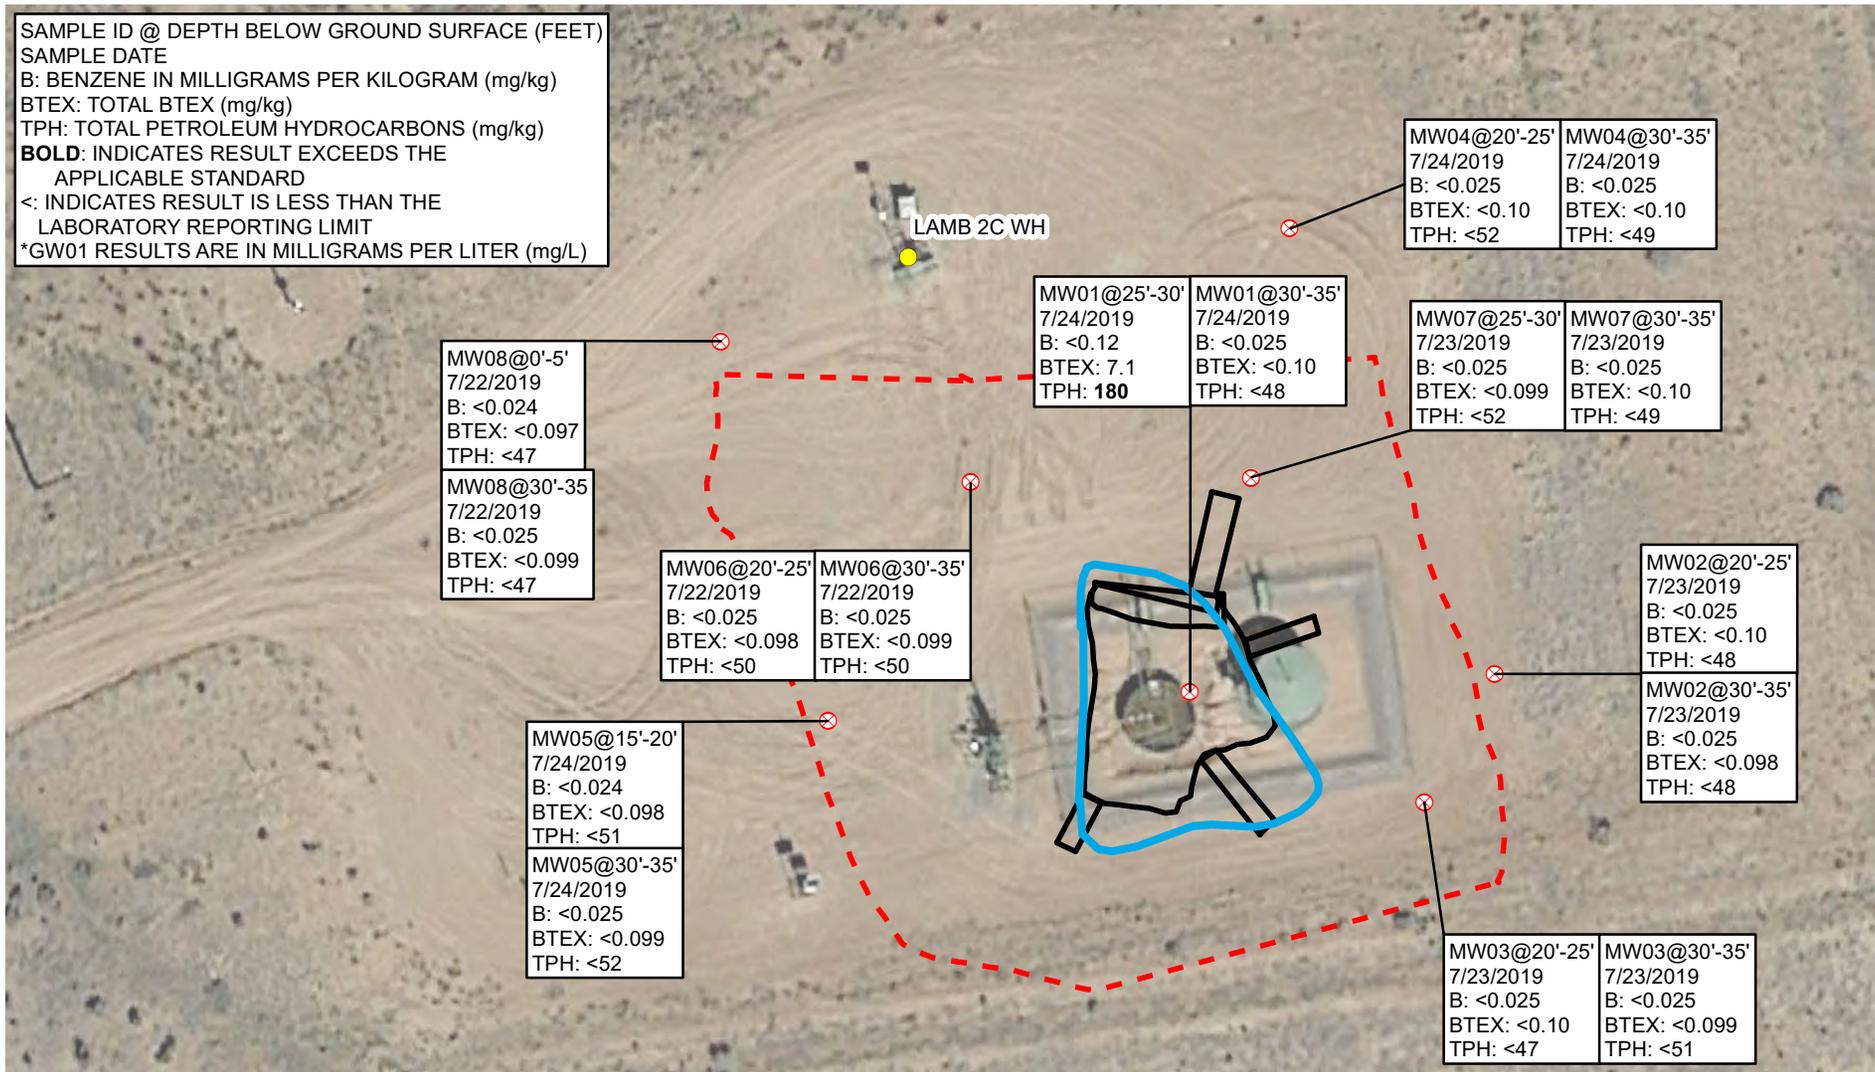
- MONITORING WELL
- WELLHEAD
- EXCAVATION EXTENT 05/03/2019
- BASE OF EXCAVATION
- REMAINING IMPACTED SOIL

Following installation, LTE personnel were onsite to gauge groundwater levels and develop the monitoring wells on June 26, 2019. During this event, groundwater was not observed in any of the wells. On August 1, 2019, LTE return to the Site to determine if groundwater had infiltrated the monitoring wells with enough of a volume to develop or collect groundwater samples. Again, no groundwater was observed in any of the monitoring wells.

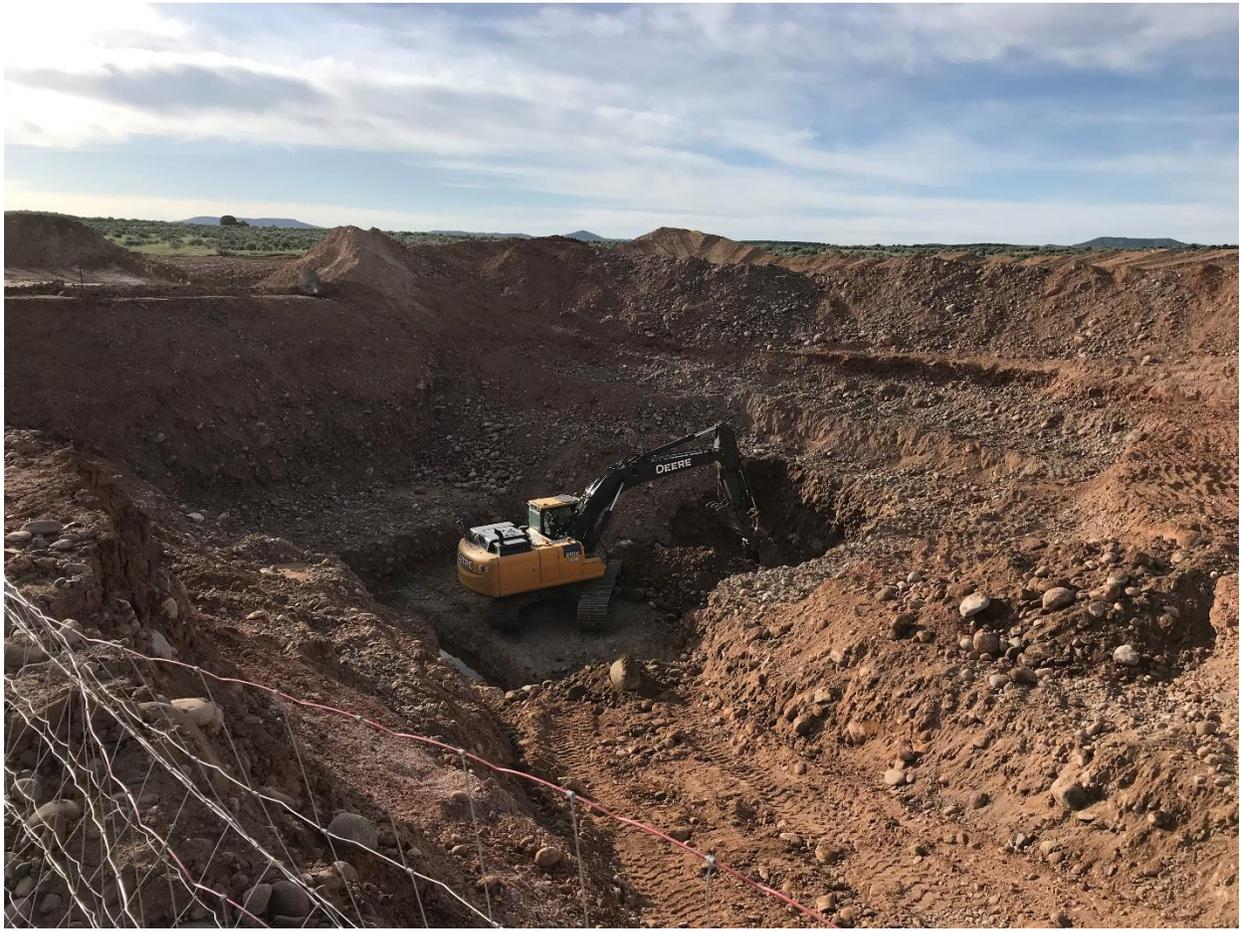
Excavation Extent

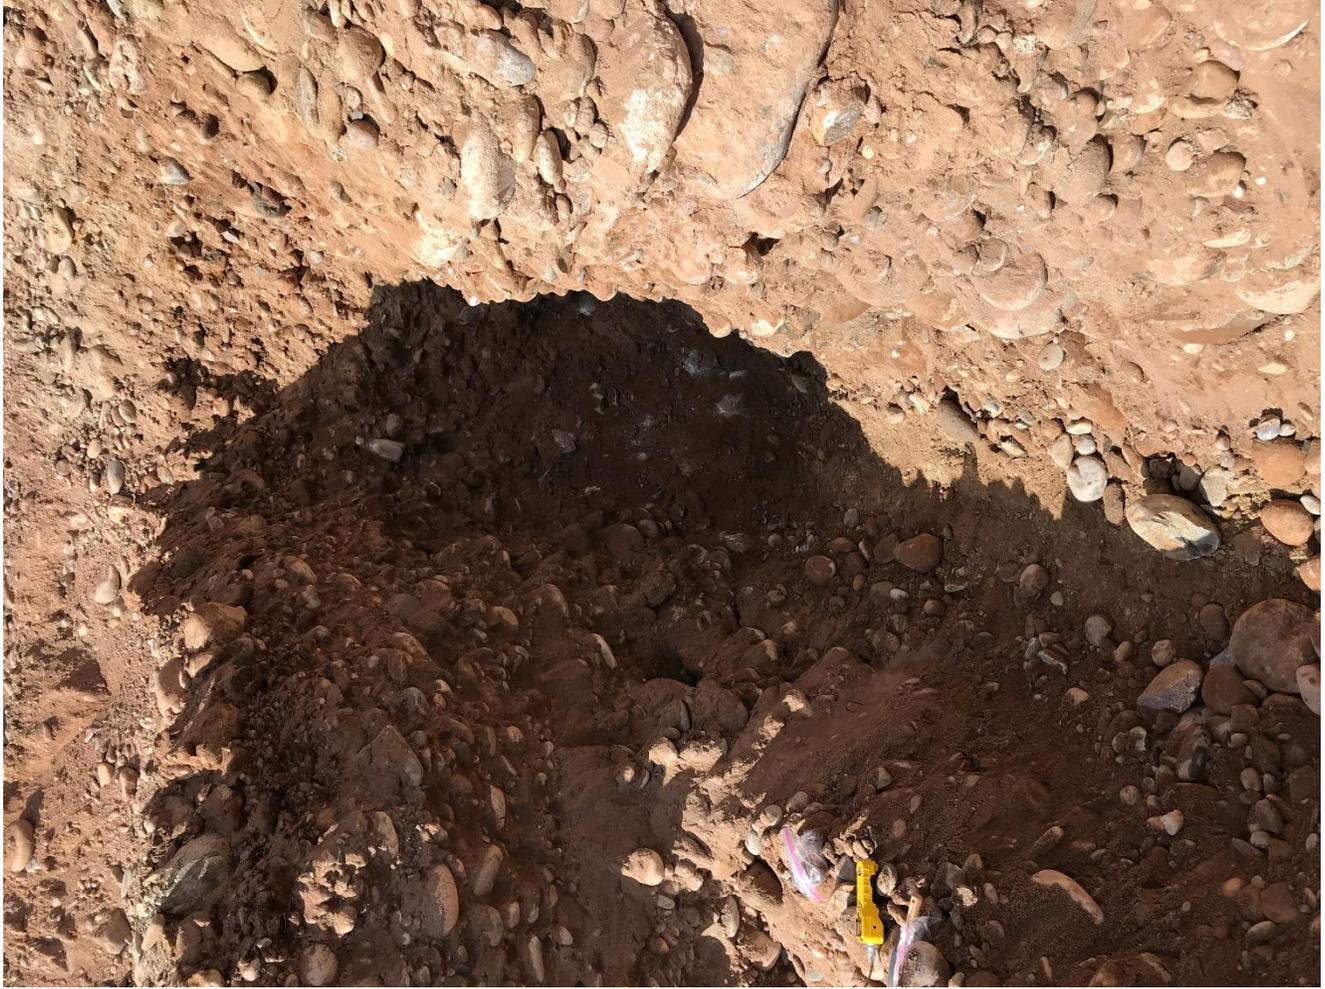
Cobbles in the subsurface

The geology at the Site consists of dark reddish-brown, dry, silty sand to approximately 14 feet bgs, followed by a loose, dry, sand and gravel with cobbles greater than eight inches in diameter to approximately 25 feet bgs. From approximately 25 feet to 35 feet bgs, a dense, light brown, slightly moist, sandy silt was encountered. Moist sediments were encountered near 30 feet bgs, but no saturated sediments were observed and no clear water table was identified in the soil borings. LTE set the groundwater monitoring wells with screened intervals corresponding to the moist intervals and the depth of the excavation where potential groundwater was previously observed.

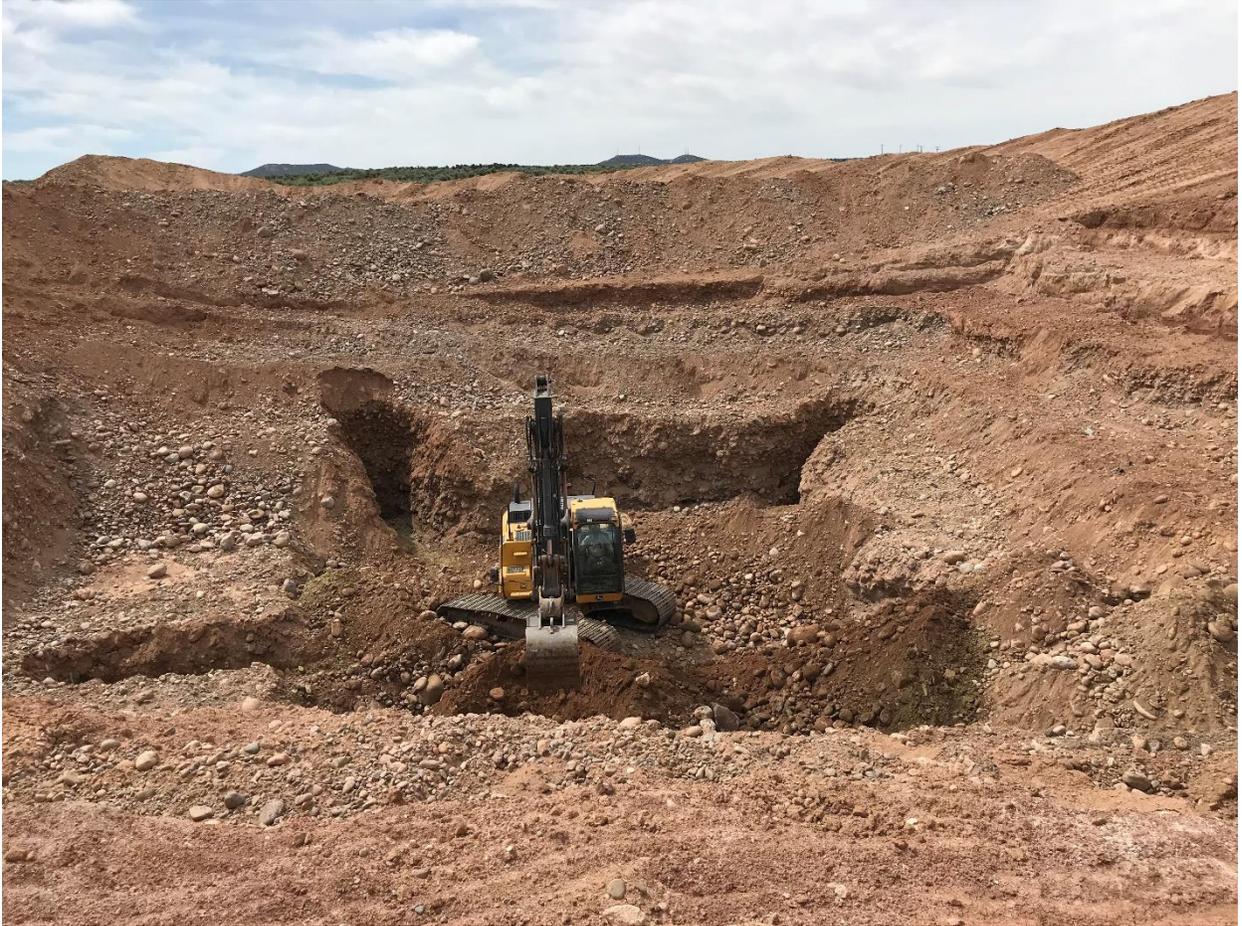
Trenching Activities

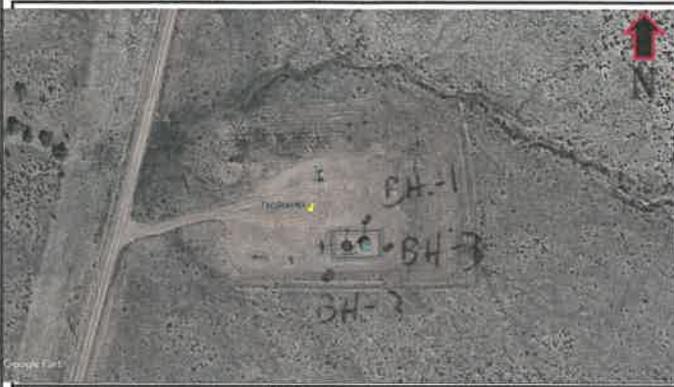
Boring/Well Number: BH-3	Project: Lambe 2C
Date: 1-3-2019	Project Number: 017818005
Logged By: Josh Adams	Drilled By: Geomat

Penetration Resistance	Moisture Content	Vapor (ppm)	HC Staining?	Sample #	Depth (ft. bgs.)	Sample Run	Recovery	Soil/Rock Type	Lithology/Remarks	Well Completion
					0	0-5	X	NR	7.5YR 5/8 Brown, sandy silt, cohesive, slightly plastic, no odor or stain ↓	
					1					
	M	0.2	N		2	0-5		ML	SAA	
					3					
	M	0.3	N		4	0-5		ML		
					5				SAA	
	M	0.3	N		6	5-7.5		ML		
					7				brown poorly graded sand w/ gravel cobbles encountered, remake sampler, NR	
	P	0.1	N		8	5-7.5		SP		
					9				refusal @ 9.5' cobbles	
					10					
					11					
					12					
					13					
					14					
					15

Since hand augering was insufficient for penetrating the subsurface deeper than 11 feet bgs, four boreholes (BH-1 to BH-4) were advanced via hollow-stem auger outside of the bermed area in each cardinal direction from the known impacted area on January 4, 2019. Boreholes were advanced to 9 feet to 12 feet bgs before refusal was encountered at what was determined to be a cobble layer. Soil in the boreholes was described and field screened. No impacts were observed via field screening and no soil samples were collected from the hollow-stem boreholes. Soil boring logs are included as Attachment 2.

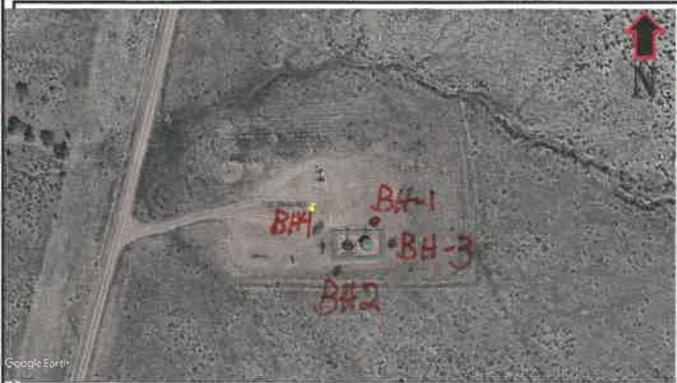
Boring/Well Number: BH-4	Project: Lambe 2C
Date: 1-3-2019	Project Number: 017818055
Logged By: Josh Adams	Drilled By: Geomat

Elevation:	Detector: PID	Drilling Method: Hollow Stem	Sampling Method: Continuous/Split Spoon
Gravel Pack:	Seal:	Grout:	
Casing Type:	Diameter: 2"	Length:	Hole Diameter:
Screen Type:	Slot:	Diameter: 2"	Length: 9.0'

Penetration Resistance	Moisture Content	Vapor (ppm)	HC Staining?	Sample #	Depth (ft. bgs.)	Sample Run	Recovery	Soil/Rock Type	Lithology/Remarks	Well Completion
					0					
					1	0-5	X	NR	10YR 3/6 dark brown sandy silt cohesive, plastic no odor or stain	
	M	0.6	N		2	0-5	✓	ML		
	M	0.4	N		3		✓			
					4	0-5	✓	ML	SAA	
					5		✓			
					6	5-8	X	NR		
		0.4			7	5-8	✓	CH	10YR 3/6 dark brown sandy fine clay some gravel @ bottom of sampler	
					8		✓			
					9				cobbles/gravel encountered ~ 8' bgs, remove sampler	
					10					
					11					
					12					
					13					
					14					
					15				refusal @ 9' cobbles

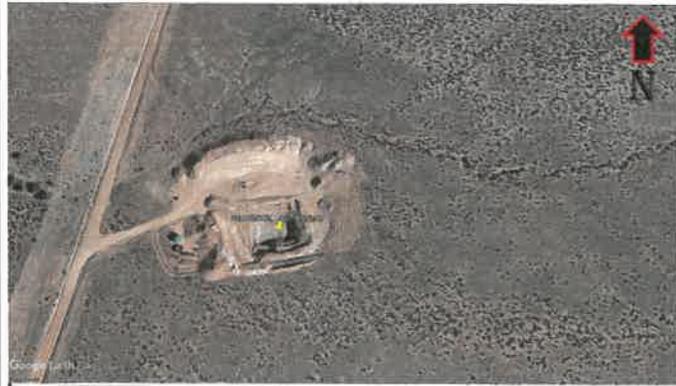
Penetration Resistance	Moisture Content	Vapor (ppm)	HC Staining?	Sample #	Depth (ft. bgs.)	Sample Run	Recovery	Soil/Rock Type	Lithology/Remarks	Well Completion	
	Dry	0.0	NO		0			SP-SM	compact, lb. reddish brown, medium grain poorly sorted, trace silicified	X	X
					1					X	X
					2					X	X
					3	1				X	X
					4					X	X
					5			SP-SM	SAA no stain/odor	X	X
					6					X	X
					7					X	X
					8					X	X
	Dry	1.1	NO		9	2		GP	Loose, lb. brown, poorly sorted coarse sand and gravel, cobbles up to 8" diameter NO stain/odor	X	X
					10					X	X
					11					X	X
					12					X	X
					13	3				X	X
					14					X	X
		9.8			15			GP	SAA, cobbles < 8" diameter no stain/odor	X	X

Penetration Resistance	Moisture Content	Vapor (ppm)	Staining	Sample #	Depth (ft. bgs.)	Sample Run	Recovery	Soil/Rock Type	Lithology/Remarks	Well Completion
					15					
					16					
					17					
					18	4		GP	SAA no stain/odor	
	Dry	5.1	NO		19					
					20					
					21					
					22					
					23	5				
					24			GP	SAA no stain/odor	
	moist	19.9	NO	MW06 20-25' 8:15	25					
					26					
					27			GP	SAA no stain/odor	
	wet				28	GW				GW
					29	6				
	moist	1.6	NO		30			SM	Compact, dark brown black, fine sand and silt, some clay < 15% no stain/odor	
					31					
					32	7				
					33					
					34			SM	Compact, lt brown, fine sand & silt some clay < 15% no stain/odor	
	moist	0.0	NO	MW06 30-35' 7:00	35					
					36					
					37
