SUBJECT: Closure Report for the Mohawk State #001 Release (NGRL1313754595), Chaves County, New Mexico

On behalf of Marathon Oil Permian LLC (Marathon), Souder, Miller & Associates (SMA) has prepared this Closure Report that describes the activities of a release of liquids related to oil and gas production activities at the Mohawk State #001 site. The site is in Unit P, Section 20, Township 8S, Range 33E, Chaves County, New Mexico, on State land. Figure 1 illustrates the vicinity and site location on an USGS 7.5-minute quadrangle map.

Table 1: Release Information and Closure Criteria			
Name	Mohawk State #001	Company	Marathon Oil Permian, LLC
API Number	30-005-29108	Location	33.6002, -103.58209
Incident Number	NGRL1313754595		
Estimated Date of Release	April 30, 2013	Date Reported to NMOCD	April 30, 2013
Landowner	State	Reported To	NMOCD
Source of Release	Heater treater sight glass		
Released Volume	15 bbls	Released Material	Oil & Produced Water
Recovered Volume	15 bbls	Net Release	0
NMOCD Closure Criteria	>100 feet to groundwater		
SMA Response Dates	August 5, September 24-25, October 8, 2019

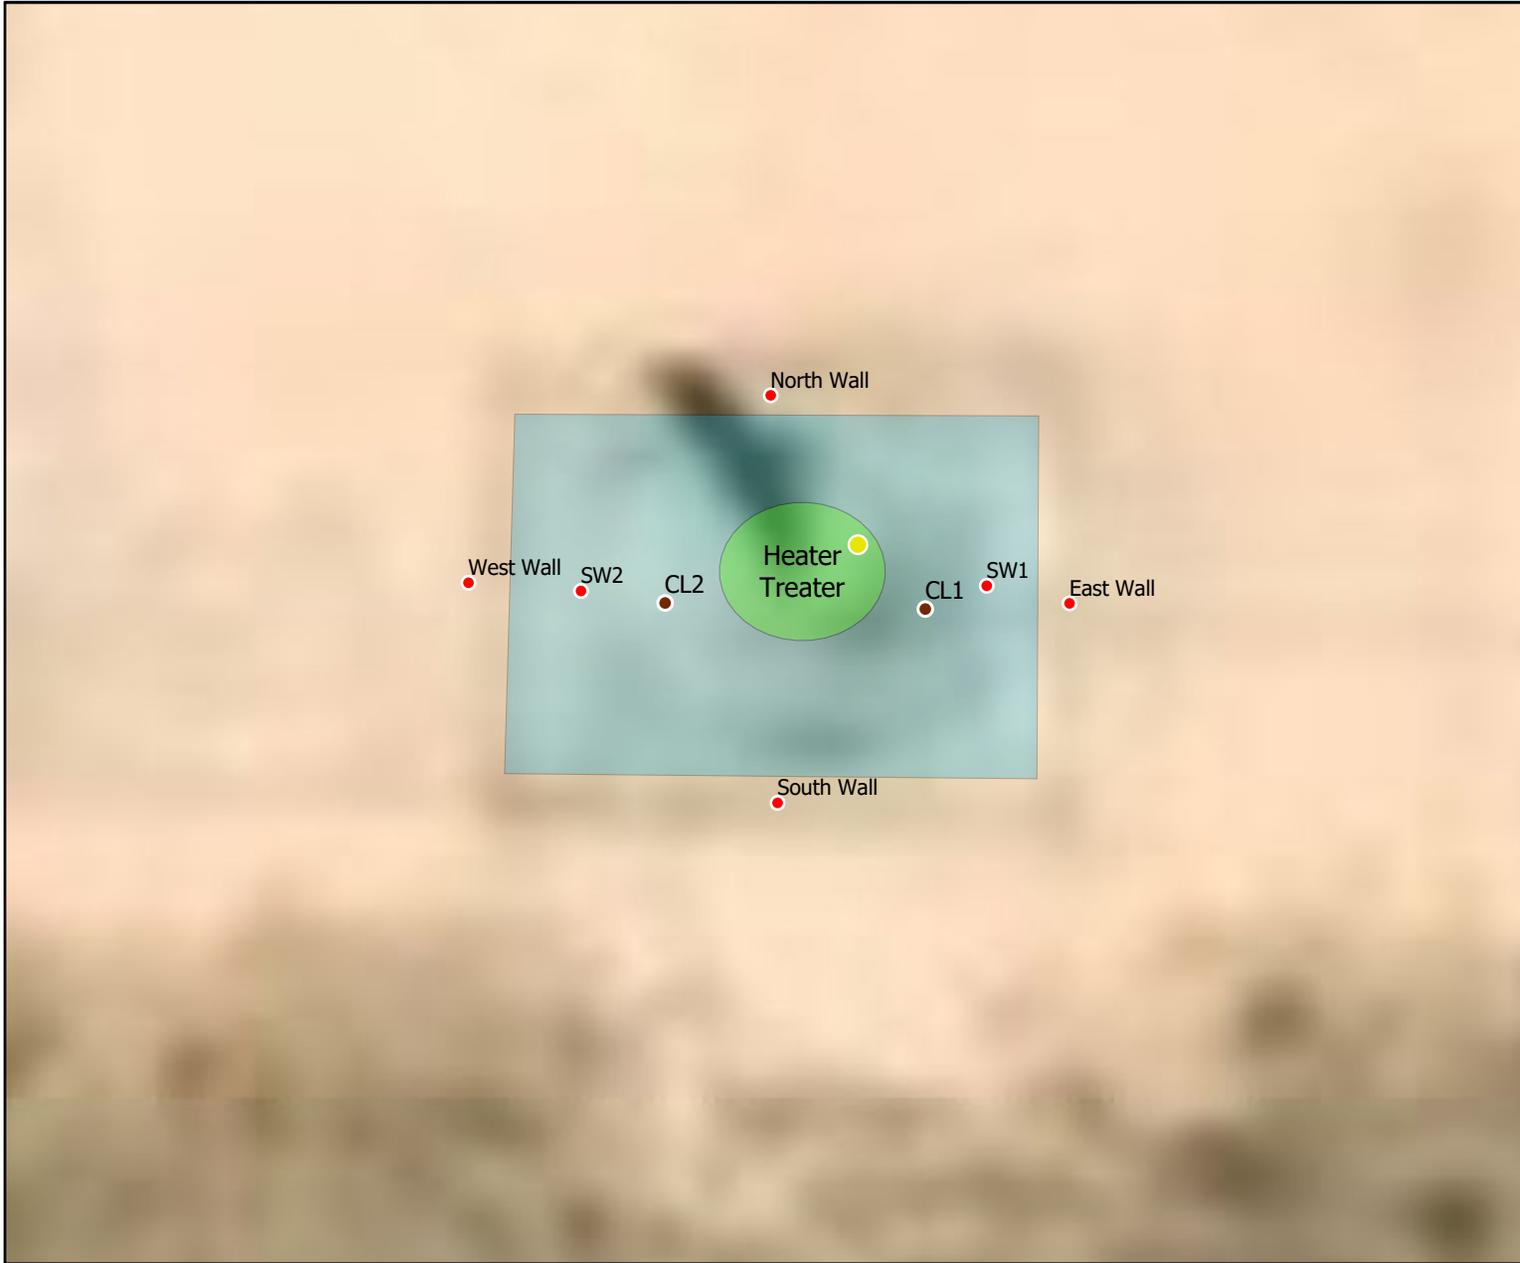
Laboratory results indicate that NMOCD closure criteria for groundwater depth of greater than 100 feet bgs service has been met. Figure 3 shows the extent of the excavation and sample locations.

- Point of Release
- BH Sample Locations
- SW Sample Locations
- 1.5' Excavation

Site and Sample Location Map
 Mohawk State (Heater Treater) - Marathon Oil LLC
 UL: P S: 20 T: 8S R: 33E Chaves County, New Mexico

From September 24-25, 2019, SMA personnel returned to the site to oversee excavation within the dirt containment. The impact area was excavated to a depth of 1.5 ft. bgs utilizing hand tools. The area of excavation measured approximately 29 feet by 23 feet.

Upon completion, two samples (CL1, CL2) were collected from the base, and two samples (CSW1, CSW2) were collected from the sidewalls of the excavation and processed for the laboratory methods as described above. After excavation, a 20-mil liner was placed in the footprint of the excavation.

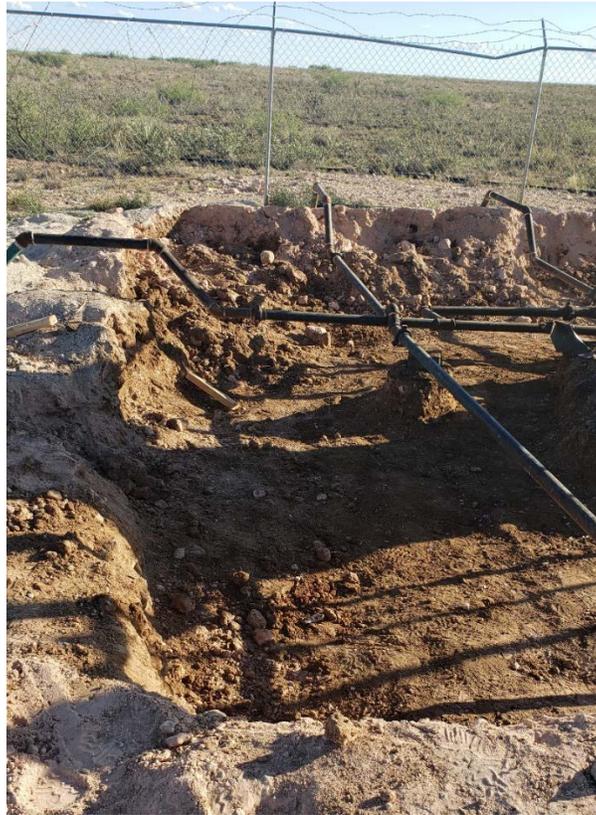
SW1, CL1 facing south

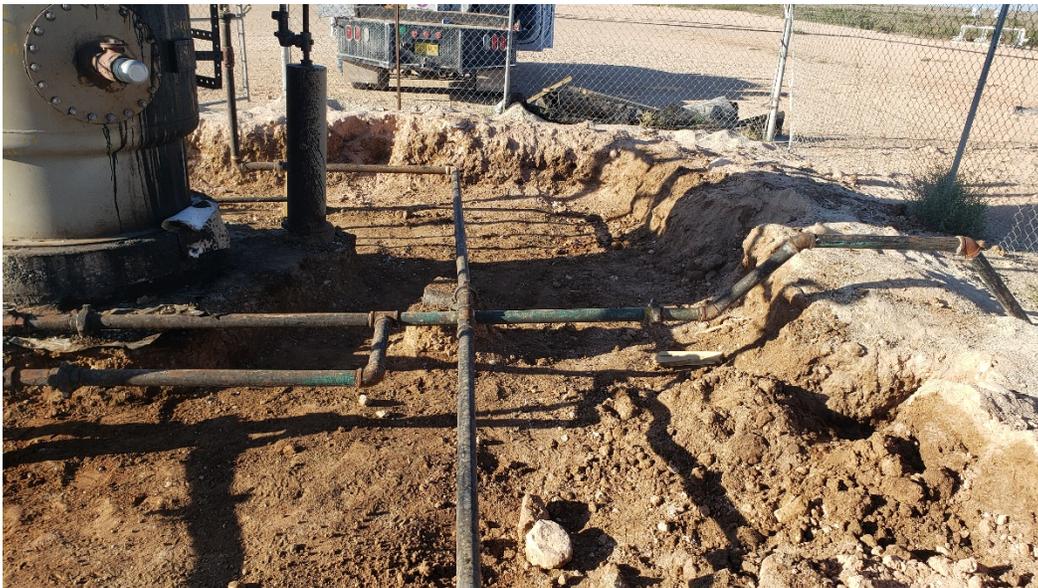
SW1, CL1 facing north

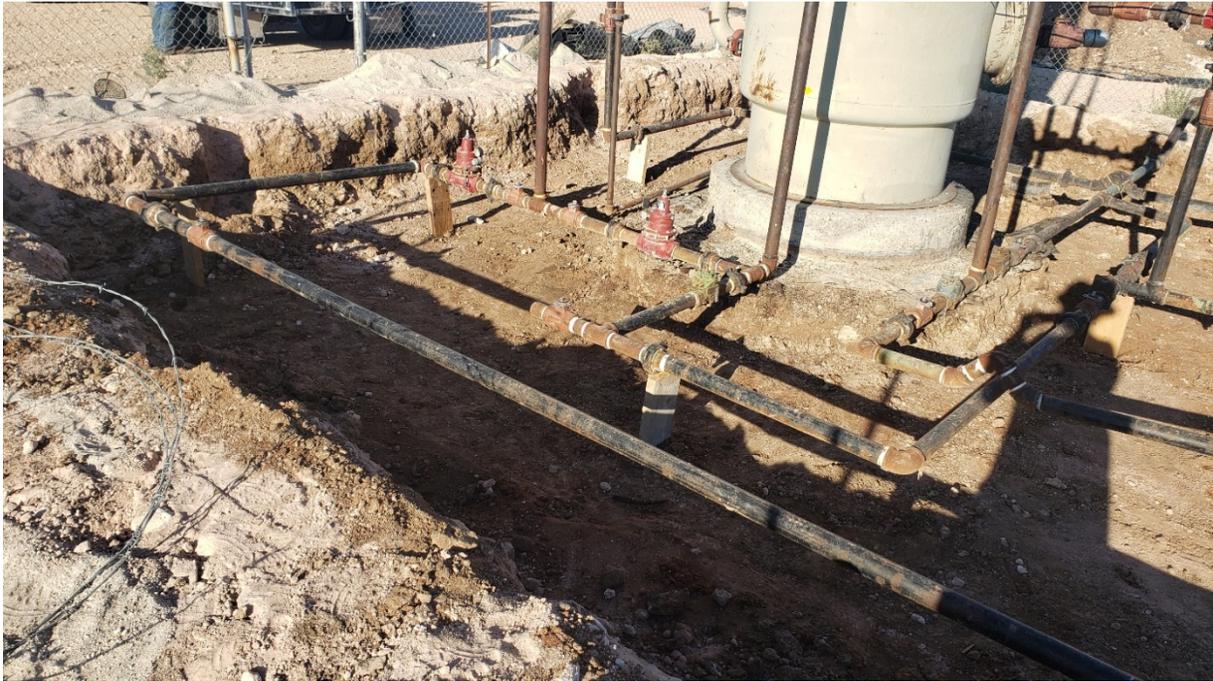
SW2, CL2 facing east

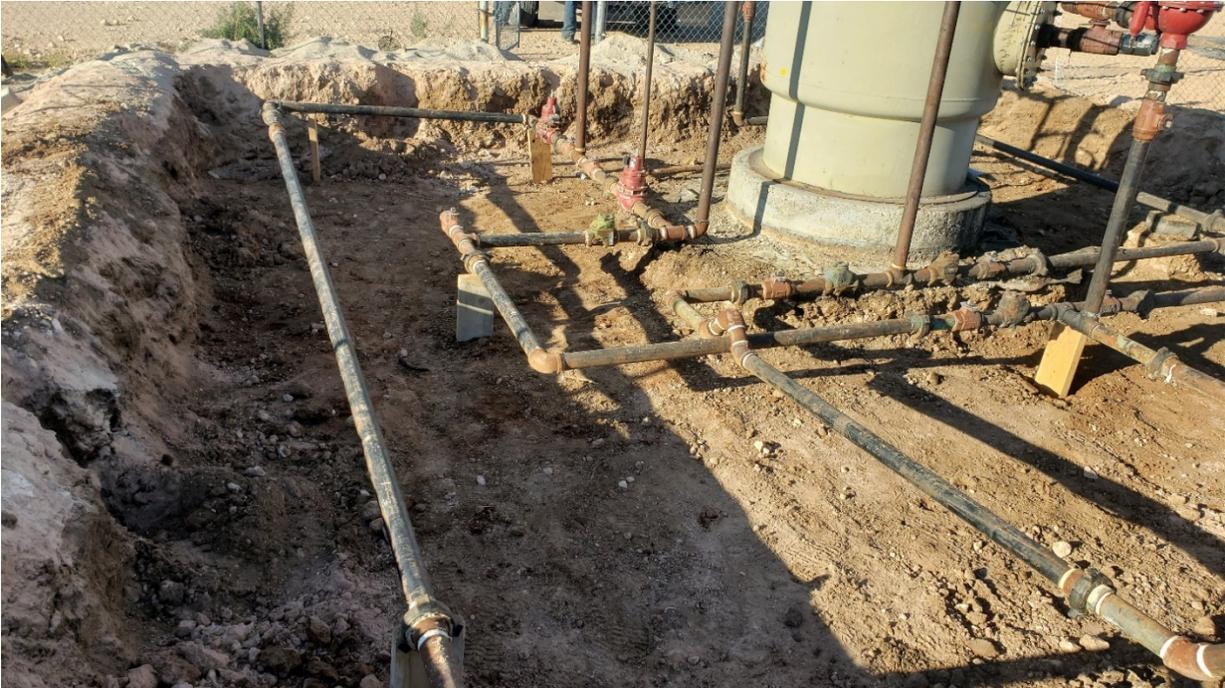
SW2, CL2 facing north.
