Report Type: Closure Report 1RP-5362

Site:	Macho State #001H				
Company:	COG Operating LLC				
Section, Township and Range	Unit D	Sec. 02	T 24S	R 33E	
Lease Number:	API No. 30-025-39884				
County:	Lea County				
GPS:	32.25163			-103.55052	
Surface Owner:	State				
Directions:	From the intersection of Delaware Basin Rd (HWY 21) and X-L Road, turn west on X-L Road and travel approximately 3.9 miles to the end of the lease road. Turn south onto lease road and travel approximately 1.3 miles. Turn east onto lease road and travel approximately 1.1 miles to the end of the lease road. Site is adjacent south to the pad location.

Re: Closure Report for the COG Operating, LLC, Macho State #001H, Unit D, Section 02, Township 24 South, Range 33 East, Lea County, New Mexico. 1RP-5362

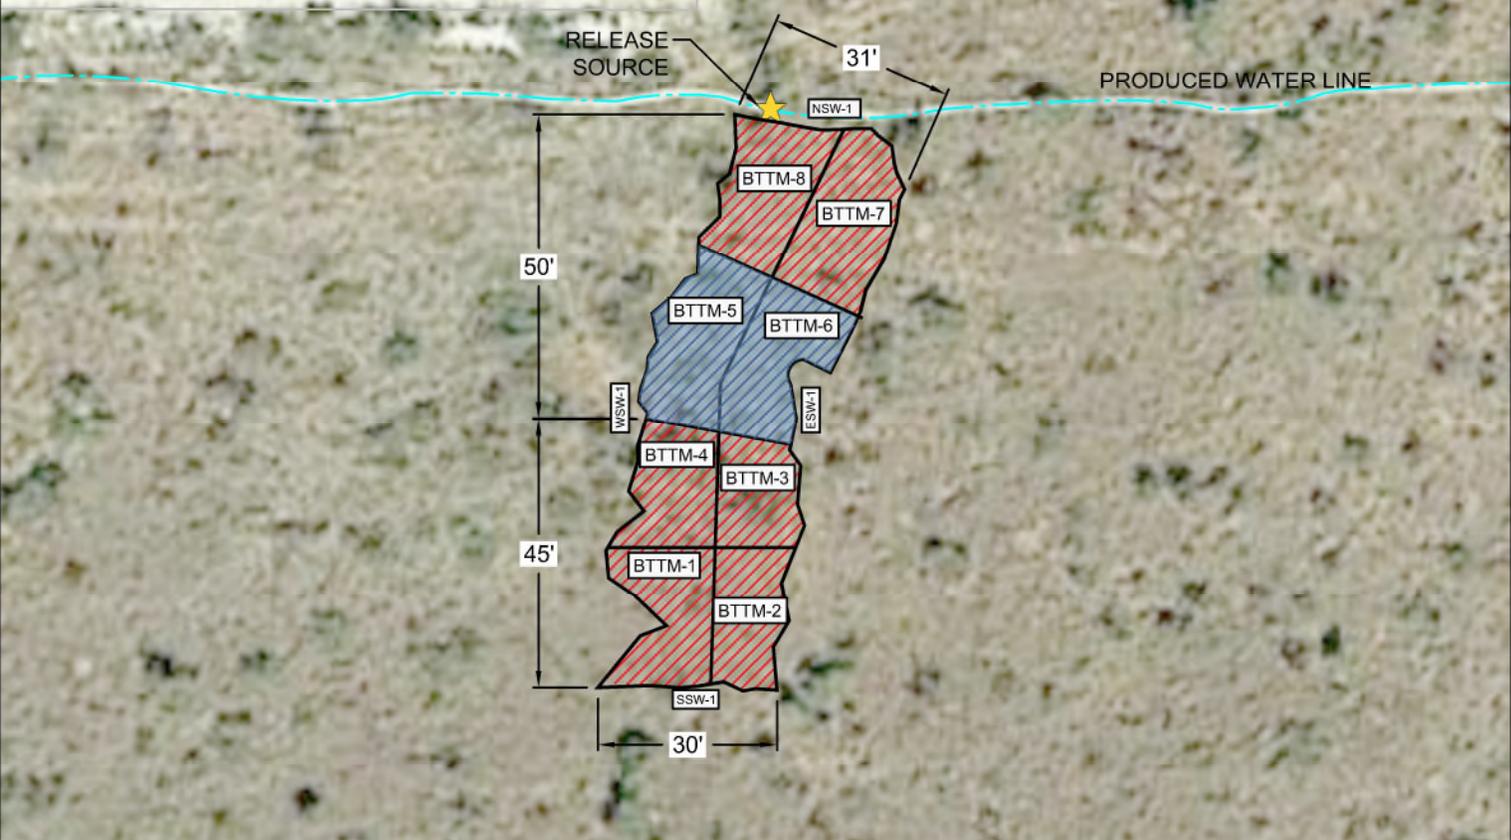
- BTTM BOTTOM HOLE SAMPLE LOCATIONS
-

Tetra Tech personnel were onsite from March 18 - 20, 2019 to supervise the remediation activities. The release area was excavated to total depths between 4.0' to 4.5' below surface. A 20-mil liner was installed in the bottom hole areas of 5 and 6 to prevent further chloride migration in the subsurface. Eight (8) bottom hole and four (4) sidewall composite samples were collected every 400 square feet to ensure proper removal of the impacted soils. The samples were submitted to the laboratory to be analyzed for TPH method 8015 extended, BTEX method 8021B, and Chloride by EPA Method 300.0. The sampling results are summarized in Table 1. The excavation depths and sample locations are shown in Figure 4.

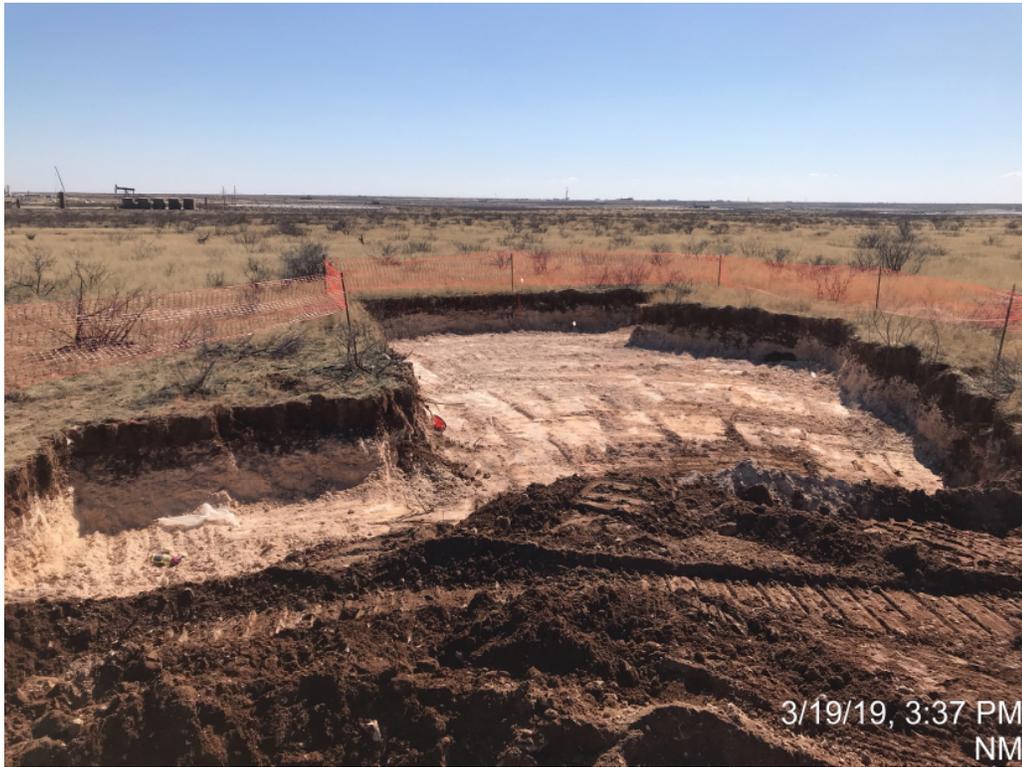
View Southwest – View of excavation area

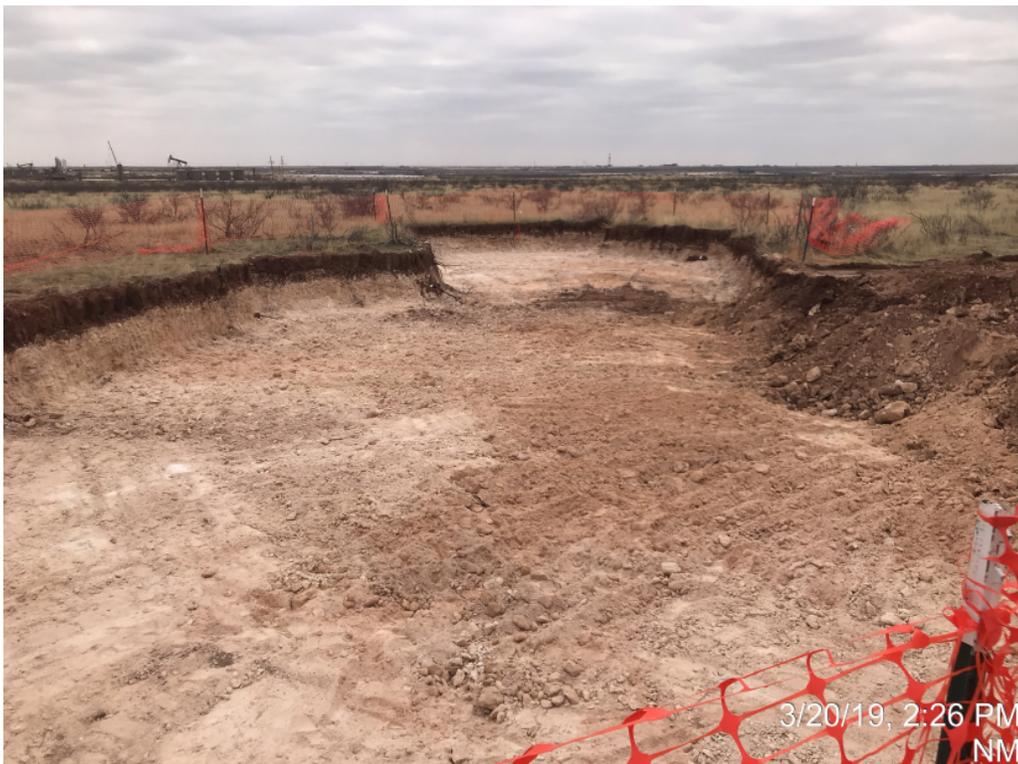
View South – View of excavation area

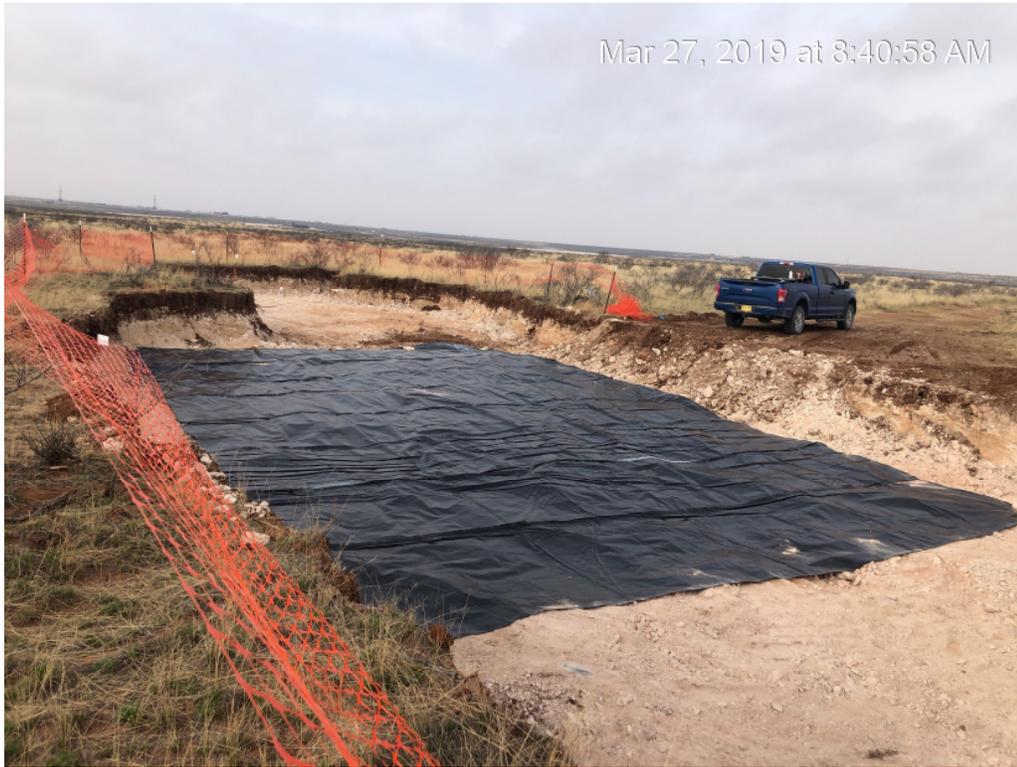
View Southwest – View of excavation and liner installation at Bottom Hole 5 and 6

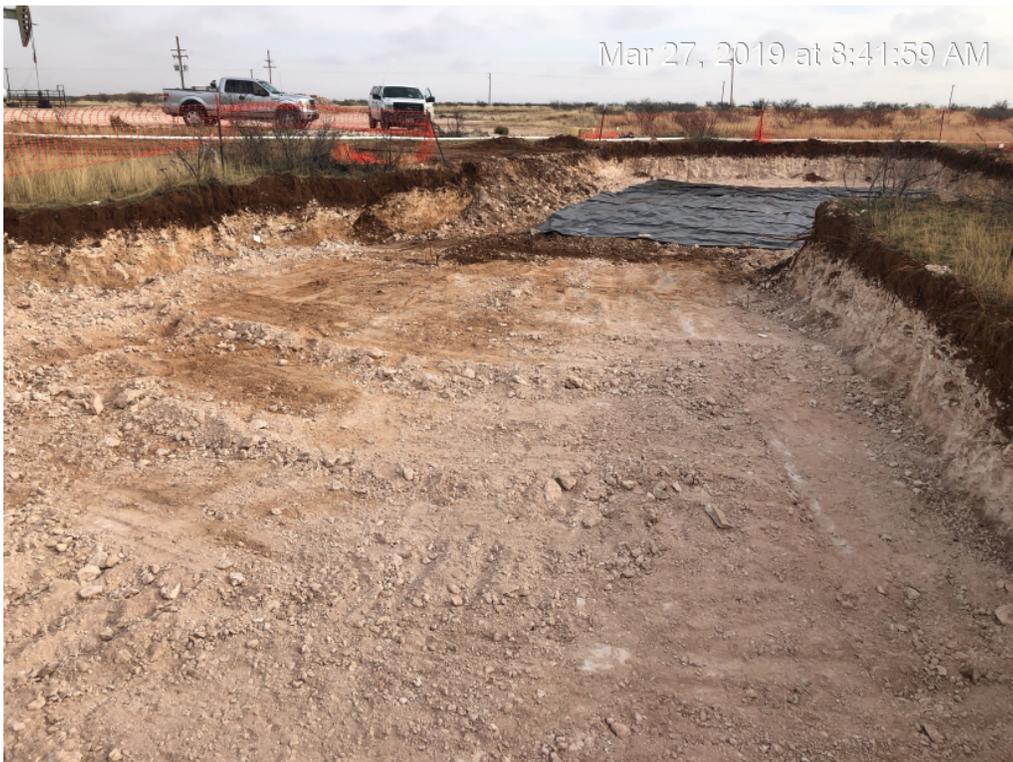
View North – View of excavation and liner installation at Bottom Hole 5 and 6
