RE: 1RP-4898 NEDU 218

## **Closure Report**

Re: NEDU 218  
Case # 1RP-4898

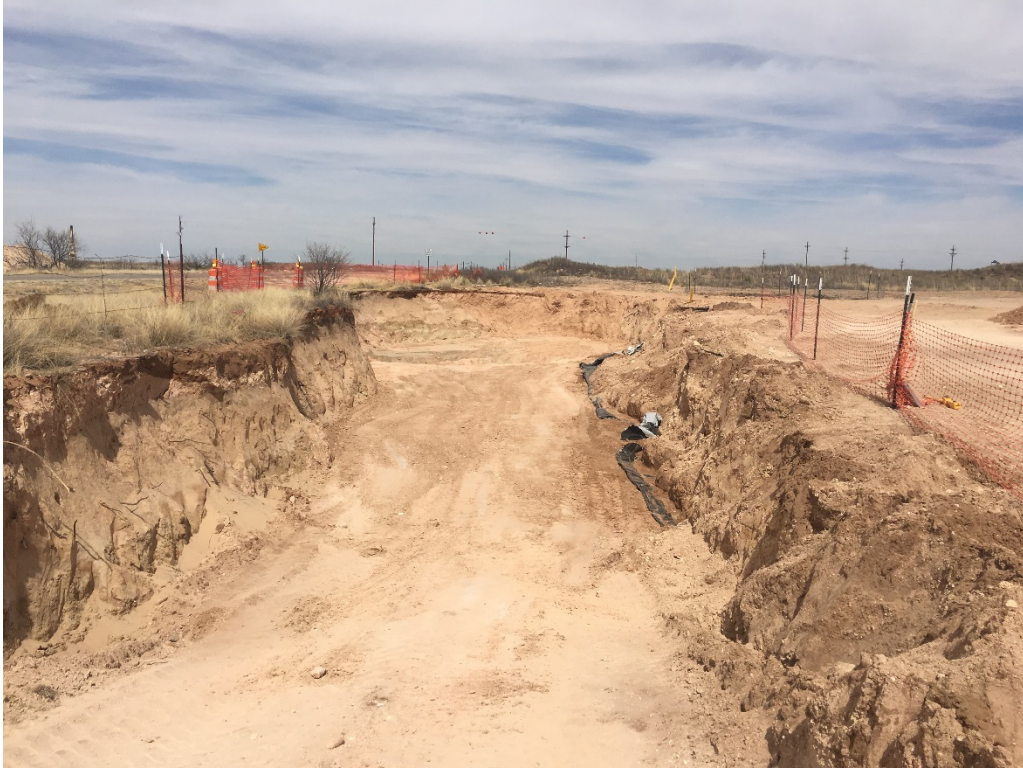
Photo of Excavation

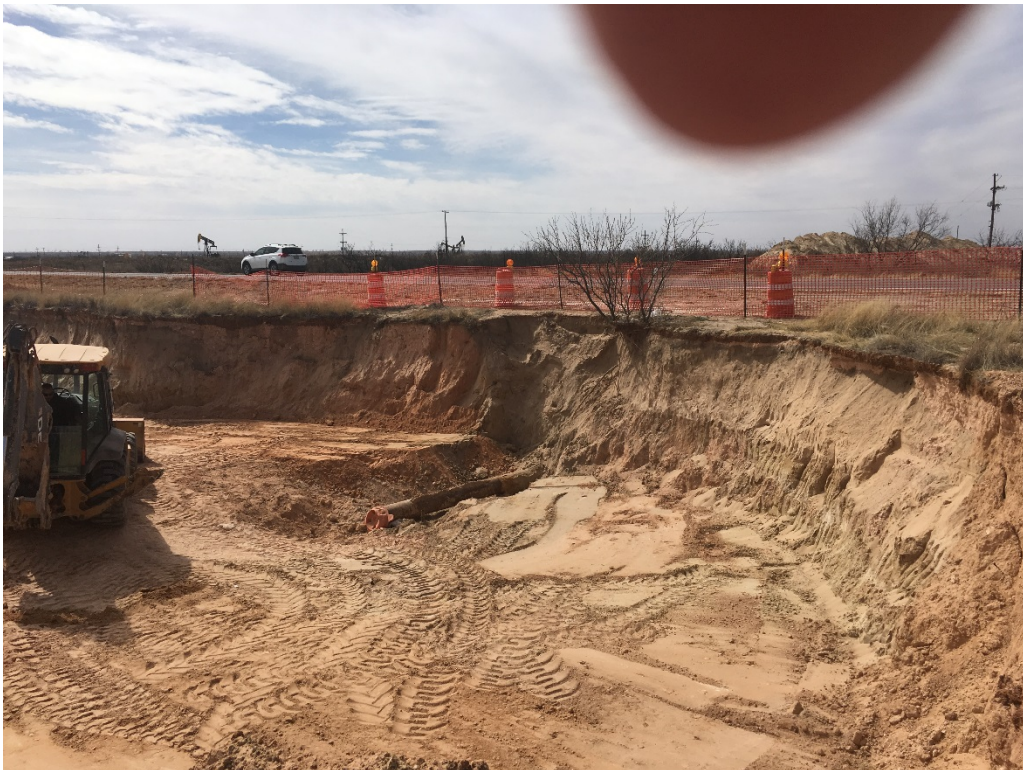
Photo of Excavation

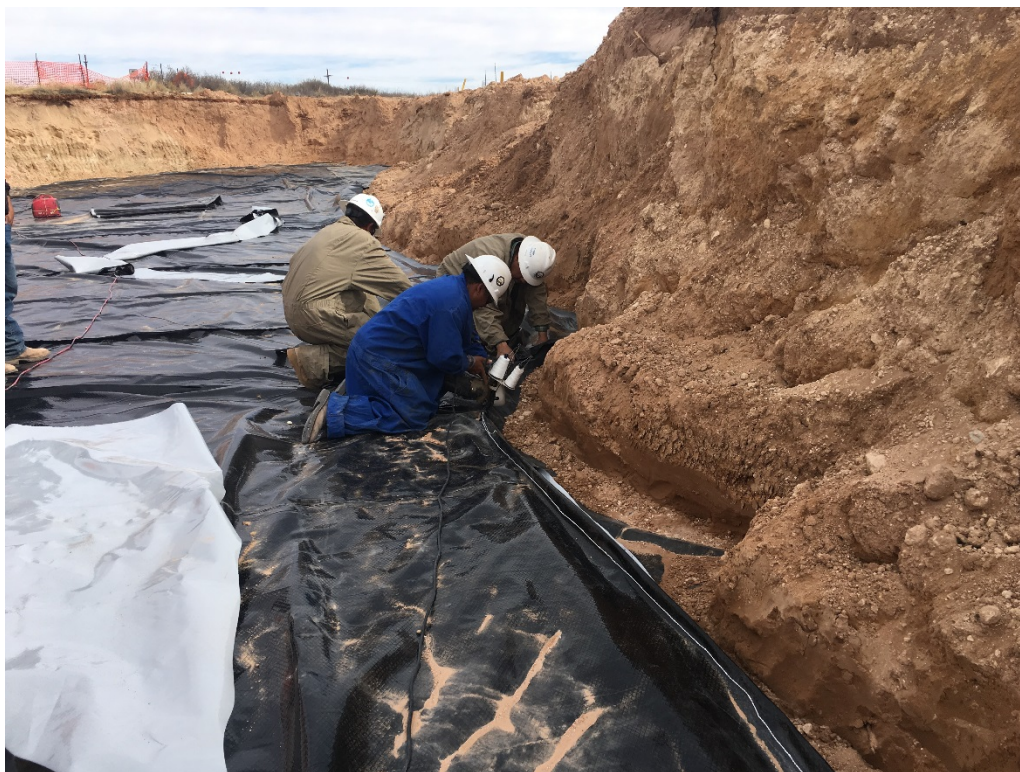
Photo of Sowing New Liner to Existing Liner

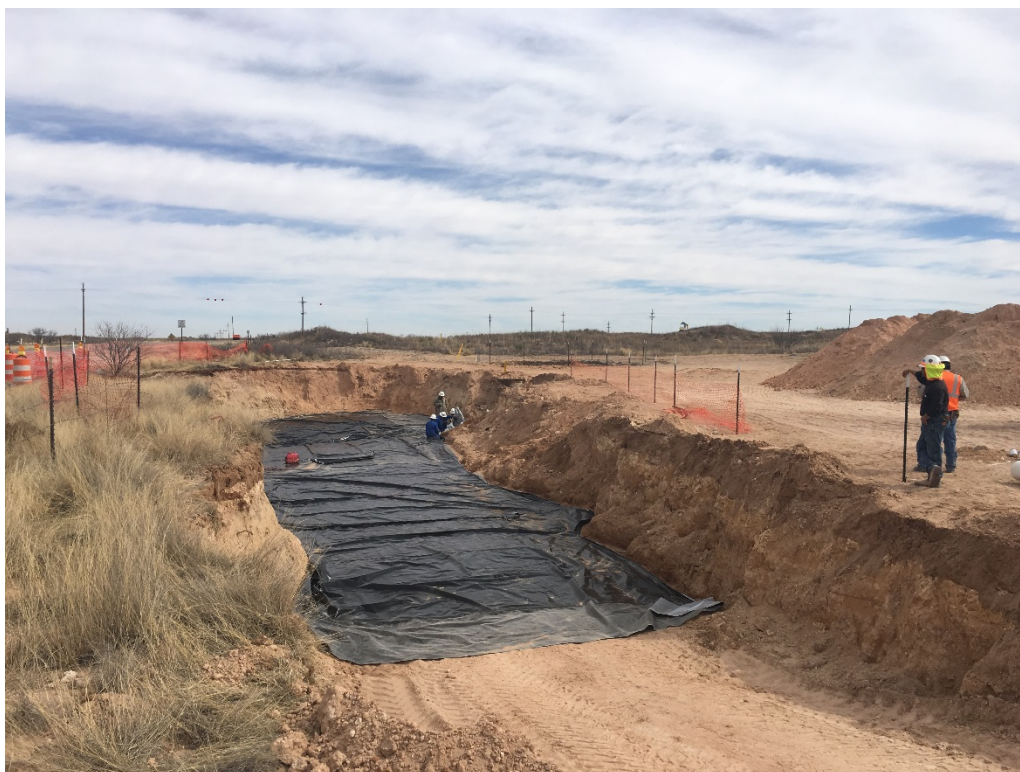
Photo of Sowing New Liner to Existing Liner

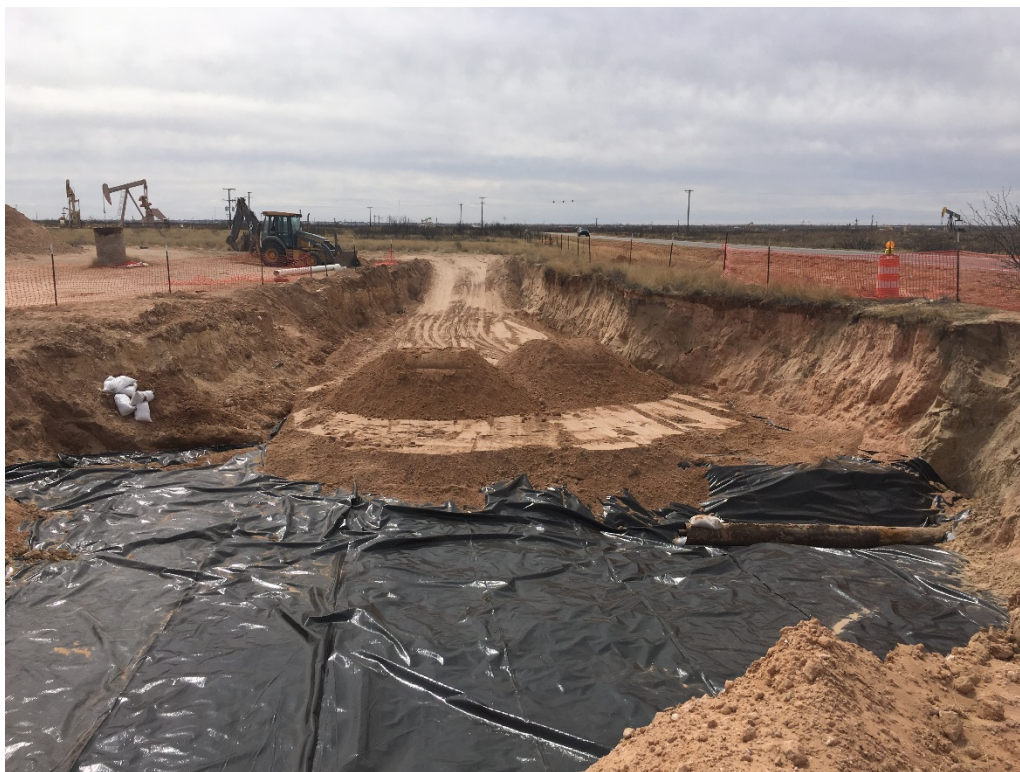
Photo of Backfilling

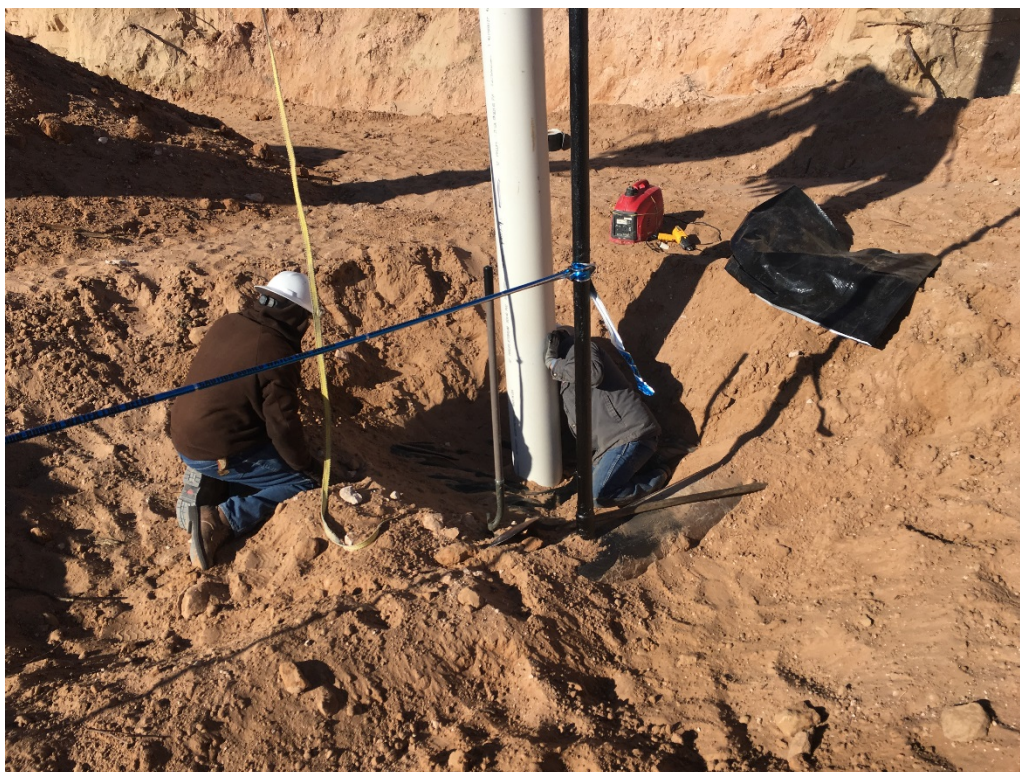
Photo of Installing 10" Casing for BH 1

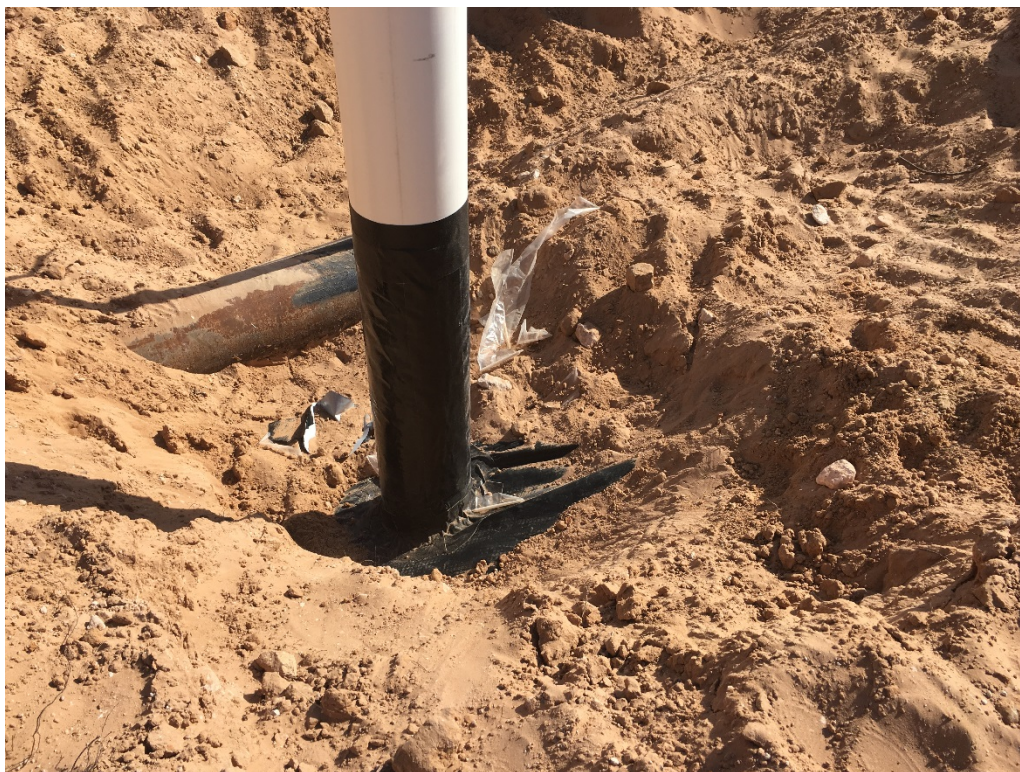
Photo of 10" Casing Complete With Liner

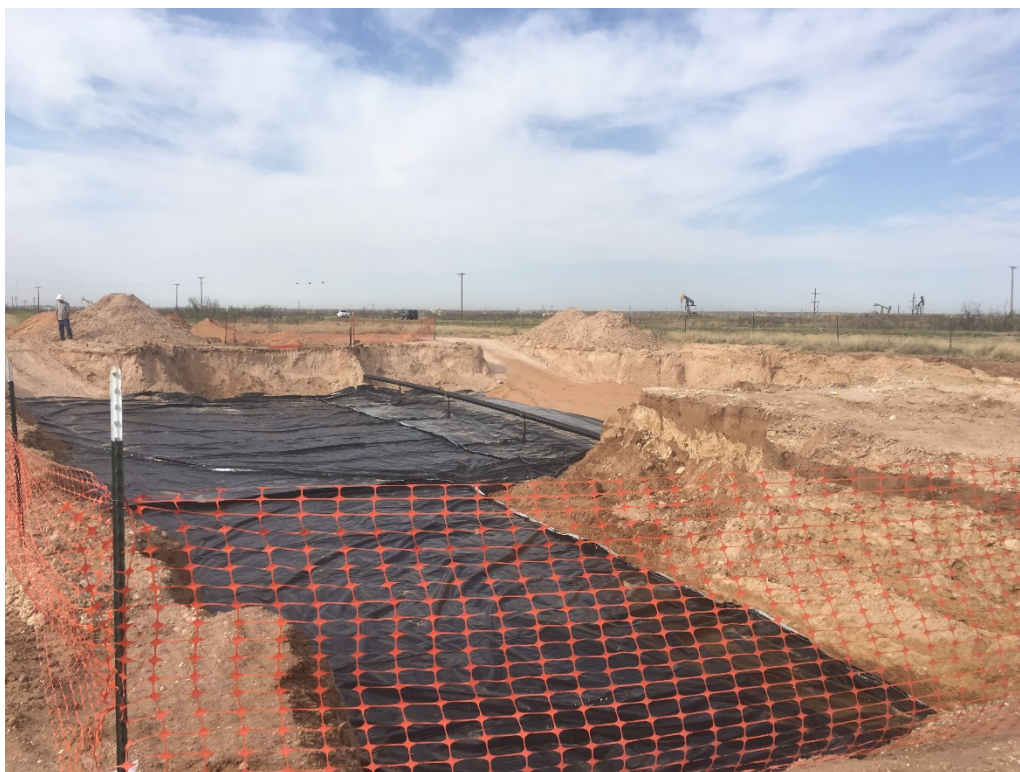
Photo of Liner for South Excavation
