## Release Notification

Site Name: <b>Rincon 91</b>	Site Type: <b>Wellsite</b>
Date Release Discovered: <b>10/15/2020</b>	API# (if applicable) <b>30-039-06627</b>

**Rincon 91 Narrative****10/9/2020**

Enduring Resources, LLC  
BGT Closure Report  
Rincon Unit 91  
30-039-06627

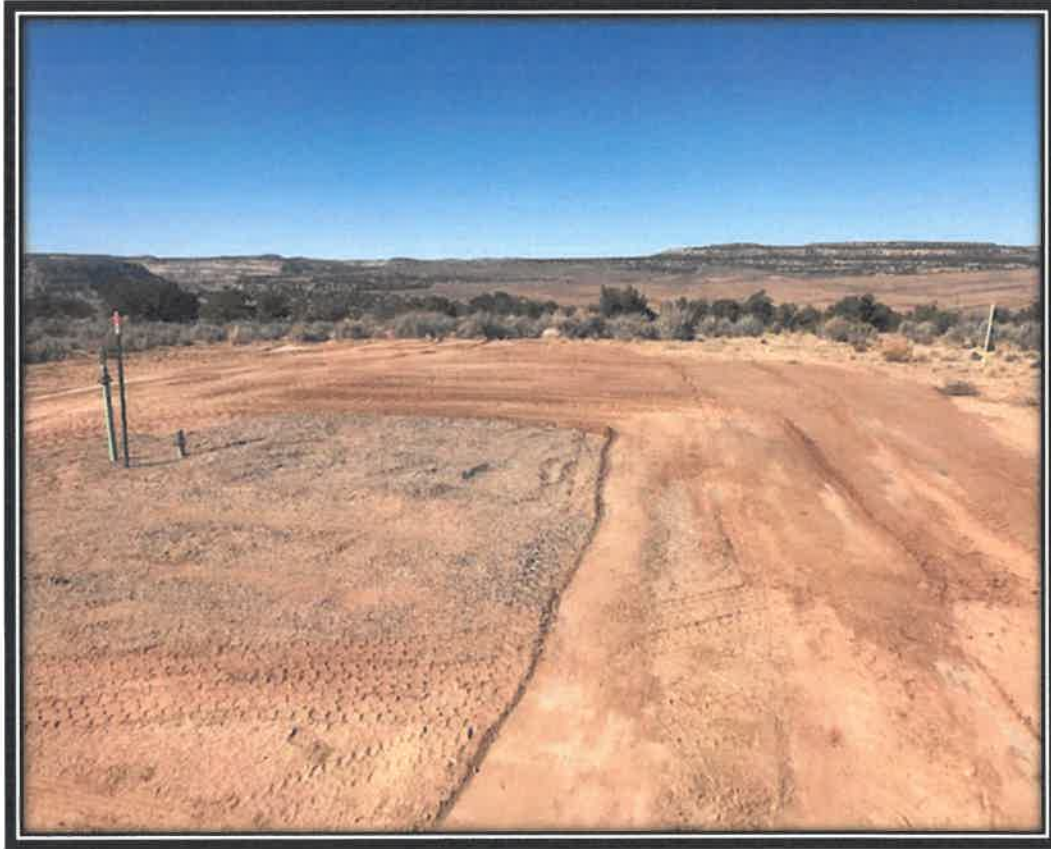
Photo: Area Backfilled

Excavated area was backfilled and recontoured to meet NMOCD specifications; see attached *Photo Page*.
