VANGUARD NATURAL RESOURCES

Onsurez #1
2RP-2397

Corrective Action Plan

**RE: Corrective Action Plan
Vanguard Onsurez #1 (2RP-2397)
UL/C sec. 11 T23S R28E
API No. 30-015-23592**

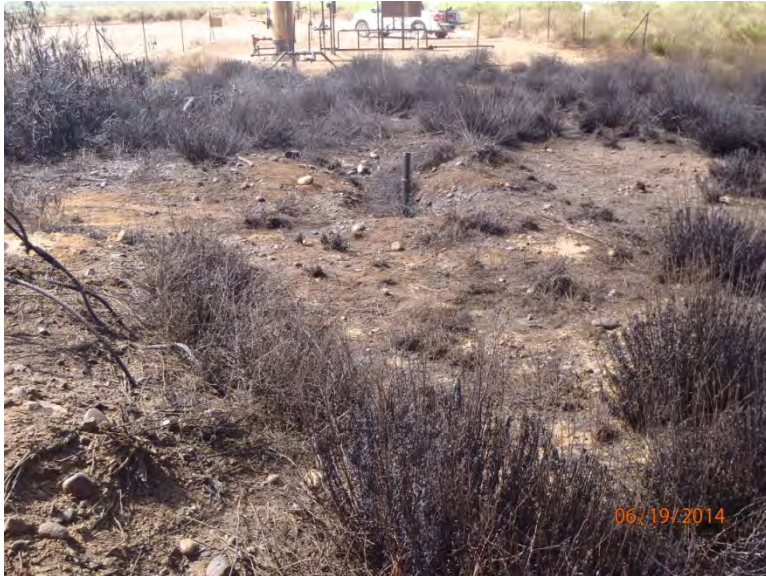
Pop off on separator, releases and blow mist of oil and water in pasture. Pop off was replaced and piped to water tank.

Source of release, facing south

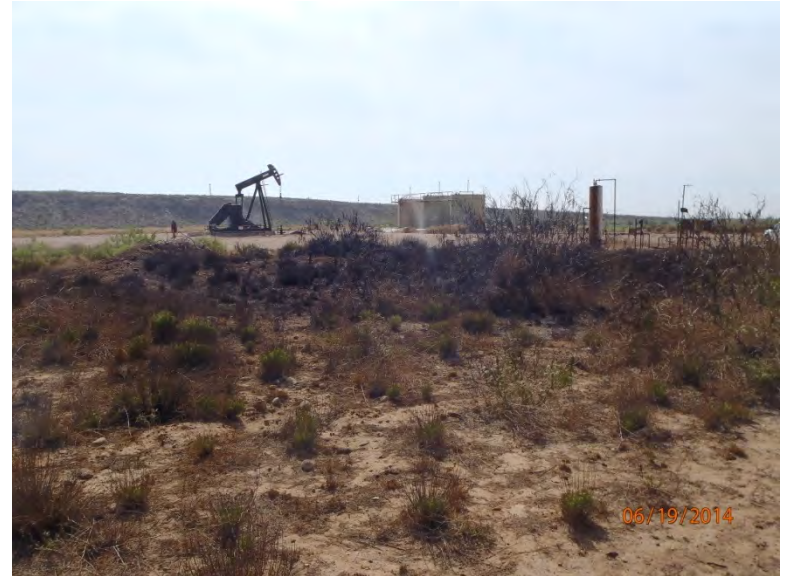
On June 13th, 2014, Vanguard discovered a release of oil and produced water. A separator pop off released a mist of 10 barrels of oil and produced water over 8,871 square feet of battery pad and pasture land. A total of 5 barrels of fluid was recovered. Vanguard submitted an initial C-141 to NMOCD on July 25th, 2014, which was approved on July 28th, 2014 (Appendix A).

Initial release area, facing southeast

Based on the laboratory analysis data, the release in the pasture area will be scraped to 1 ft to 1.5 ft. Once the scrape is completed, a composite bottom sample of the scrape will be taken and field tested for chloride and organic vapors. If field testing indicates that the bottom composite will not return laboratory chloride, GRO and DRO readings below regulatory standards, the scrape will be advanced to a depth where field sampling indicates that these constituents will return laboratory readings below regulatory standards. The final bottom composite of the scrape will be taken to a commercial laboratory to confirm that chloride, GRO and DRO readings return values below regulatory standards.

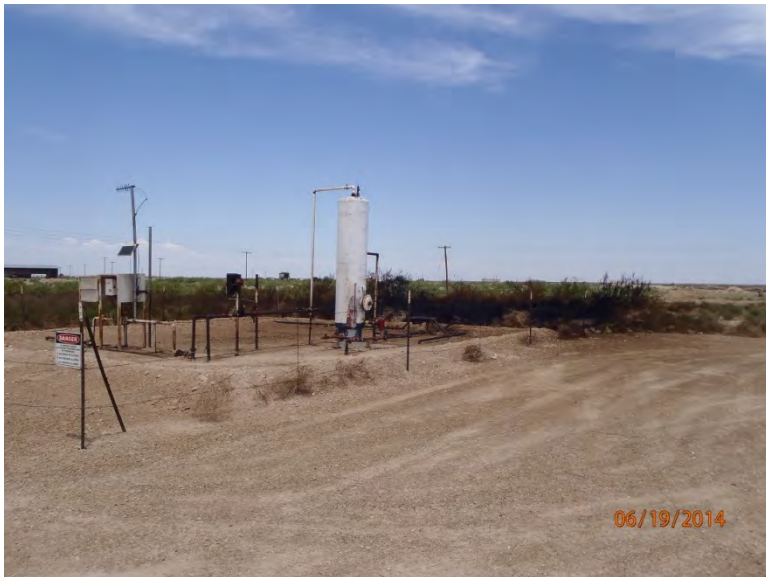
Initial release area, facing northwest

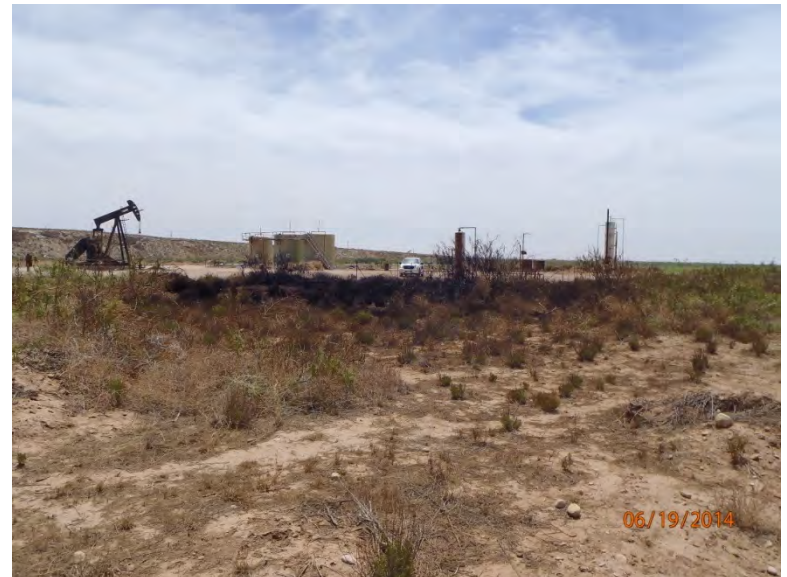
Initial release area, facing southeast

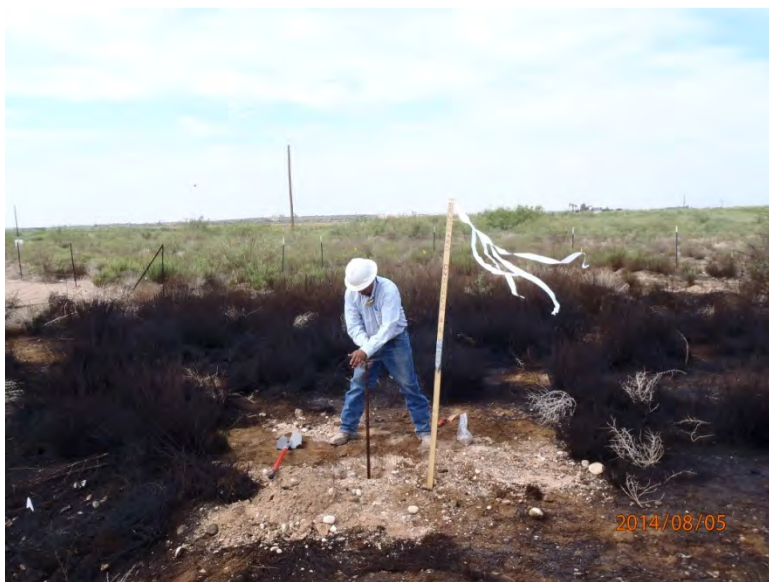
Auguring for depth, facing southwest

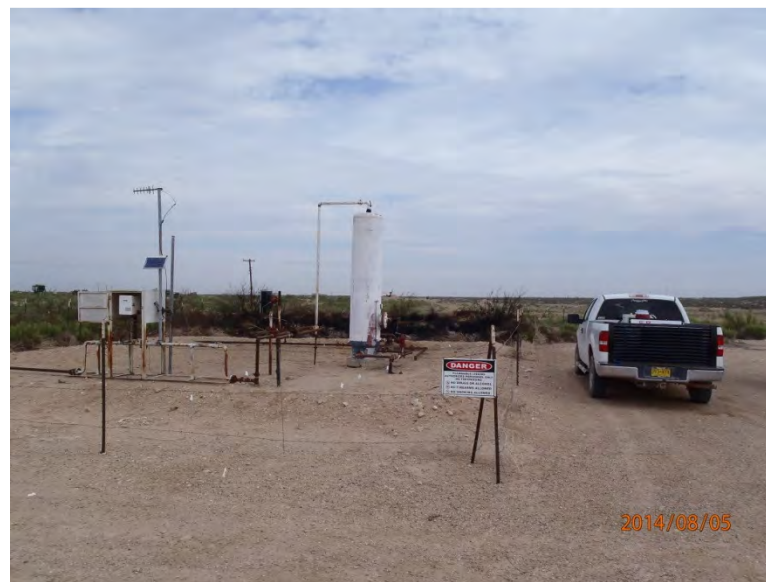
The overspray on the lease pad was not sampled; because, the staining was so unpronounced that by August 5th, 2014, the staining was no longer visible (Appendix C).

Lease pad, facing north
