CLOSURE REPORT

BOPCO, LP
PLU-JV-CVX-Big Sinks #017H
Eddy County, New Mexico
Unit Letter "C", Section 7, Township 25 South, Range 31 East
Area 1: Latitude 32.152162 North, Longitude 103.818873 West
NMOCD Reference #2RP-2403
Area 2: Latitude 32.151831 North, Longitude 103.818964 West
NMOCD Reference #2RP-2402

RE: Final Closure Report
Bopco – PLU-JV-CVX-Big Sinks #017H
UL-C, Section 7, Township 25 South, Range 31 East
Eddy County, New Mexico
NMOCD Reference # 2RP 2403 and # 2RP 2402

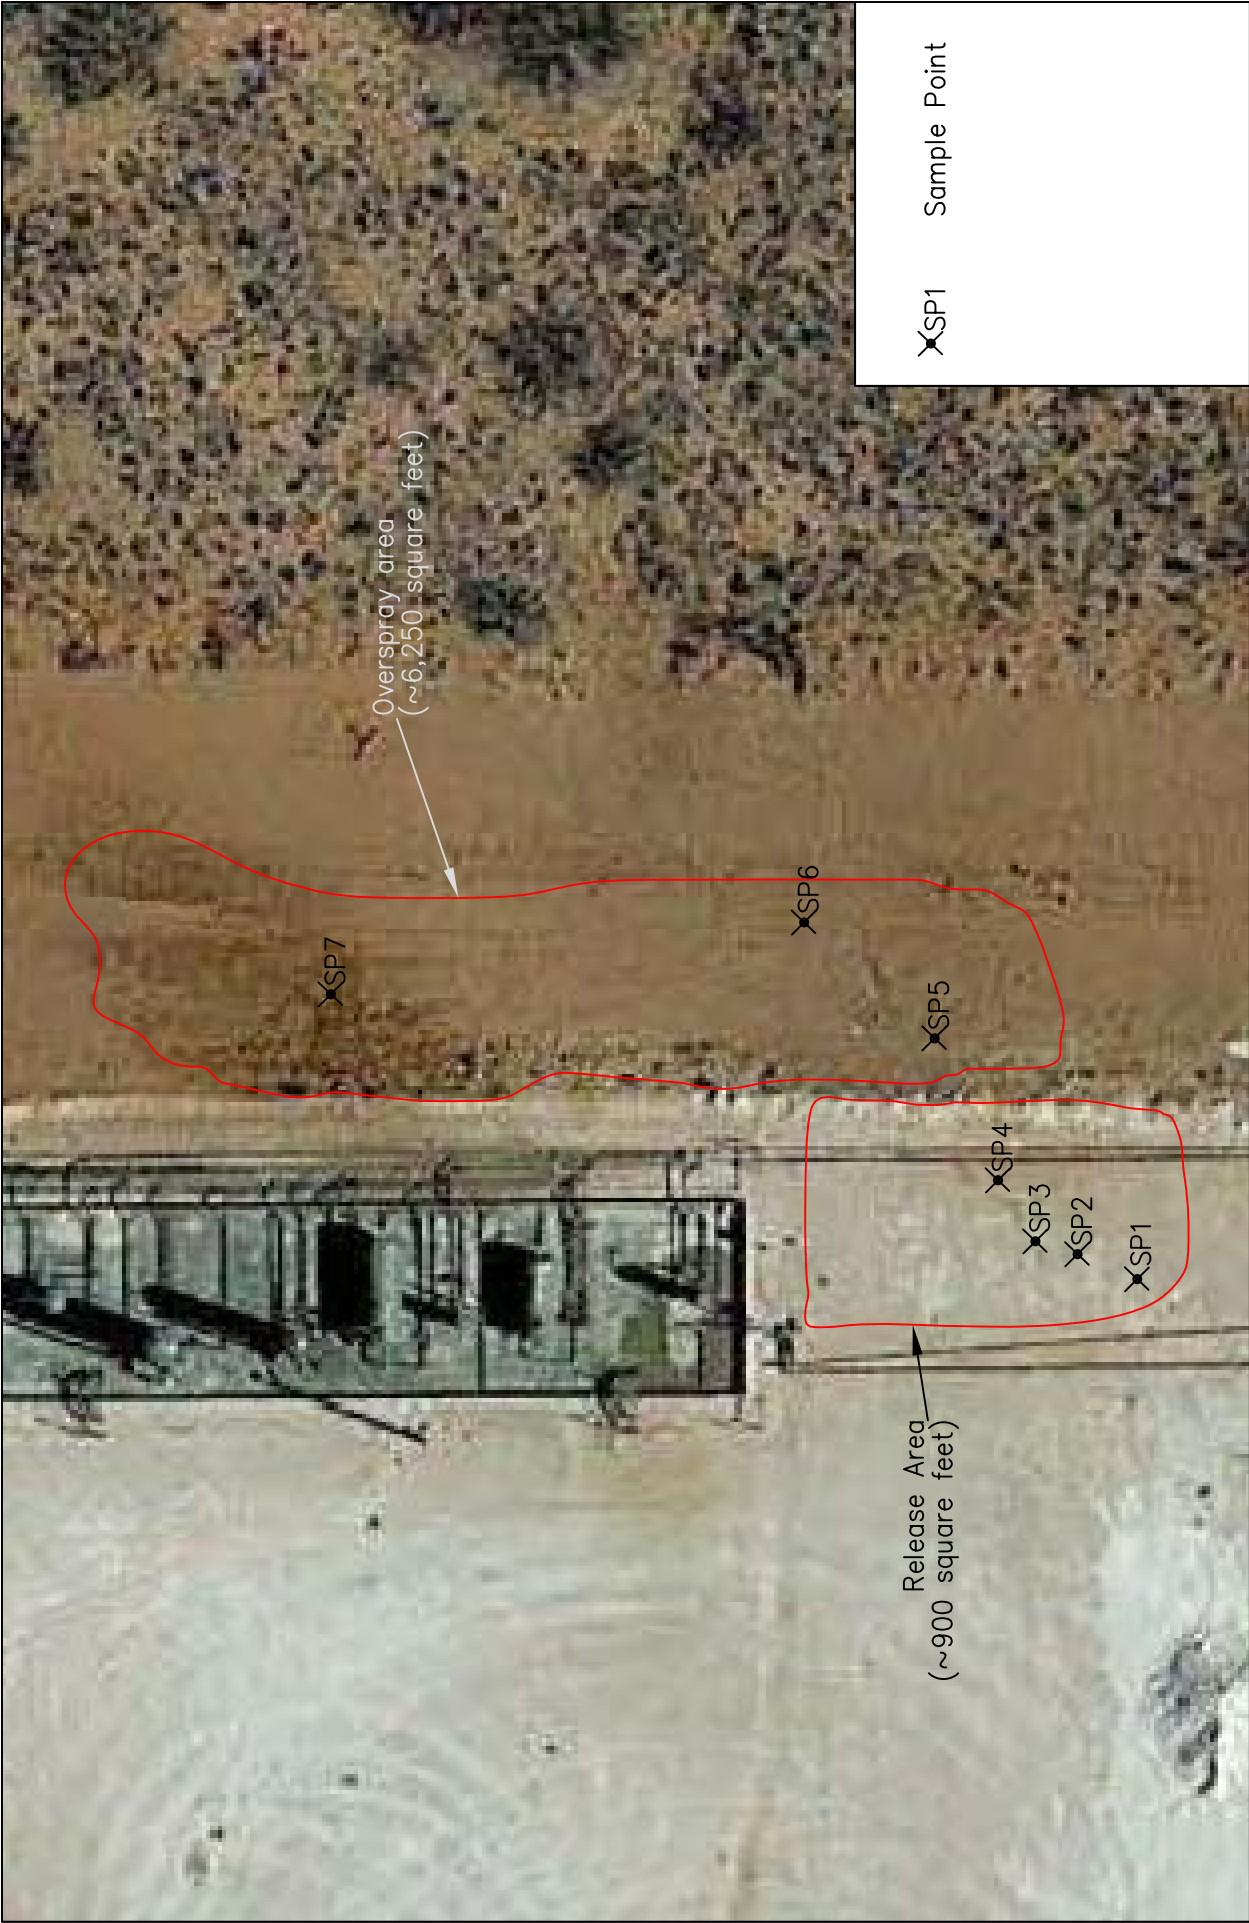
Figure 3 Site/Sample Map Bopco, L.P. PLU-JV-CVX-Big Sinks #017H	Eddy County, New Mexico NE 1/4 of NW 1/4, Sec. 7, T25S, R31E N 32° 9' 7.24" W 103° 49' 9.86" Elevation: 3,372 feet amsl		DWG By: D Dominguez October 2014		REVISED:		 
			  Feet		SHEET 1 of 1

EPI personnel mobilized on the site on September 25, 2014 to collect soil samples via sample trench to determine the vertical extent of contamination. A total of twenty-six (26) soil samples were collected from seven (7) sample locations and sent to Cardinal Labs in Hobbs, New Mexico, for testing. Laboratory analytical results indicate the excavation in general is void of Benzene, BTEX, TPH and Chloride concentrations in excess of NMOCD Recommended Remedial Action Levels (RRALs) of 10 mg/Kg, 50 mg/Kg, 5,000 mg/Kg, and 1,000 mg/Kg, respectively. Sample SP4 indicates Chloride concentrations in excess of NMOCD RRALs to a depth of one (1) foot bgs. Sample SP5 indicates TPH concentrations in excess of NMOCD RRALs at surface level (reference *Figure 3* and *Table 2*).

On October 2, 2014 approximately 74 cubic yards of contaminated material that had been excavated and stockpiled on site was transported to Lea Land for disposal. The release area was excavated to a depth of one (1) foot bgs in the areas of SP1 – SP3. The area around SP4 was excavated to a depth of two (2) feet bgs.

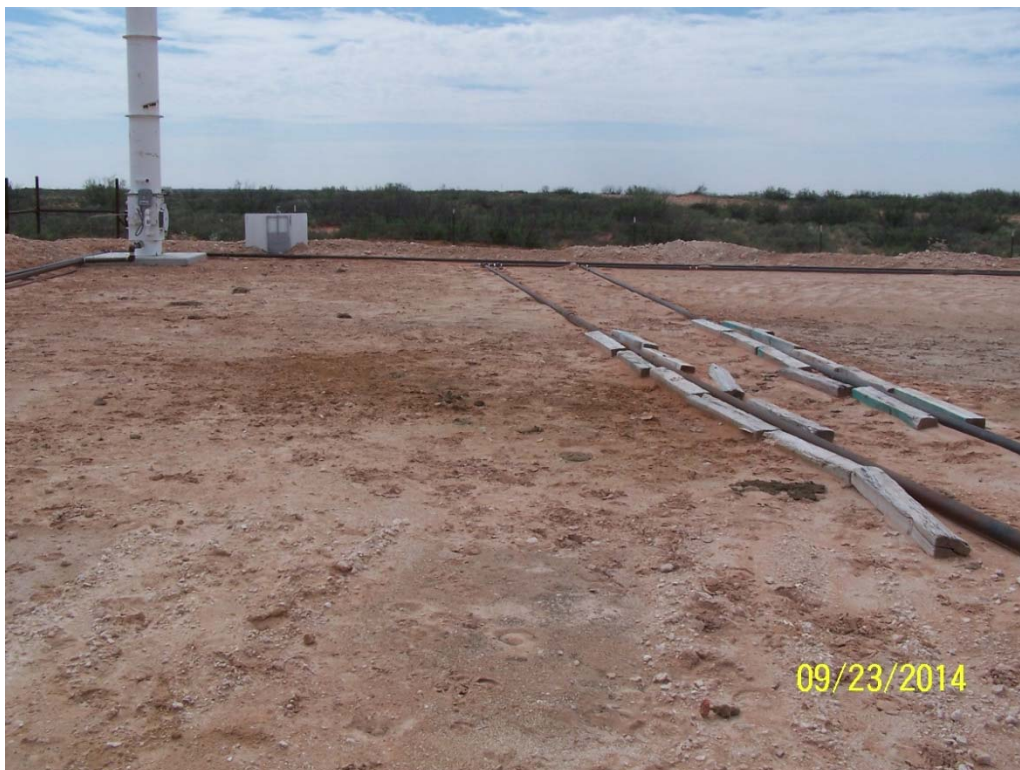
Photograph #1 – Looking south across release area

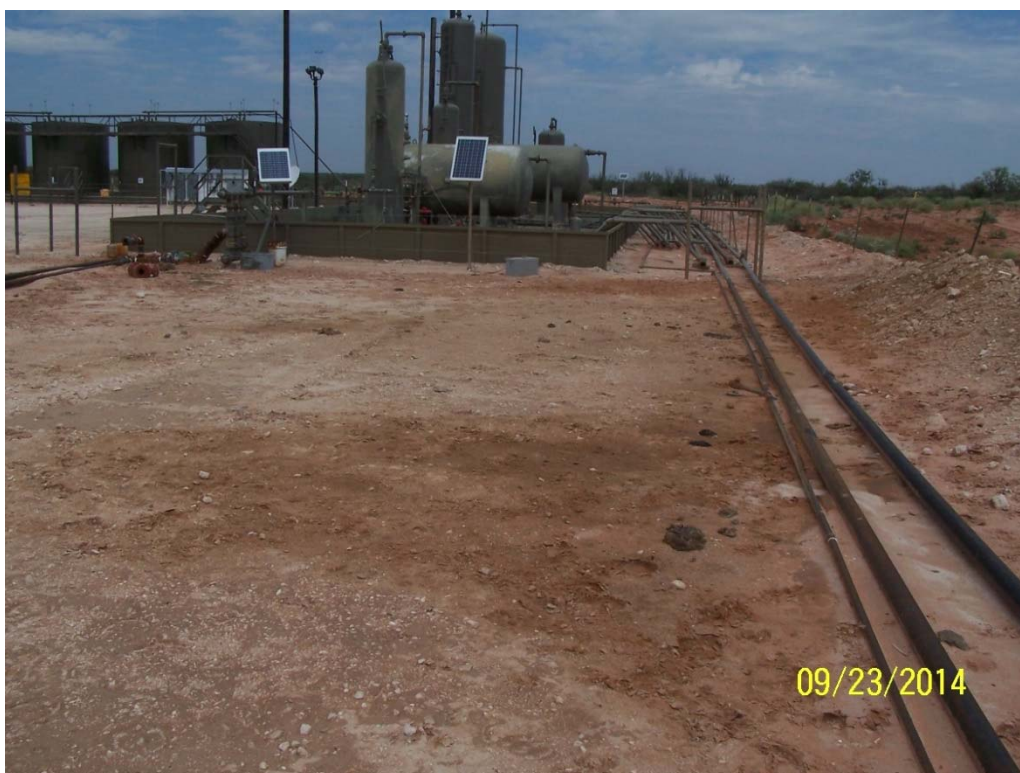
Photograph #2 – Looking north across release area

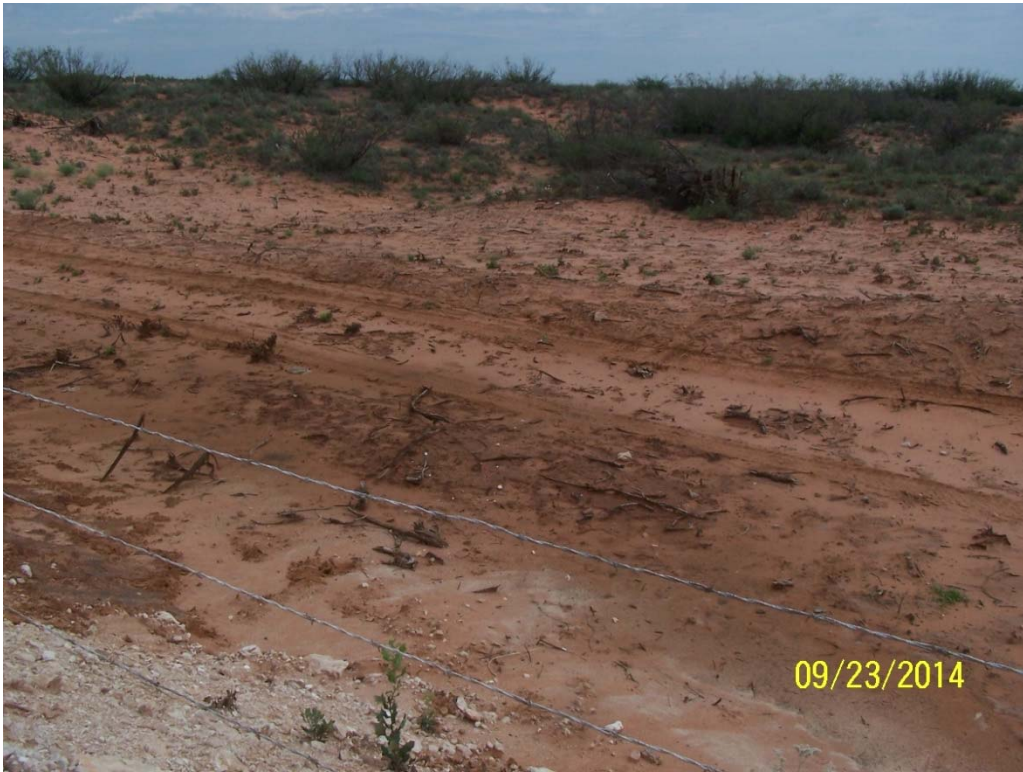
Photograph #3 – Looking east across release area

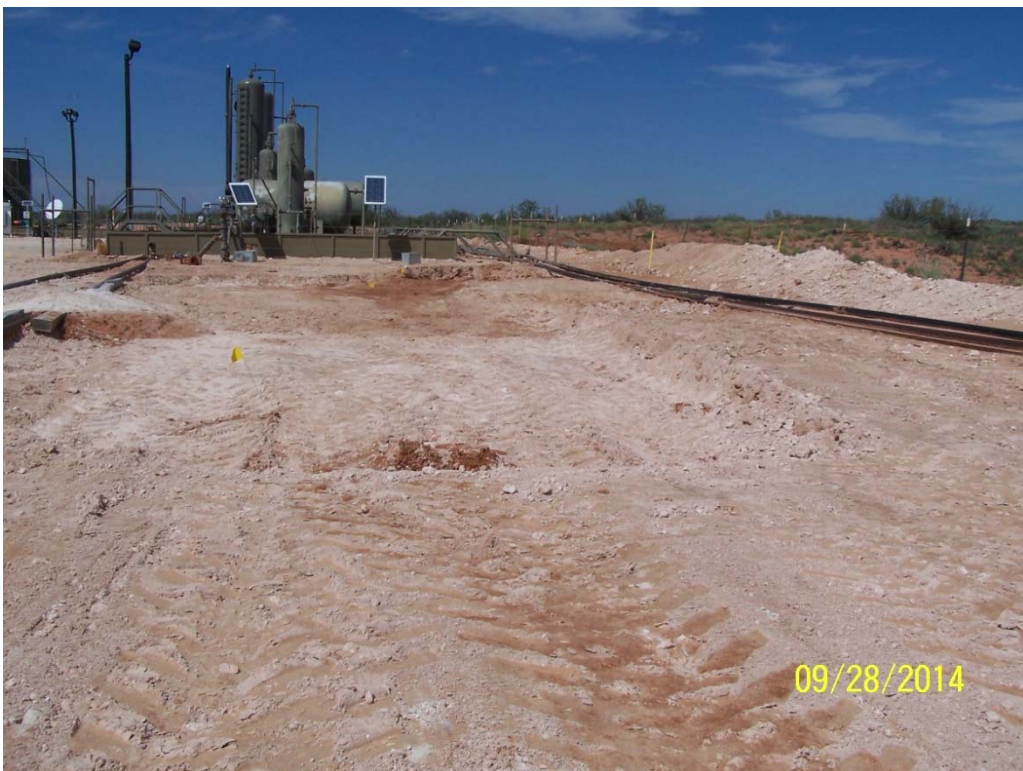
Photograph #4 – Looking north across excavation

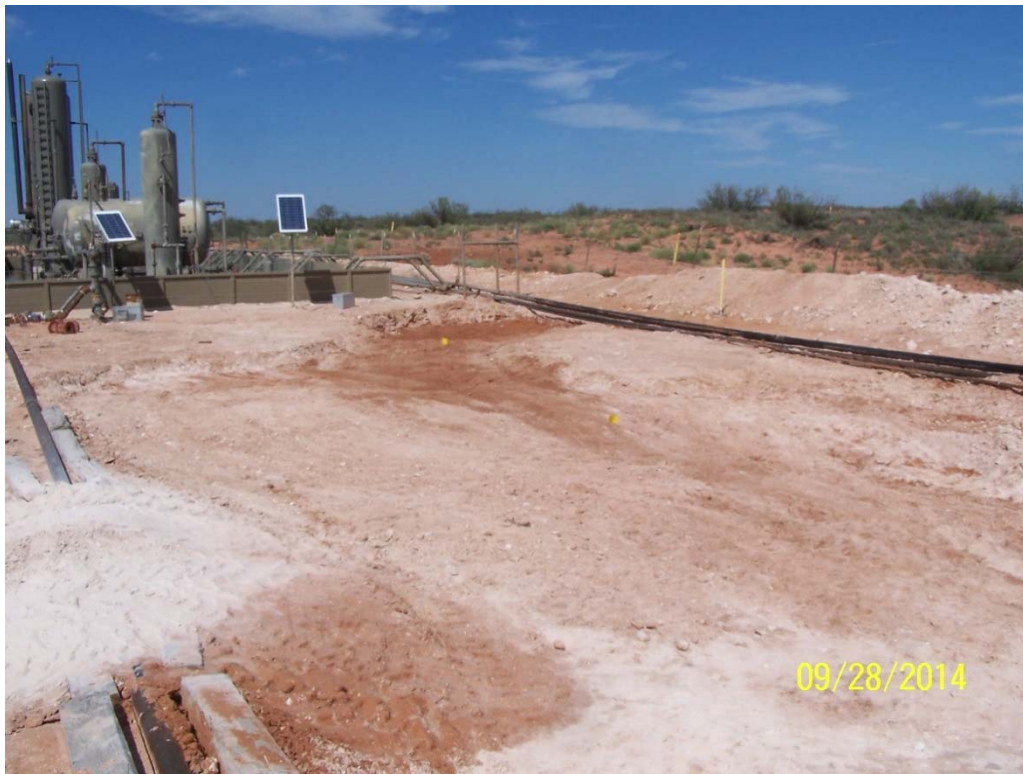
Photograph #5 – Looking north across excavation

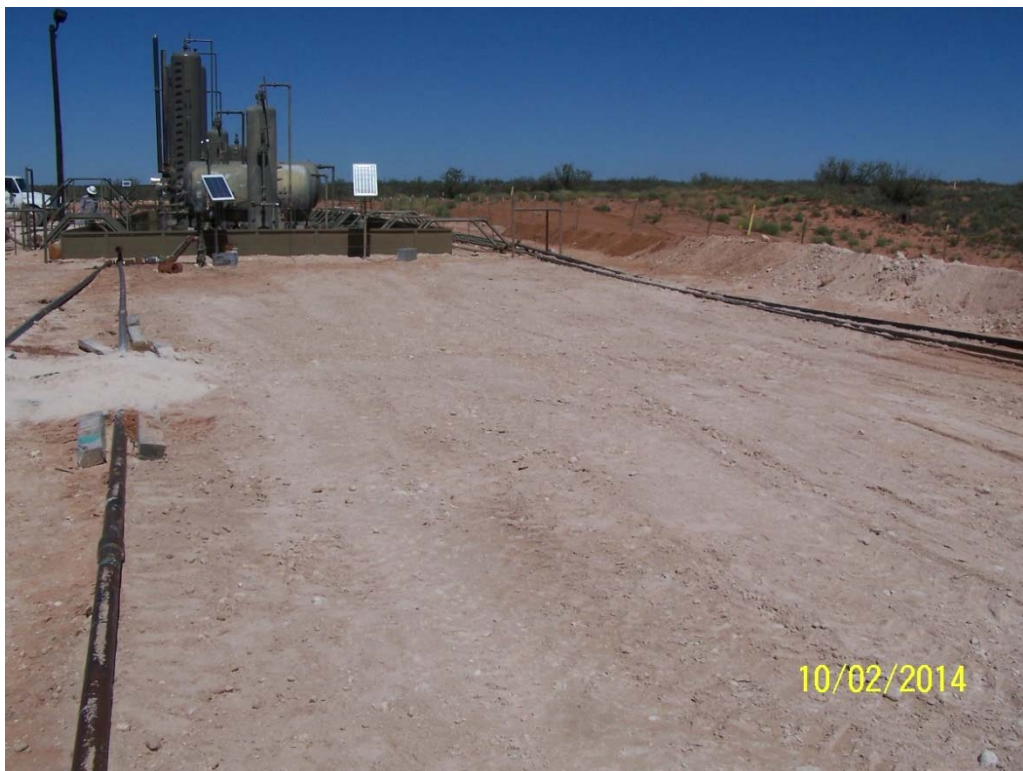
Photograph #6 – Backfilled area

The excavation was backfilled utilizing stockpiled clean caliche until the entire excavation was brought to grade with the existing pad area to protect against wind/water erosion. The area around SP5, where TPH concentrations were in excess of NMOCD RRALs, has been blended

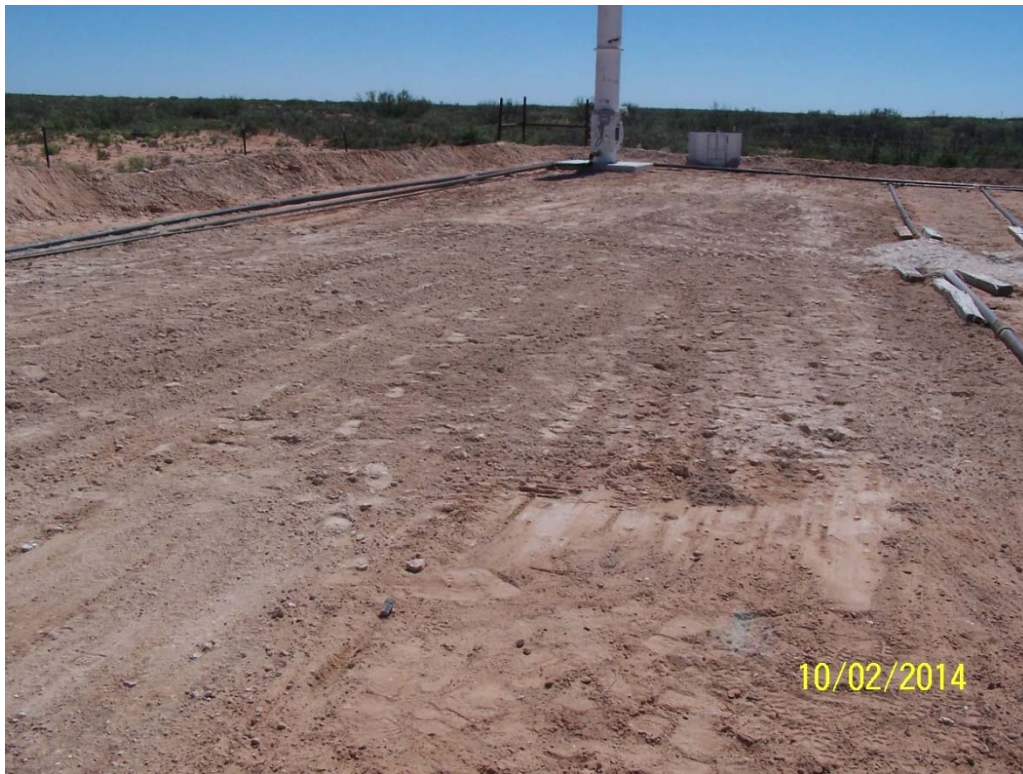
Photograph #7 – Backfilled area

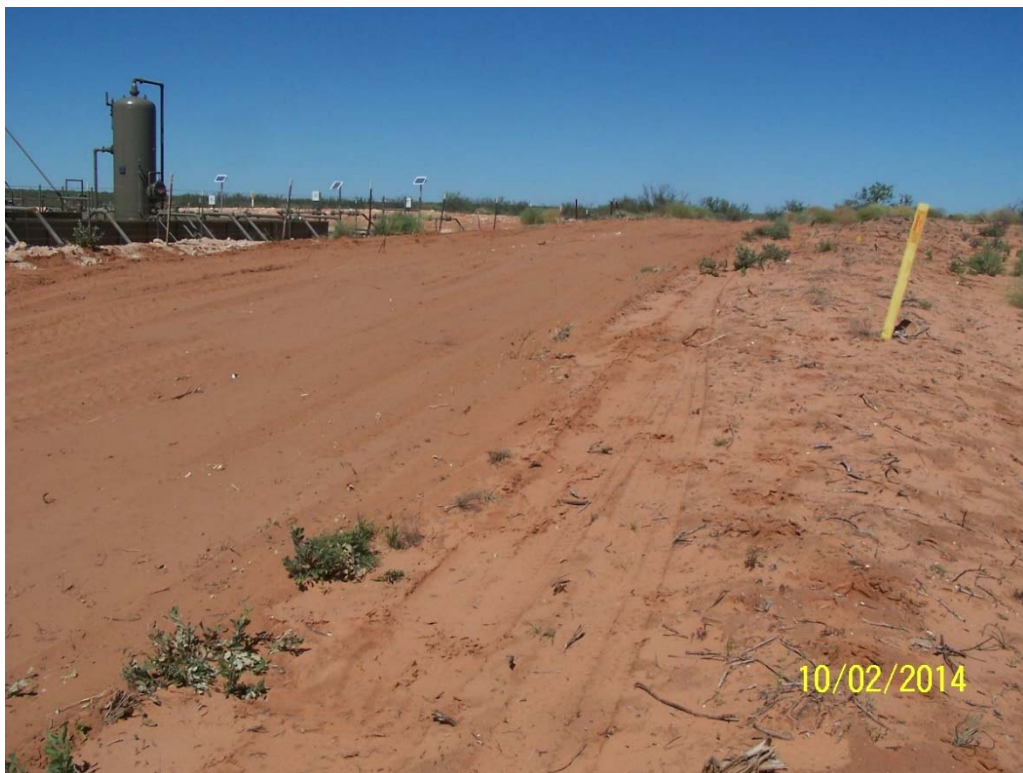
Photograph #8 – Blended pasture area

down, along with the entire overspray area, with clean soil from the immediate vicinity as per NMOCD approval. The disturbed area off the working location and caliche pad will be disced and deep drill seeded with a mixture approved by the property owner. However, it is recommended completing this activity in late spring 2015 when ground conditions are more conducive to vegetative growth.
