REMEDIATION SUMMARY & RISK-BASED SITE CLOSURE REQUEST

**BOPCO, LP
INDIAN FLATS BASS FEDERAL WELL #3
Eddy County, New Mexico
Unit Letter "L" (NW/SW), Section 35, Township 21 South, Range 28 East
Latitude 32.434079° North, Longitude 104.064599° West
NMOCD Reference #: 2RP-2191**

October 2014

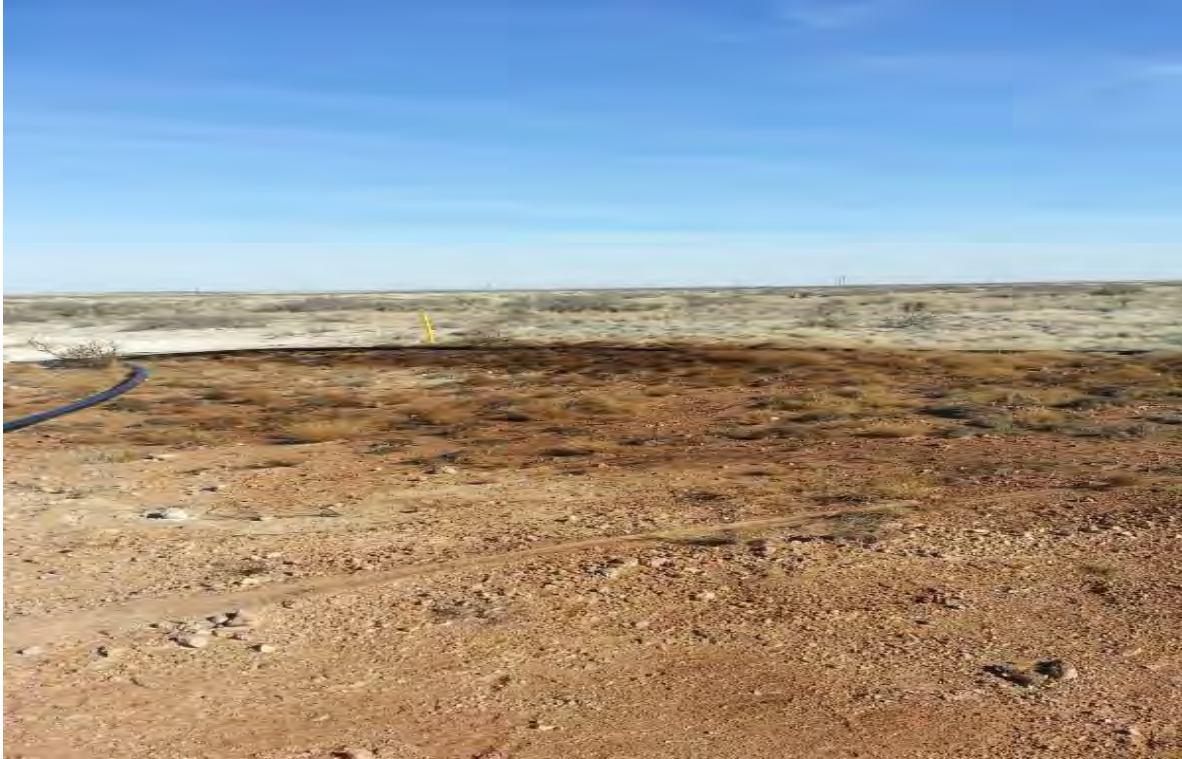
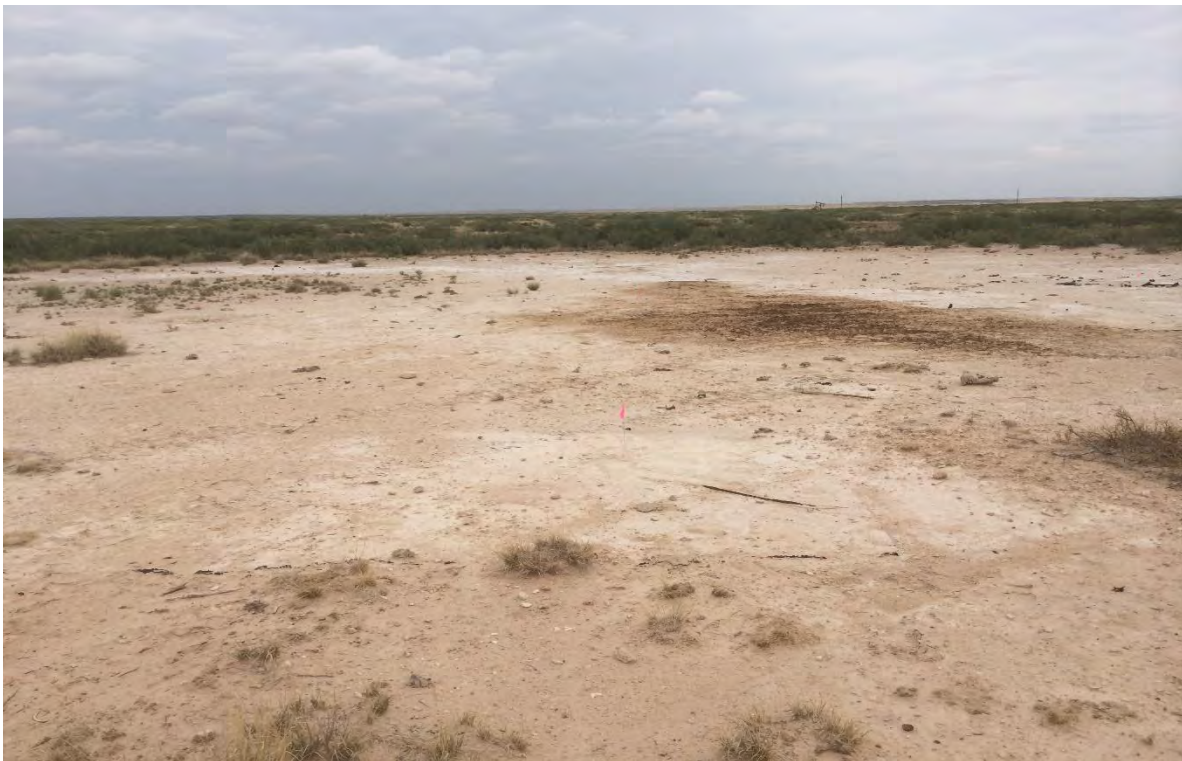
Indian Flats Bass Federal Well #3 - Release Site

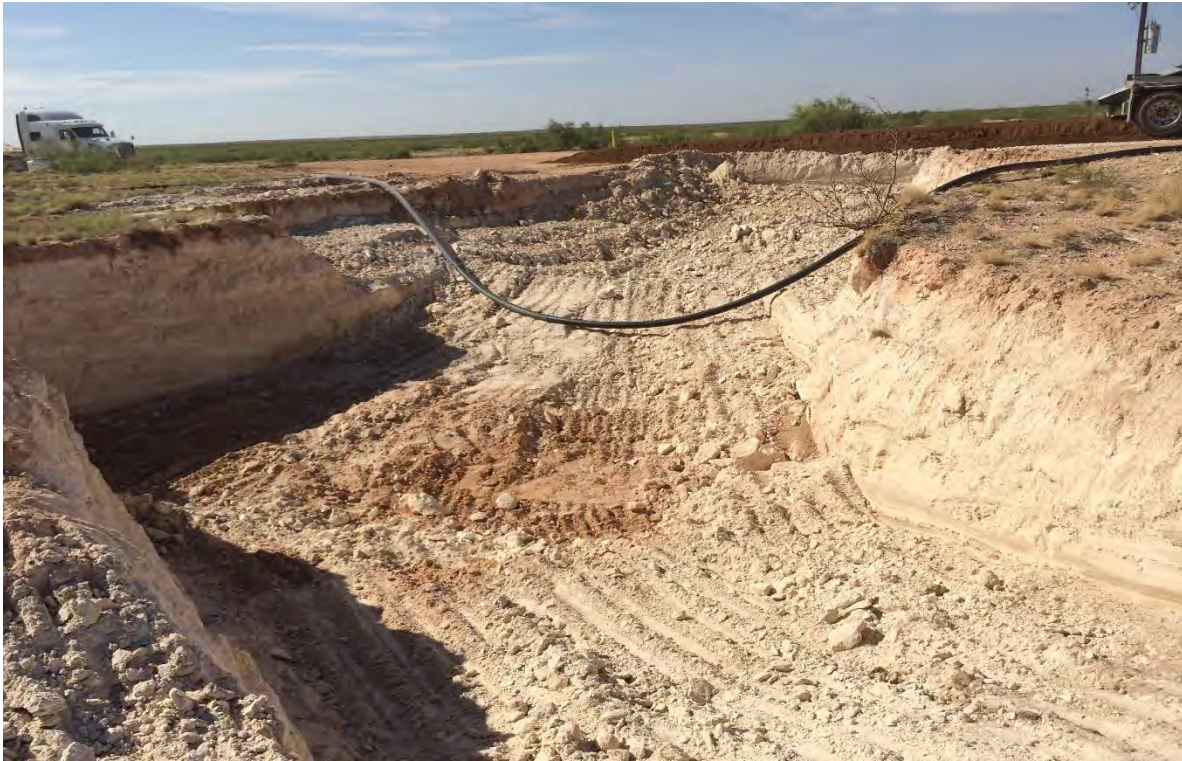
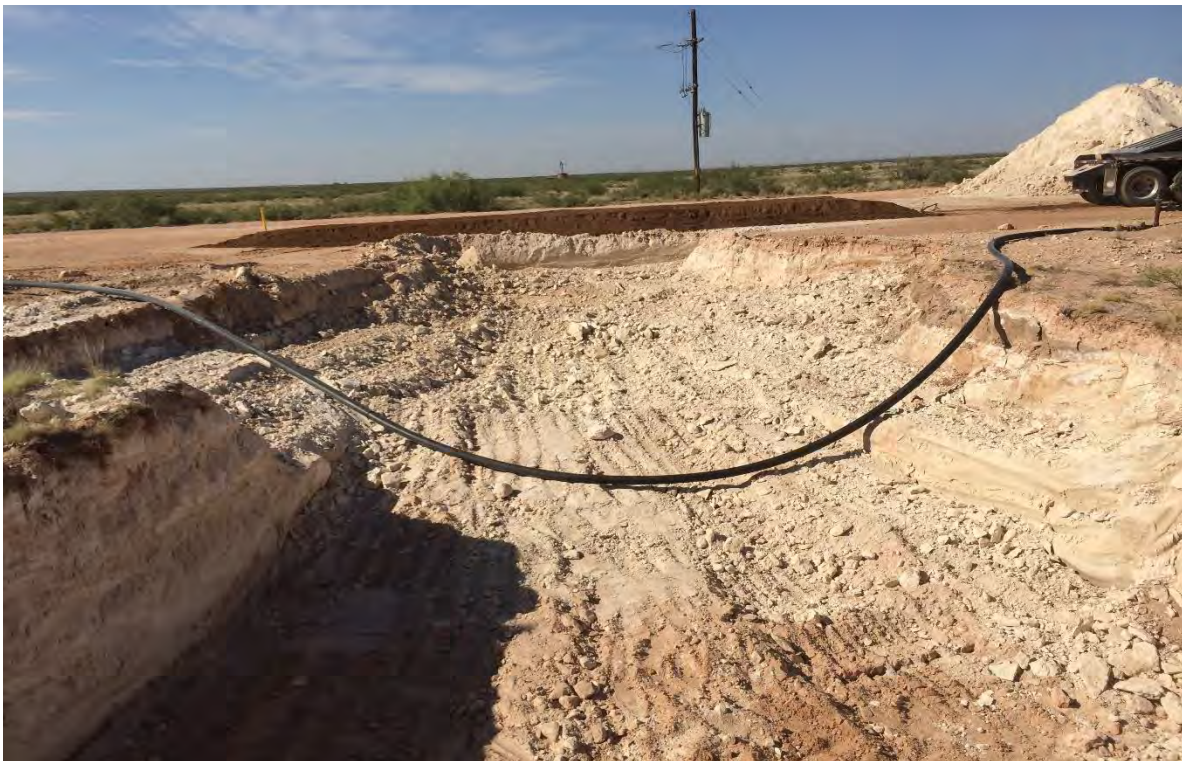
Indian Flats Bass Federal Well #3 - Excavation

From July 30 through August 5, 2014, approximately five hundred and sixty cubic yards (560 yd³) of impacted soil was excavated and transported to Lea Land, Inc. (NMOCD Permit # WM-01-035), for disposal.

Based on laboratory analytical results and field-screens, from August 1 through August 8, 2014, the excavation was backfilled with non-impacted soil, compacted, and contoured to fit the surrounding topography. Prior to backfilling, final dimensions of the excavation were approximately seventy feet (70') in length, varying in width from approximately twenty feet (20') to approximately thirty feet (30'), and averaging approximately seven feet (7') in depth.

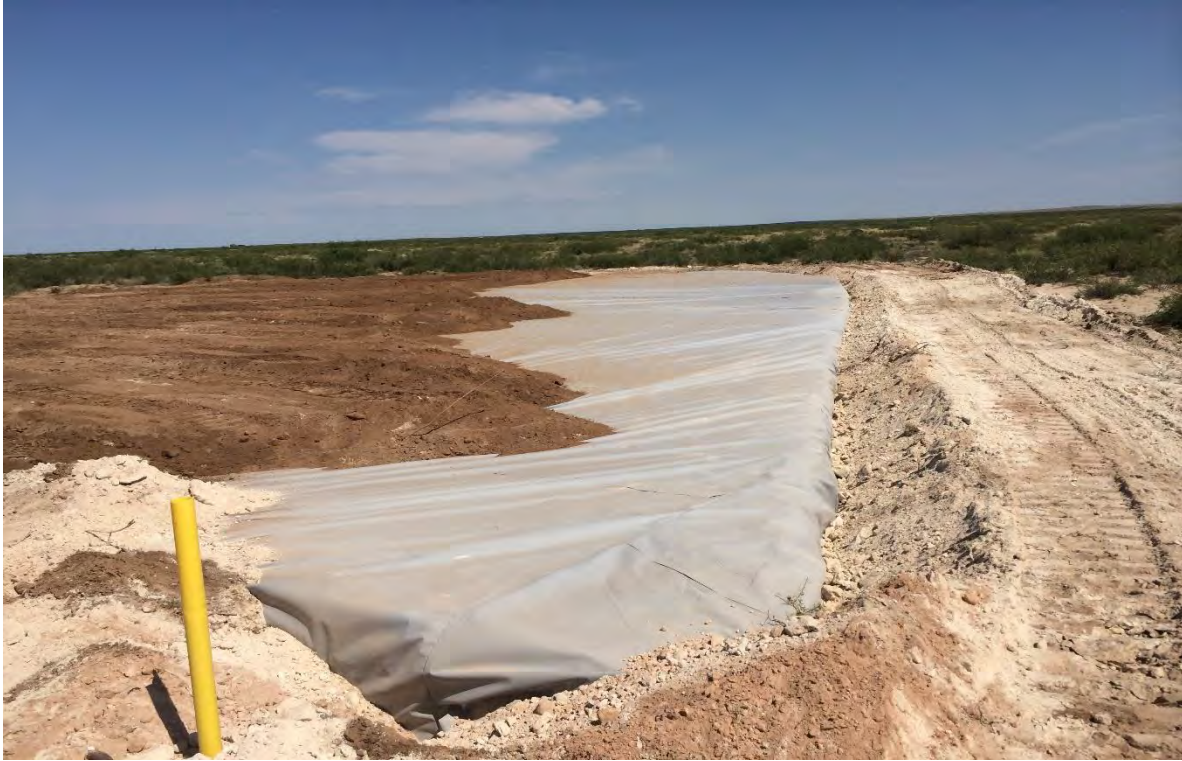
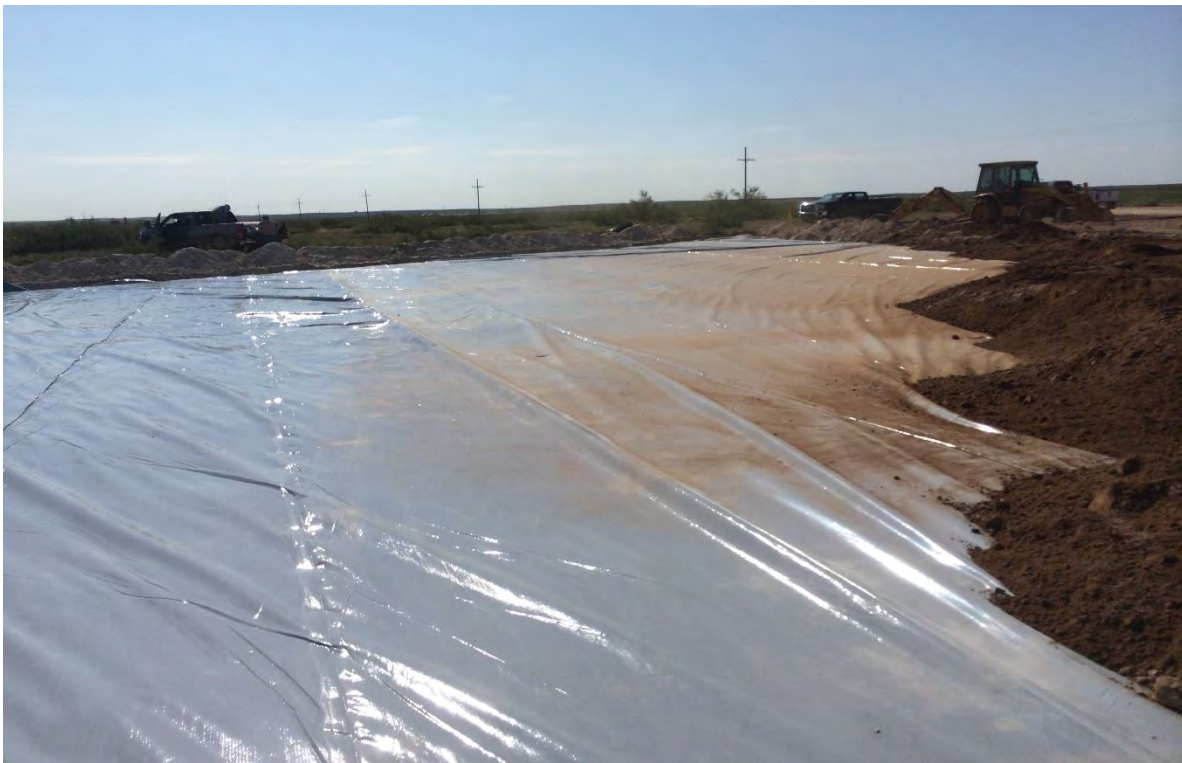
Indian Flats Bass Federal Well #3 – Liner Installation, Reserve Pit Area

Indian Flats Bass Federal Well #3 - Liner Installation, Reserve Pit Area

On August 7, 2014, a twenty-millimeter (20mm), impermeable, polyurethane liner measuring approximately one hundred and fifty feet (150') in length and approximately one hundred and twenty-six feet (126') in width was installed atop the reserve pit area. Following installation, the liner was covered with non-impacted material, and the area was compacted and contoured to fit the surrounding topography.

The reserve pit area was capped with a twenty-millimeter (20mm), impermeable, polyurethane liner. This engineered control will help mitigate future releases and effectively inhibit vertical migration of contaminants to groundwater.

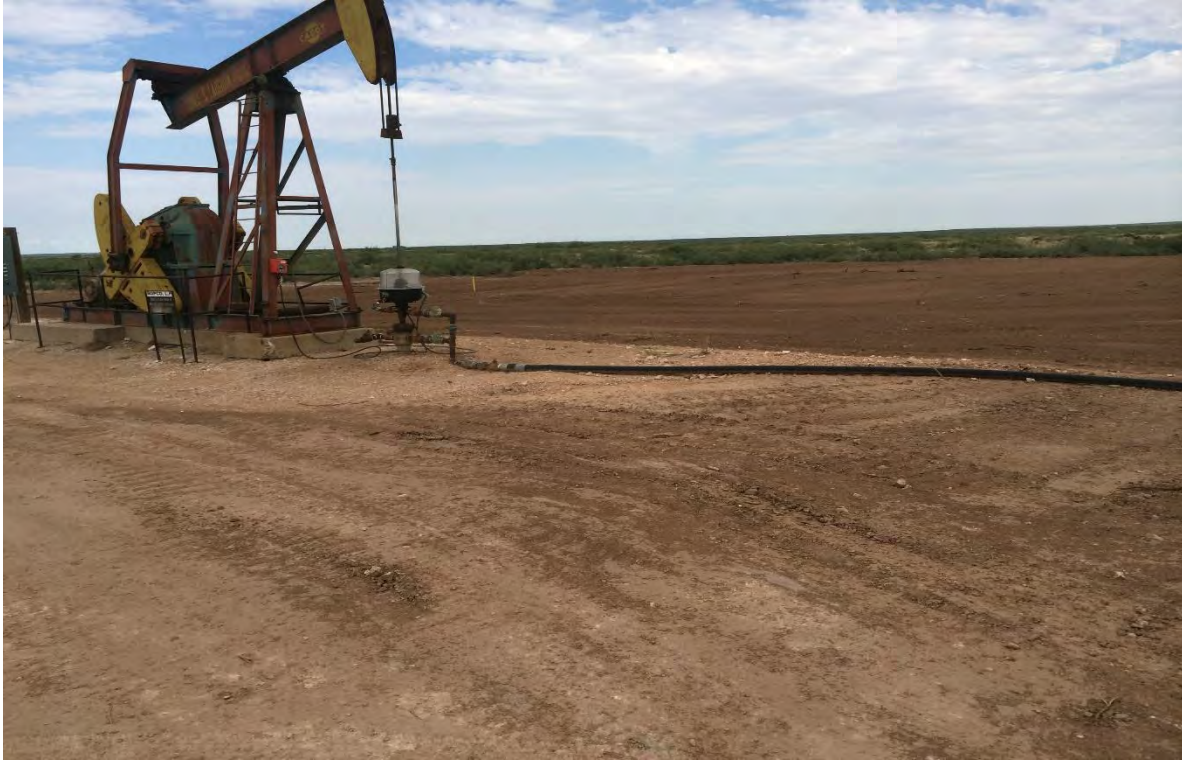
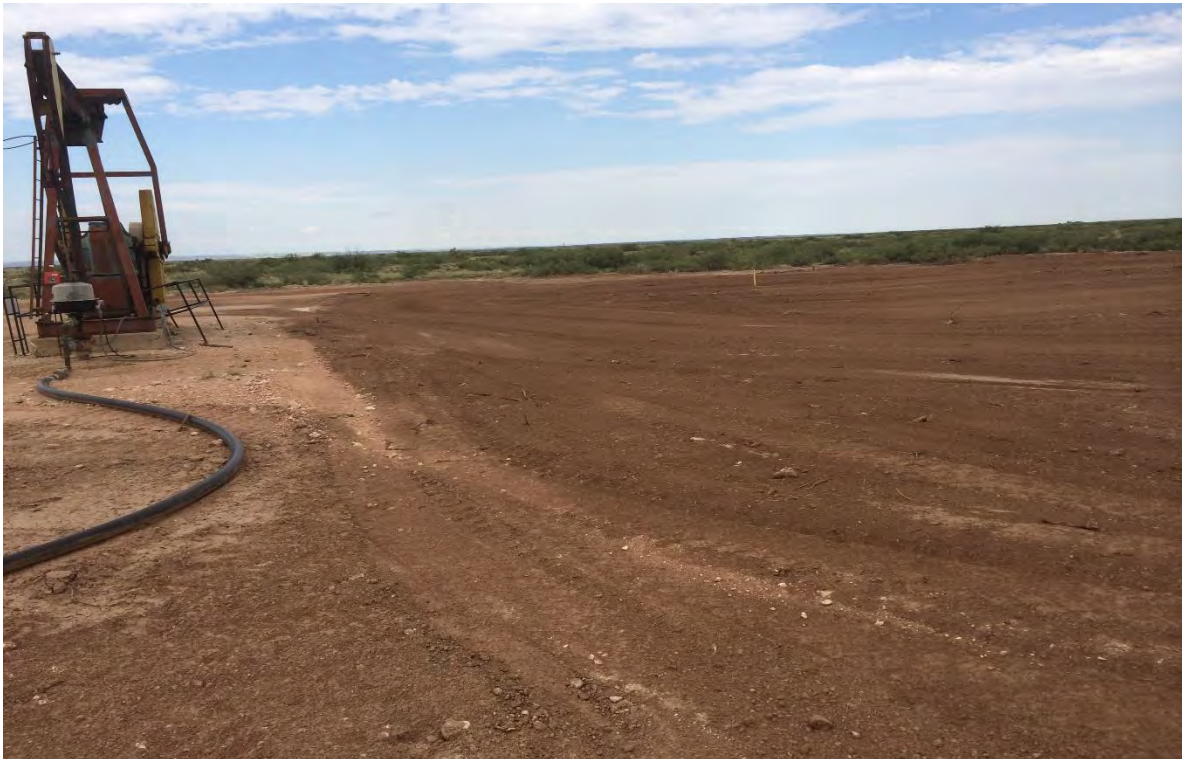
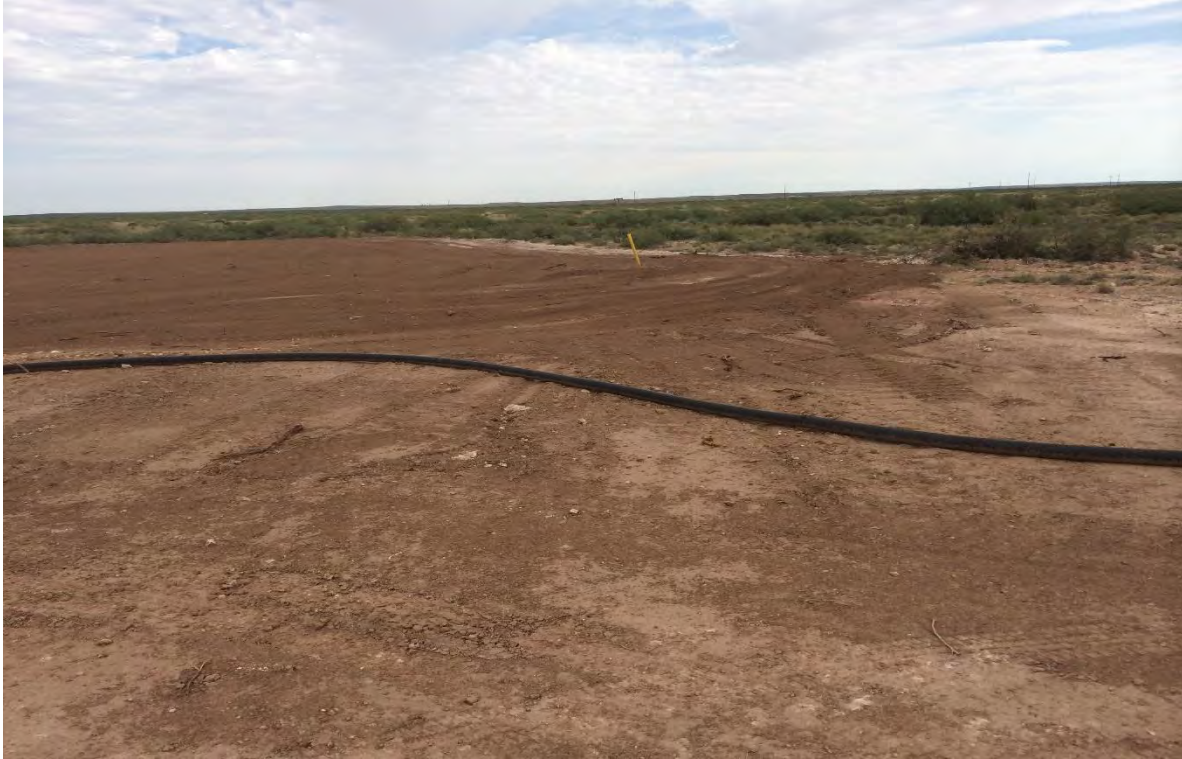
Indian Flats Bass Federal Well #3 – Excavation & Reserve Pit Area
(Following Backfilling; Looking Northwest)

Indian Flats Bass Federal Well #3 – Reserve Pit Area
(Following Backfilling; Looking West-Northwest)

Indian Flats Bass Federal Well #3 – Excavation & Reserve Pit Area
(Following Backfilling; Looking North)

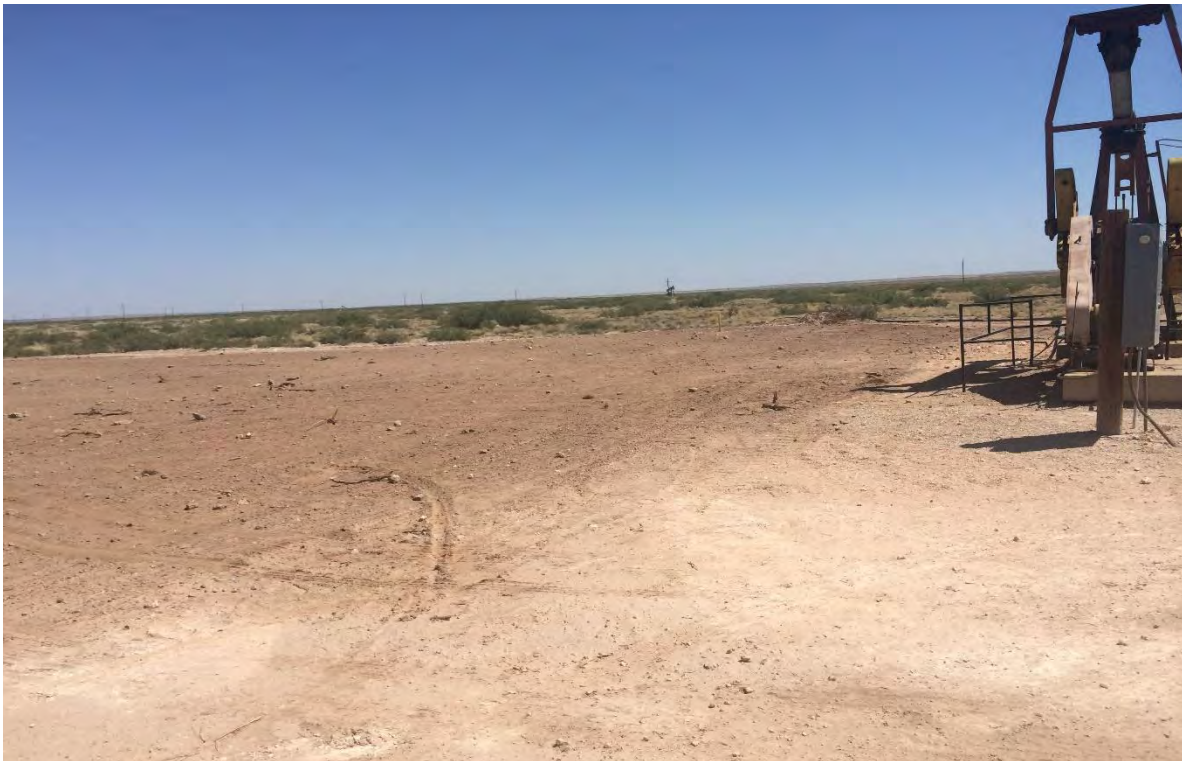
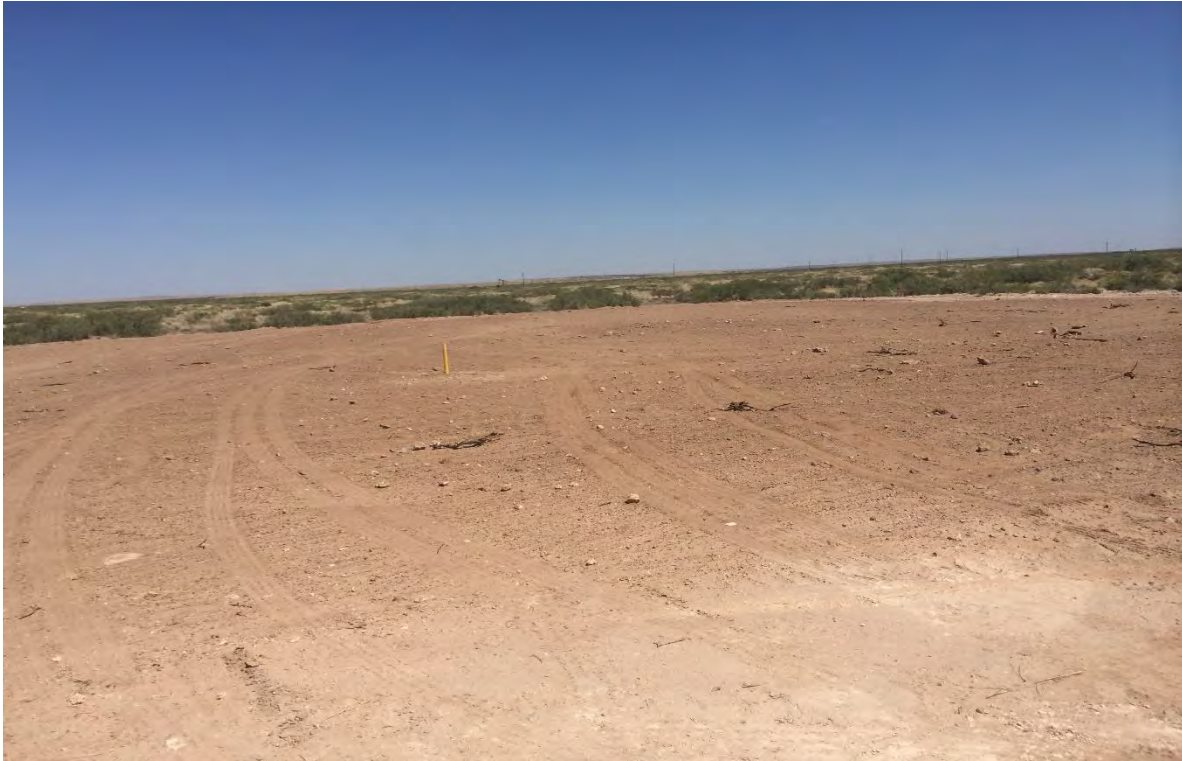
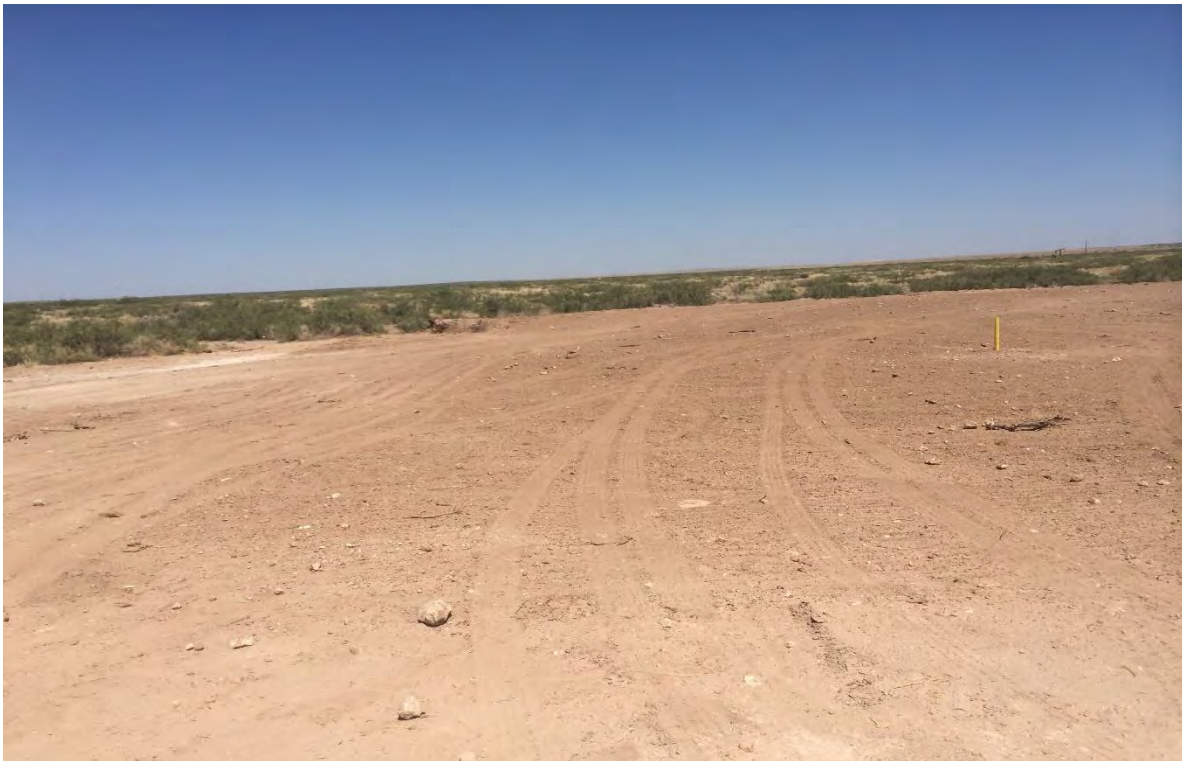
Indian Flats Bass Federal Well #3 – Excavation & Reserve Pit Area
(Following Seeding; Looking East-Northeast)

Indian Flats Bass Federal Well #3 – Reserve Pit Area
(Following Seeding; Looking North-Northeast)

Indian Flats Bass Federal Well #3 – Reserve Pit Area
(Following Seeding; Looking North-Northwest)

On August 28, 2014, the excavation and reserve pit area were seeded with a BLM-approved seed mixture. Post-seeding photographs of the site are included in Appendix B.
