## Report Type: Closure Report

Site:	Salada Vista 36 State #2					
Company:	COG Operating LLC					
Section, Township and Range	Sec 31	T 19S	R 31E			
Lease Number:	API-30-015-28591					
County:	Eddy County					
GPS:	32 37.354° N			103 54.997° W		
Surface Owner:	State					
Mineral Owner:						
Directions:	From the intersection of Hwy 360 and CR 222, travel East on CR 22 for apx. 3.15 miles, turn NORTH onto lease road for apx 0.7 miles, turn EAST onto lease road for apx 0.4 miles to location on south side of lease road.

**Re: Closure Report for the COG Operating LLC., Salada Vista 36 State #2, Unit D, Section 31, Township 19 South, Range 31 East, Eddy County, New Mexico.**

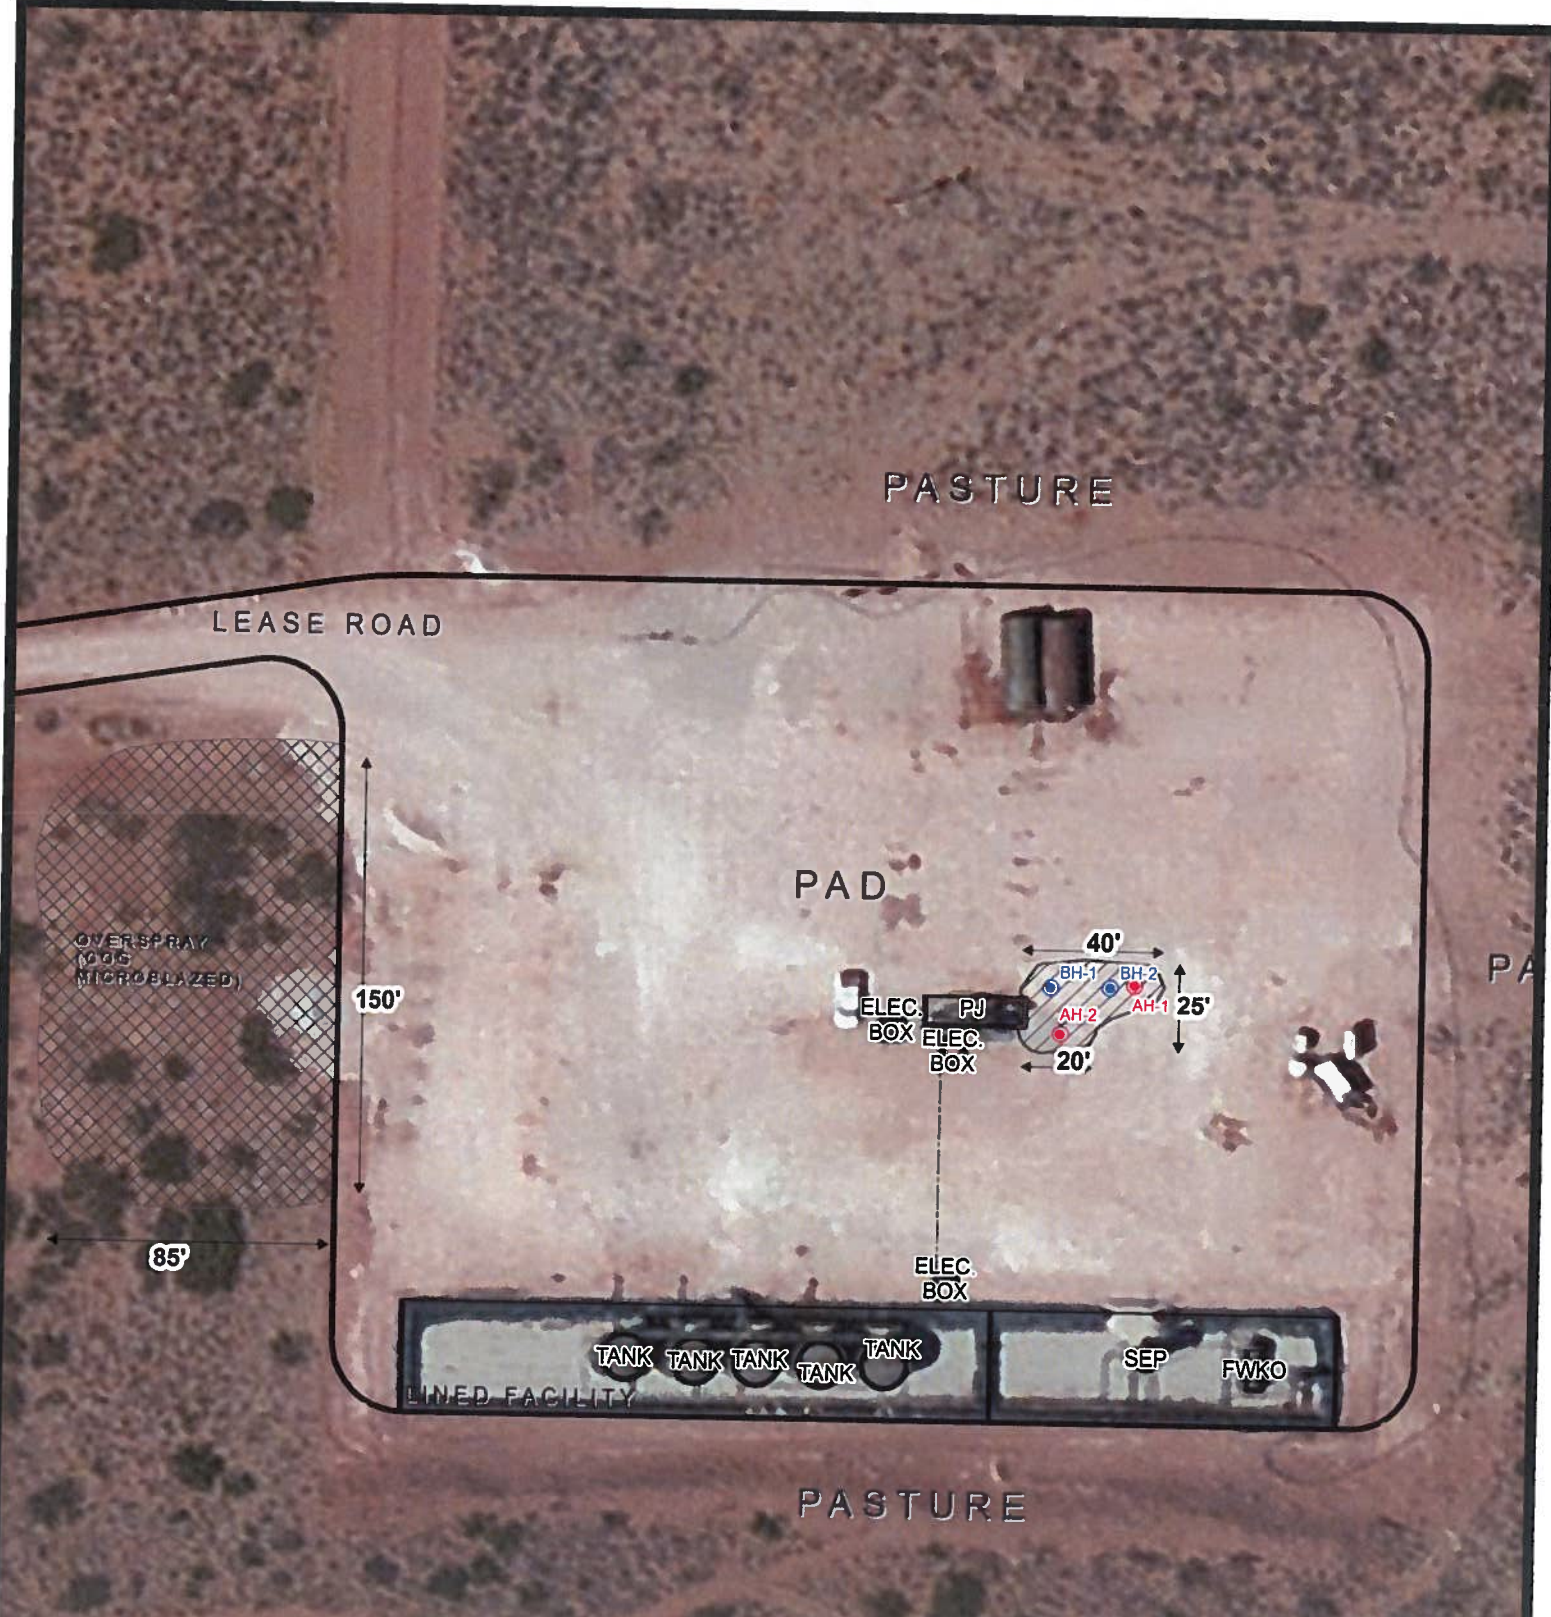
Figure 3

On January 21, 2014, Tetra Tech personnel inspected and sampled the spill area. Three (3) auger holes (AH-1, AH-2 and AH-3) were installed using a stainless steel hand auger to assess the impacted soils. Selected samples were analyzed for TPH analysis by EPA method 8015 modified, BTEX by EPA Method 8021B and chloride by EPA method 300.0. Copies of laboratory analysis and chain-of-custody documentation are included in Appendix C. The results of the sampling are summarized in Table 1. The auger hole locations are shown on Figure 3.

On March 3, 2014, Tetra Tech personnel installed two (2) boreholes (BH-1 and BH-2) using a drilling rig to vertically define the chloride impact. The borehole locations are shown on Figure 3. The sampling results are summarized in Table 1. Copies of laboratory analysis and chain-of-custody documentation are included in Appendix C.

Spill Assessment Map

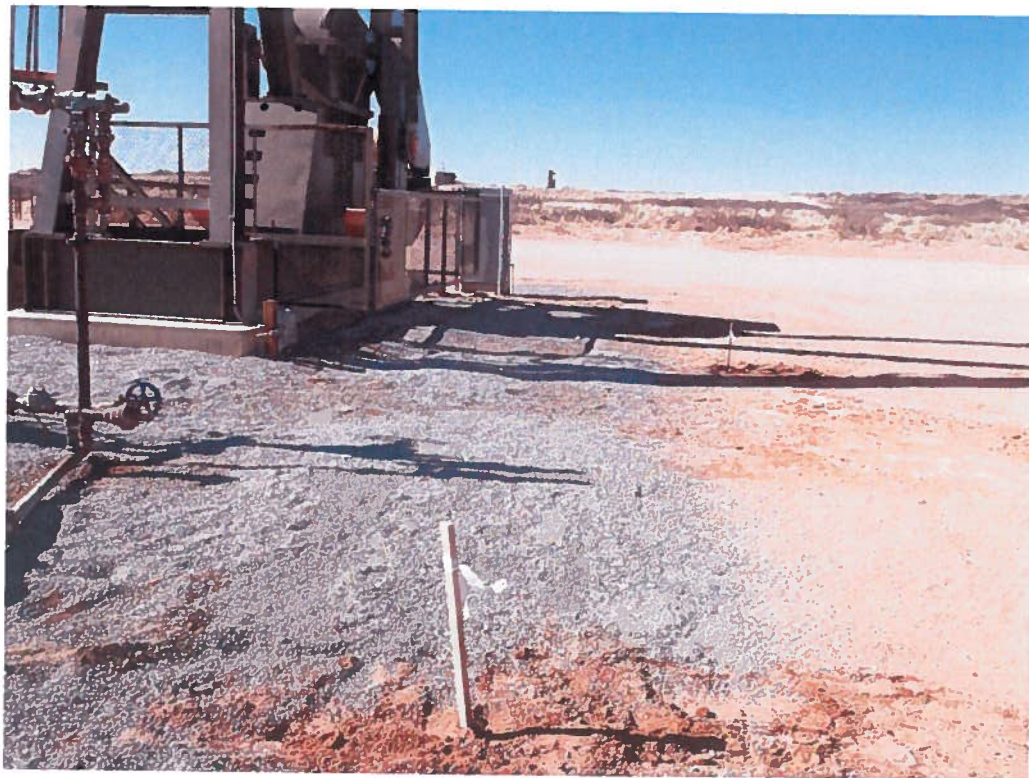
View West – Area of AH-1 and AH-3

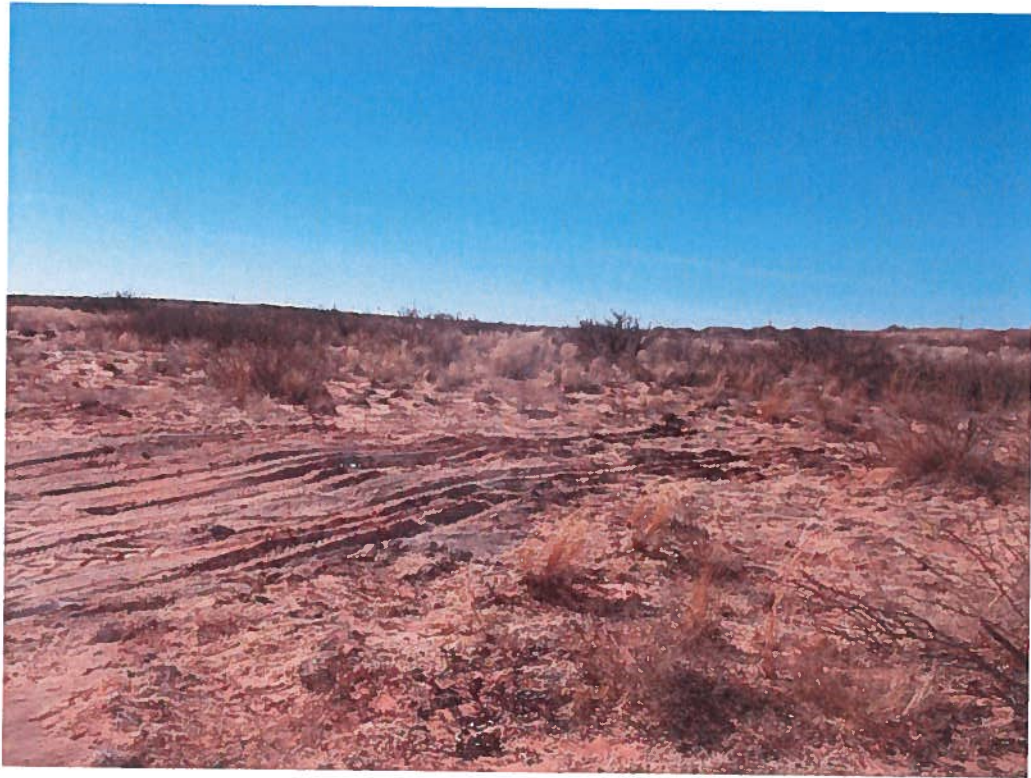
View West – Area affected by overspray

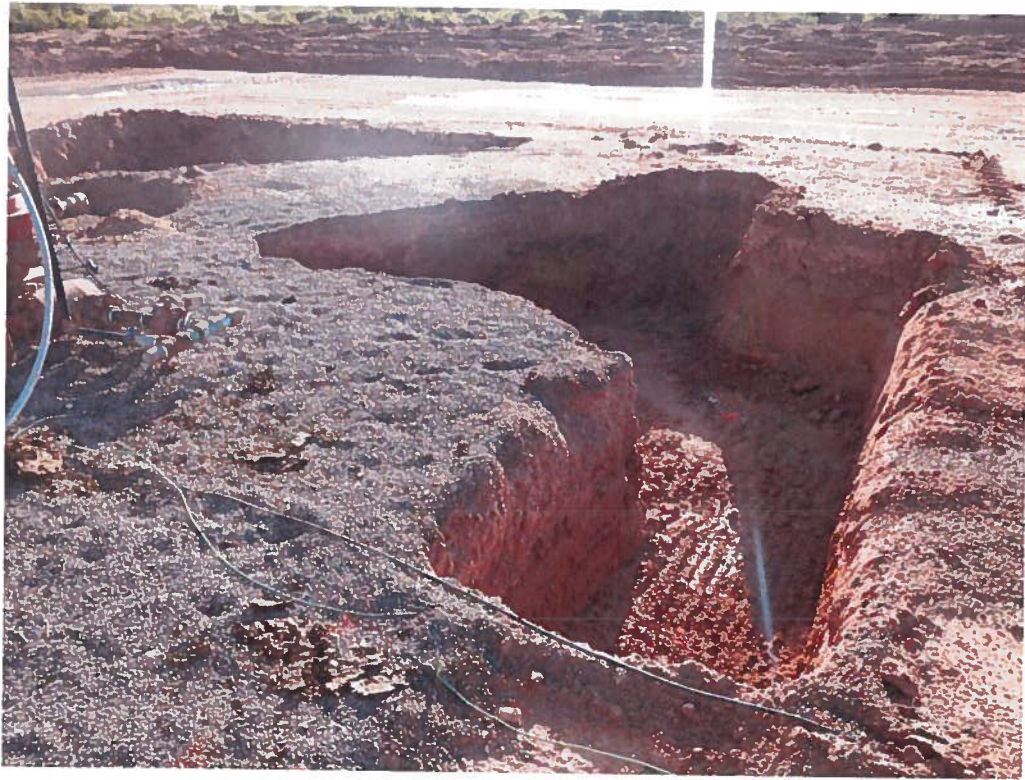
View East – Excavated area of AH-2

On February 24, 2014, Tetra Tech supervised the removal impacted material as highlighted (green) in Table 1 and shown on Figure 4. As proposed in the work plan, the areas of auger holes (AH-1 and AH-2) were excavated to depths of approximately 3.5' below surface and a clay material was placed to cap the area and prevent further migration of contaminants left in place. Once the areas were excavated to the appropriate depths, the excavations were backfilled with clean soil to grade, and approximately 52 cubic yards of excavated material was hauled to proper disposal.

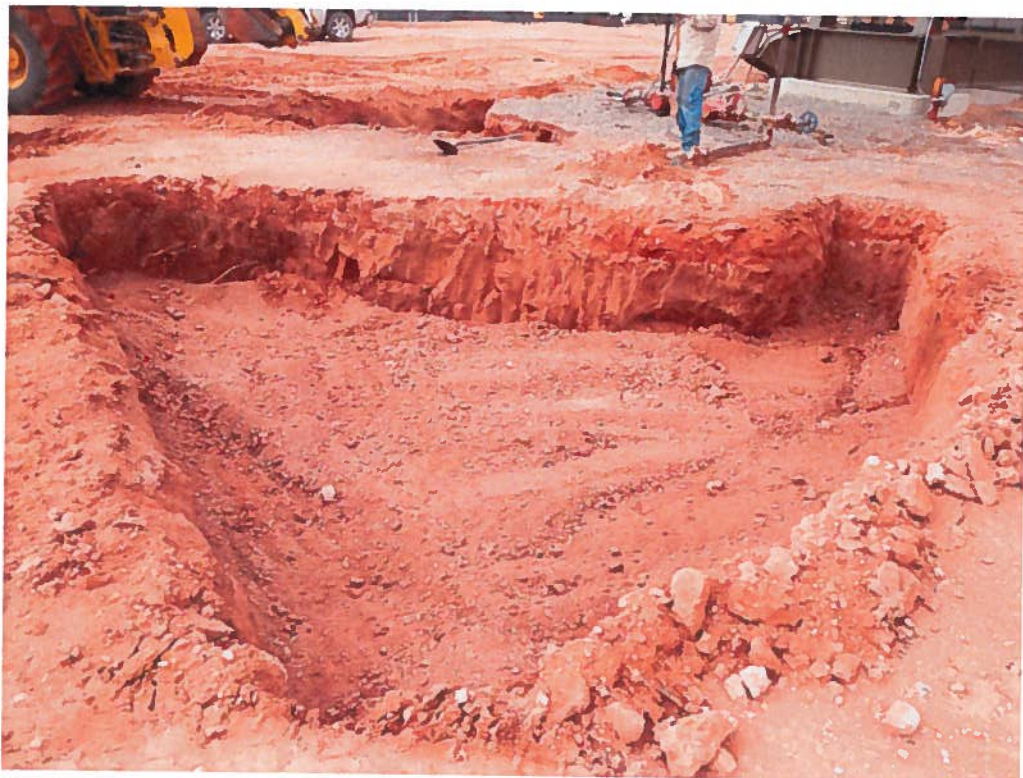
View West – Clay capped area of AH-1

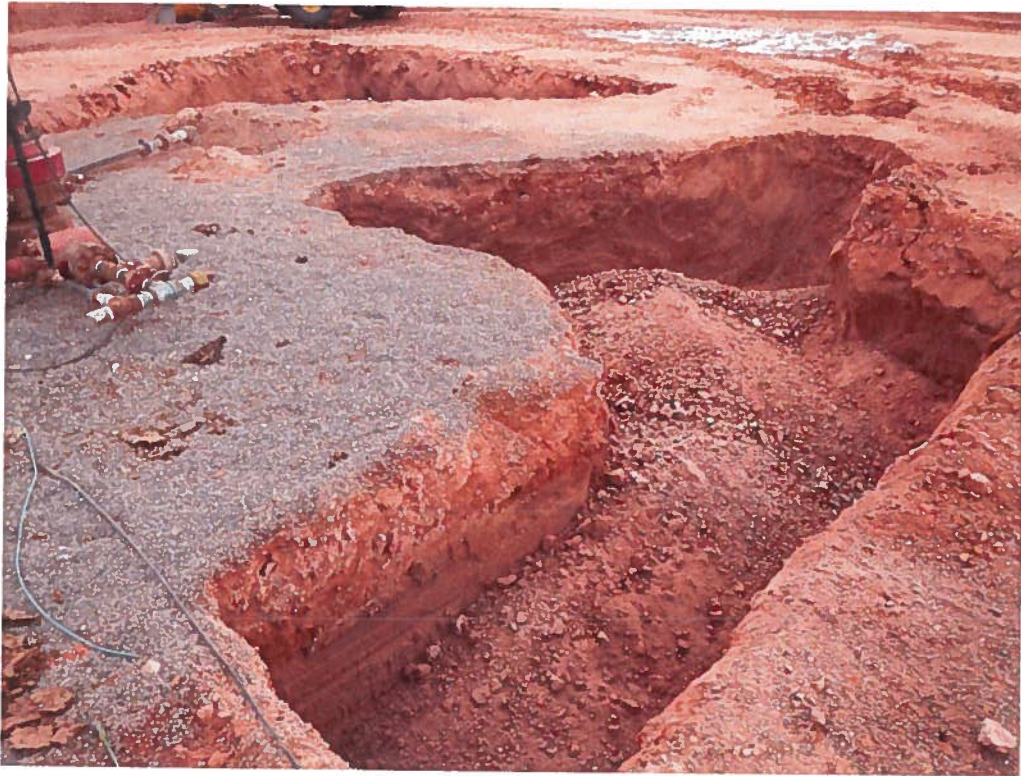
View East – Clay capped area of AH-2

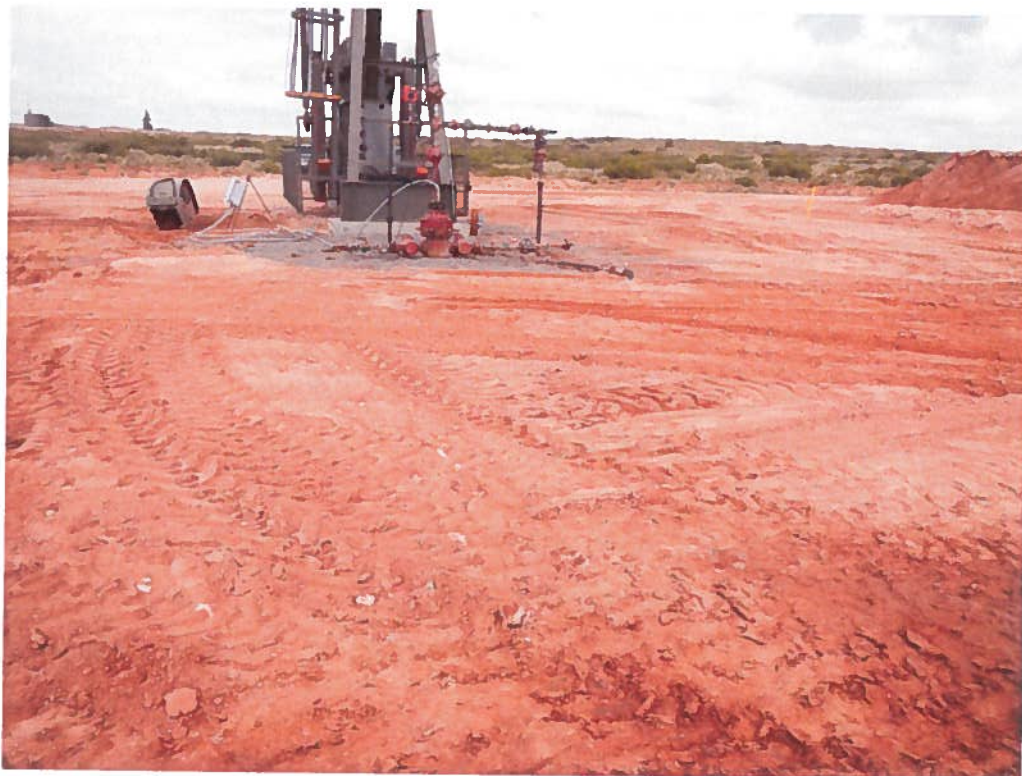
View West – Backfilled excavation area
