CLOSURE REPORT

BOPCO, L.P.
PLU-CVX-JV-BS 27-1H
Eddy County, New Mexico
Unit Letter "E", Section 3, Township 25 South, Range 31 East
Latitude 32.160773 North, Longitude 103.770594 West
NMOCD Reference #2RP-2508

RE: Final Closure Report
Bopco – PLU-CVX-JV-BS 27-1H
UL-E, Section 3, Township 25 South, Range 31 East
Eddy County, New Mexico
NMOCD Reference # 2RP 2508

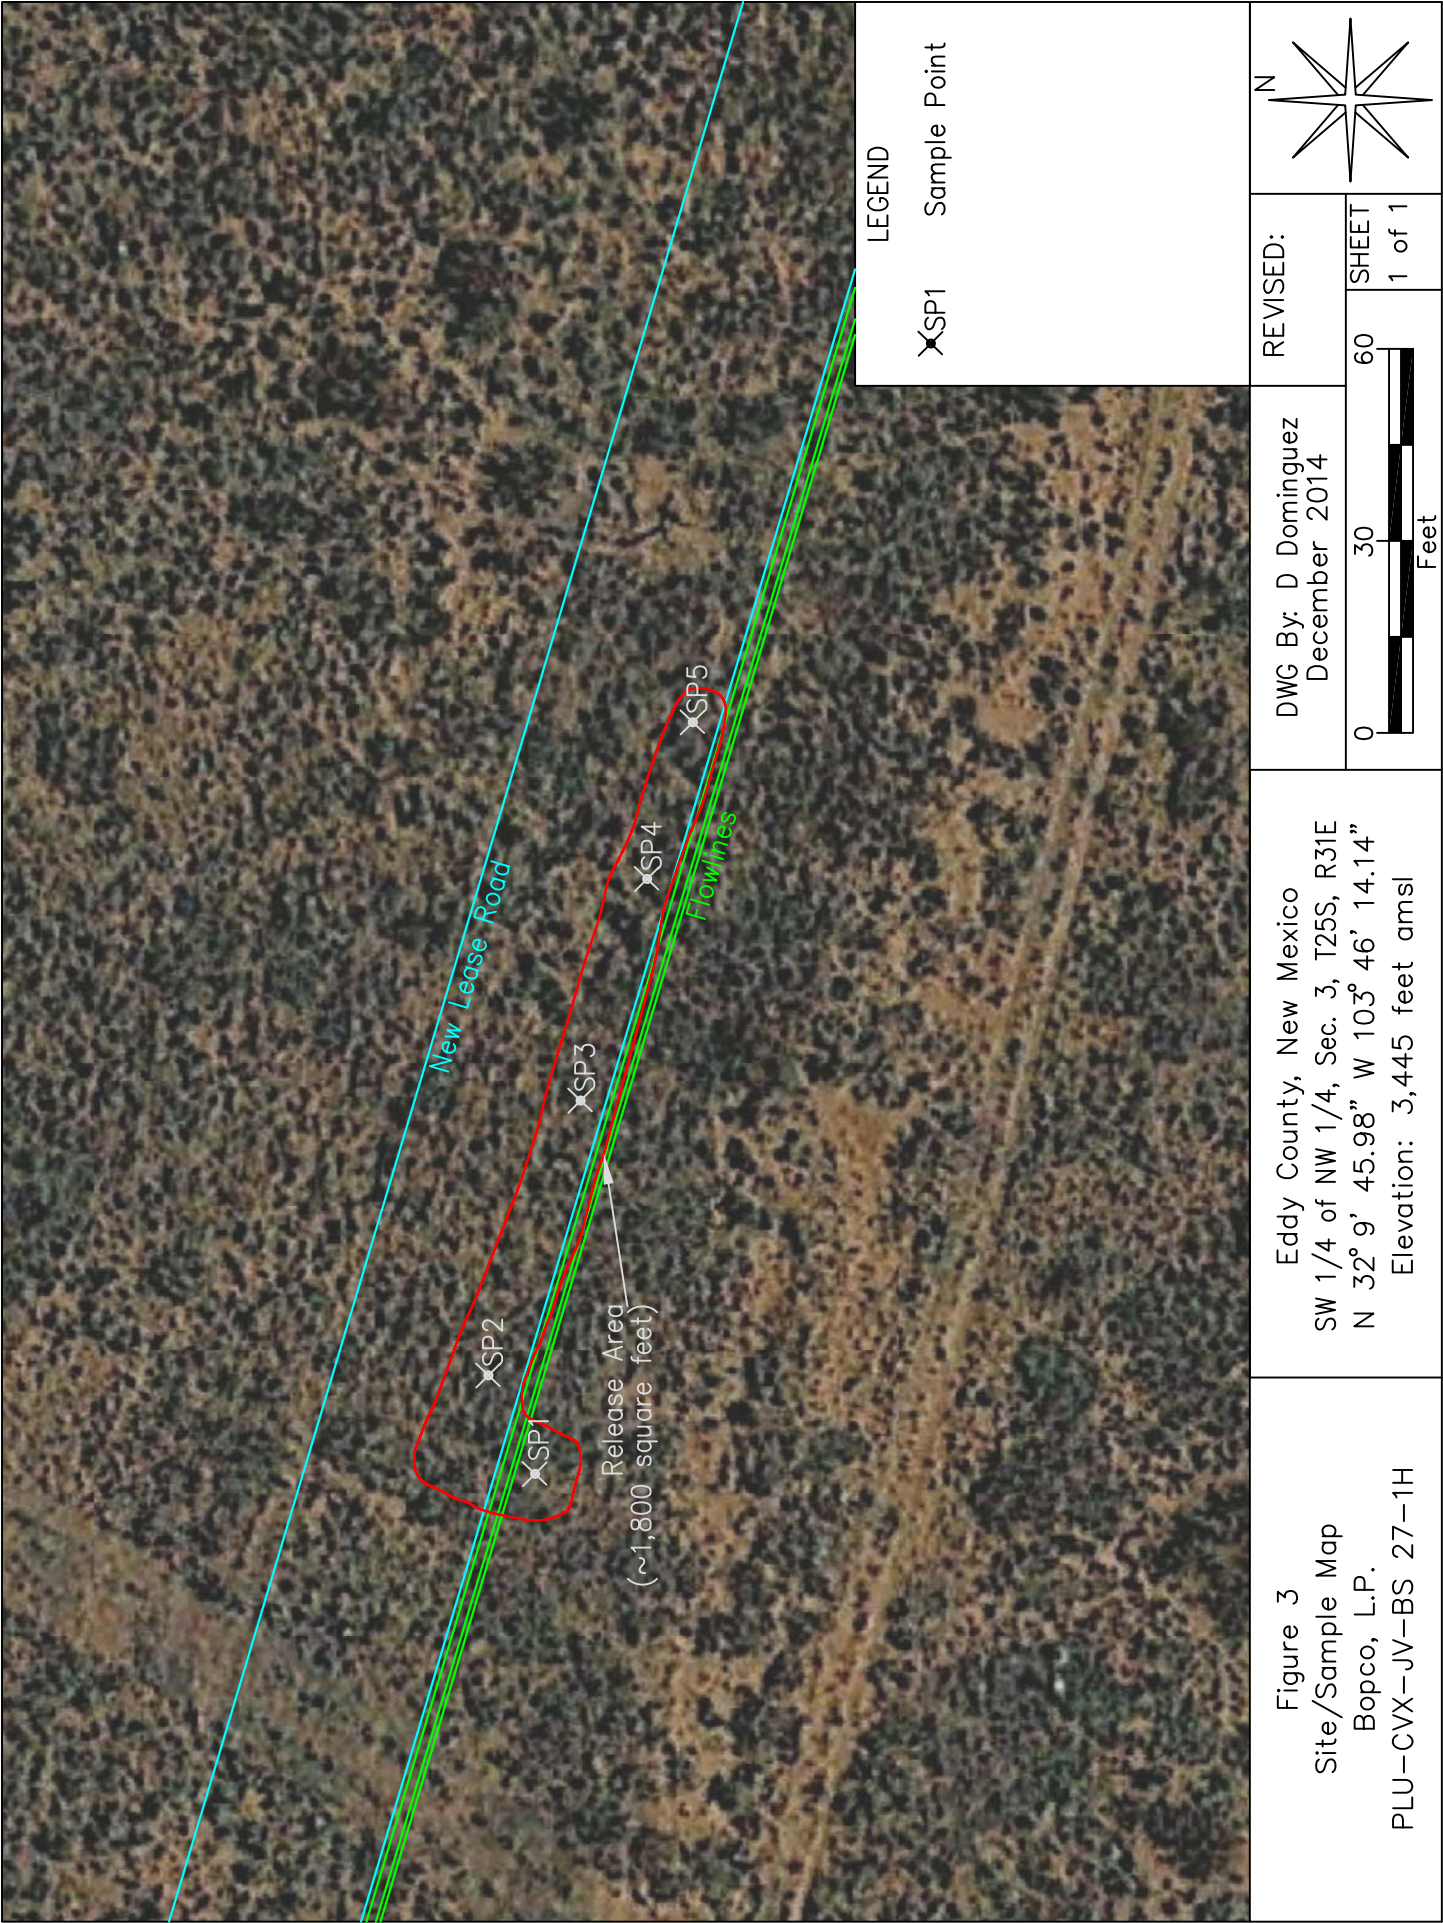
EPI personnel mobilized on the site on October 24, 2014 to collect soil samples via hand auger to determine the vertical extent of contamination. A total of twenty-one (21) soil samples were collected from five (5) sample locations. On October 29, 2014 eight (8) additional, deeper, soil samples were collected from three (3) of the sample points; all samples were sent to Cardinal Labs in Hobbs, New Mexico; testing for Chloride concentrations. Laboratory analytical results indicate the release area is void of Chloride concentrations in excess of NMOCD Recommended Remedial Action Levels (RRALs) of 1,000 mg/Kg, in all samples except SP4. Chloride concentrations at SP4 exceed NMOCD RRALs only at a depth of four (4) to five (5) feet bgs (reference *Figure 3* and *Table 2*).

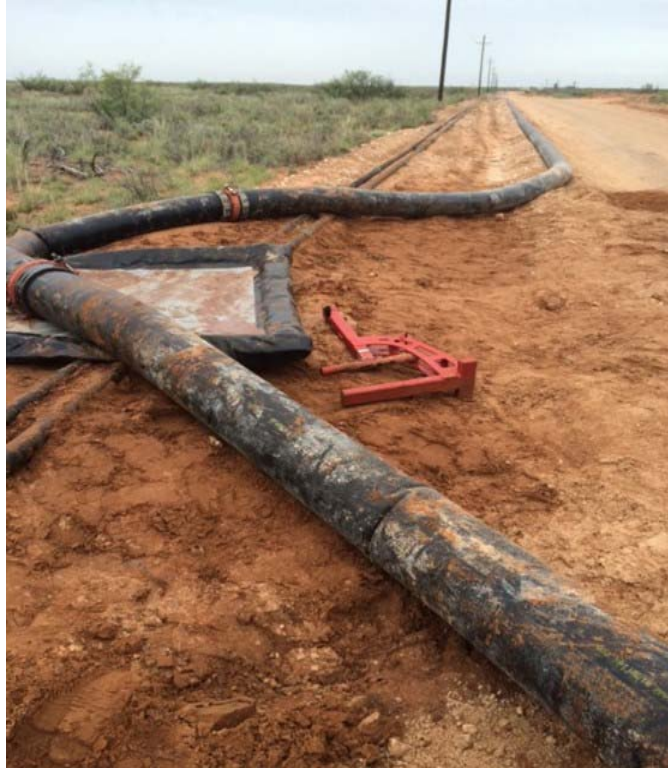
Photograph #1 – Release Point

A pickup truck operated by Baker Hughes backed over a 10 inch lay flat frac hose creating a tear. The line was isolated and a section of hose was replaced. The spill impacted approximately 1,800 sq. ft. of caliche lease road and bar-ditch. A vacuum truck on-site recovered the free standing fluid. The remainder of the spill soaked into the road. A sampling event was conducted to determine the need for further remediation.

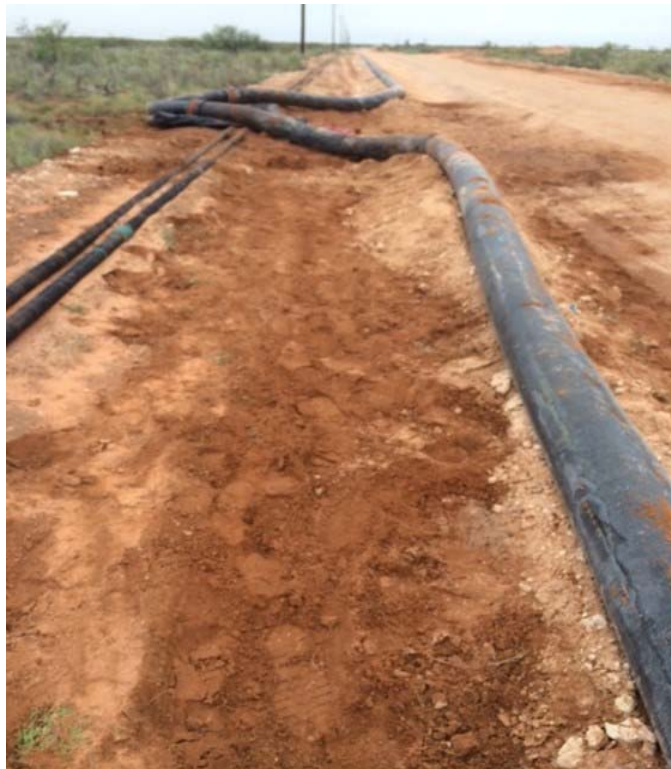
Photograph #2 – Looking across release area

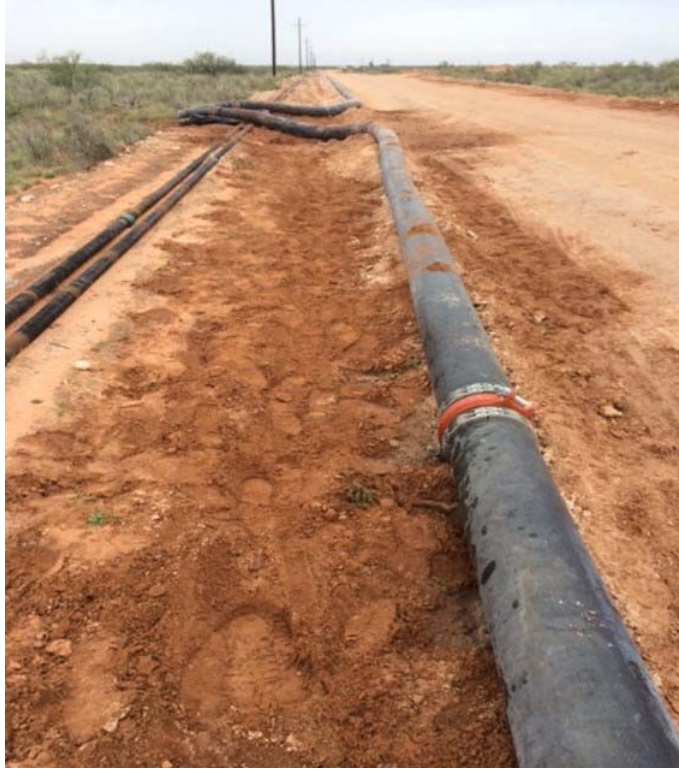
Photograph #3 – Looking across release area

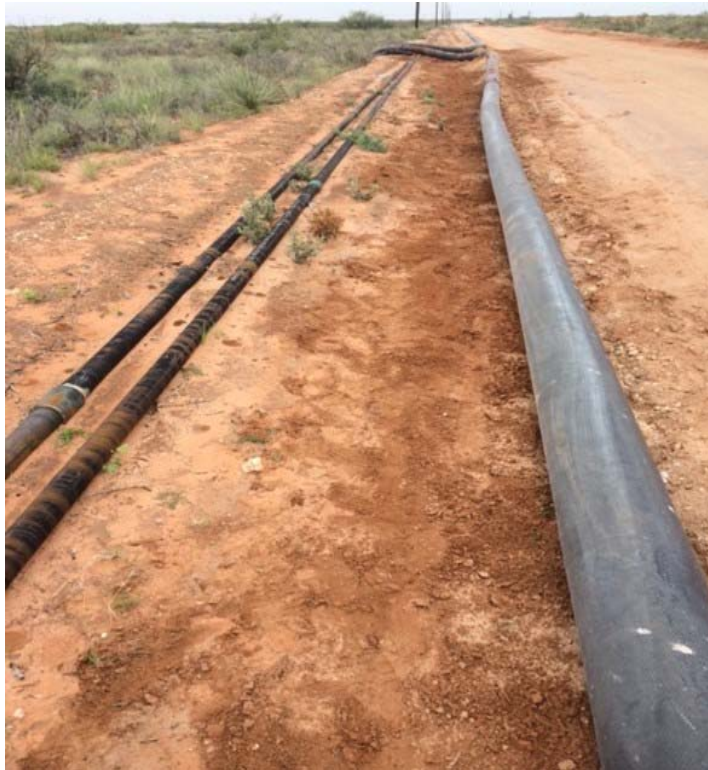
Photograph #4 – Looking across release area
