CLOSURE REPORT

BOPCO, L.P.
Poker Lake Unit #274
Eddy County, New Mexico
Unit Letter "O", Section 12, Township 24 South, Range 29 East
Latitude 32.225443 North, Longitude 103.936917 West
NMOCD Reference #2RP-2507

RE: Final Closure Report
Bopco – Poker Lake Unit #274
UL-O, Section 12, Township 24 South, Range 29 East
Eddy County, New Mexico
NMOCD Reference # 2RP 2507

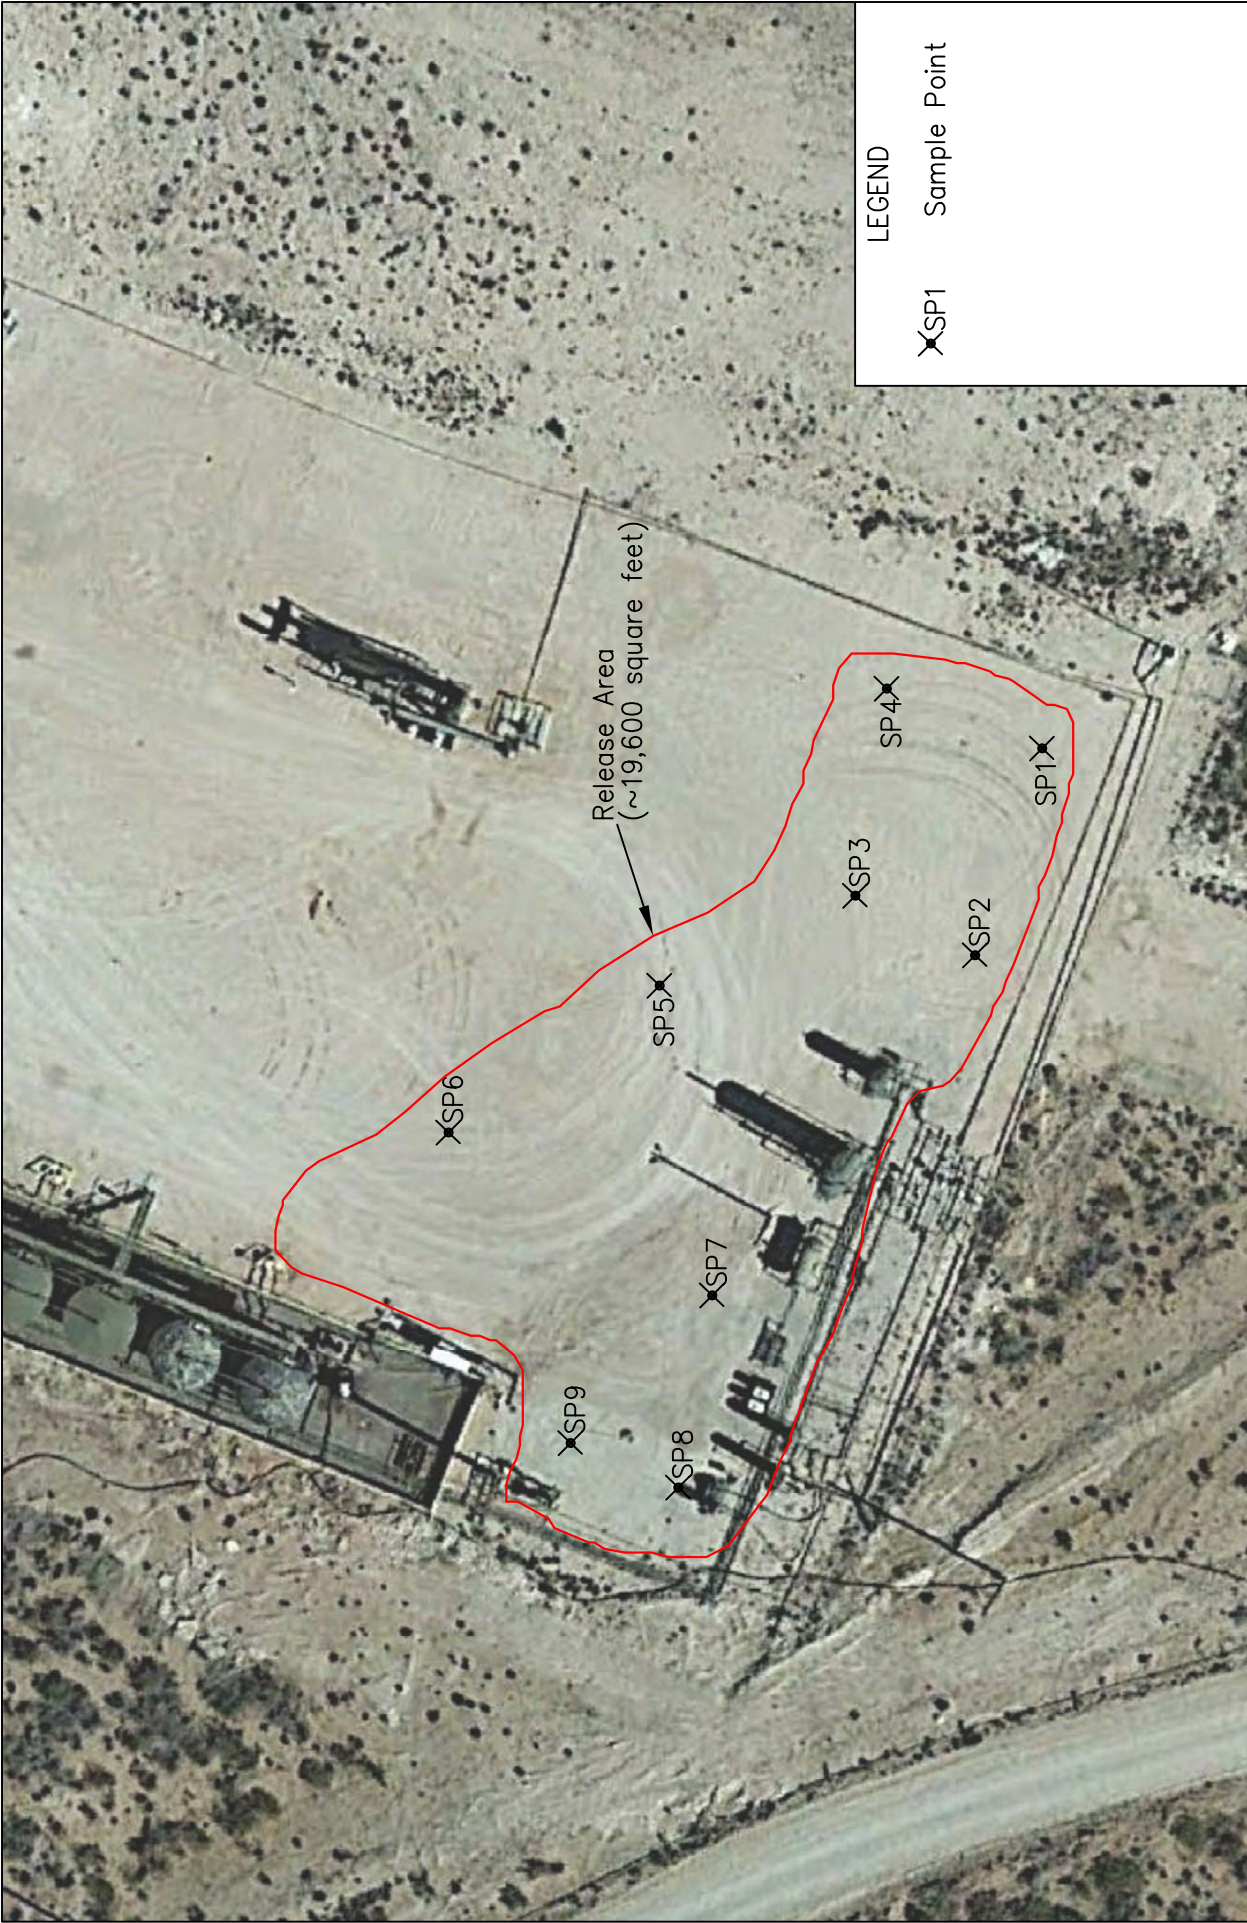
✕SP1	Sample Point		
DWG By: D Dominguez December 2014		0 40 80 Feet	SHEET 1 of 1
Figure 3 Site/Sample Map Bopco, L.P. Poker Lake Unit #274		Eddy County, New Mexico SW 1/4 of SE 1/4, Sec. 12, T24S, R29E N 32° 13' 33.50" W 103° 56' 13.58" Elevation: 3,113 feet amsl

EPI personnel mobilized on the site on November 17, 2014 to collect soil samples via backhoe to determine the vertical extent of contamination. A total of twenty-seven (27) soil samples were collected from seven (7) sample locations. On November 19, 2014 seven (7) additional soil samples were collected from two (2) new sample points; all samples were sent to Cardinal Labs in Hobbs, New Mexico, for testing. Laboratory analytical results indicate the excavation is void of Benzene, BTEX, TPH, and Chloride concentrations in excess of NMOCD Recommended Remedial Action Levels (RRALs) of 10 mg/Kg, 50 mg/Kg, 5,000 mg/Kg, and 1,000 mg/Kg, respectively, in the areas of SP1 – SP5, and SP8. Chloride concentrations exceed NMOCD RRALs in the area of SP6 to a depth of two (2) feet bgs. In the area of SP7 TPH concentrations exceed NMOCD RRALs at surface level, with Chloride concentrations exceeding NMOCD RRALs to a depth of four (4) feet bgs. In the area of SP9 Benzene concentrations exceed NMOCD RRALs at one (1) foot bgs while TPH concentrations exceed NMOCD RRALs to a depth of two (2) feet bgs (reference *Figure 3* and *Table 2*).

From November 17 - 26, 2014 the release area was excavated to a depth of one (1) foot bgs in the areas of SP1 – SP8; SP9 was excavated to a depth of three (3) feet bgs. Approximately

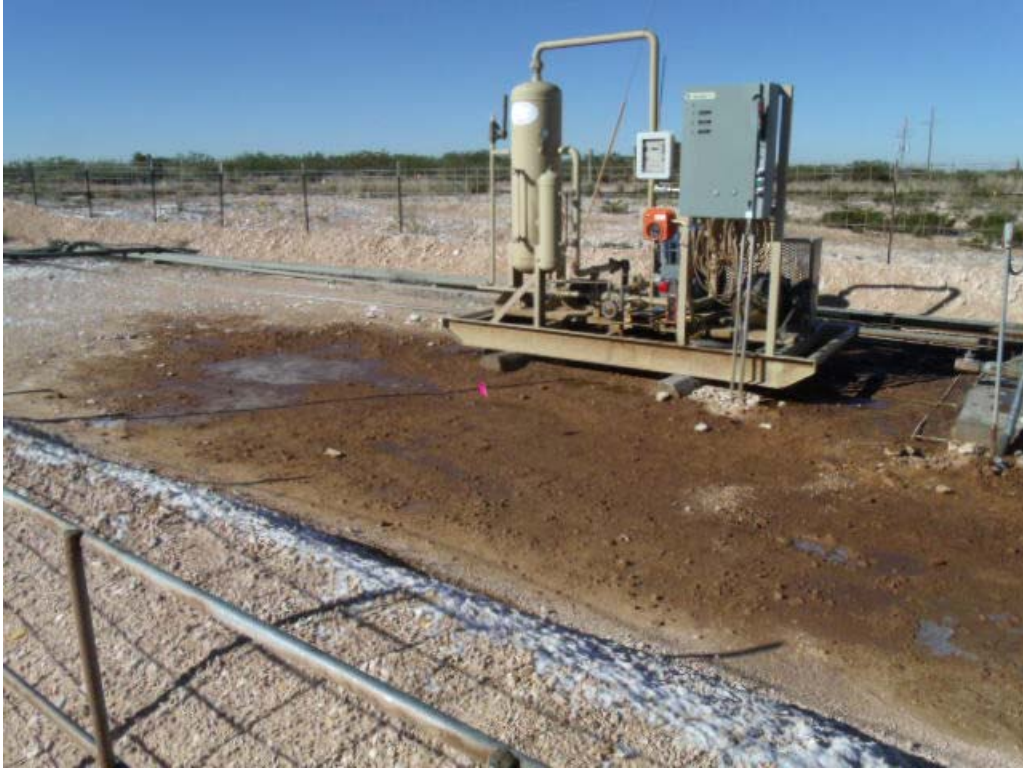
Photograph #1 – Looking across release area

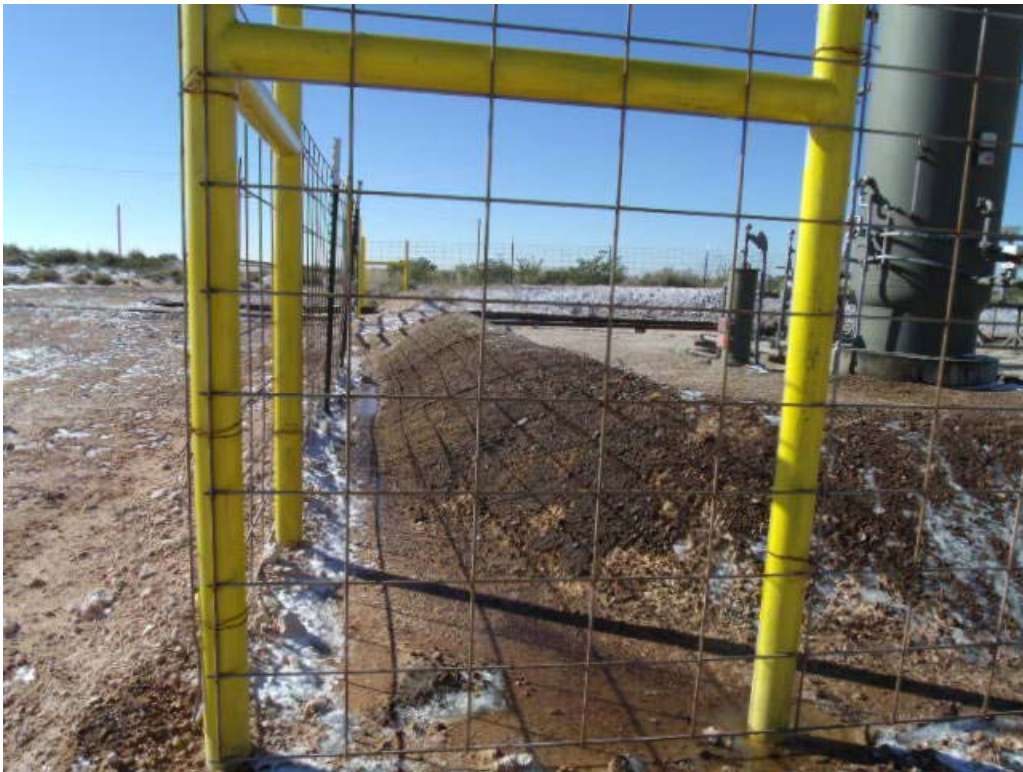
Photograph #2 – Looking across release area

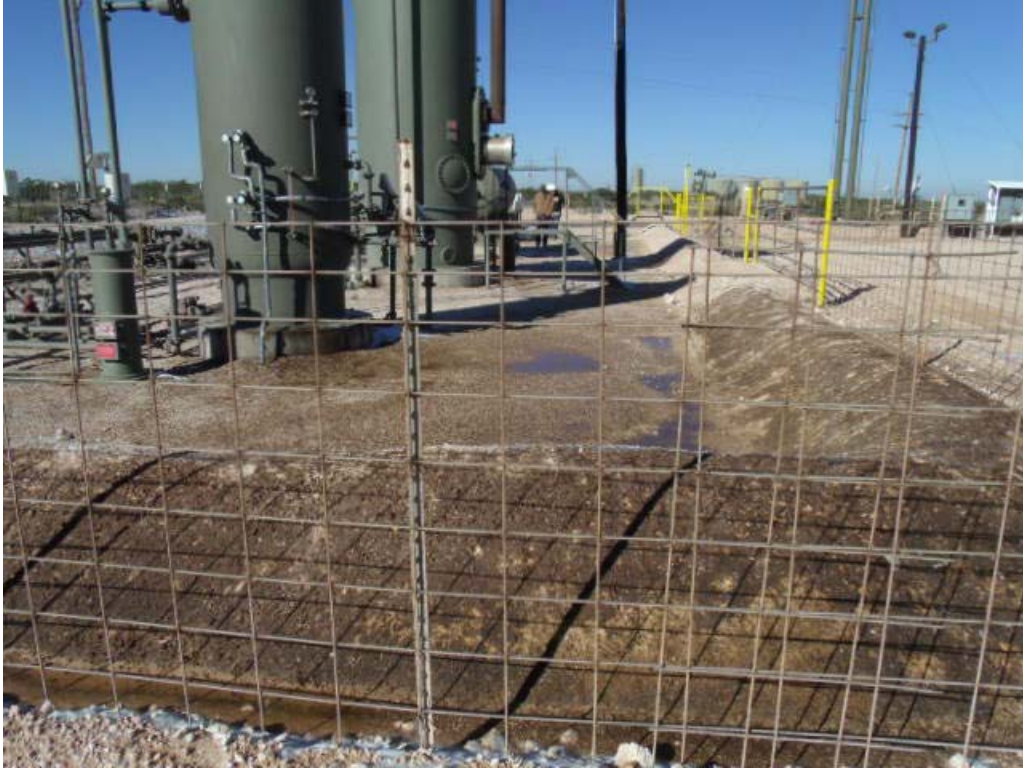
Photograph #3 – Looking across release area

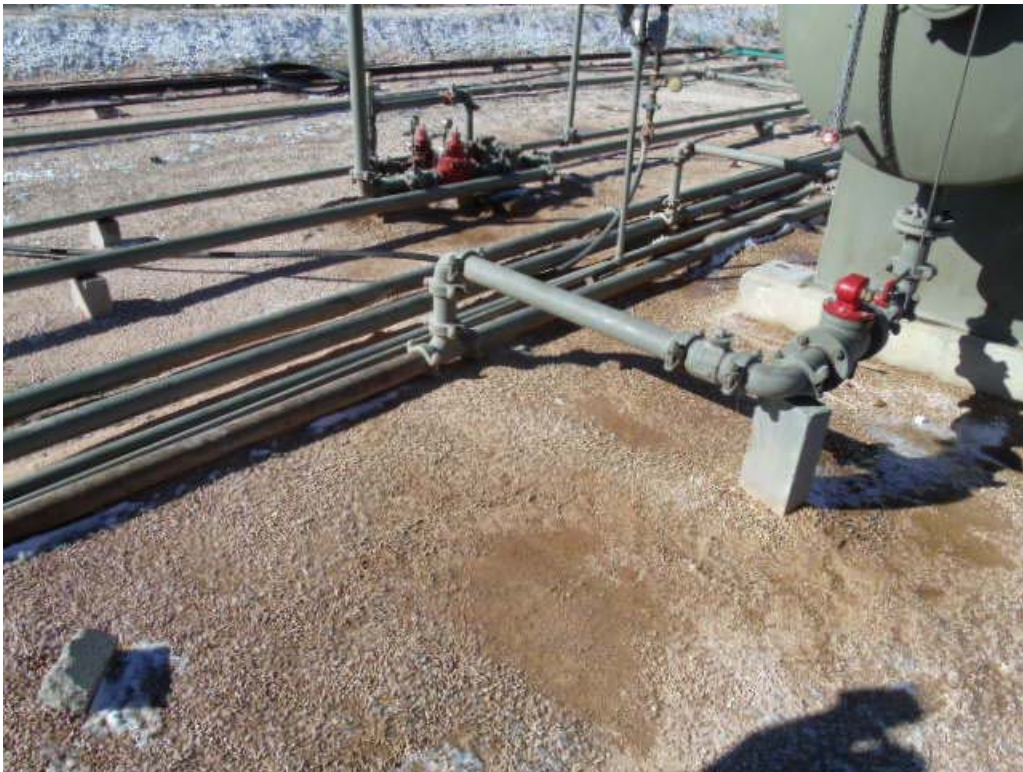
Photograph #4 – Looking across release area

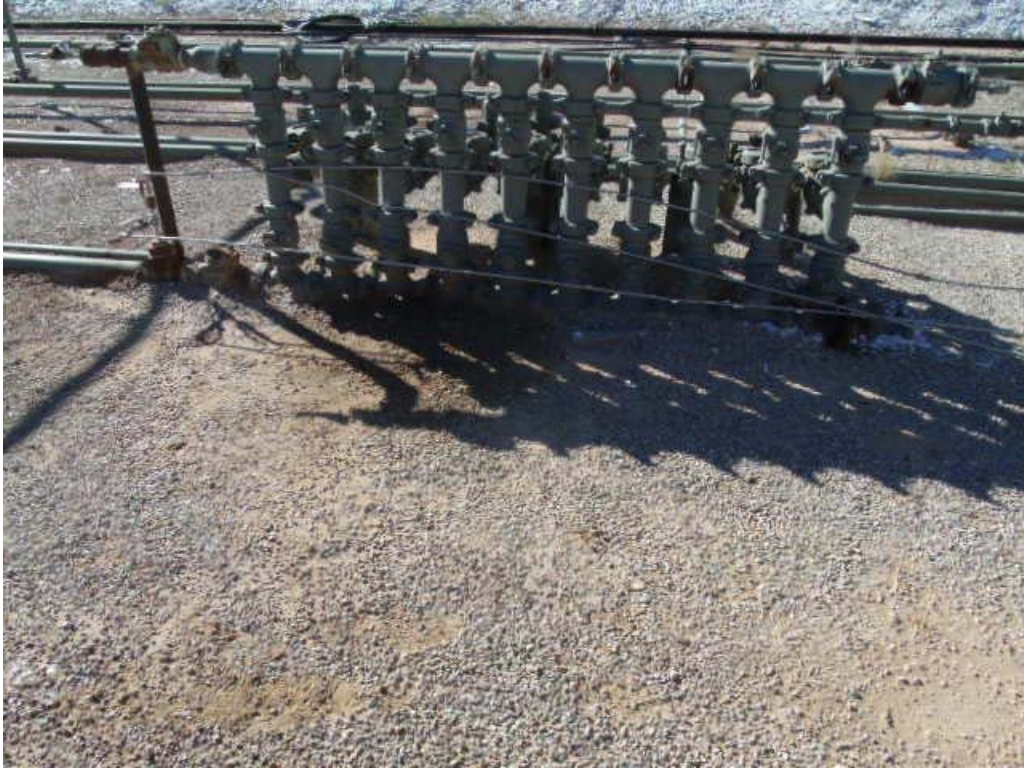
Photograph #5 – Release area

The float inside the free water knock out failed to shut of the fluid level causing oil to pressure up and go out the flare line. The float system was repaired. The release impacted approximately 19,600 sq. ft. of tank battery and well pad area with heavy to moderate oil saturation. The release also misted an area of approximately 49,200 sq. ft. in the pasture north west of the tank battery location. The area was reviewed by EH&S on 9/11/14; there had been a significant rain event, there was very little oil residue remaining on the vegetation. The saturated soil on the pad had been scraped up and stockpiled onsite.

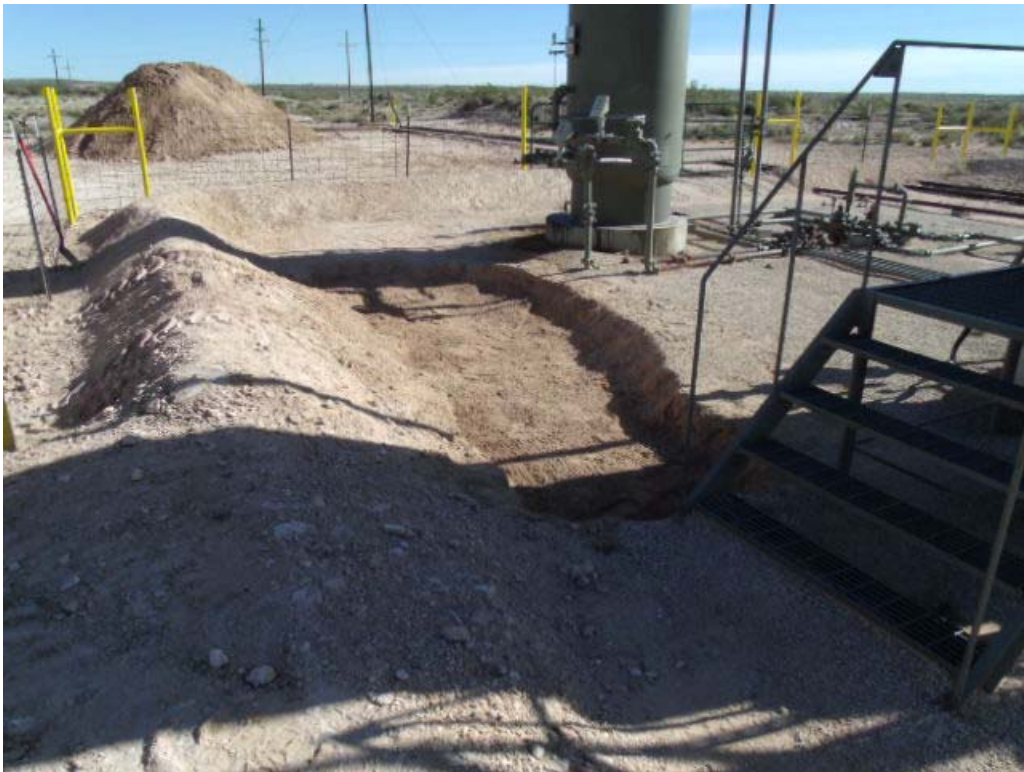
Photograph #6 – Excavated area

201.48 tons of contaminated soil was excavated and hauled to a state approved facility for disposal.

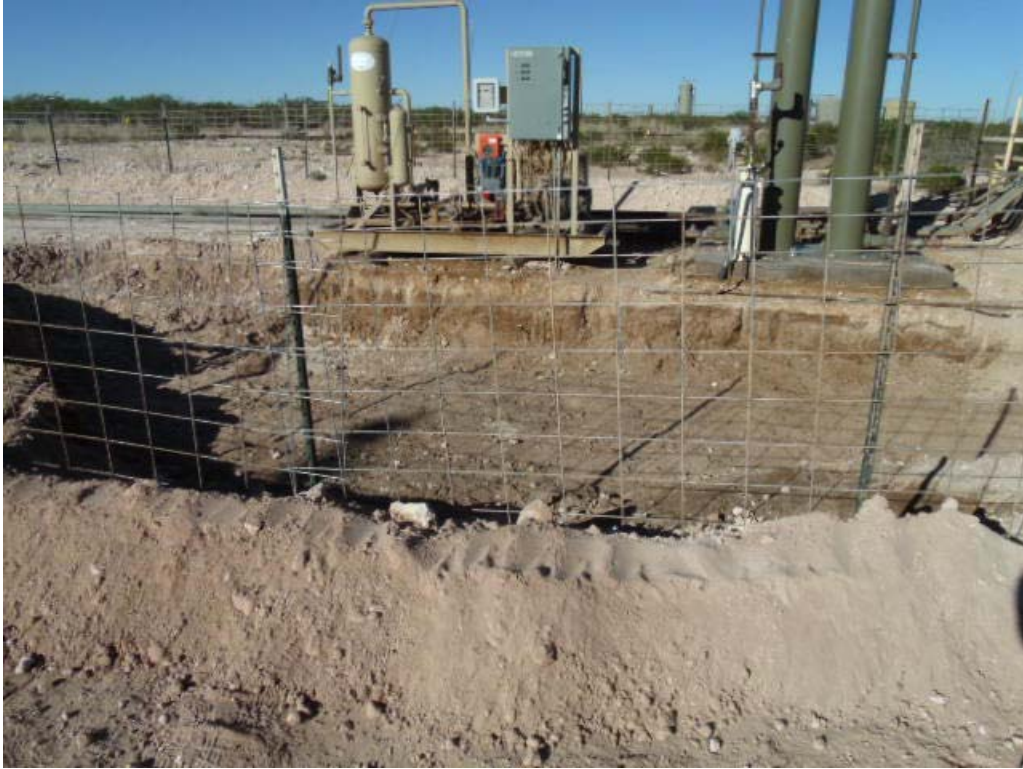
Photograph #7 – Excavated area

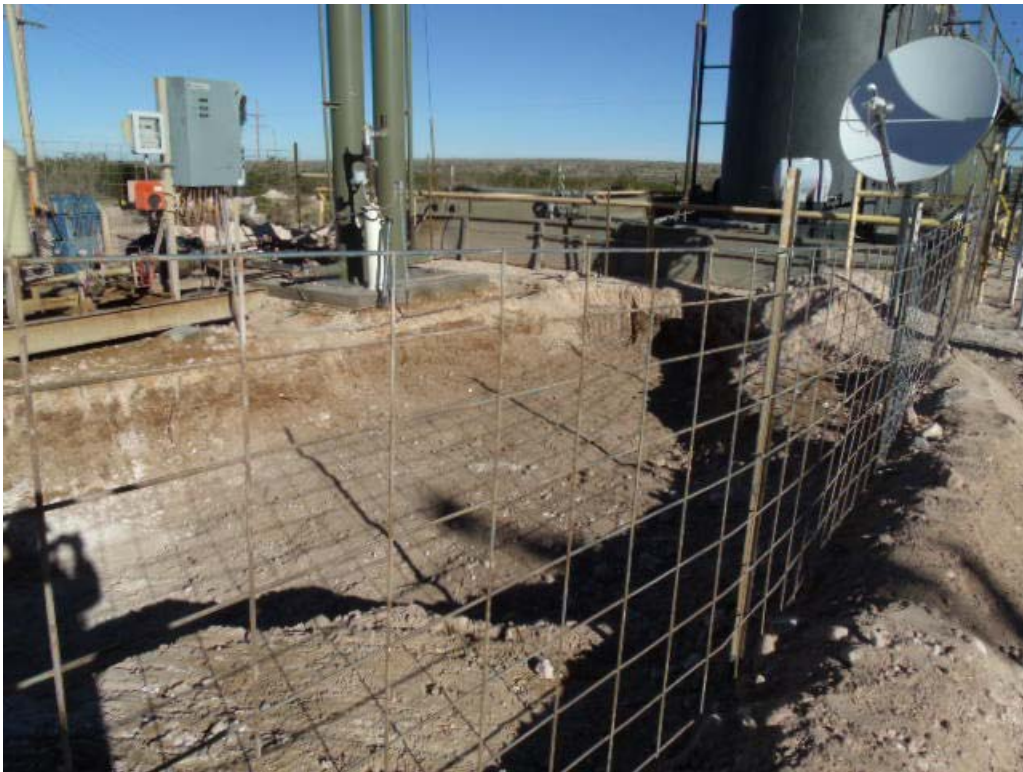
Photograph #8 – Excavated area

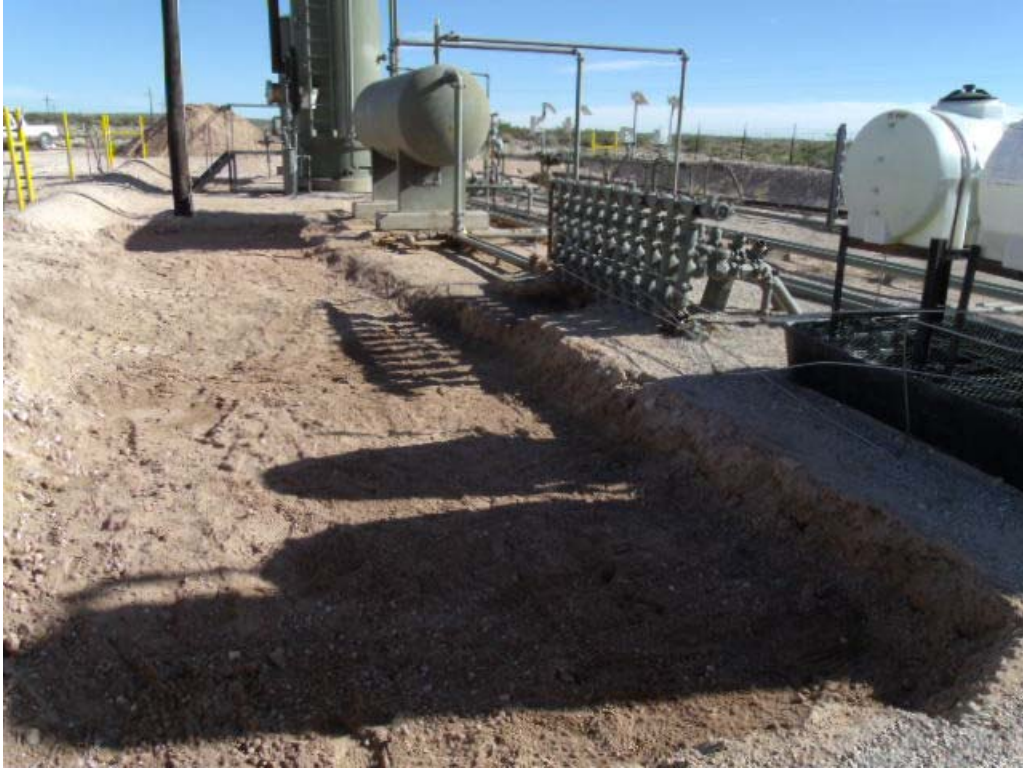
Photograph #9 – Excavated area

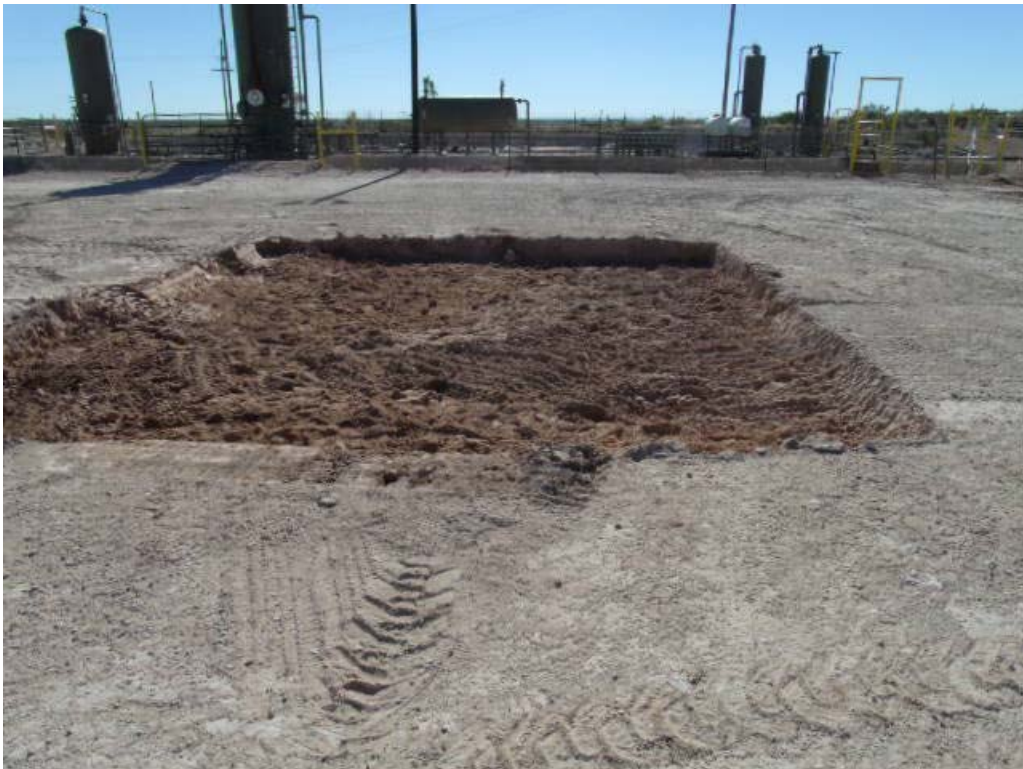
Photograph #10 – Excavated area

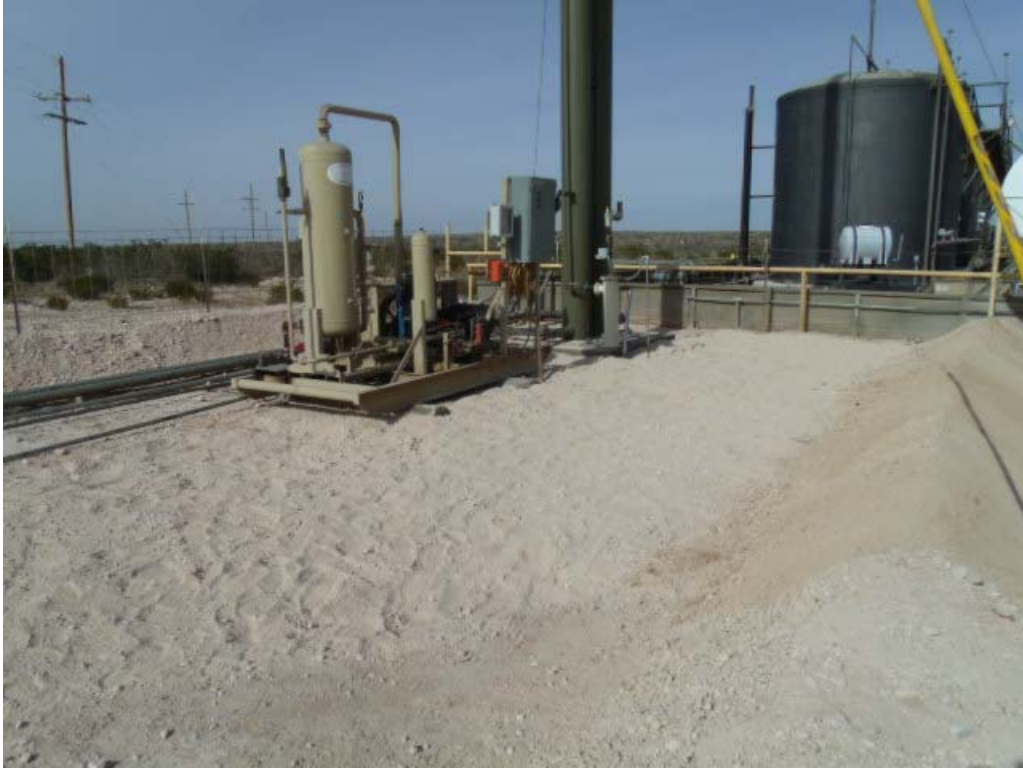
Photograph #11 – Backfilled area

The excavation was backfilled with approximately 129.73 tons of clean soil that was left over from previous work and stockpiled on site. Approximately 71.75 tons of clean soil were hauled in to complete backfilling activities. All soil was free of rocks, clumps or deleterious material. The entire disturbed area was then contoured to blend with existing pad area and protected against wind/water erosion.

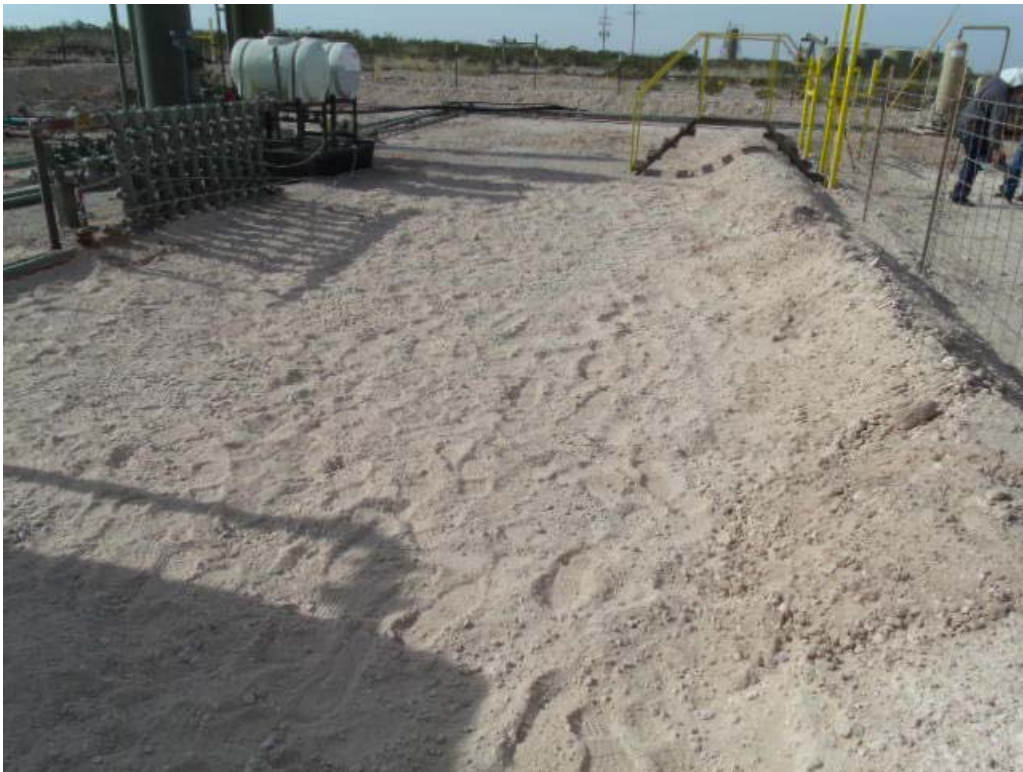
Photograph #12 – Backfilled area

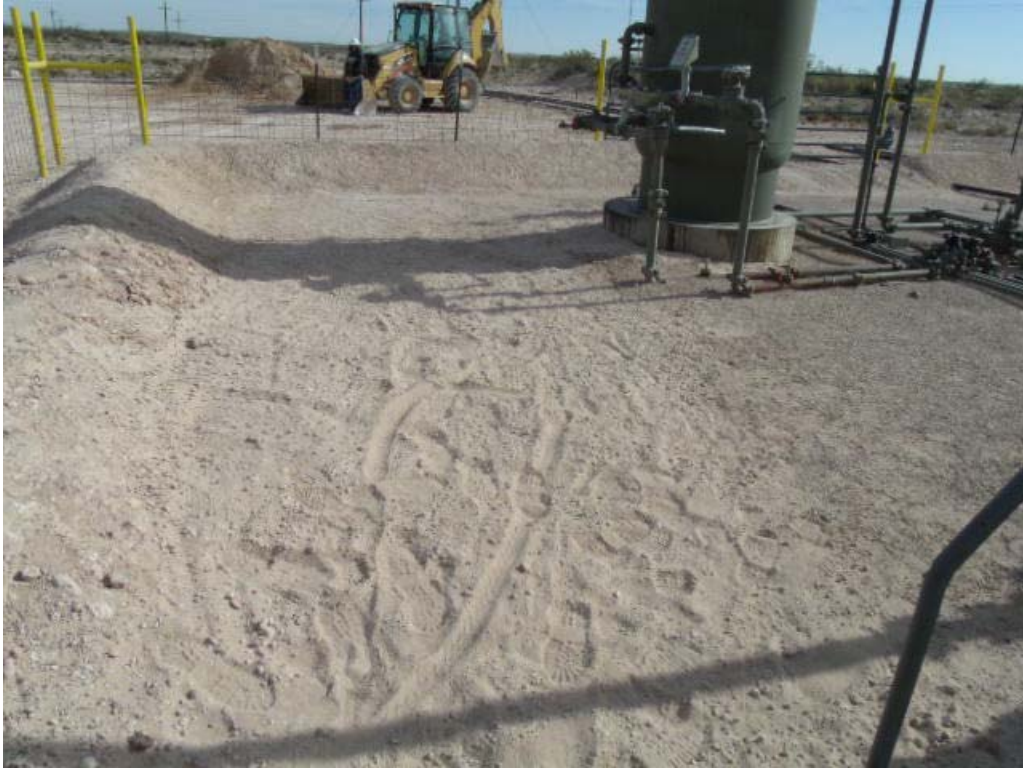
Photograph #13 – Backfilled area

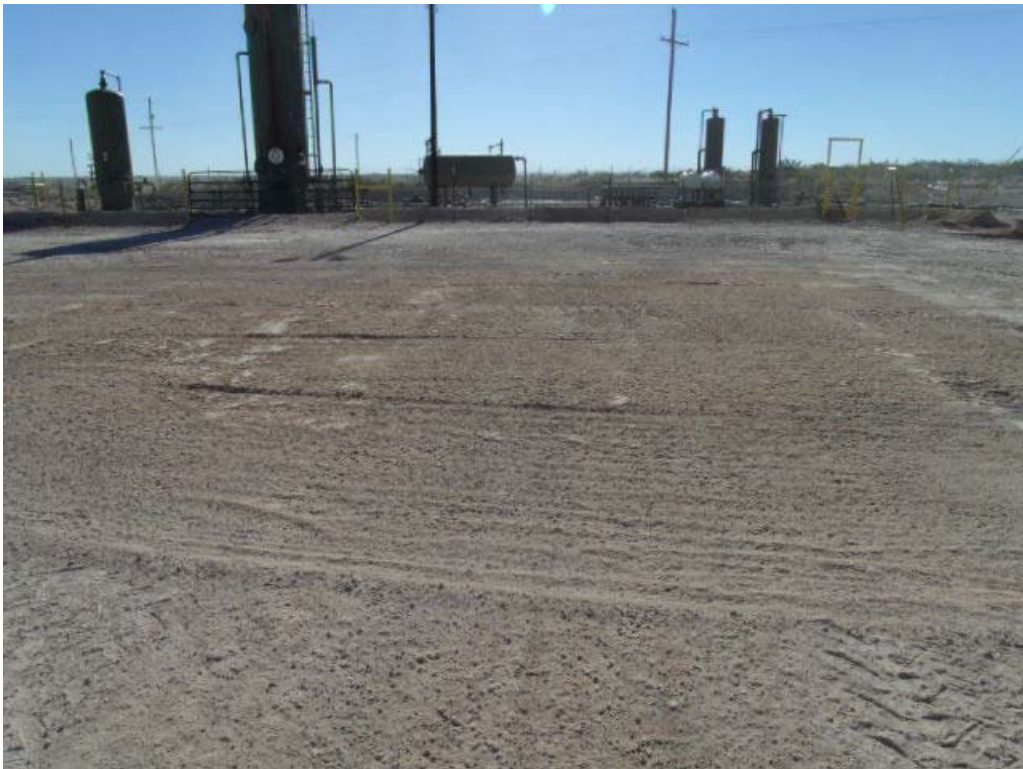
Photograph #14 – Backfilled area
