H E West B #33

REMEDIATION WORK PLAN

API No. 30-015-25944

Release Date: February 12th, 2015

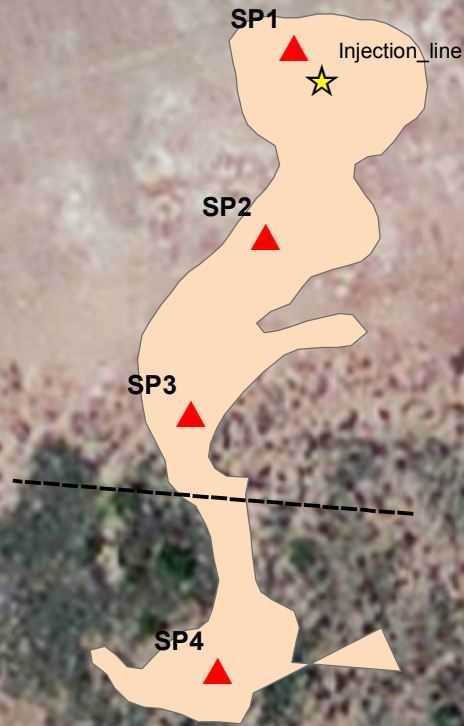
Site Diagram

The site is located northeast of Loco Hills NM, in Lea County. The leak site resulted from a truck hitting the well and breaking off a tubing valve. The impacted area is the caliche pad and south into the pasture. A site map is attached. A C-141 was submitted to the NMOCD on February 17th, 2015.

Spill Area:
8,088 sq. ft.

Scrape the caliche pad to 6" bgs and backfill with clean caliche. Remove the pasture impacted soil down to 3' bgs. DFSI proposes to use the surrounding terrain for backfill and contour; then seed with a BLM, OCD approved seed mix.
